# RE-INSPECTION REPORT

6094 Sabal Creek Blvd

07/30/2018 10:20 pm

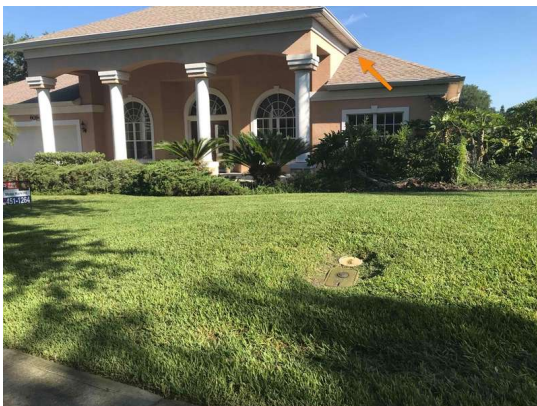
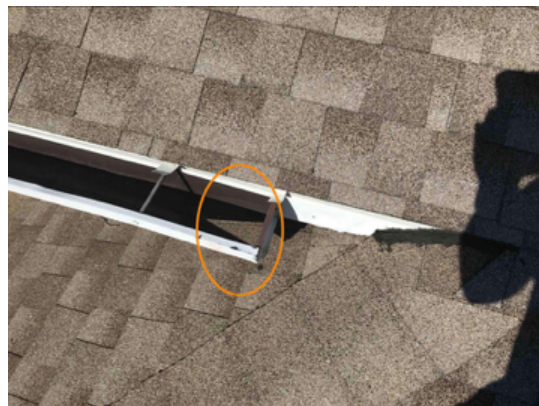
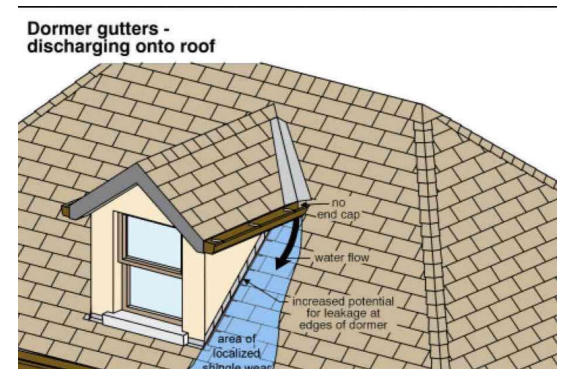
End caps are in place.

## GUTTER DRAINS ON ROOF

One or more downspouts terminated above a roof surface, and rainwater from the downspouts washes over the roof surface below. This is a common configuration, but in some cases large quantities of rainwater can damage shingles by removing granules and reduce the life of the roof surface. Consider installing extensions to route the rainwater directly to the closest gutter below to prevent such damage.

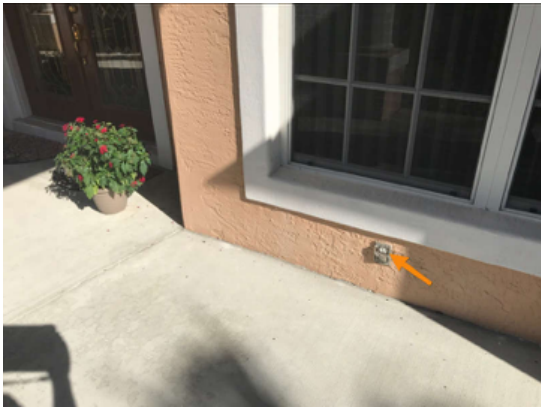
New Cover was installed on electrical outlet

## WATERPROOF COVER DAMAGED

Waterproof cover(s) over one or more electric receptacles are damaged or broken. This is a safety hazard due to the risk of shock and fire. Damaged covers should be replaced where necessary.

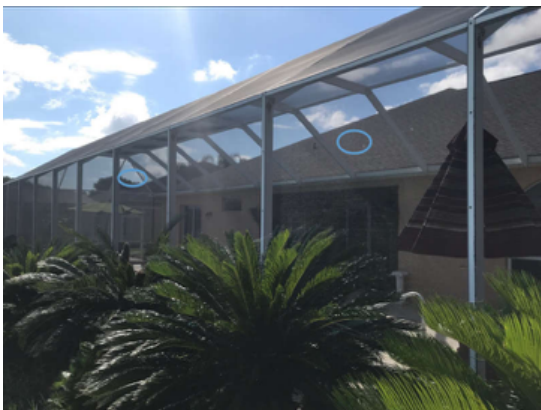
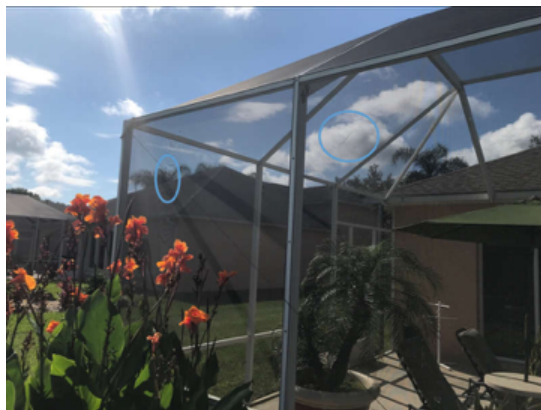
4 new screens were installed on most damaged sections.

## SCREEN ENCLOSURE SCREEN TORN/PATCHED

One or more screens are torn or missing in the frame(s) of the screen patio. Recommend making the necessary repairs.

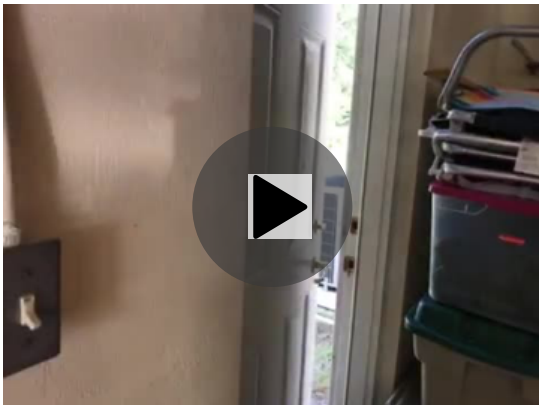
The door was adjusted and opens more freely now.

## EXTERIOR DOOR DIFFICULT

One or more exterior doors were difficult or sticking. Recommend that a qualified person repair as necessary.

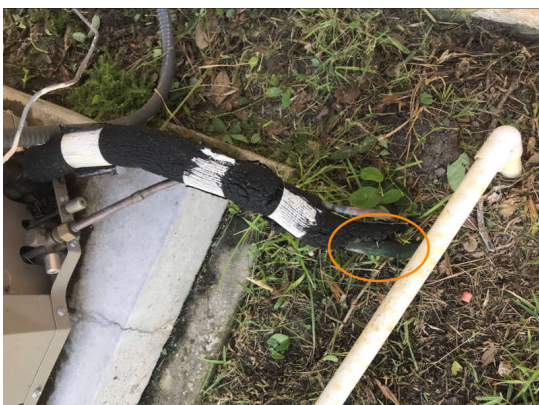
A section of insulation was added.

## LINE INSULATION

Insulation for the outside condensing unit's refrigerant lines is damaged, deteriorated and/or missing in one or more areas. This may result in reduced efficiency and increased energy costs. A qualified heating and cooling contractor should replace insulation as necessary.

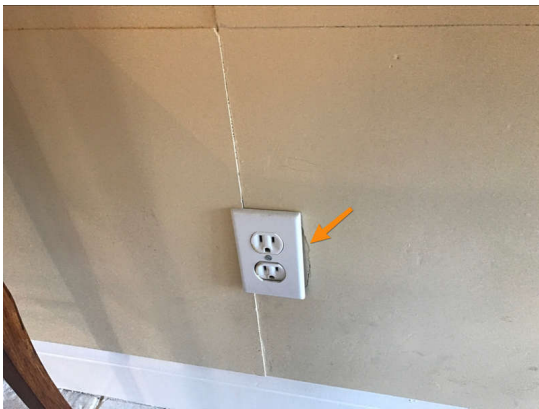
The receptacle has been tightened, however the cover plate cracked during the process... Owners advised they will replace plate.

## RECEPTACLE DAMAGE

One or more receptacles were broken or damaged. This is a potential shock or fire hazard. Recommend that a qualified electrician replace such receptacles as necessary.

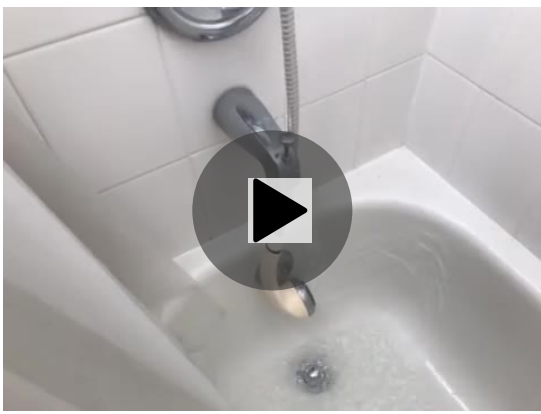
The valve has been repaired/replaced and functions as intended.

## MIXING VALVE

The mixing valve in one or bathrooms is not properly operating. The mixing valve allows the hot and cold water to mix so the temperature can be controlled by any person. The mixing valve is not properly mixing hot and cold water at the valve. There is only hot or cold water coming out of the mixing valve. It is recommended to have a Certified Plumbing Contractor make the necessary repairs.

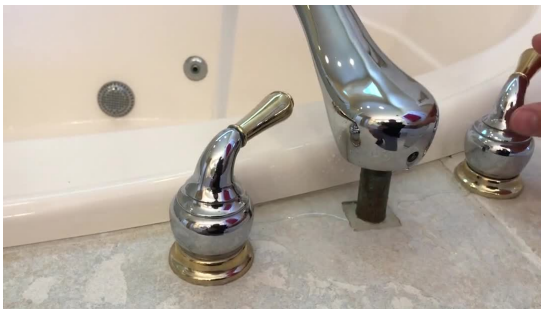
The area of the leak was caulked. No apparent leaks noted at time of inspection.

Bathroom 3: Bathub  
**FAUCET LEAKS ON**

One or more faucets leak by handle(s) or at their base when turned on. A qualified plumber should evaluate and repair as necessary.

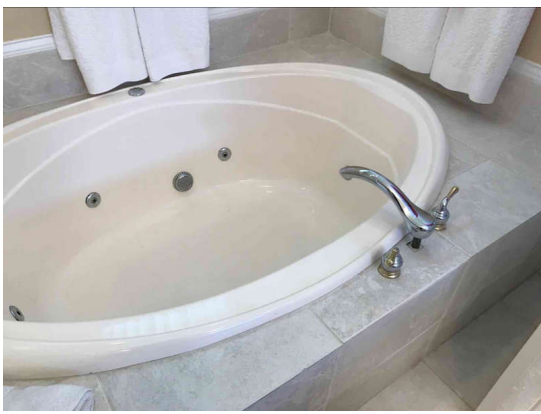
The jetted tub was operational at time of inspection.

Bathroom 3: Bathub  
**JETTED TUB INOPERABLE**

The jetted tub was inoperable. The tub should be evaluated and repaired as needed.

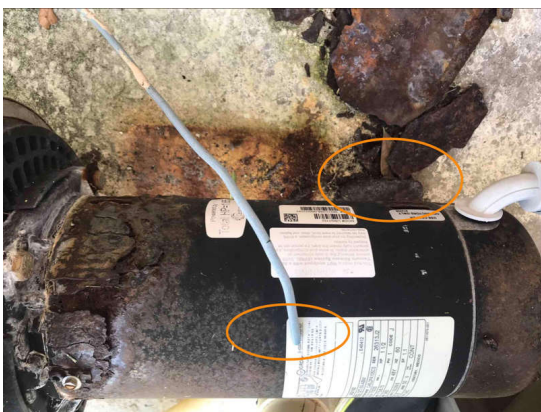
The bonding Cable was NOT repaired/replaced at time of inspection

## BONDING

The bonding wire is missing or not properly connected to the pool circulation pump and or other pool equipment. It is highly recommended to have the wire properly installed for safety.
