REPAIR REQUEST LIST

1467 Cottonwood Rd
05/28/2024 12:23 pm

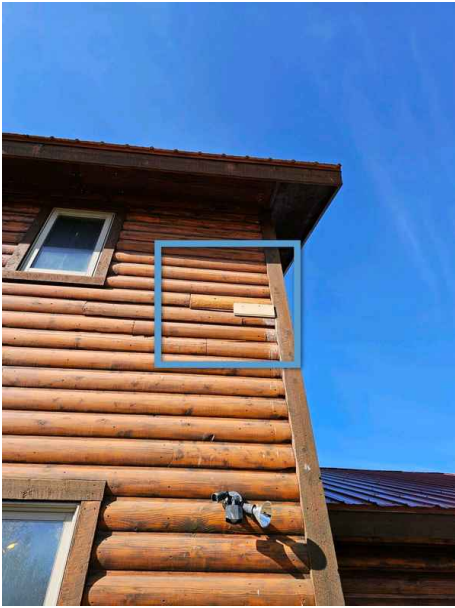
Original Inspection 4/23

Recent or past repairs to the exterior siding was observed. We could not determine the reason for the repairs and recommend asking the seller about repairs and why they were needed.

All bird damage has been repaired.

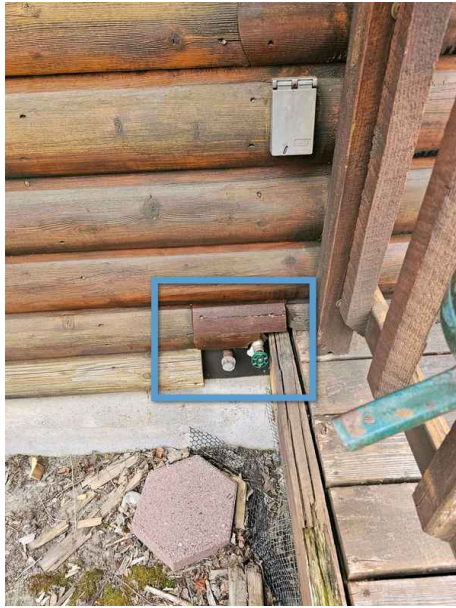
Repaired as of 5/29

Repair was done as of 5/29.

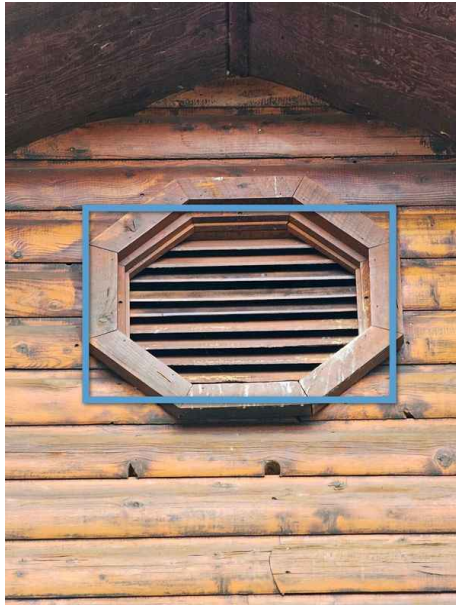
Repaired as of 5/29

Repair was made as of 5/29

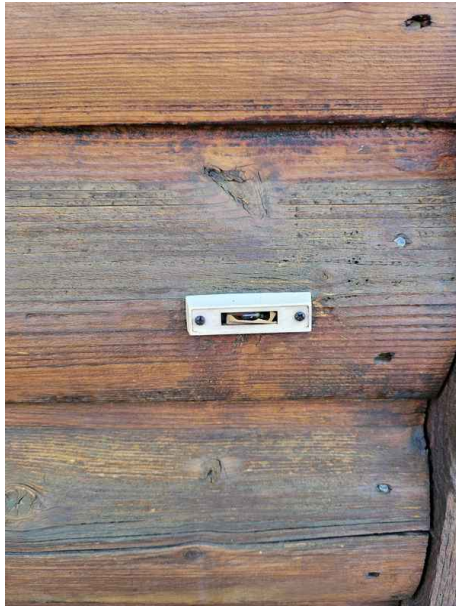
The doorbell button is damaged or missing. You may want to have it replaced.

Replaced

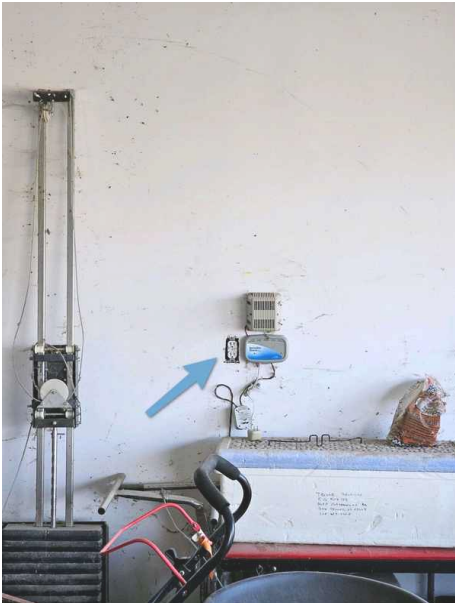
Original Inspection 4/23

Coverplates were missing on outlets, switches or junction boxes. Recommend installing cover plates.

Cover plate installed

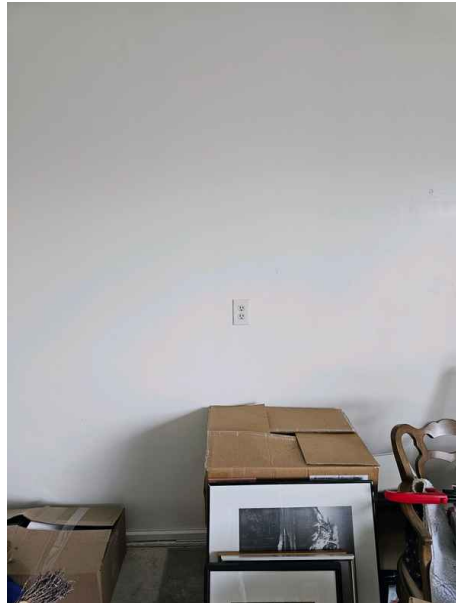
Repaired as of 5/29

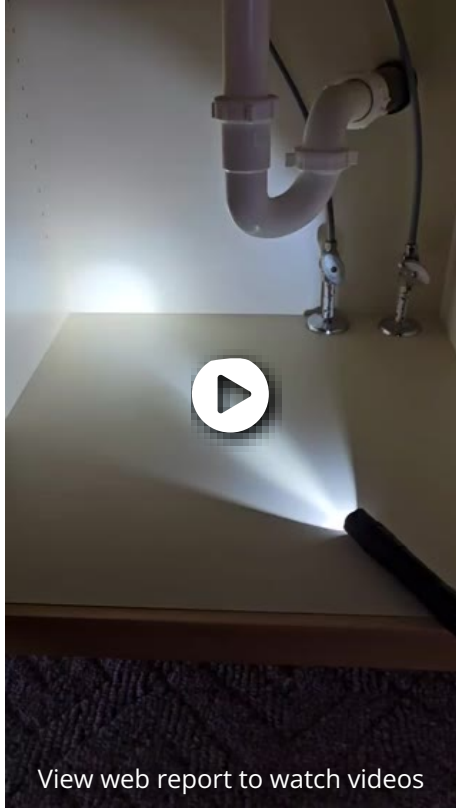
Repaired as of 5/29

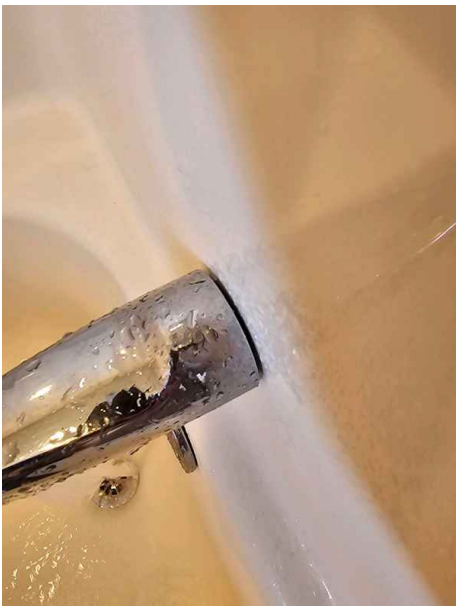
Location
1st Floor Bathroom

Gaps or openings are observed around shower valves and faucet. Recommend sealing.

Caulking was performed

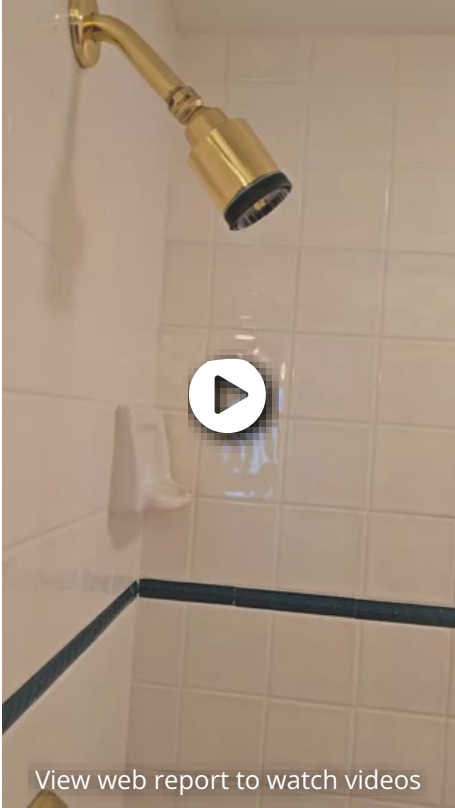
Location
Master Bathroom

There is no hot water supply at the tub-shower faucet. There is cold water supply, but when the handle is turned to the left or hot side, the water supply stops. Recommend further evaluation & repair.

Handle needs to be turned the other direction

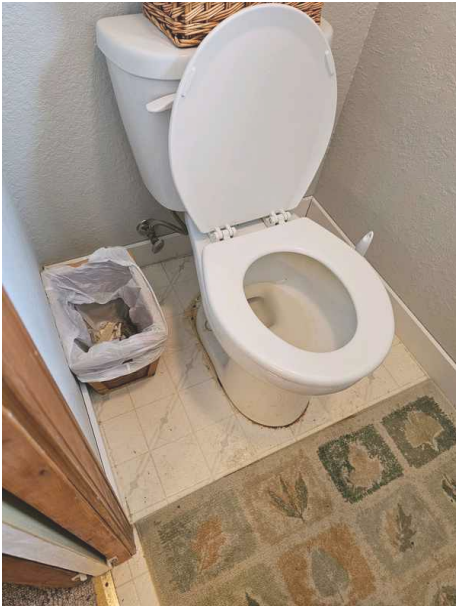
Original Inspection 4/23

Staining and lifted flooring was observed around the base of the toilet. Recommend further evaluation.

Toilet has been thoroughly cleaned. No evidence of leaking

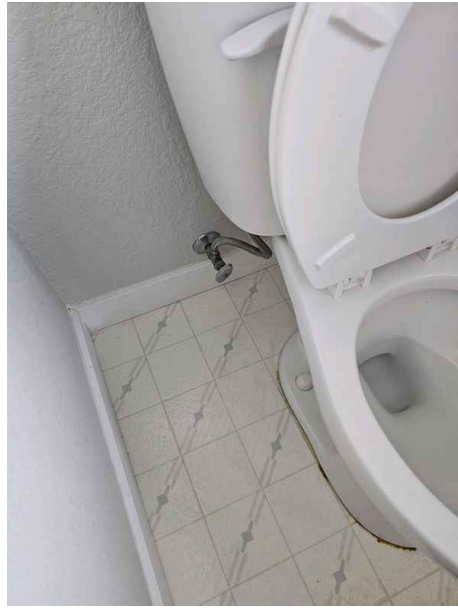
Repaired as of 5/29

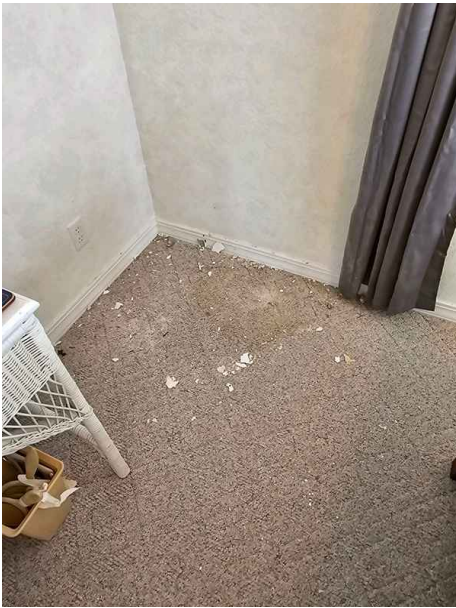
The carpet is stained. Recommend a thorough cleaning or replacement as needed.

Professional carpet cleaners have cleaned the areas of concern

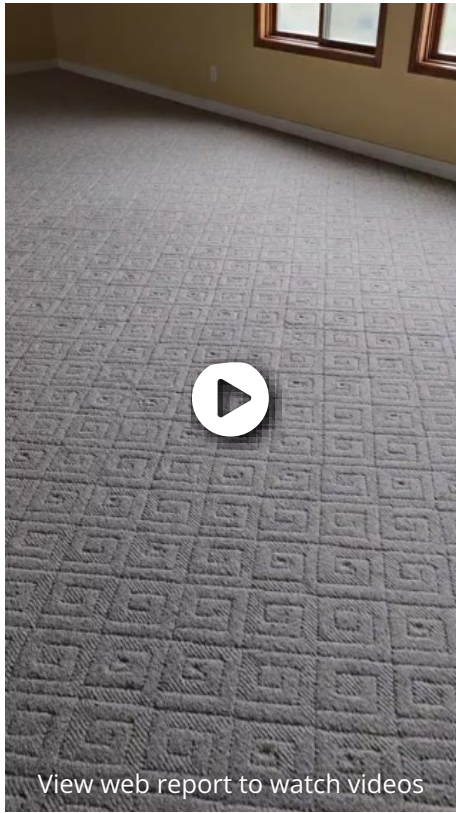
Improvements made as of 5/29
