REPAIR REQUEST LIST

1467 Cottonwood Rd
05/28/2024 12:23 pm

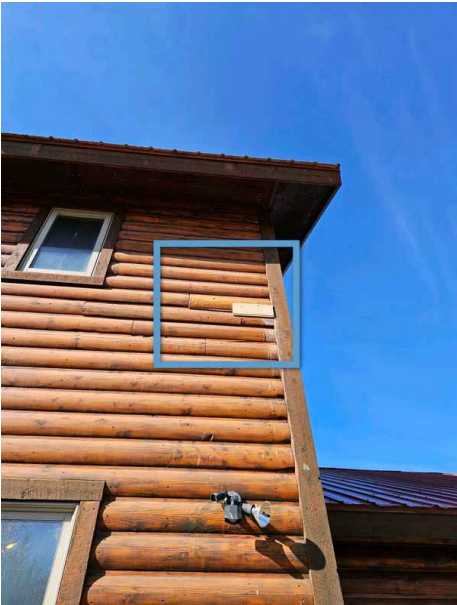
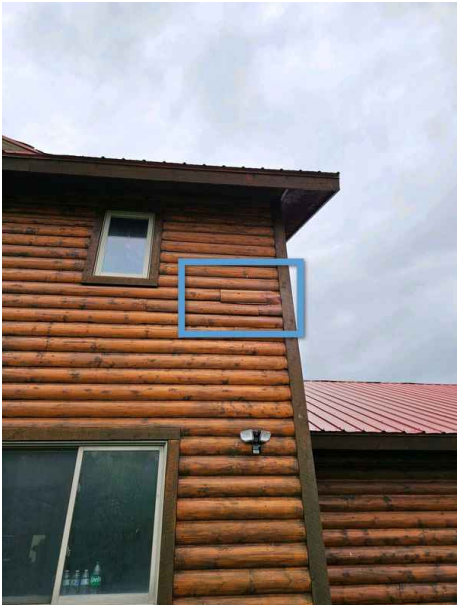
Location
Front

Recent or past repairs to the exterior siding was observed. We could not determine the reason for the repairs and recommend asking the seller about repairs and why they were needed.

All bird damage has been repaired.

Old patch was cleaned up as of 5/29

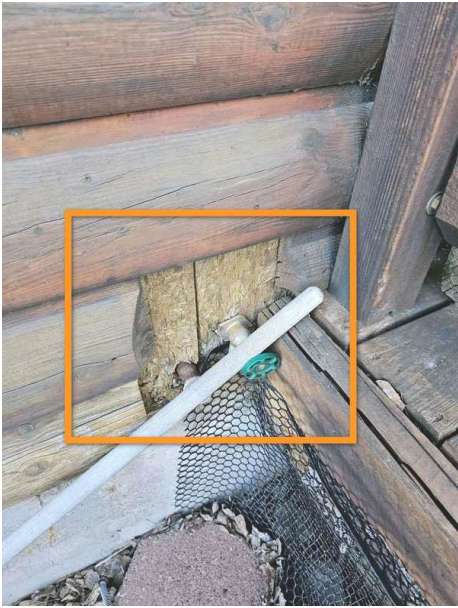
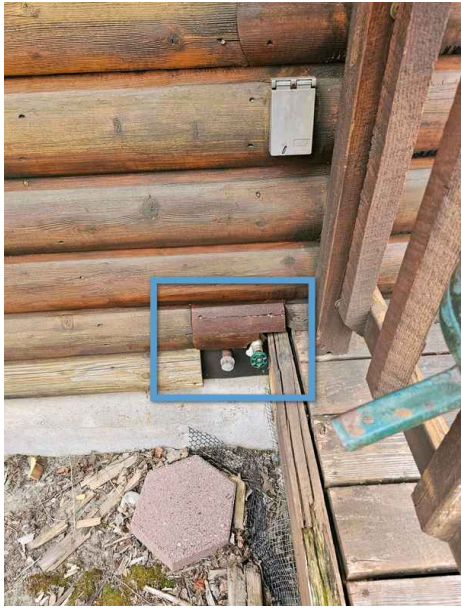
Location
Rear

Portions of the siding are missing. Recommend repairs.

Repaired.

Repair was done as of 5/29.

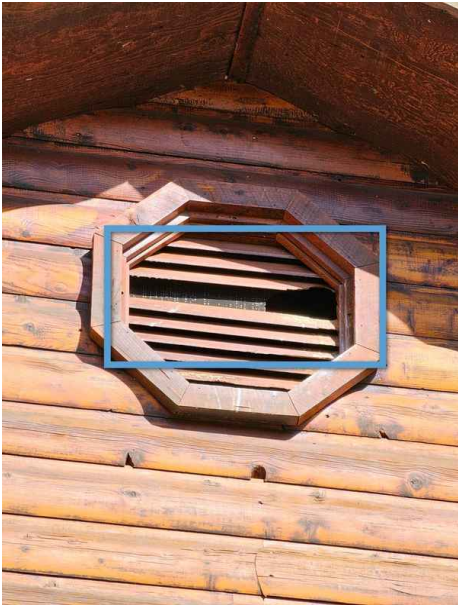
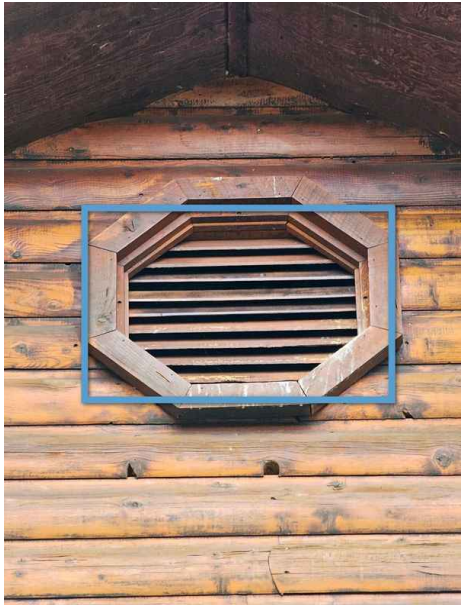
Location
Front

One or more gaps were observed. Recommend sealing to prevent pest access.

Repaired

Repair was made as of 5/29

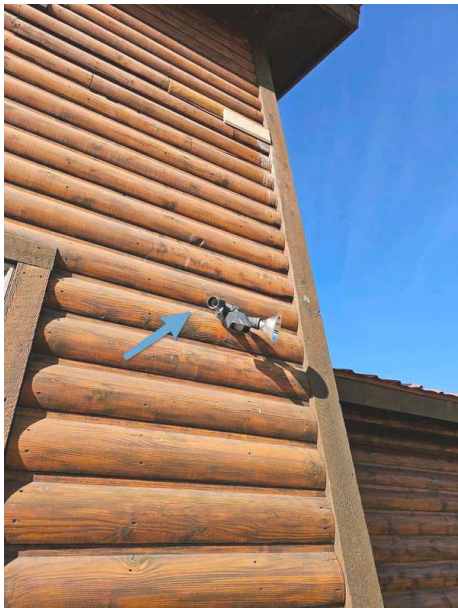
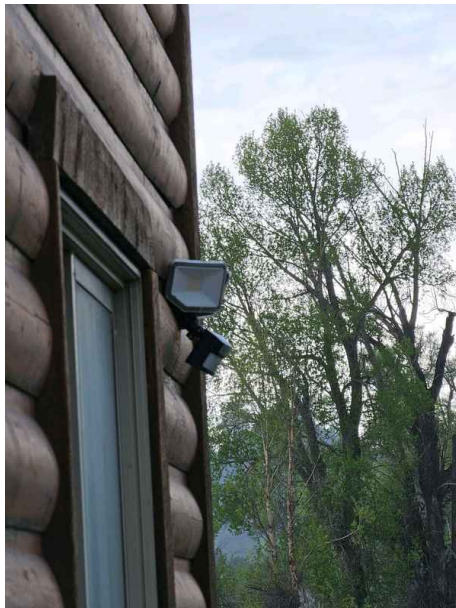
Location
Front

Some lights around the residence did not have light bulbs or the bulbs were burnt out. Recommend replacing bulbs and testing.

All new flood lights installed

Repaired as of 5/29

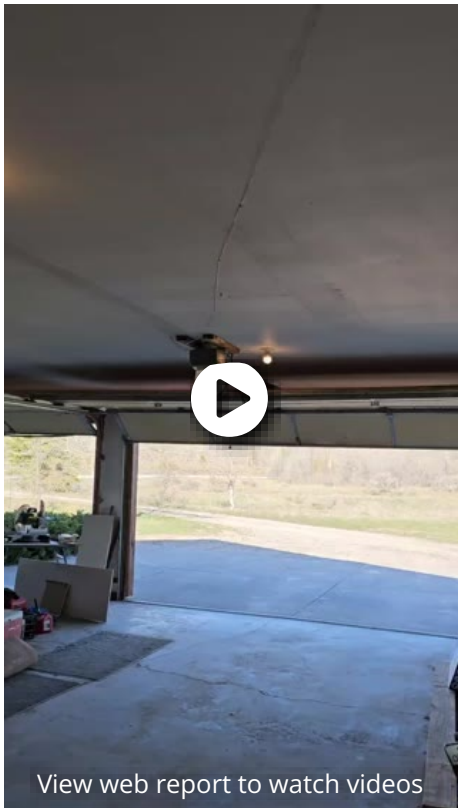
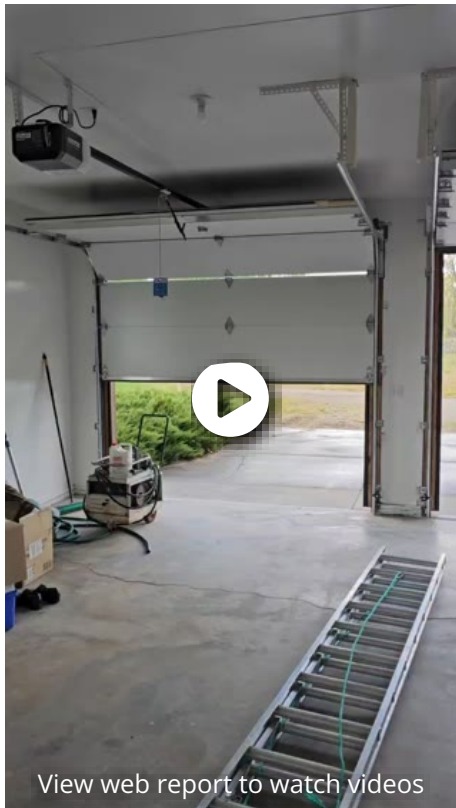
The garage door opener does not work as intended. Recommend repair.

All new garage doors installed

Repaired as of 5/29

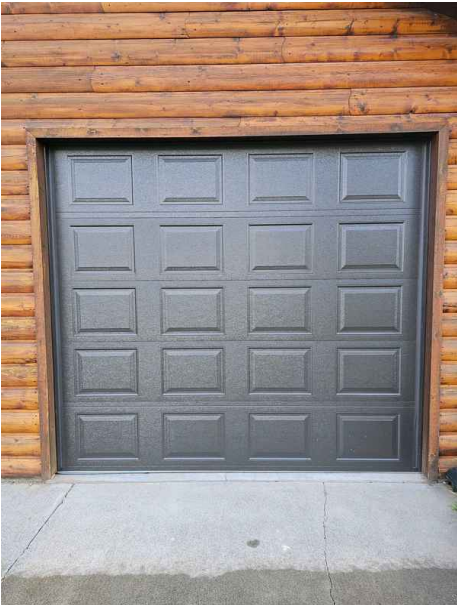
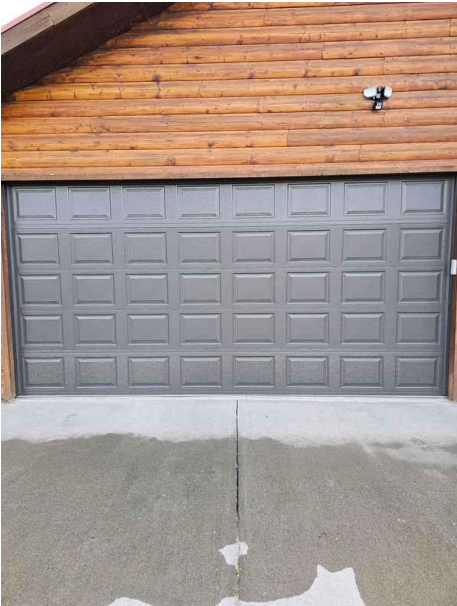
The main garage door is functional, but has cosmetic damage. Recommend repair as needed.

All new garage doors installed

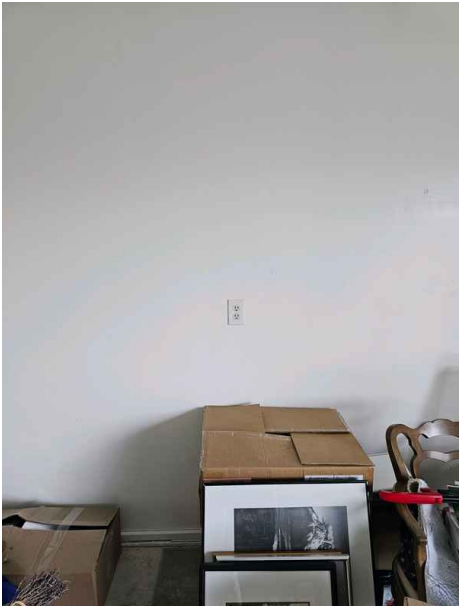
Coverplates were missing on outlets, switches or junction boxes. Recommend installing cover plates.
Repaired as of 5/29

Cover plate installed

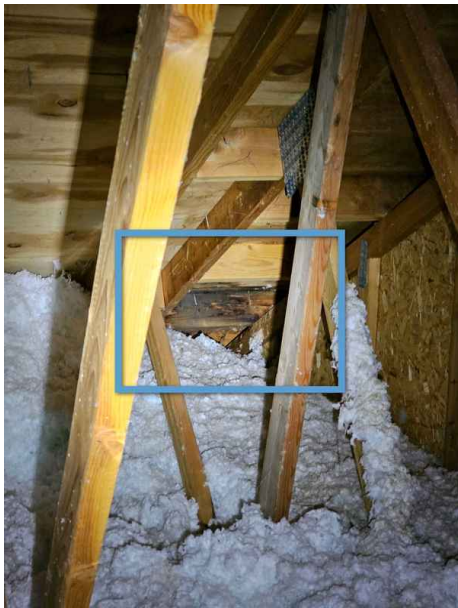
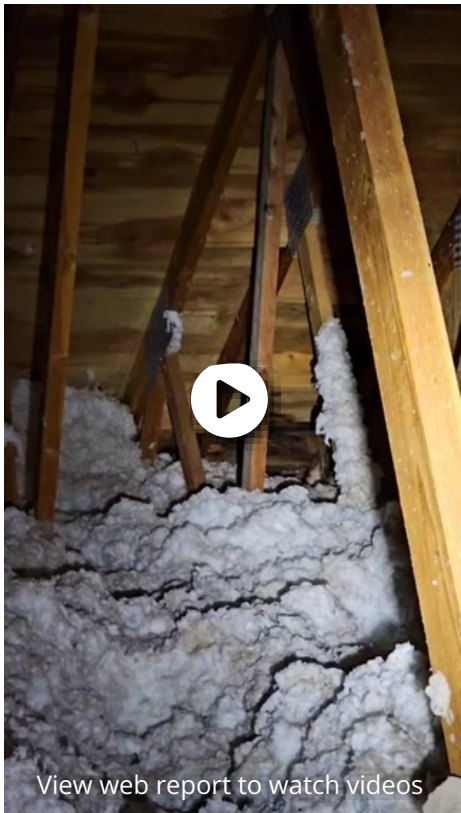
There are moisture stains on the underside of some wood decking. Recommend monitoring.
Old stain is still visible but no current moisture as of return visit 5/29 even with current rainfall.

There was a leak, but that has been addressed and repaired by Weddle & Sons Roofing

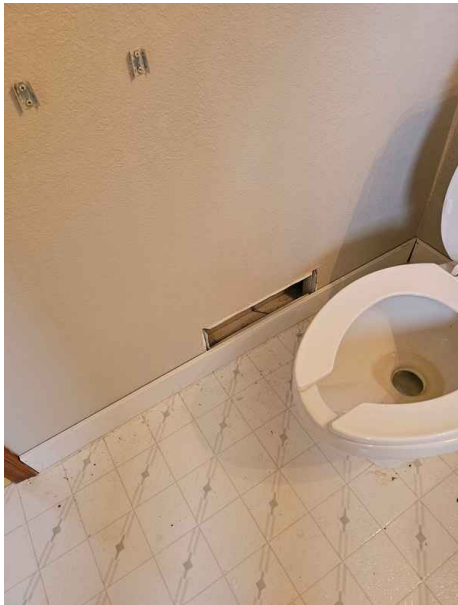
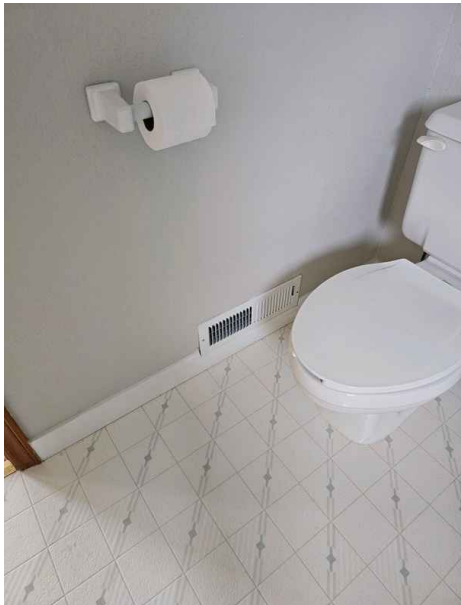
Location
2nd Floor Powder Bathroom

One or more register is missing. Recommend installing.

All registers have been replaced if missing

Repaired as of 5/29

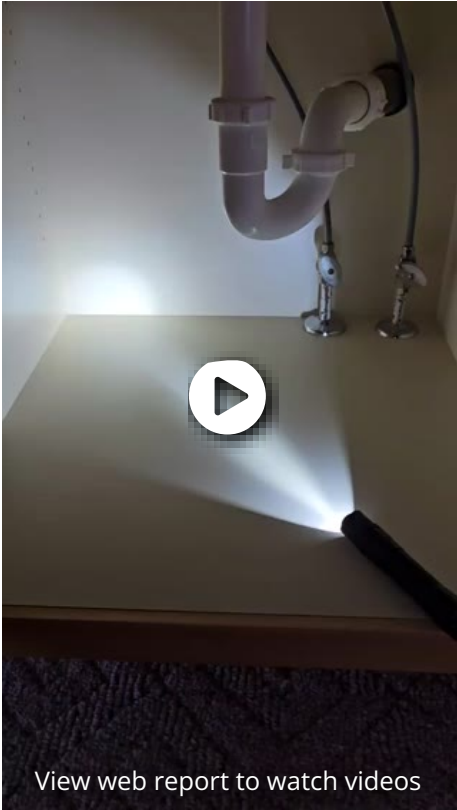
Location
2nd Floor Kitchenette

There is a leak at the drain line below the sink. Recommend repair.

Leak addressed and tightened

Repaired as of 5/29

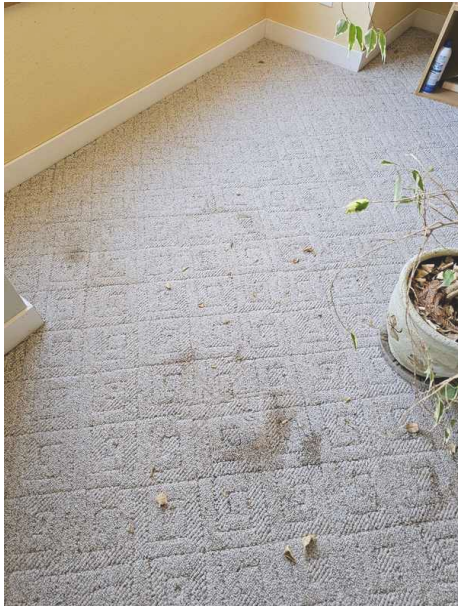
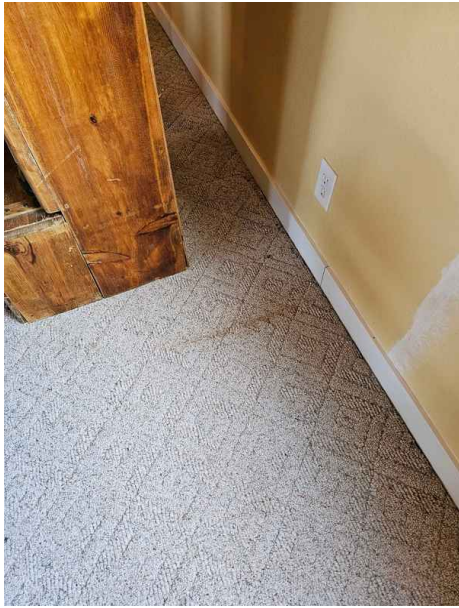
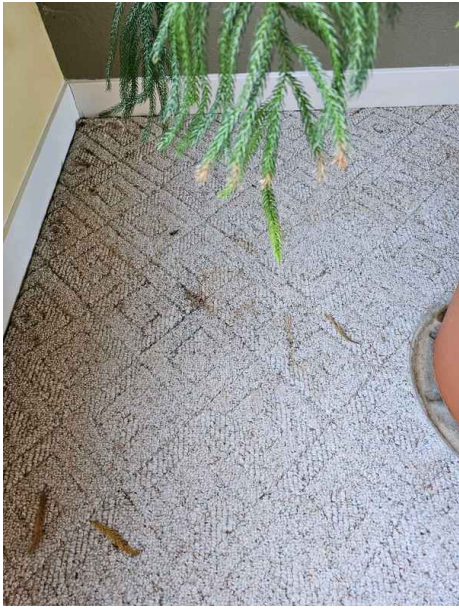
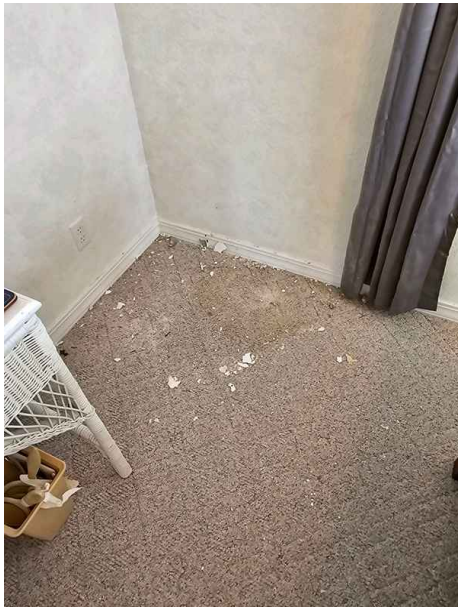
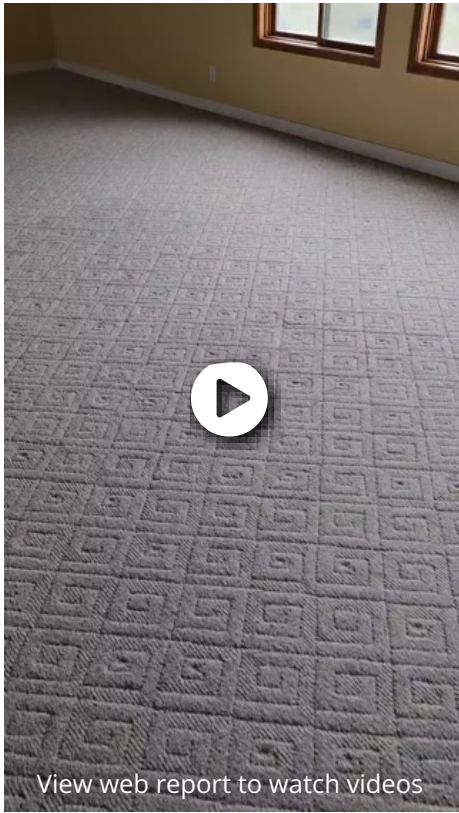
Location
Several Areas Throughout

The carpet is stained. Recommend a thorough cleaning or replacement as needed.

Professional carpet cleaners have cleaned the areas of concern

Improvements made as of 5/29

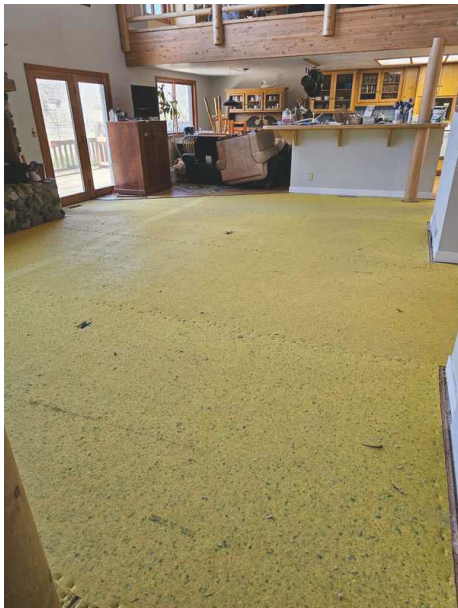
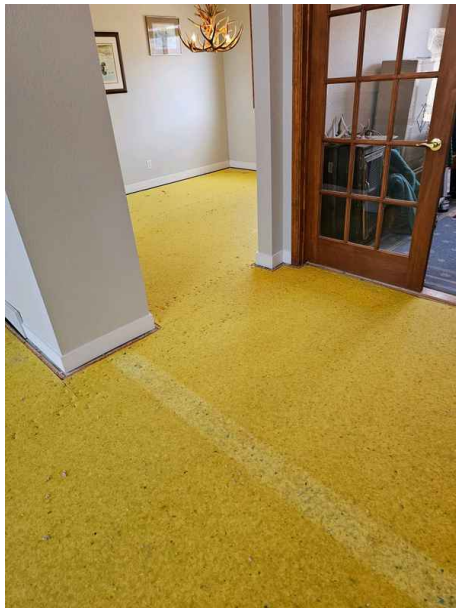
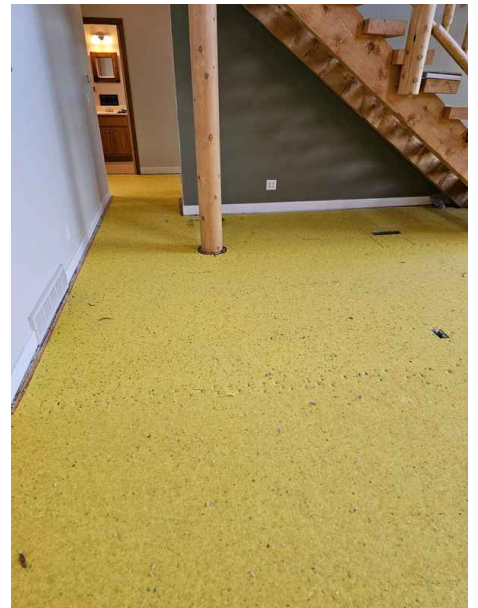
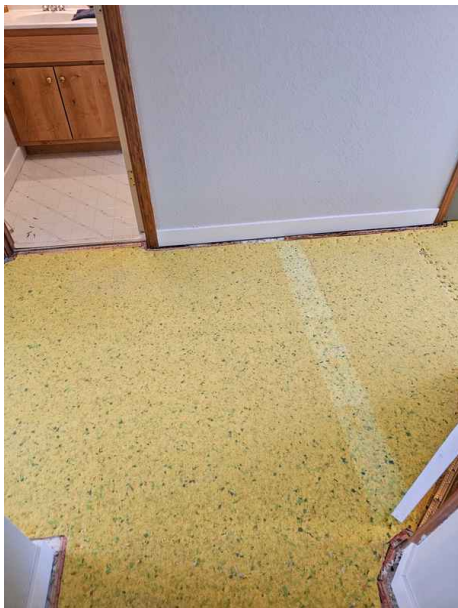
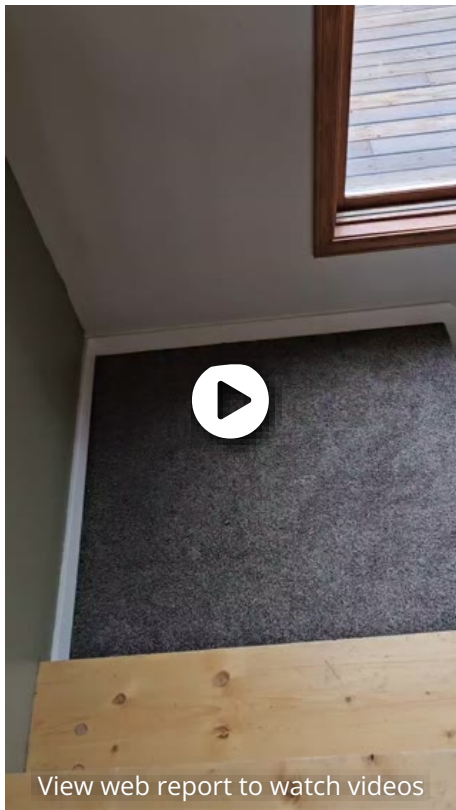
Location
Throughout 1st Floor

The flooring was removed. Recommend installing.

Repaired as of 5/29

New carpet has been installed

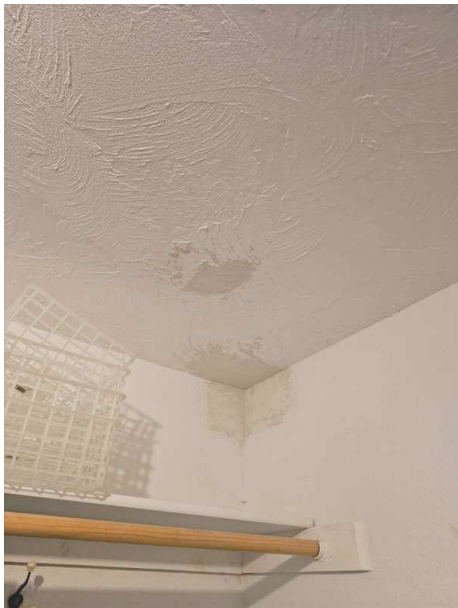
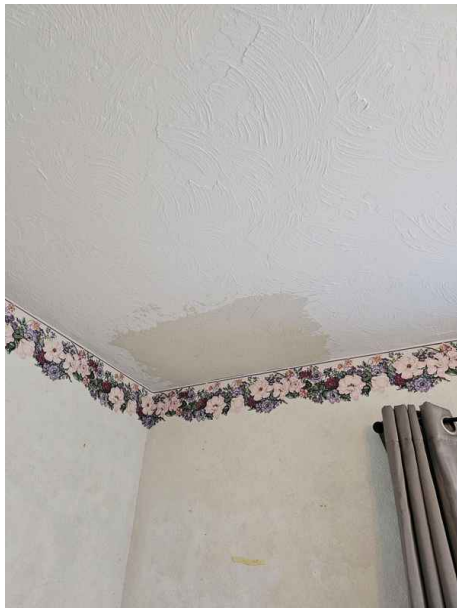
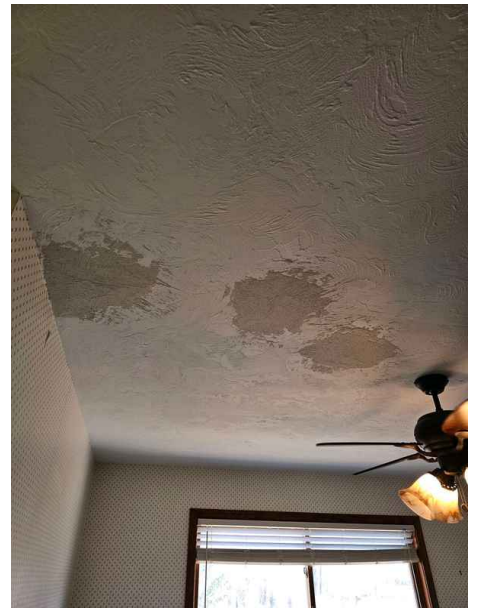
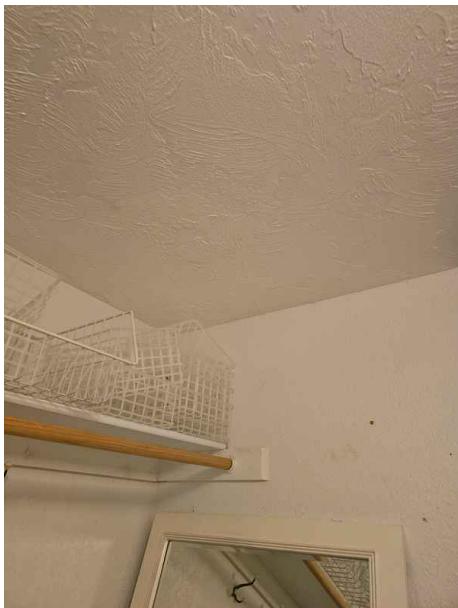
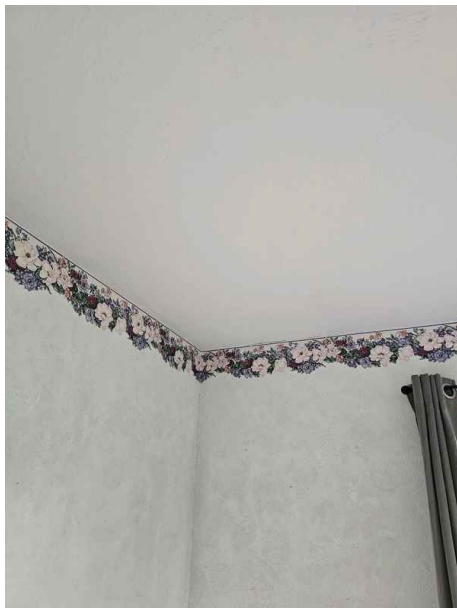
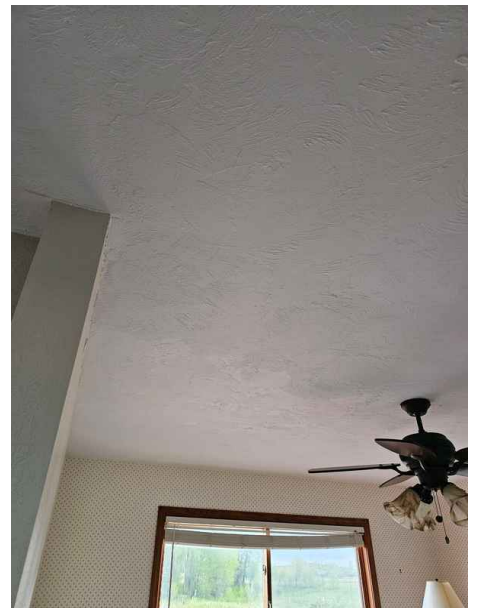
Patches or repairs were observed in the wall or ceiling. We could not determine the reason for the repairs. Recommend monitoring.

Sheetrock has been repaired

Improvement made as of 5/29

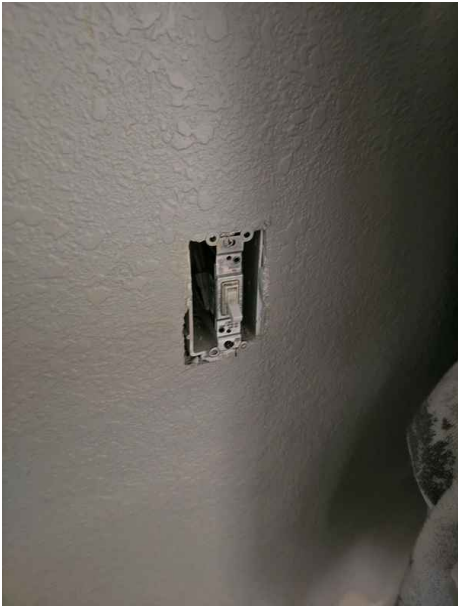
Master Bathroom

There were missing / damaged covers that should be installed

Cover plate installed
