# REPAIR REQUEST LIST

1467 Cottonwood Rd  
05/28/2024 12:22 pm

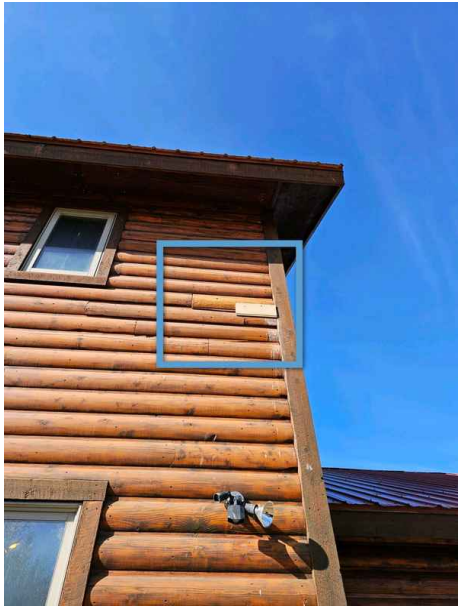
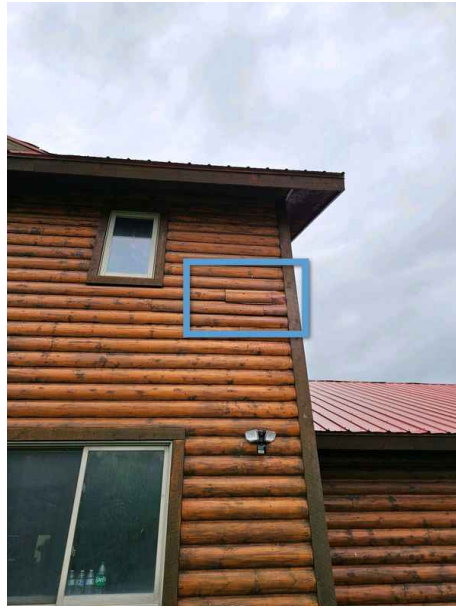
Location  
Front

Recent or past repairs to the exterior siding was observed. We could not determine the reason for the repairs and recommend asking the seller about repairs and why they were needed.

All bird damage has been repaired.

Old patch was cleaned up as of 5/29

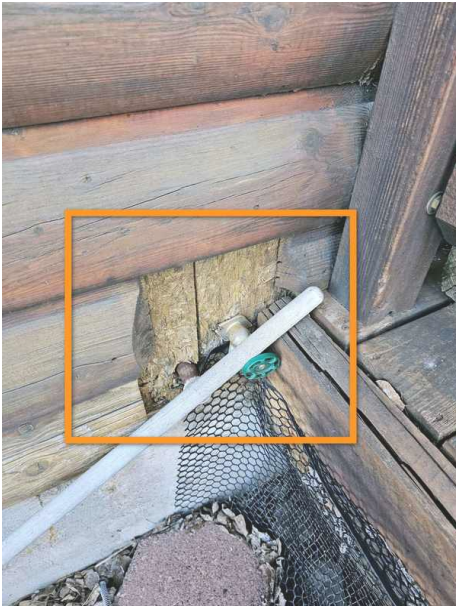
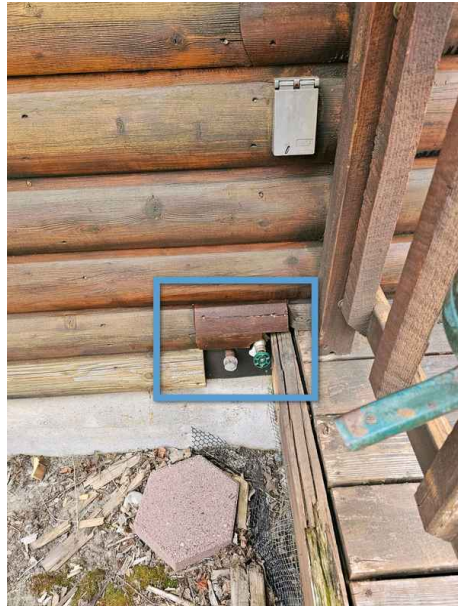
Location  
Rear

Portions of the siding are missing. Recommend repairs.

Repaired.

Repair was done as of 5/29.

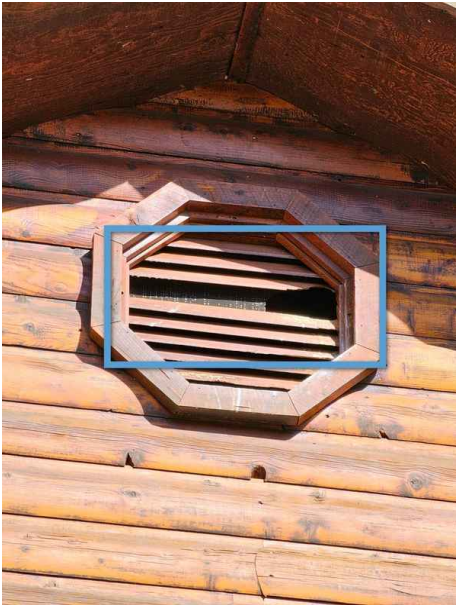
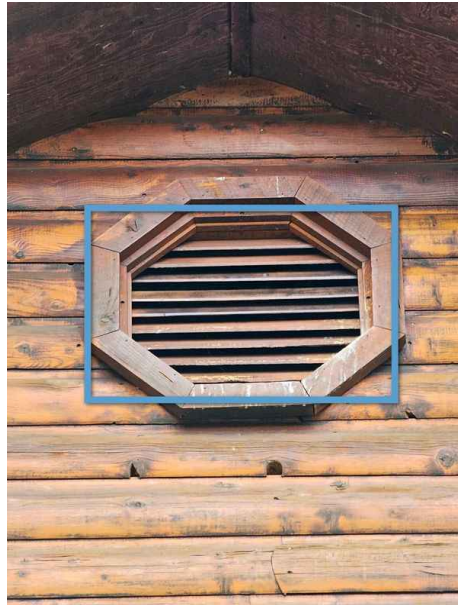
Location  
Front

One or more gaps were observed. Recommend sealing to prevent pest access.

Repaired

Repair was made as of 5/29

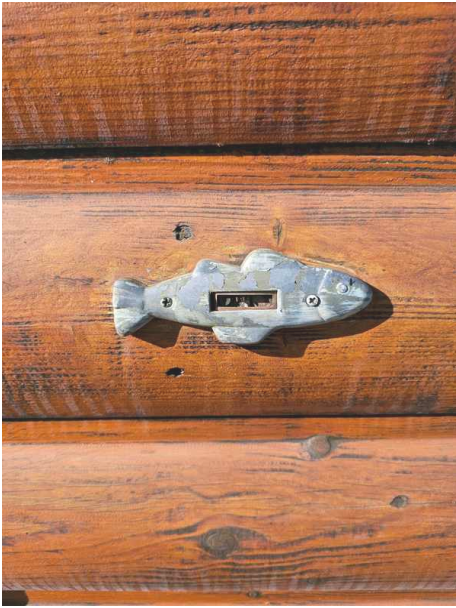
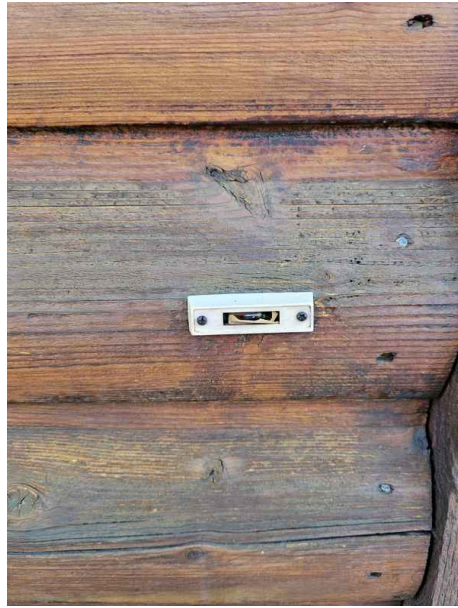
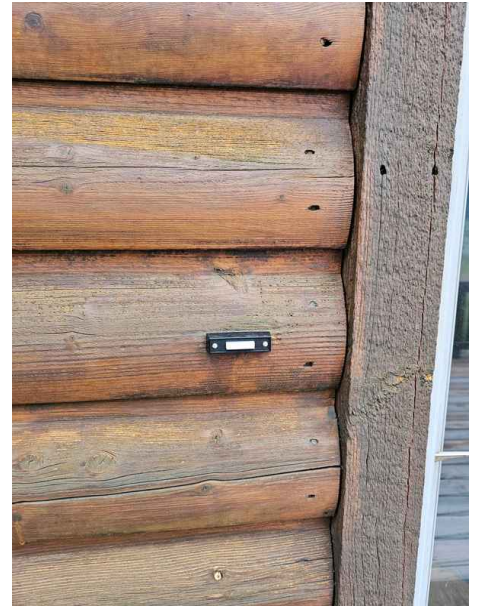
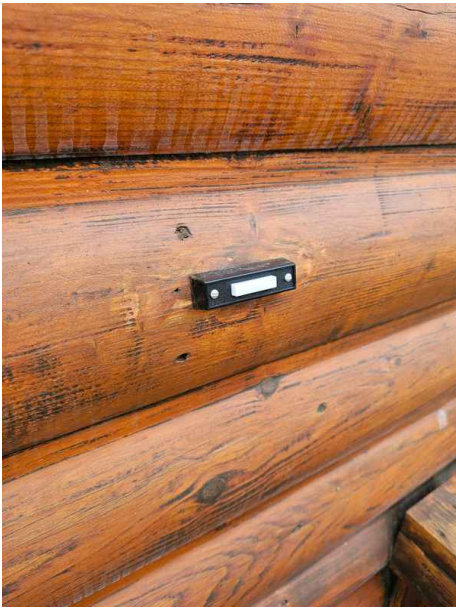
Location  
Front & Rear

The doorbell button is damaged or missing. You may want to have it replaced.

Replaced

Repaired as of 5/29

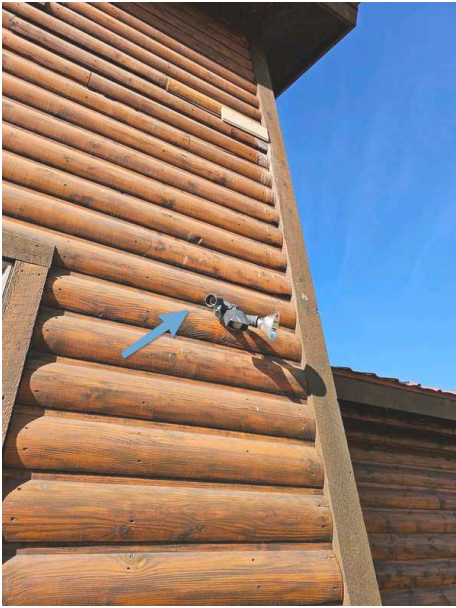
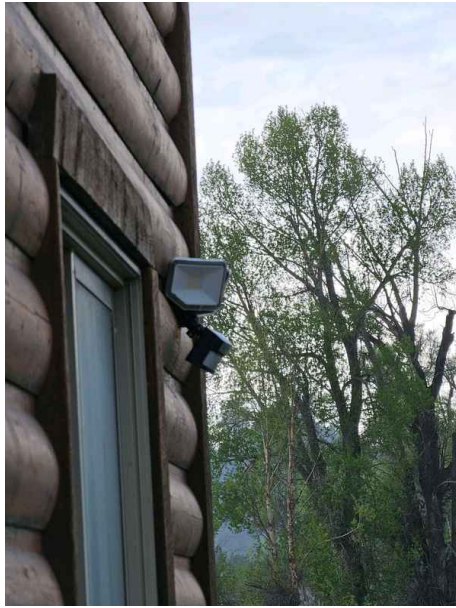
Location  
Front

Some lights around the residence did not have light bulbs or the bulbs were burnt out. Recommend replacing bulbs and testing.

All new flood lights installed

Repaired as of 5/29

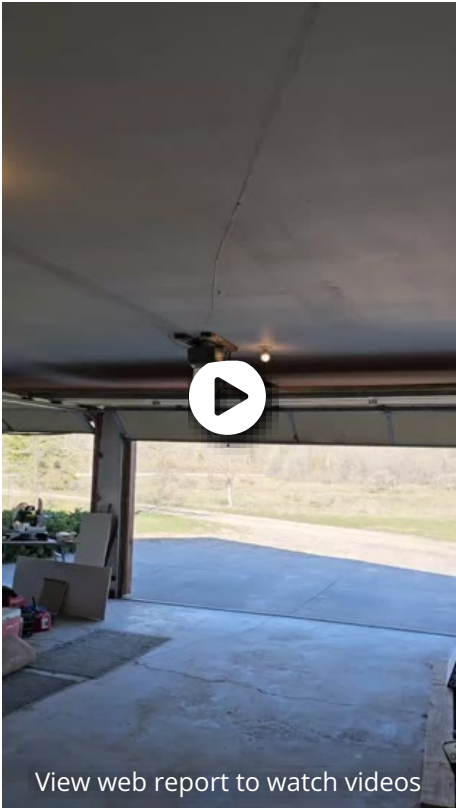
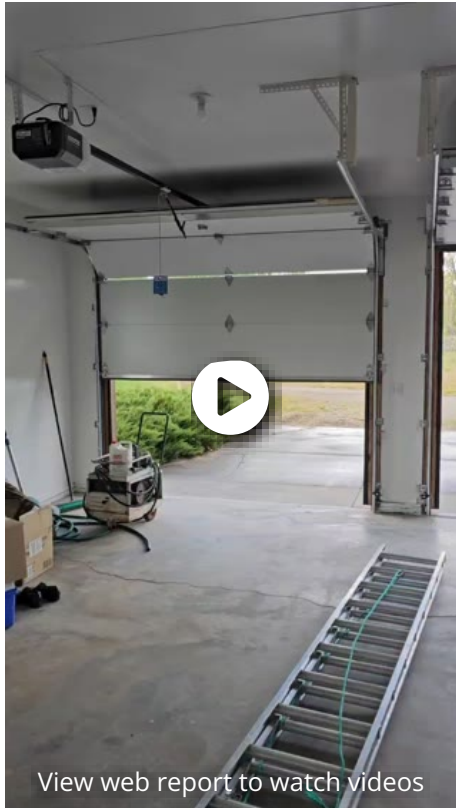
The garage door opener does not work as intended. Recommend repair.

All new garage doors installed

Repaired as of 5/29

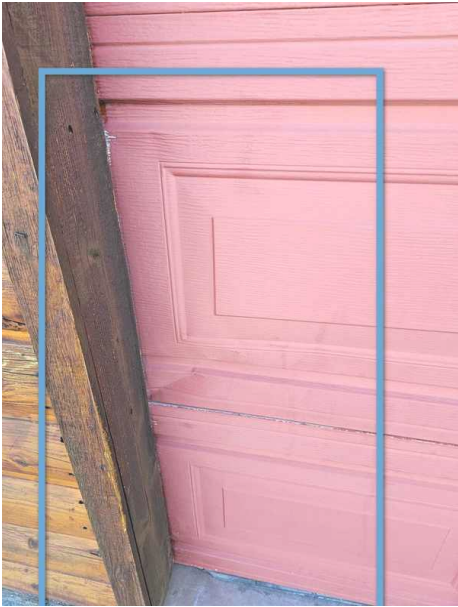
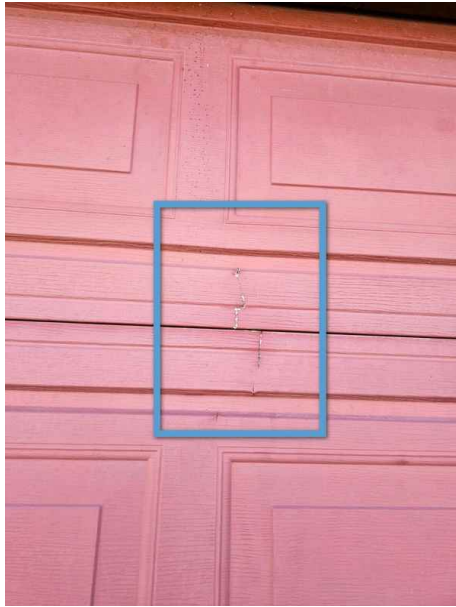
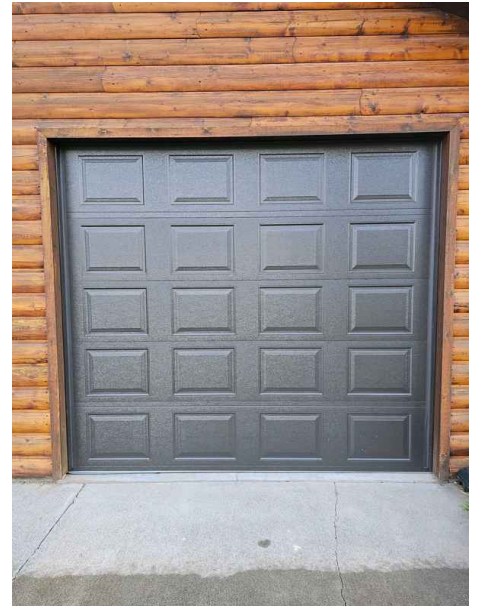
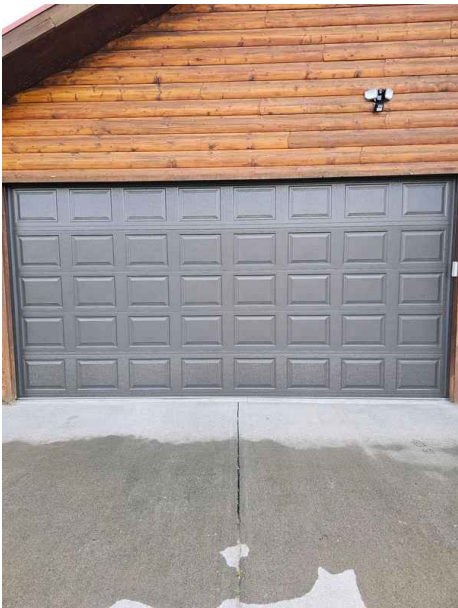
The main garage door is functional, but has cosmetic damage. Recommend repair as needed.

All new garage doors installed

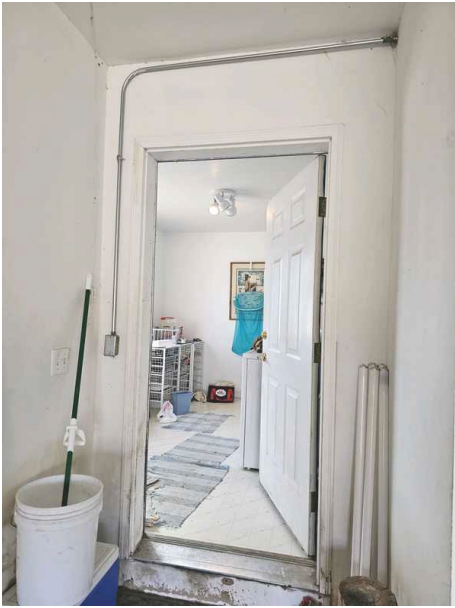
The house garage entry door is functional but does not self-close. This may not have been required when the house was built and you may elect to have self closing hinges installed for modern fire safety.

Still need to add a self closing hinge

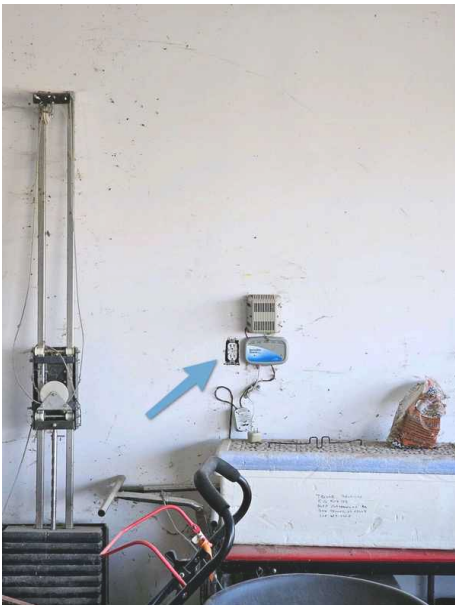
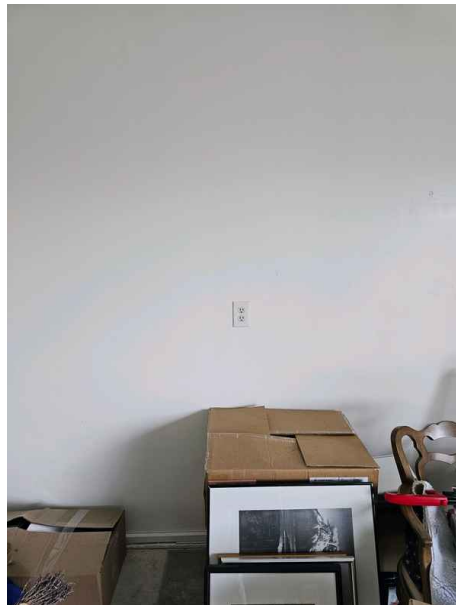
Coverplates were missing on outlets, switches or junction boxes. Recommend installing cover plates.

Cover plate installed

Repaired as of 5/29

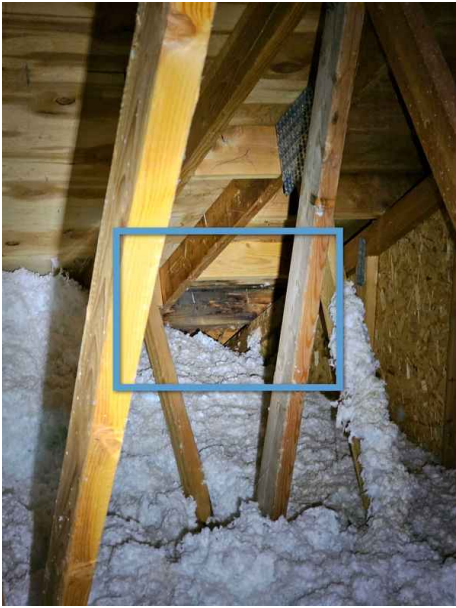
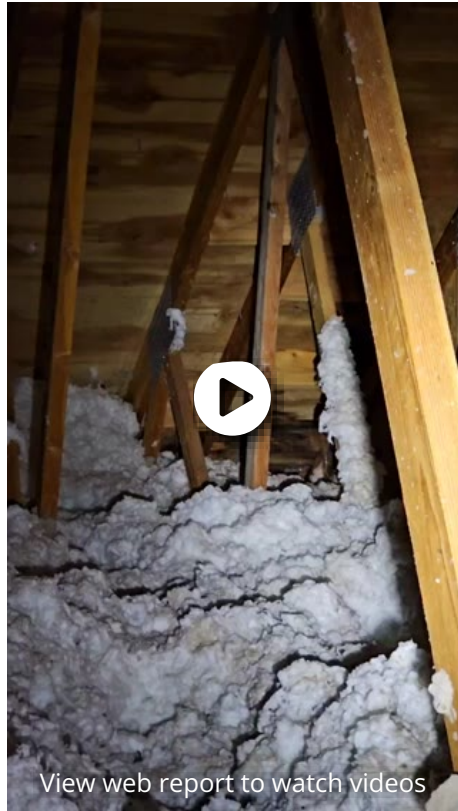
There are moisture stains on the underside of some wood decking. Recommend monitoring.

Old stain is still visible but no current moisture as of return visit 5/29 even with current rainfall.

There was a leak, but that has been addressed and repaired by Weddle & Sons Roofing

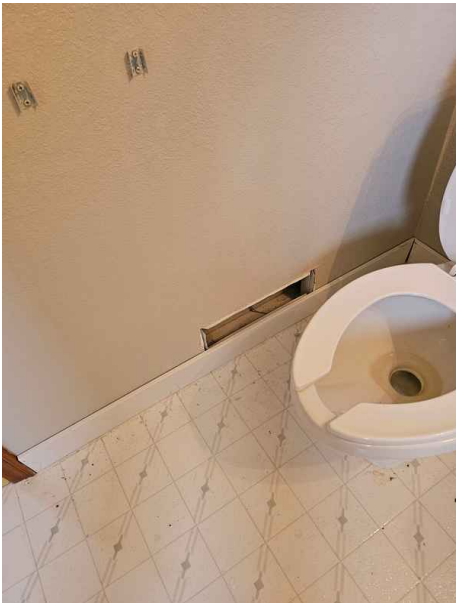
Location  
2nd Floor Powder Bathroom

One or more register is missing. Recommend installing.

All registers have been replaced if missing

Repaired as of 5/29

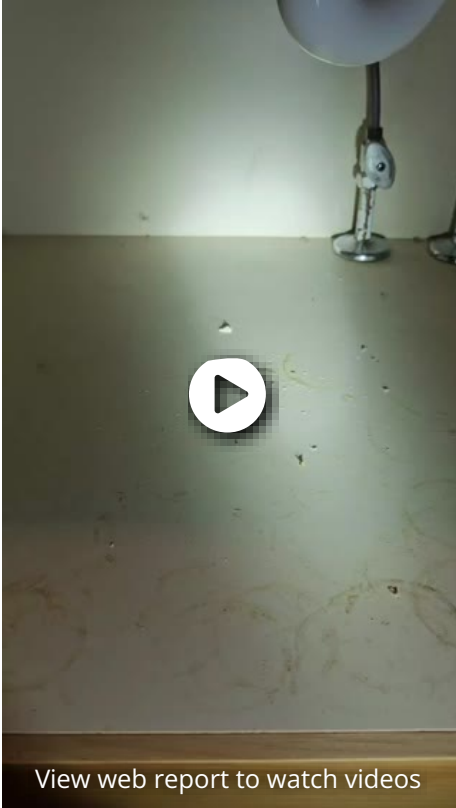
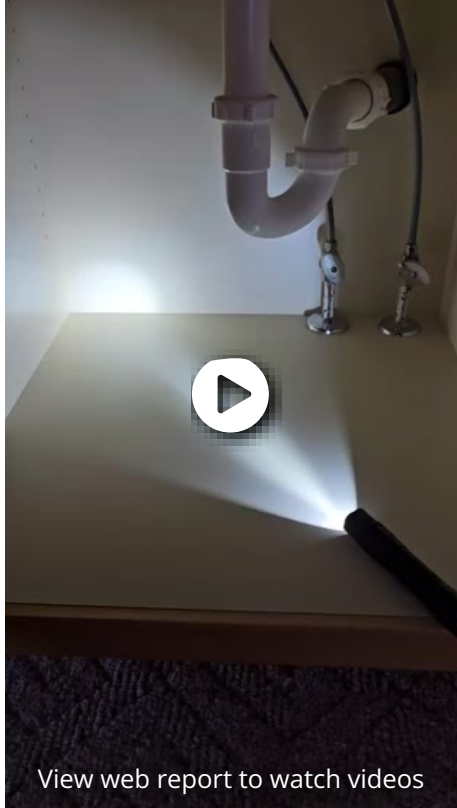
Location  
2nd Floor Kitchenette

There is a leak at the drain line below the sink. Recommend repair.

Leak addressed and tightened

Repaired as of 5/29

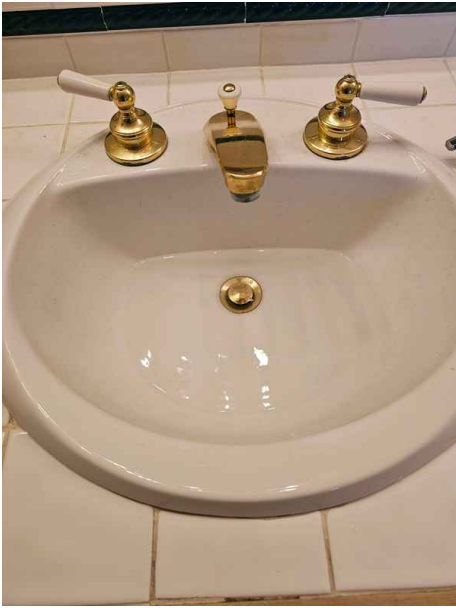
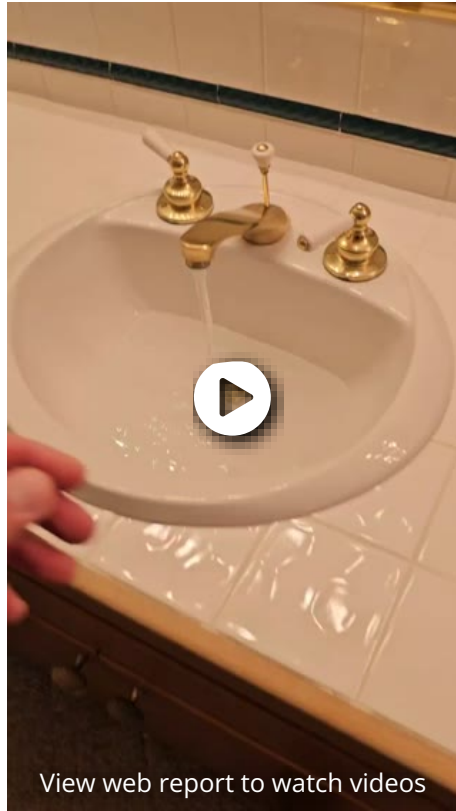
Location  
Master Bathroom

The sink drains slowly. Recommend repair.

Repaired

Repaired as of 5/29

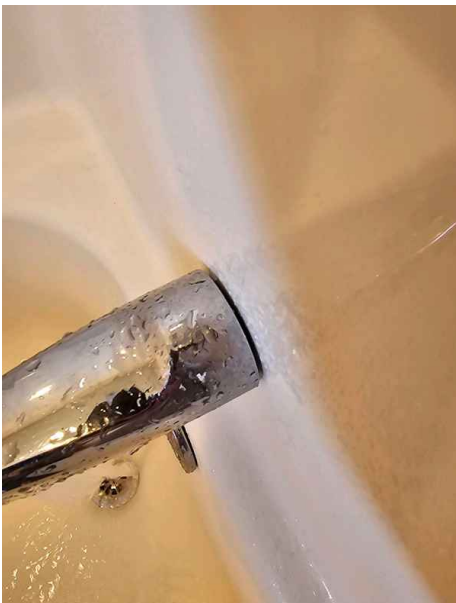
Location  
1st Floor Bathroom

Gaps or openings are observed around shower valves and faucet. Recommend sealing.

Caulking was performed

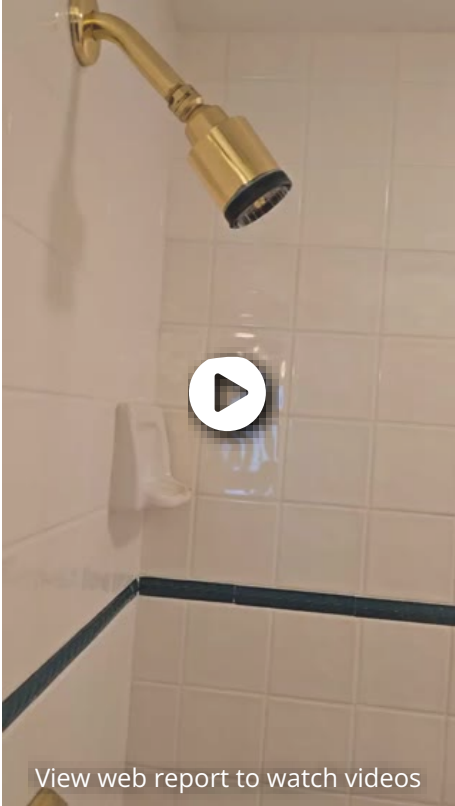
Location  
Master Bathroom

There is no hot water supply at the tub-shower faucet. There is cold water supply, but when the handle is turned to the left or hot side, the water supply stops. Recommend further evaluation & repair.

Handle needs to be turned the other direction

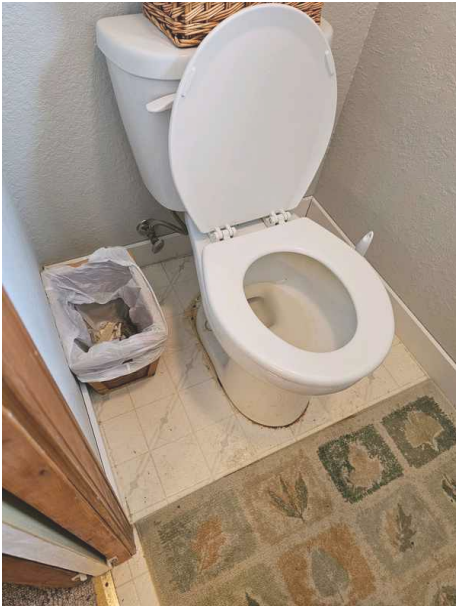
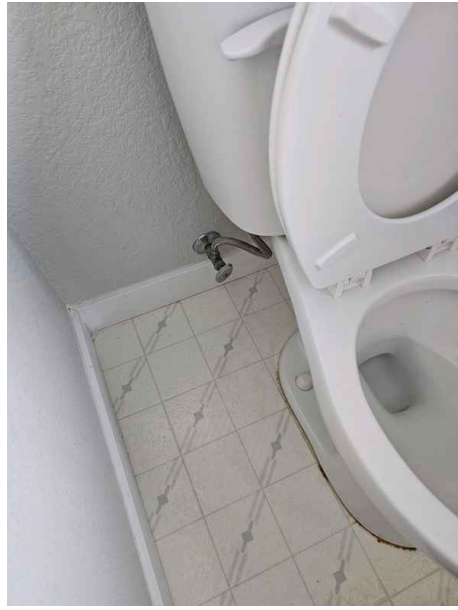
Location  
Master Bathroom

Staining and lifted flooring was observed around the base of the toilet. Recommend further evaluation.

Toilet has been thoroughly cleaned. No evidence of leaking

Repaired as of 5/29

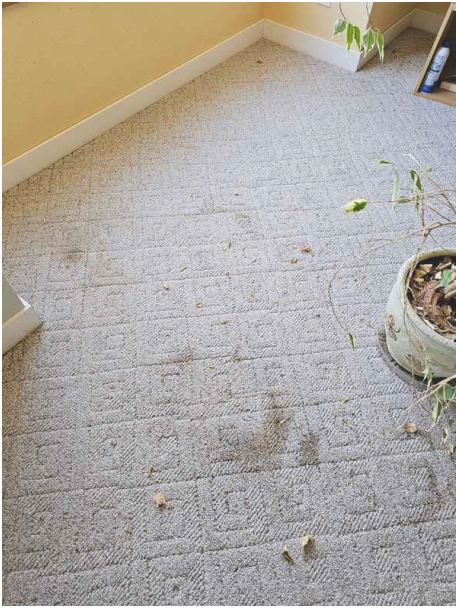
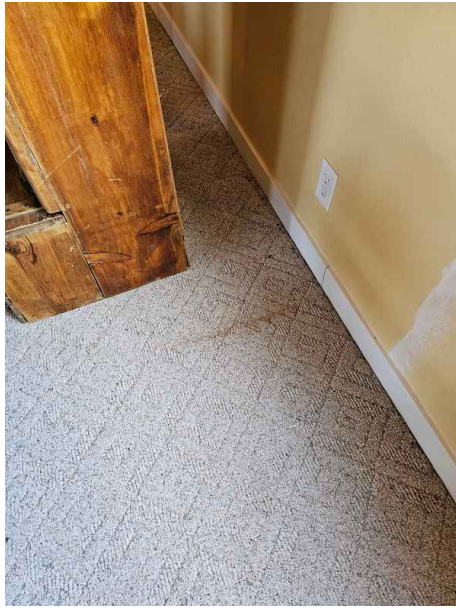
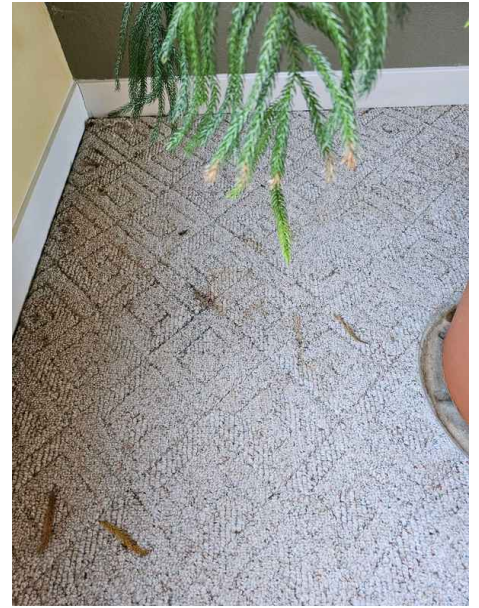
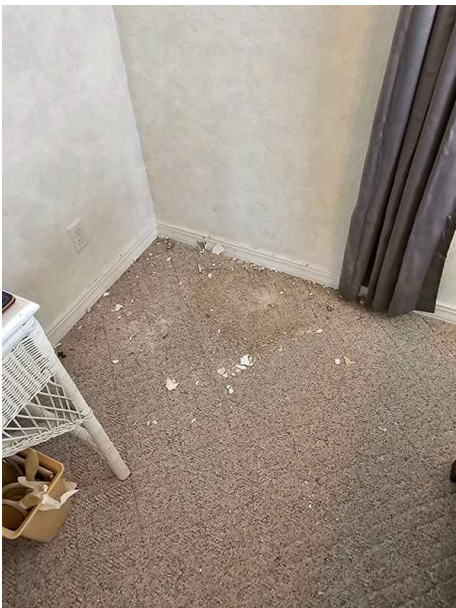
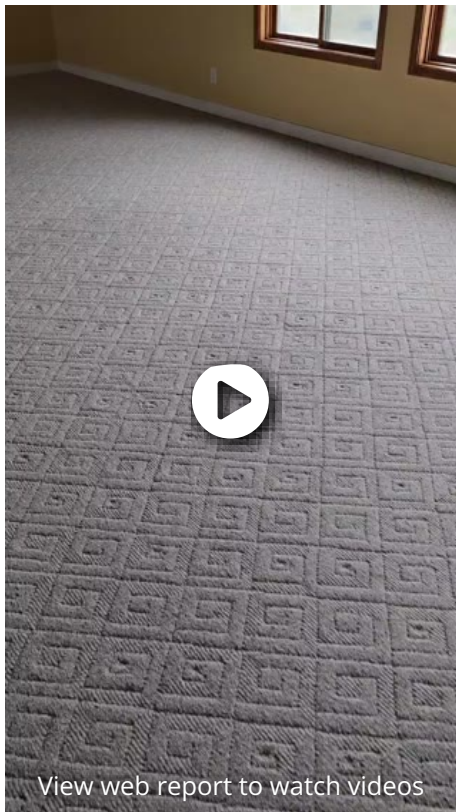
Several Areas Throughout

The carpet is stained. Recommend a thorough cleaning or replacement as needed.

Improvements made as of 5/29

Professional carpet cleaners have cleaned the areas of concern

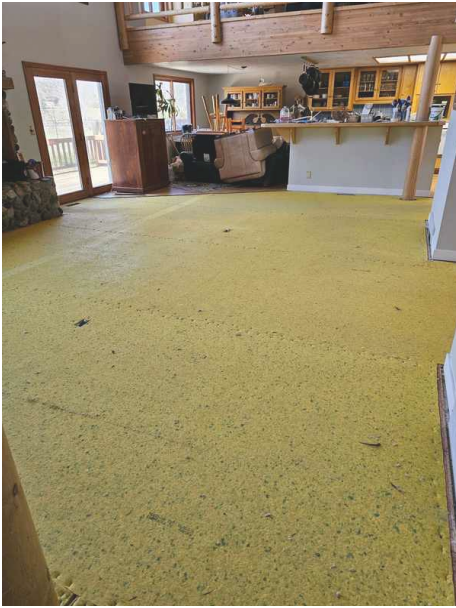
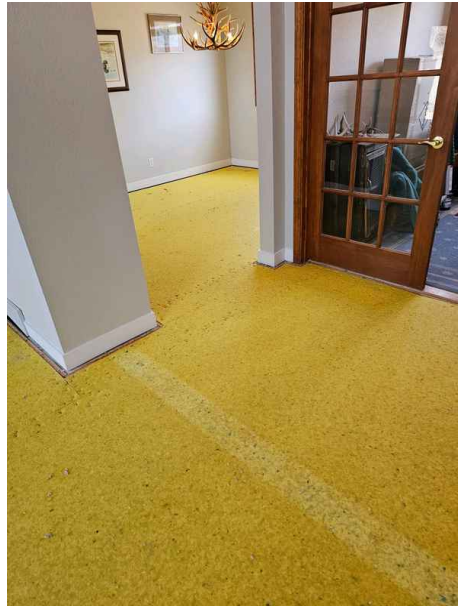
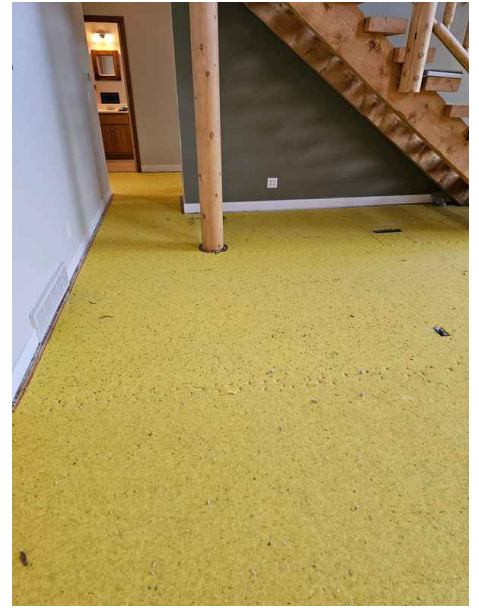
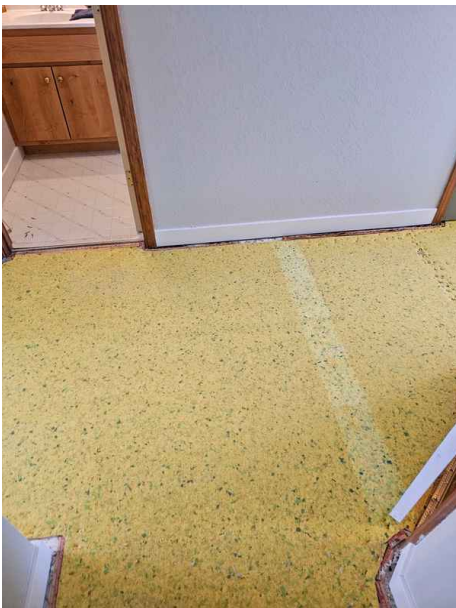
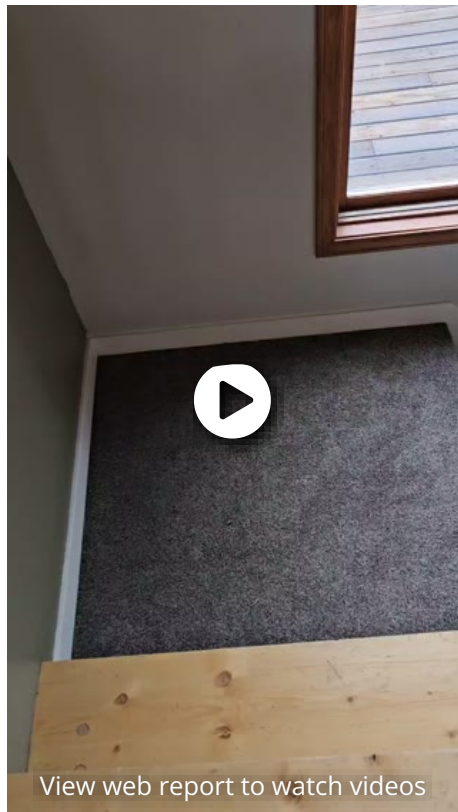
Throughout 1st Floor

The flooring was removed. Recommend installing.

Repaired as of 5/29

New carpet has been installed

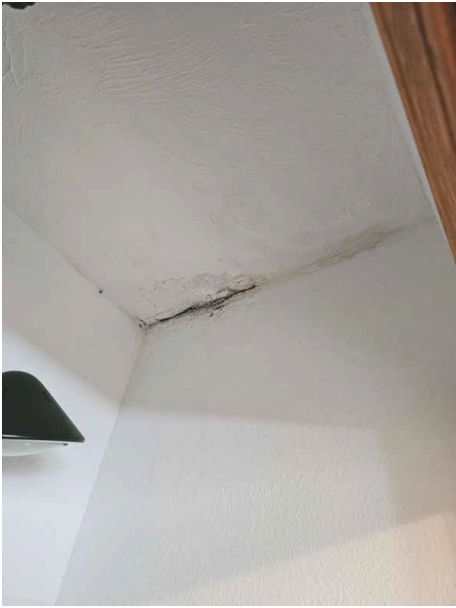
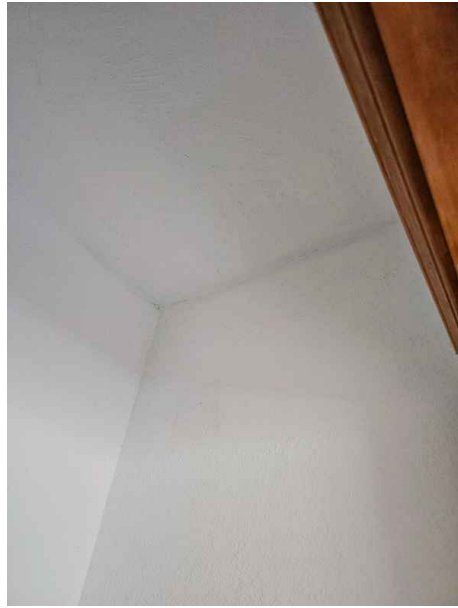
Location  
1st Floor Rear Bedroom Closet

There is evidence of moisture intrusion. Recommend further evaluation and repair as needed.

Sheetrock has been repaired

Repaired as of 5/29

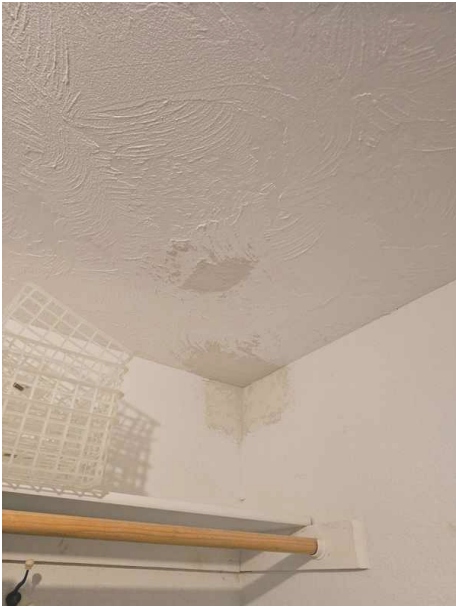
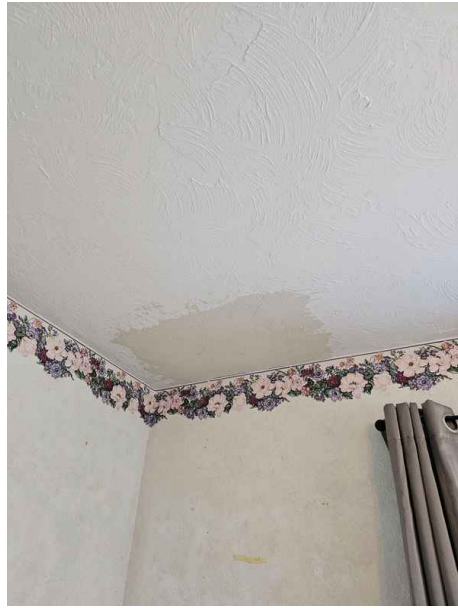
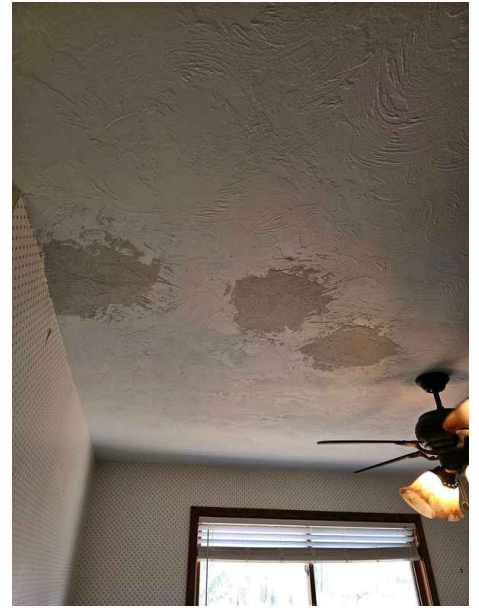
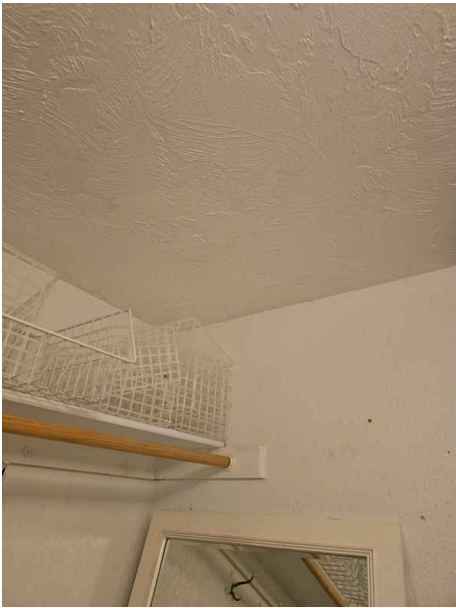
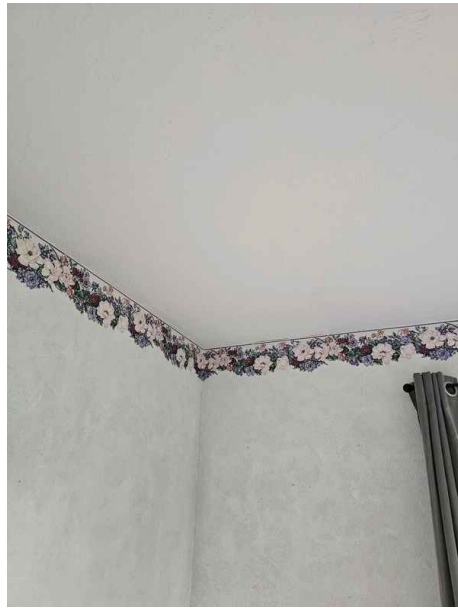
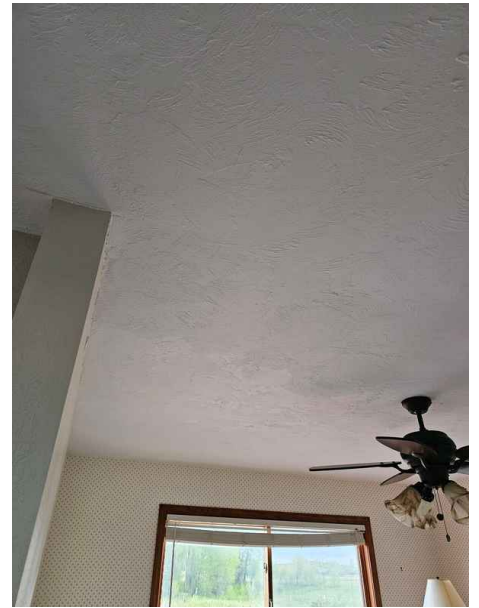
Several Throughout

Patches or repairs were observed in the wall or ceiling. We could not determine the reason for the repairs. Recommend monitoring.

Sheetrock has been repaired

Improvement made as of 5/29

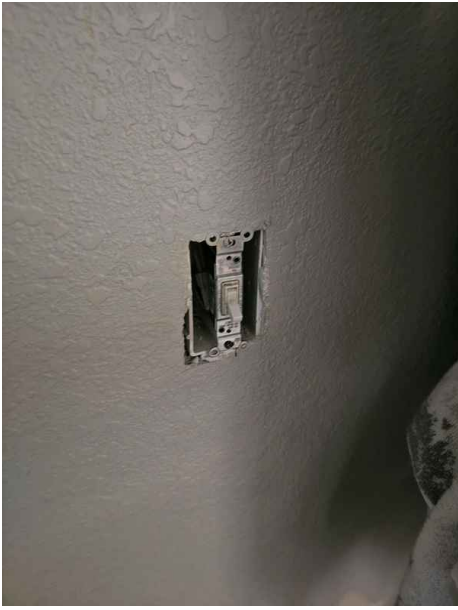
Location  
Master Bathroom

There were missing / damaged covers that should be installed

Cover plate installed
