REPAIR REQUEST LIST

1234 Main Street
04/06/2022 1:51 pm

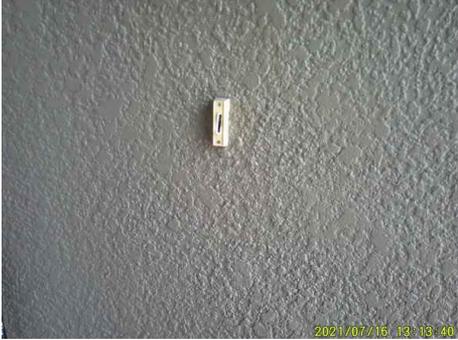
3.11.1 - Exterior: Doorbell DOORBELL BUTTON CRACKED

I observed cracked doorbell button. Recommend replacement.

Replacement Requested.

Contact a handyman or DIY project

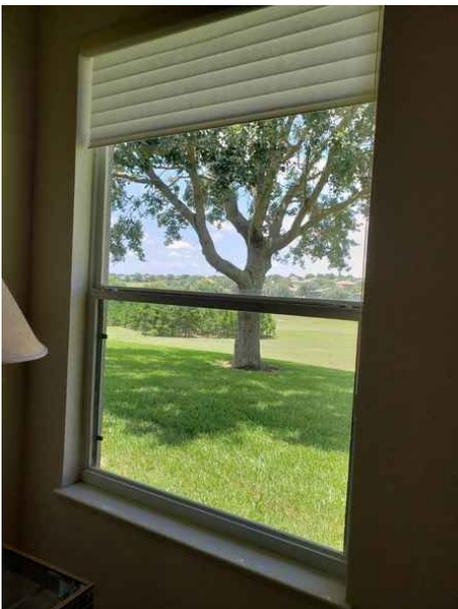
Left window in living space adjacent to kitchen on rear of house

6.2.2 - Doors, Windows & Interior: Windows WINDOW NOT SECURE

Top window pane seal is broken. Pane moves when touched and there is rubbing against bottom pane when opening. Recommend qualified professional to repair or replace.

Replacement Requested by qualified and licensed window professional or general contractor.

Contact a qualified window repair/installation contractor.

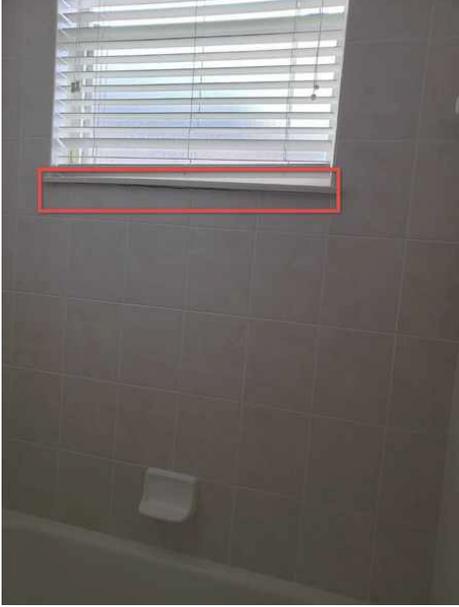
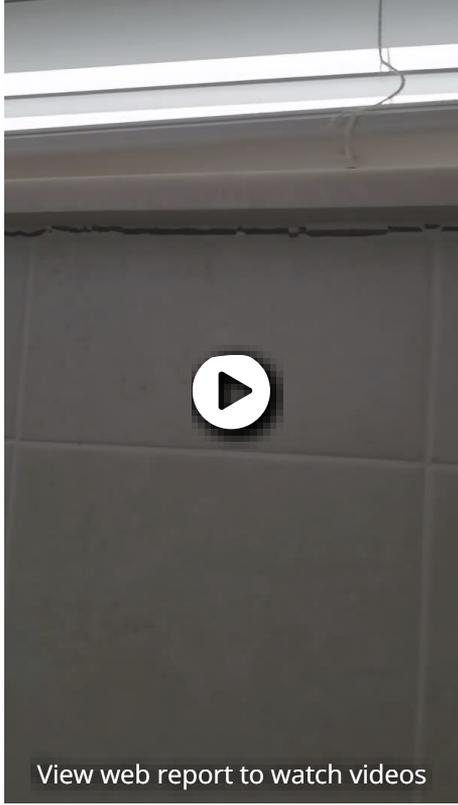
Bathroom 1 - Front left of house

7.2.1 - Bathrooms: Sinks, Tubs & Showers
DAMAGED CAULK IN SHOWER

I observed damaged/separated caulk and in the bathroom shower. Windowsill has curved and pulled away from tile leaving gap in caulk. This could allow moisture to get behind tiles. Recommend further evaluation and repair from a qualified professional.

Credit requested for further evaluation and repair.

Contact a qualified general contractor.

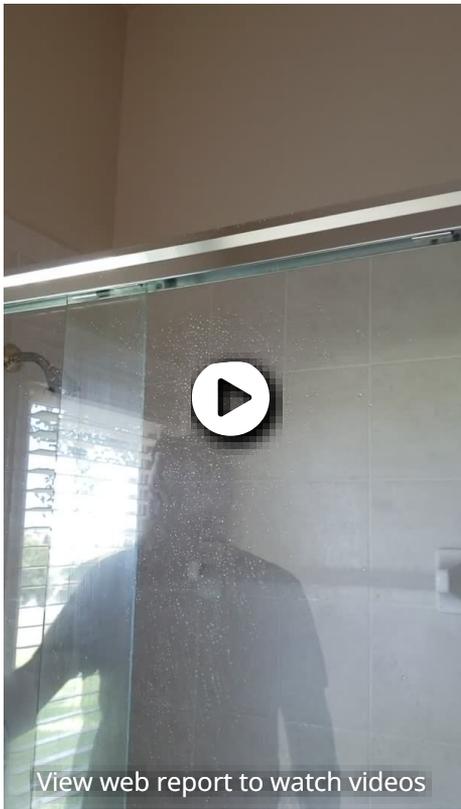
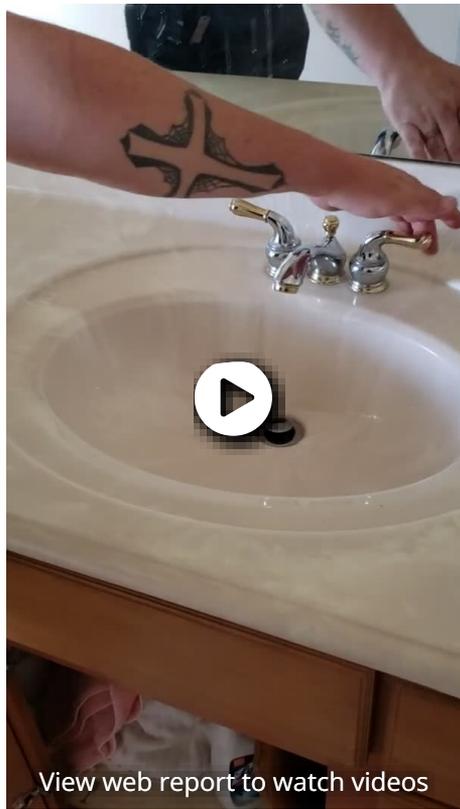
7.2.2 - Bathrooms: Sinks, Tubs & Showers
REDUCED WATER PRESSURE

I observed the water pressure in Bathroom 2 (left rear of home), the pressure was low with both faucet handles to the full open position. The shower also had low water pressure and was spraying outside of the shower door. In need of correction.

Credit requested for evaluation and correction by plumber.

Contact a qualified professional.

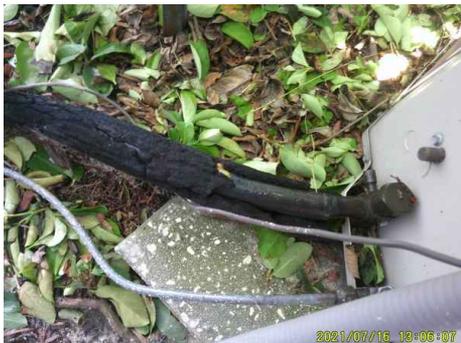
Location
Exterior - left side of house

9.3.1 - Cooling: Condensate
COOLANT LINE INSULATION WORN

I observed the insulation around the coolant line is aged and deteriorated. Recommend replacement by qualified professional.

Replacement Requested.

Recommendation
Contact a qualified professional.
