REPAIR REQUEST LIST

1234 Main St.
04/06/2022 1:51 pm

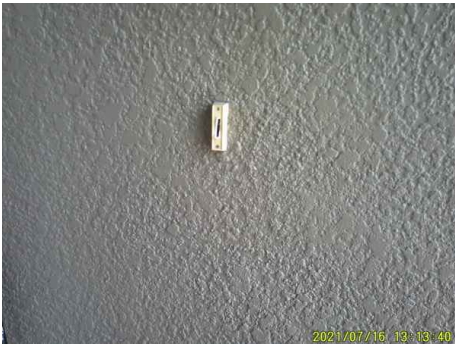
3.11.1 - Exterior: Doorbell DOORBELL BUTTON CRACKED

I observed cracked doorbell button. Recommend replacement.

Replacement Requested.

Contact a handyman or DIY project

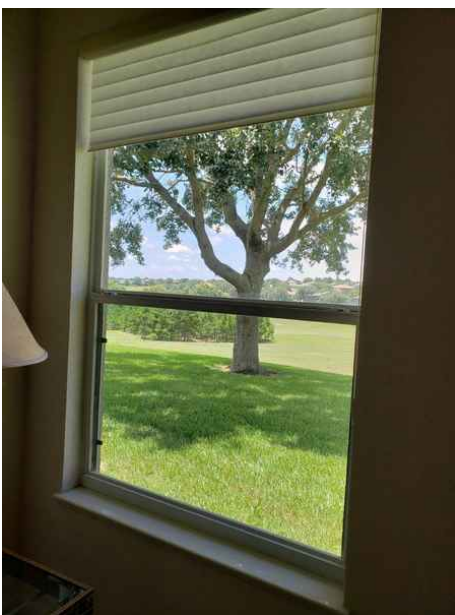
Left window in living space adjacent to kitchen on rear of house

6.2.2 - Doors, Windows & Interior: Windows WINDOW NOT SECURE

Top window pane seal is broken. Pane moves when touched and there is rubbing against bottom pane when opening. Recommend qualified professional to repair or replace.

Replacement Requested by qualified and licensed window professional or general contractor.

Contact a qualified window repair/installation contractor.

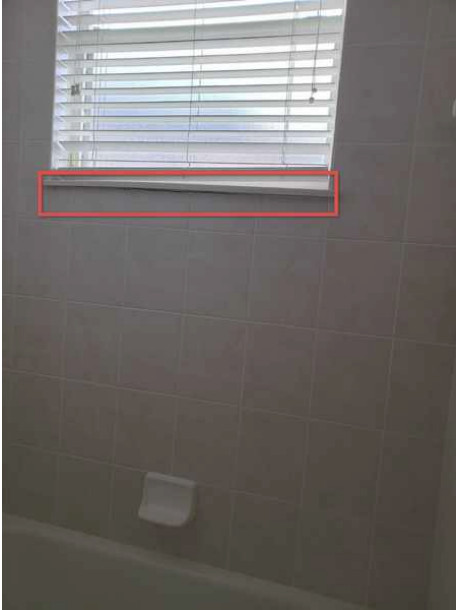
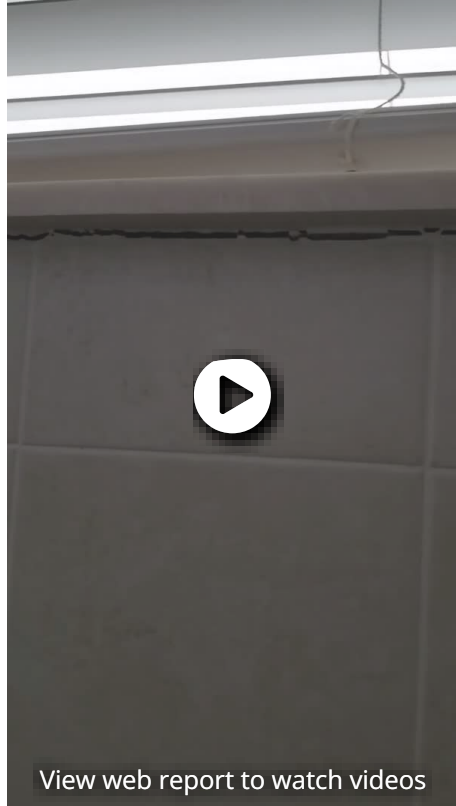
Bathroom 1 - Front left of house

7.2.1 - Bathrooms: Sinks, Tubs & Showers
DAMAGED CAULK IN SHOWER

I observed damaged/separated caulk and in the bathroom shower. Windowsill has curved and pulled away from tile leaving gap in caulk. This could allow moisture to get behind tiles. Recommend further evaluation and repair from a qualified professional.

Credit requested for further evaluation and repair.

Contact a qualified general contractor.

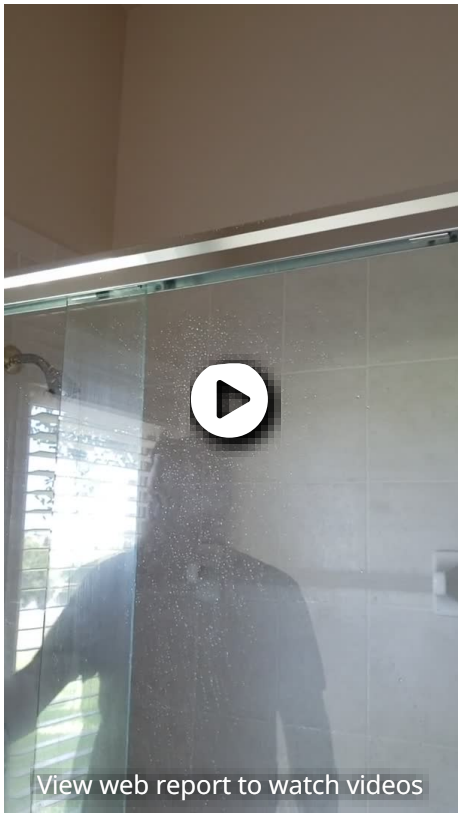
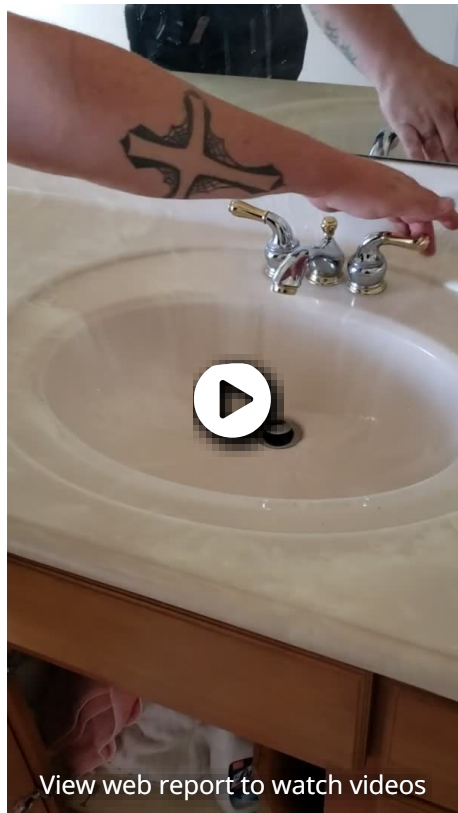
7.2.2 - Bathrooms: Sinks, Tubs & Showers
REDUCED WATER PRESSURE

I observed the water pressure in Bathroom 2 (left rear of home), the pressure was low with both faucet handles to the full open position. The shower also had low water pressure and was spraying outside of the shower door. In need of correction.

Credit requested for evaluation and correction by plumber.

Contact a qualified professional.

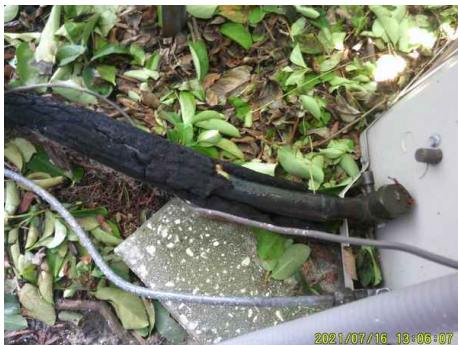
Location
Exterior - left side of house

9.3.1 - Cooling: Condensate
COOLANT LINE INSULATION WORN

I observed the insulation around the coolant line is aged and deteriorated. Recommend replacement by qualified professional.

Replacement Requested.

Recommendation
Contact a qualified professional.
