REPAIR REQUEST LIST

3523 Kent Rd
07/30/2022 10:28 am

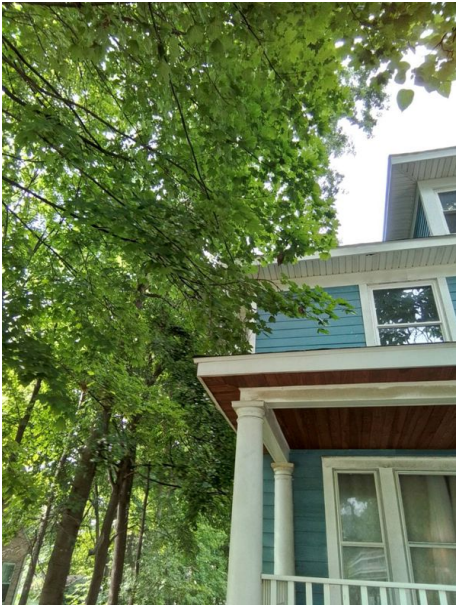
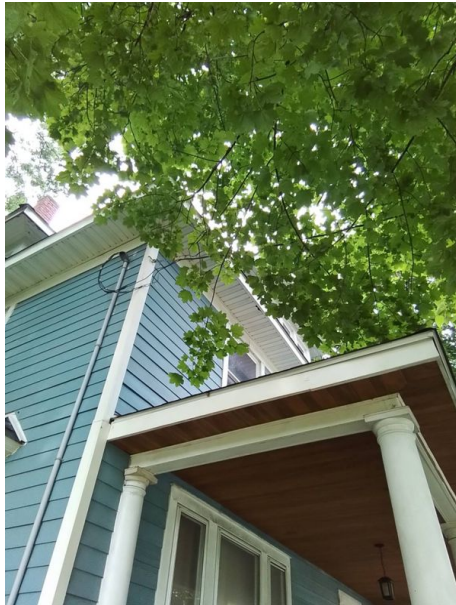
3.2.1 - Electrical: Service Drop CLEARANCE FROM TREES

Serious Concern/Action Needed

The overhead service-drop conductors had inadequate clearance from tree branches. This condition should be corrected by a qualified contractor or the utility service provider (whichever has jurisdiction) to avoid abrasion and damage to the conductors. Work around the service conductors should be performed by a qualified personnel only. Injury or death may result from attempts at correction by those without proper qualifications.

Contact a qualified professional.

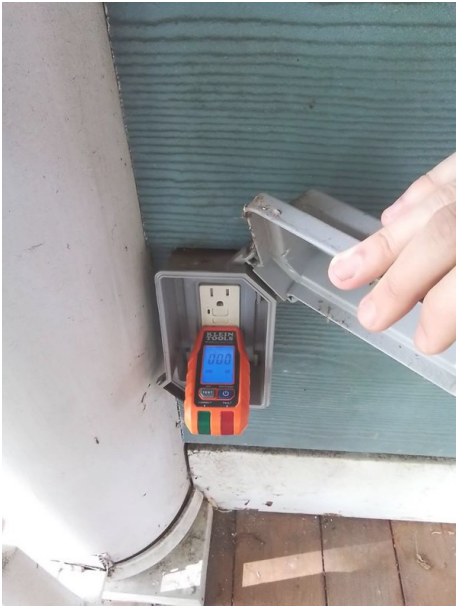
3.7.1 - Electrical: Branch Circuits GFCI: MULTIPLE FAILURES- QC

Serious Concern/Action Needed

Multiple ground fault circuit interrupter (GFCI) electrical receptacles did not respond adequately to testing. GFCI receptacles should be checked and replaced as needed by a qualified electrical contractor.

Contact a qualified electrical contractor.

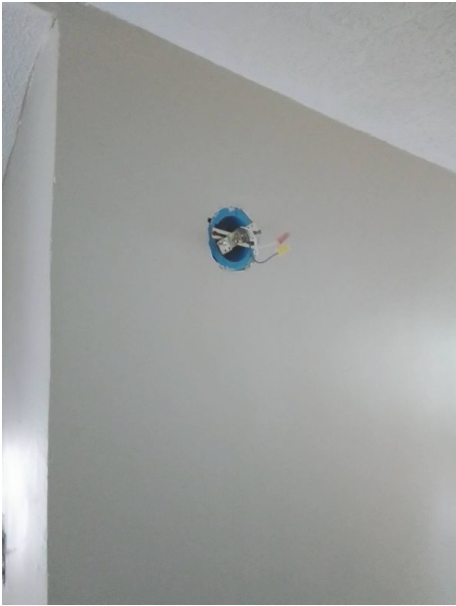
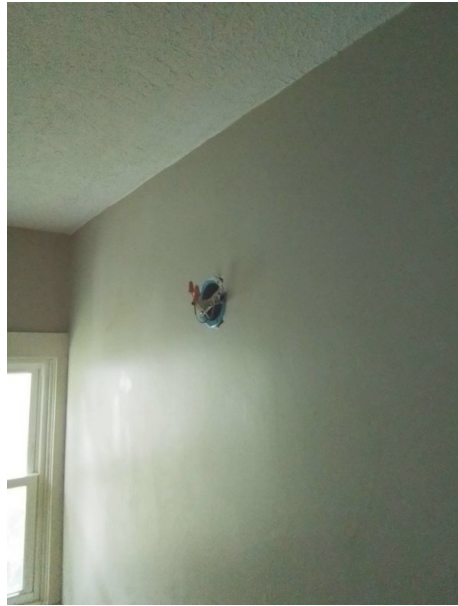
3.7.2 - Electrical: Branch Circuits

Serious Concern/Action Needed

An interior light fixture was missing. Electrical conductors were exposed to touch. Conductors should be properly terminated and a light fixture or listed cover should be installed by a qualified electrical contractor.

Contact a qualified electrical contractor.

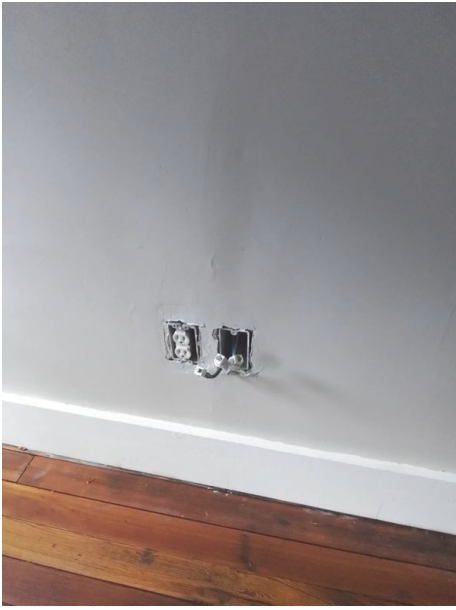
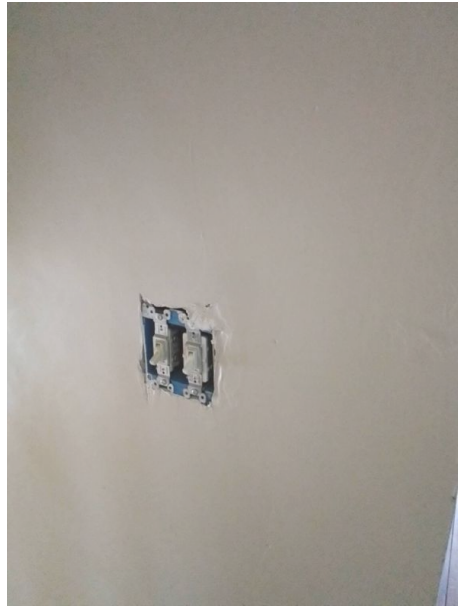
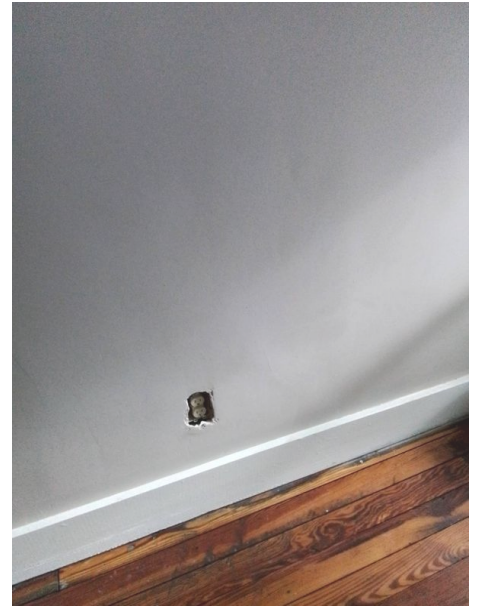
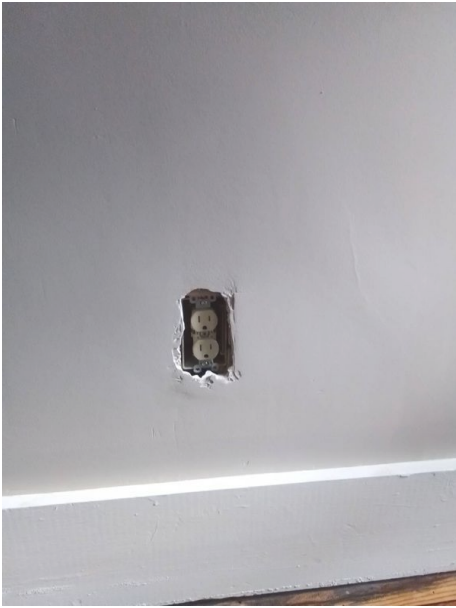
3.7.3 - Electrical: Branch Circuits

Serious Concern/Action Needed

Electrical receptacle cover plates were missing. This condition left energized electrical components exposed to touch, a shock/electrocution hazard. Listed cover plate should be installed by qualified personnel.

Contact a qualified handyman.

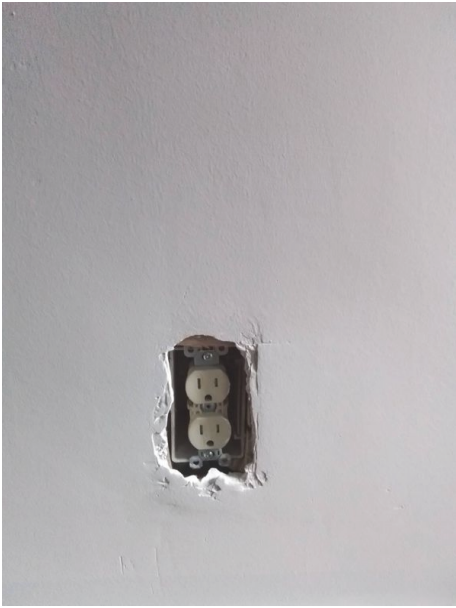
3.7.4 - Electrical: Branch Circuits
RECEPTACLE: LOOSE- QC

Moderate Concern/Repair

An electrical receptacle was improperly secured and moved when a plug were inserted. Receptacles should be securely installed to prevent fire, shock and/or electrocution hazard. This condition should be corrected by a qualified electrical contractor.

Contact a qualified electrical contractor.

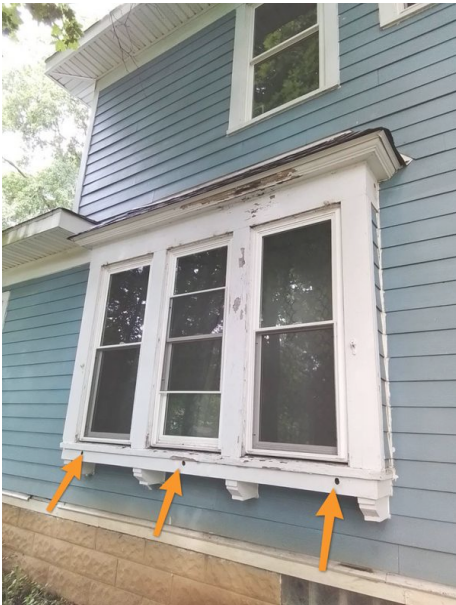
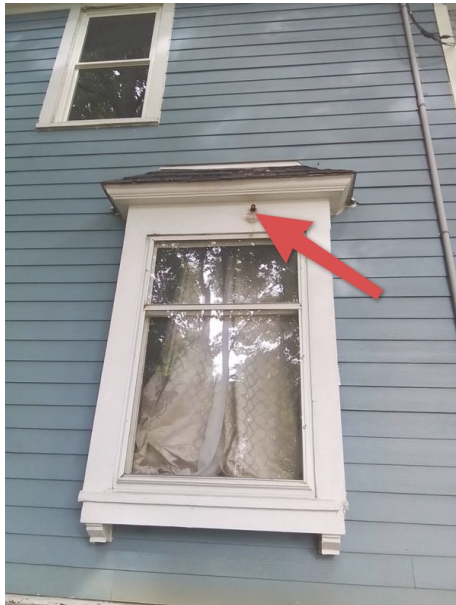
5.4.1 - Exterior: Wall Exteriors
HOLES, PENETRATIONS IN SIDING

Moderate Concern/Repair

Siding at the exterior wall has holes that should be sealed or repaired to prevent moisture and insect entry.

Contact a qualified professional.

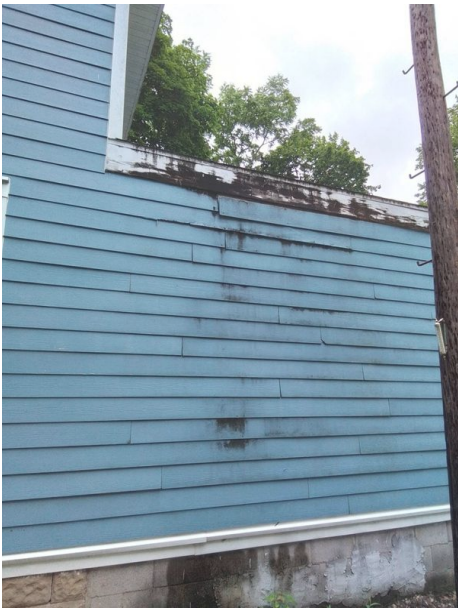
5.4.2 - Exterior: Wall Exteriors
SEVERE DAMAGE TO SIDING

Moderate Concern/Repair

Siding damaged by improper roof drainage allowing water to run down exterior wall of house. Recommend siding be replaced and overhang or gutter be installed by a qualified contractor.

1st Floor right side. No overhang allows roof runoff to run down side of house.

Contact a qualified professional.

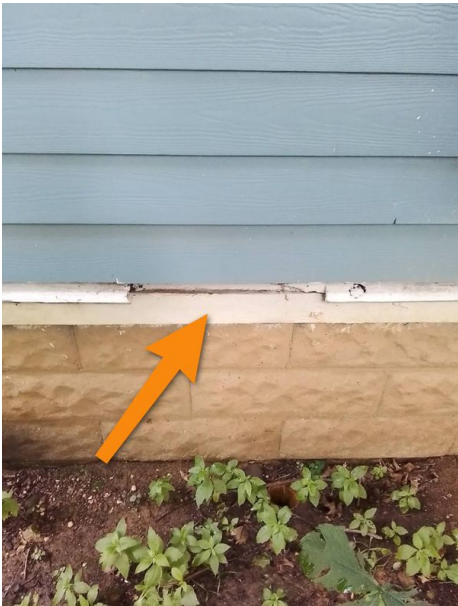
5.5.1 - Exterior: Exterior Trim
EXTERIOR TRIM: MISSING- QC

Moderate Concern/Repair

Missing exterior trim should be replaced by a qualified contractor.

Contact a qualified siding specialist.

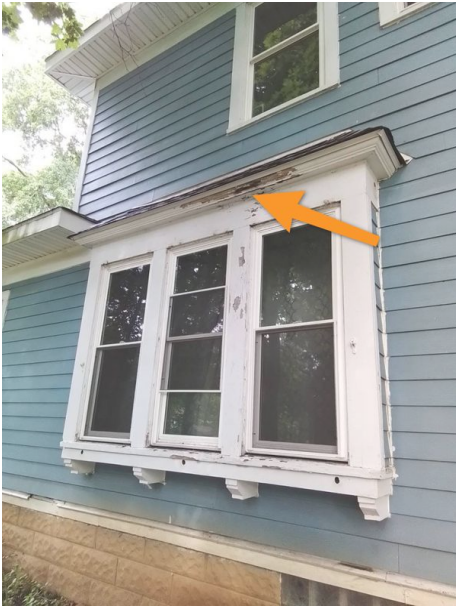
5.5.2 - Exterior: Exterior Trim
WINDOW TRIM: PAINT PEELING- QC

Moderate Concern/Repair

Window trim had peeling paint and needed maintenance. All work should be performed by a qualified contractor.

Contact a qualified professional.

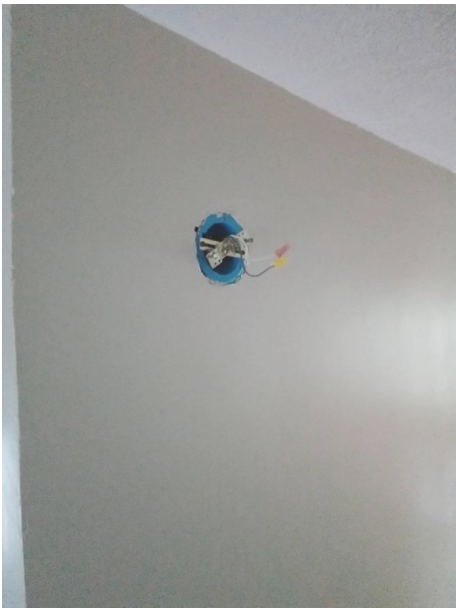
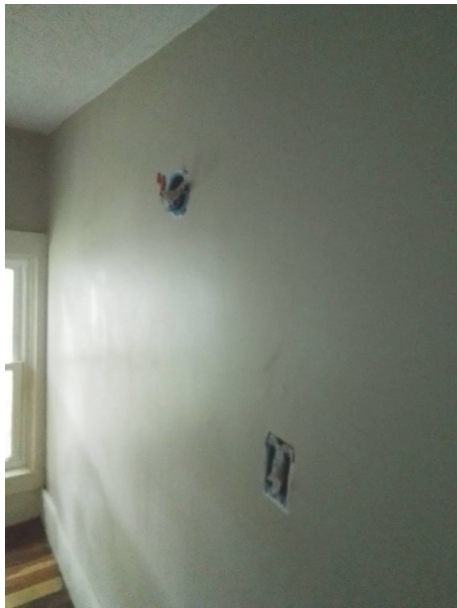
6.6.1 - Interior: Lighting
MISSING FIXTURES

Moderate Concern/Repair

Recommendation
Contact a qualified professional.

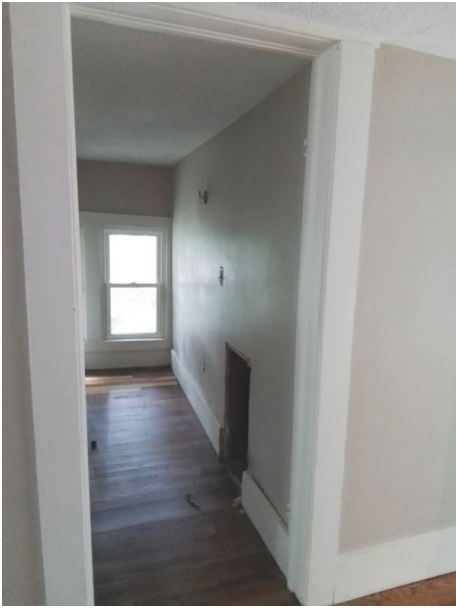
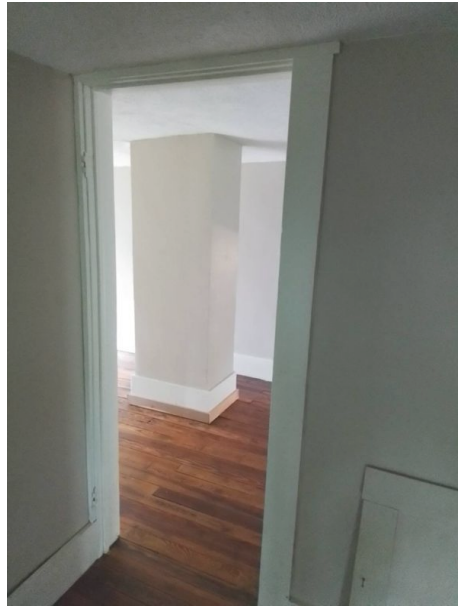
6.9.1 - Interior: Interior Doors
MISSING DOOR

Moderate Concern/Repair

Recommendation
Contact a qualified professional.

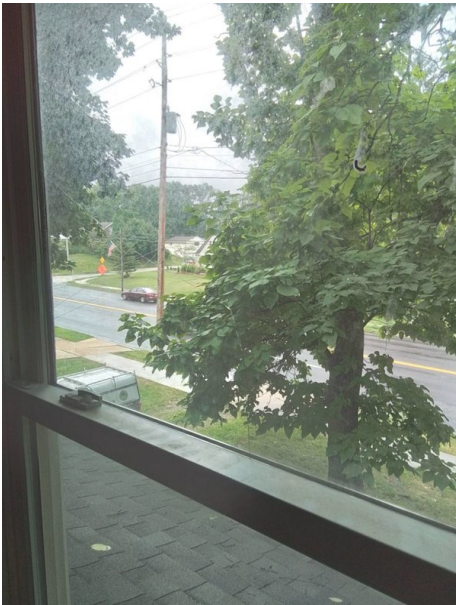
6.10.1 - Interior: Windows
GLAZING: CRACKED PANE

Serious Concern/Action Needed

A window in the upstairs front left bedroom had a cracked pane.

2nd Floor South West Bedroom

Contact a qualified window repair/installation contractor.

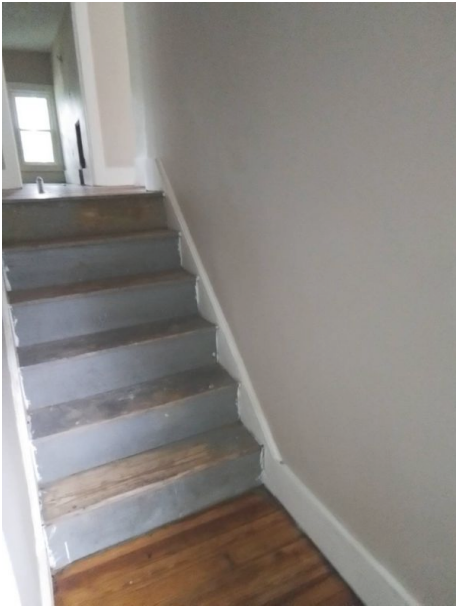
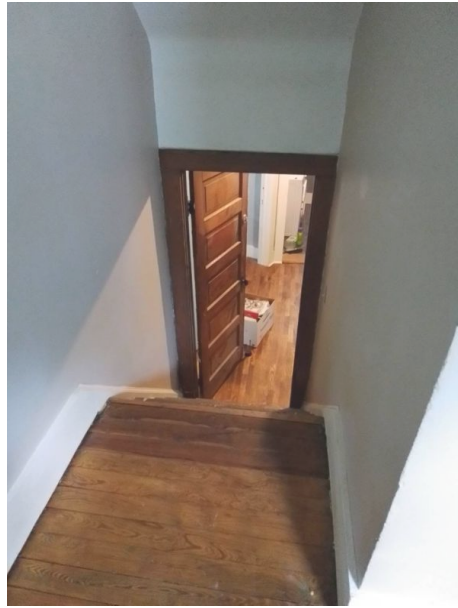
6.18.1 - Interior: Interior handrails
MISSING HANDRAILS

Serious Concern/Action Needed

Handrails are missing from the second to the third floors.

Contact a qualified professional.

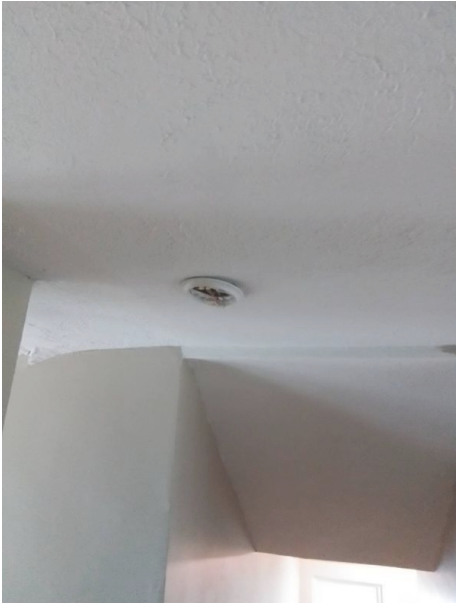
6.19.1 - Interior: Smoke detector
MISSING SMOKE DETECTOR

Moderate Concern/Repair

Missing smoke detector.

Contact a qualified professional.

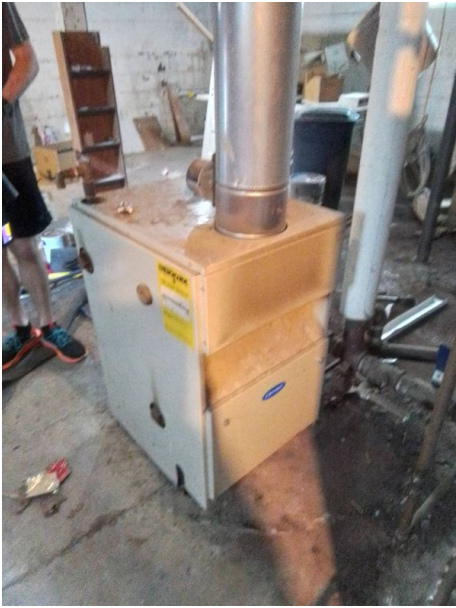
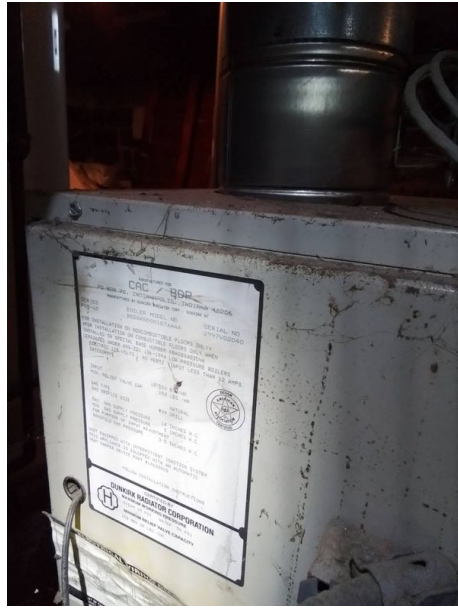
7.2.1 - HVAC: Boiler: Hydronic Heating
BOILER: OLD & DIRTY- QC

Serious Concern/Action Needed

The boiler was old and dirty. The Inspector recommends evaluation by a qualified HVAC technician to more accurately determine the boiler's condition. Replacement would be expensive.

Contact a qualified HVAC professional.

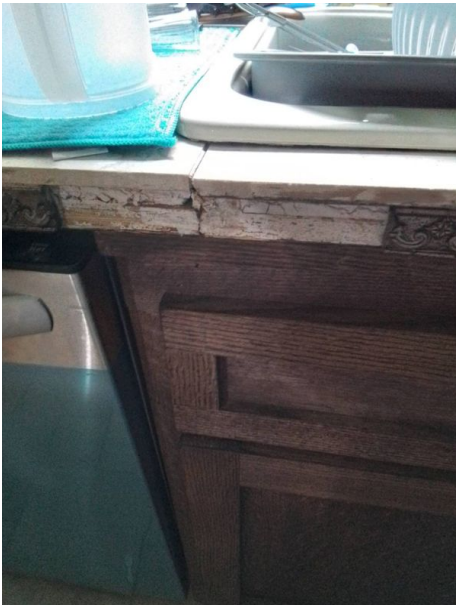
9.3.1 - Kitchen: Countertops
DAMAGE: MODERATE

Moderate Concern/Repair

The kitchen countertops had moderate damage.

Contact a qualified countertop contractor.
