REPAIR REQUEST LIST

3523 Kent Rd
07/30/2022 10:28 am

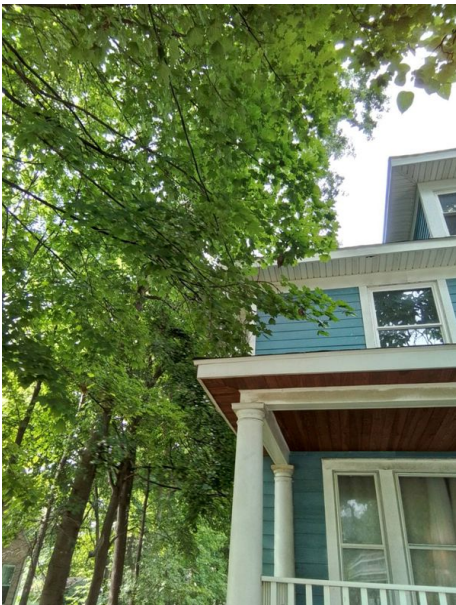
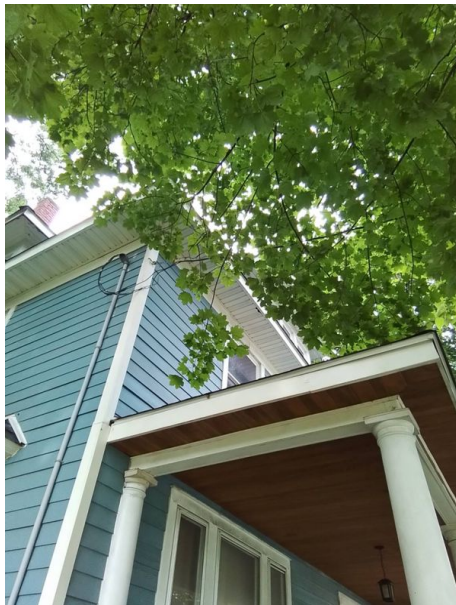
3.2.1 - Electrical: Service Drop CLEARANCE FROM TREES

The overhead service-drop conductors had inadequate clearance from tree branches. This condition should be corrected by a qualified contractor or the utility service provider (whichever has jurisdiction) to avoid abrasion and damage to the conductors. Work around the service conductors should be performed by a qualified personnel only. Injury or death may result from attempts at correction by those without proper qualifications.

Contact a qualified professional.

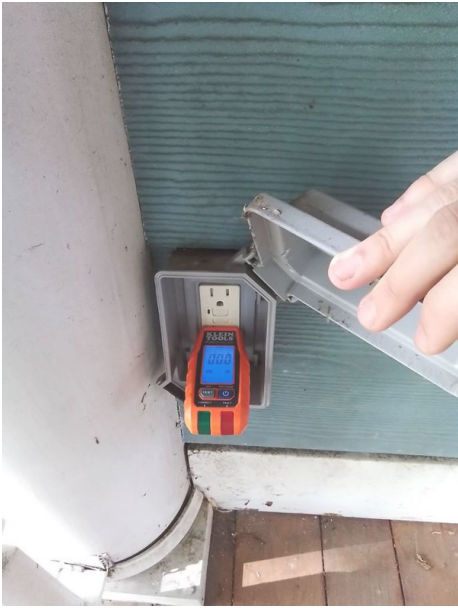
3.7.1 - Electrical: Branch Circuits GFCI: MULTIPLE FAILURES- QC

Multiple ground fault circuit interrupter (GFCI) electrical receptacles did not respond adequately to testing. GFCI receptacles should be checked and replaced as needed by a qualified electrical contractor.

Contact a qualified electrical contractor.

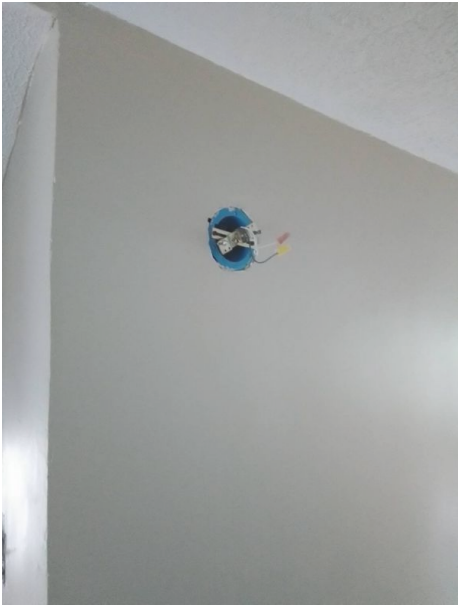
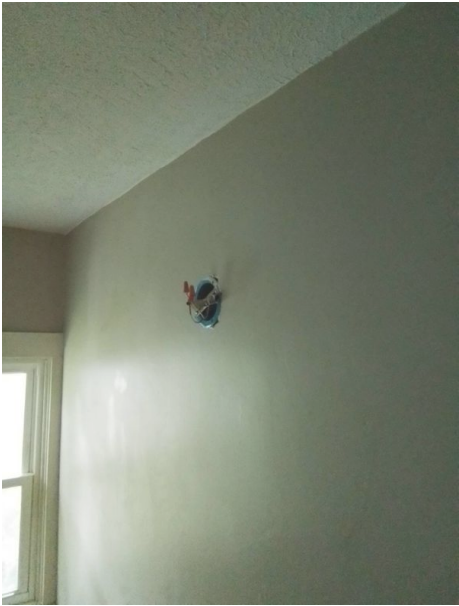
3.7.2 - Electrical: Branch Circuits
LIGHTING: MISSING LIGHT FIXTURE- QC

An interior light fixture was missing. Electrical conductors were exposed to touch. Conductors should be properly terminated and a light fixture or listed cover should be installed by a qualified electrical contractor.

Recommendation
Contact a qualified electrical contractor.

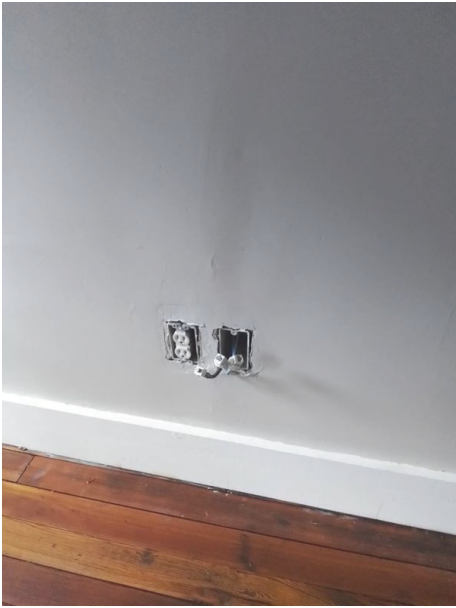
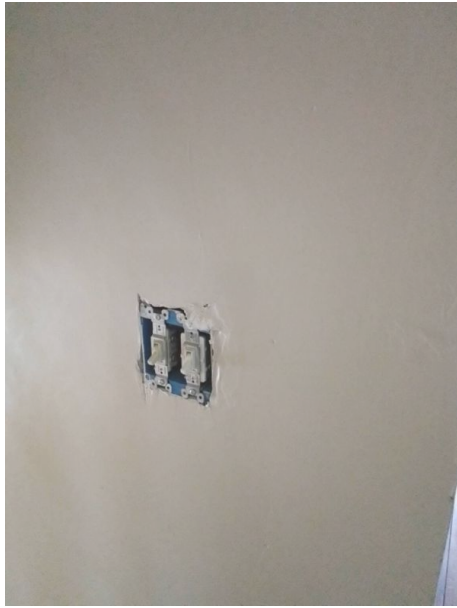
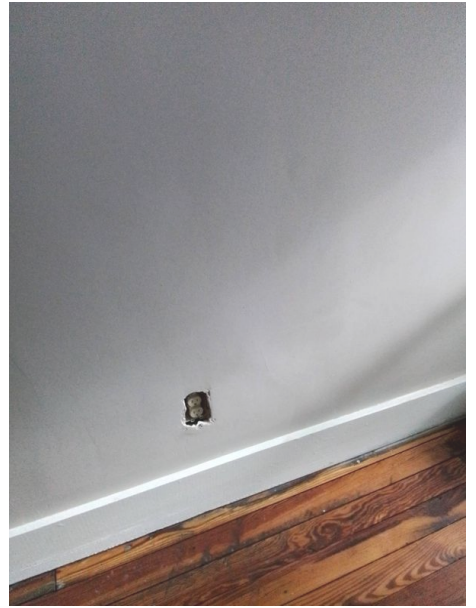
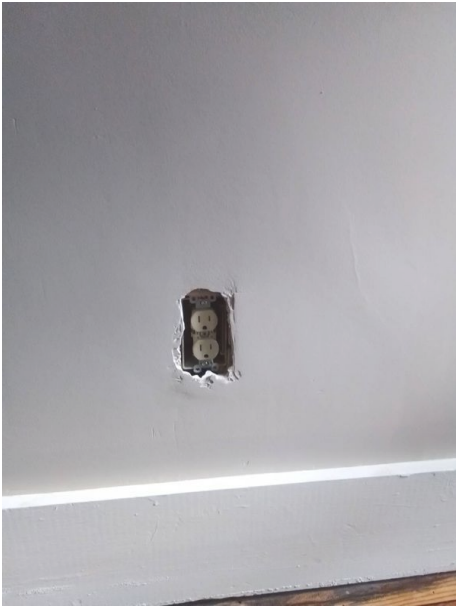
3.7.3 - Electrical: Branch Circuits
RECEPTACLE: COVER PLATES MISSING- QC

Electrical receptacle cover plates were missing. This condition left energized electrical components exposed to touch, a shock/electrocution hazard. Listed cover plate should be installed by qualified personnel.

Recommendation
Contact a qualified handyman.

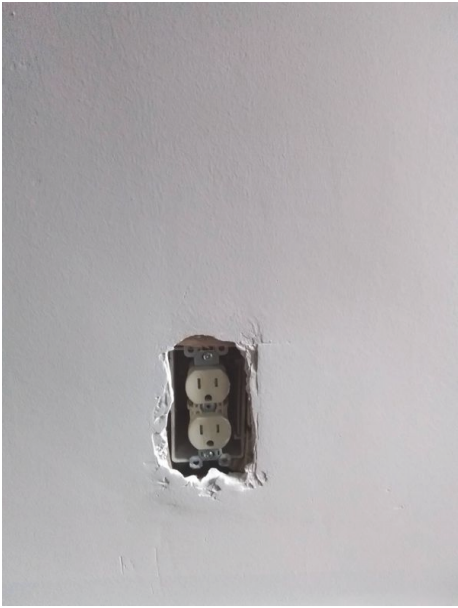
3.7.4 - Electrical: Branch Circuits
RECEPTACLE: LOOSE- QC

An electrical receptacle was improperly secured and moved when a plug were inserted. Receptacles should be securely installed to prevent fire, shock and/or electrocution hazard. This condition should be corrected by a qualified electrical contractor.

Recommendation
Contact a qualified electrical contractor.

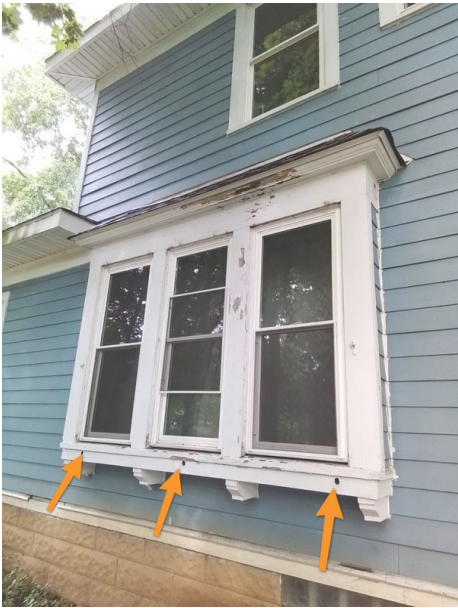
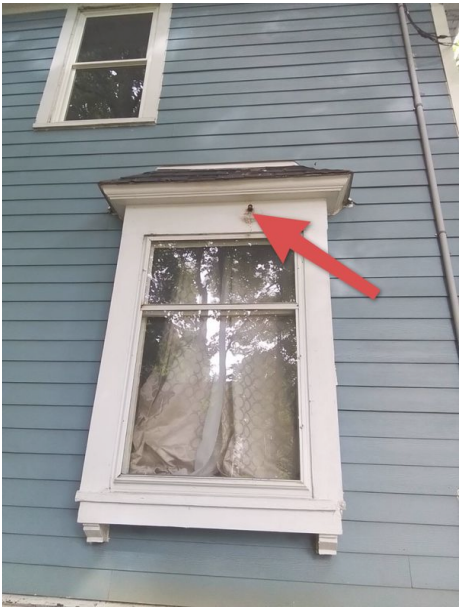
5.4.1 - Exterior: Wall Exteriors
HOLES, PENETRATIONS IN SIDING

Siding at the exterior wall has holes that should be sealed or repaired to prevent moisture and insect entry.

Recommendation
Contact a qualified professional.

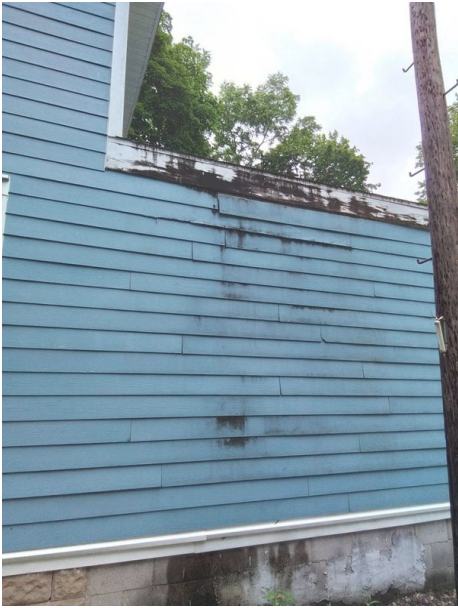
5.4.2 - Exterior: Wall Exteriors
SEVERE DAMAGE TO SIDING

Siding damaged by improper roof drainage allowing water to run down exterior wall of house. Recommend siding be replaced and overhang or gutter be installed by a qualified contractor.

1st Floor right side. No overhang allows roof runoff to run down side of house.

Recommendation
Contact a qualified professional.

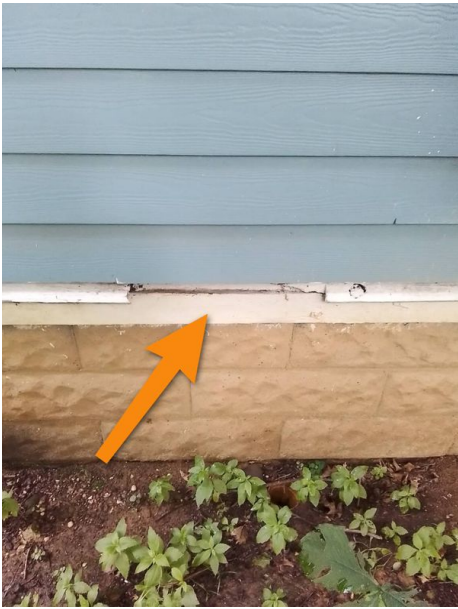
5.5.1 - Exterior: Exterior Trim
EXTERIOR TRIM: MISSING- QC

Missing exterior trim should be replaced by a qualified contractor.

Recommendation
Contact a qualified siding specialist.

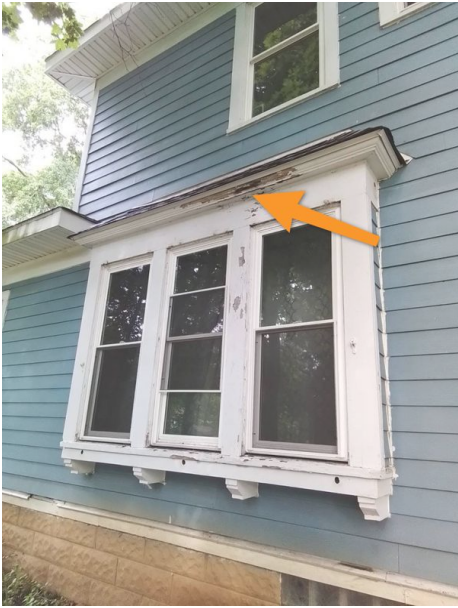
5.5.2 - Exterior: Exterior Trim
WINDOW TRIM: PAINT PEELING- QC

Window trim had peeling paint and needed maintenance. All work should be performed by a qualified contractor.

Recommendation
Contact a qualified professional.

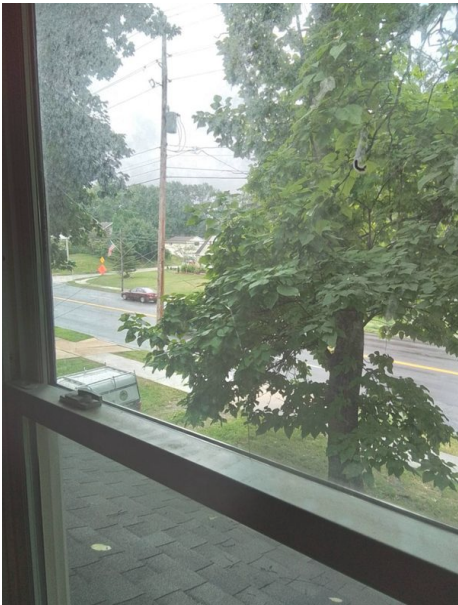
6.10.1 - Interior: Windows
GLAZING: CRACKED PANE

A window in the upstairs front left bedroom had a cracked pane.

2nd Floor South West Bedroom

Recommendation
Contact a qualified window repair/installation contractor.

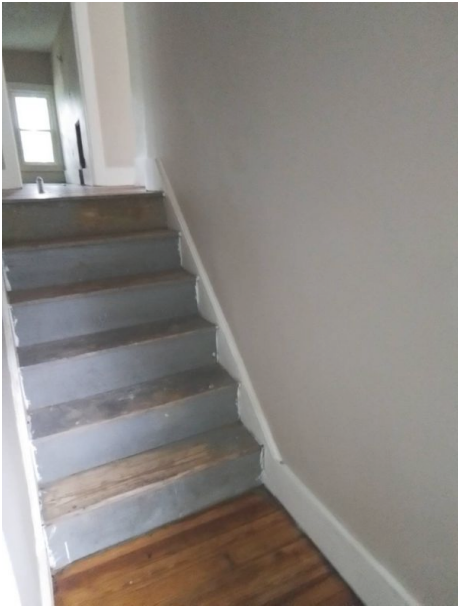
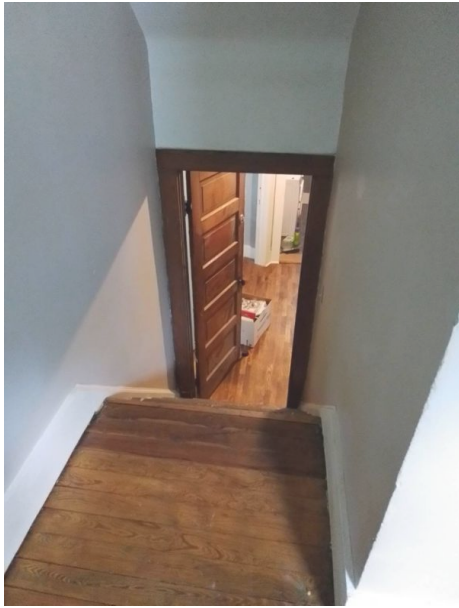
6.18.1 - Interior: Interior handrails
MISSING HANDRAILS

Handrails are missing from the second to the third floors.

Recommendation
Contact a qualified professional.

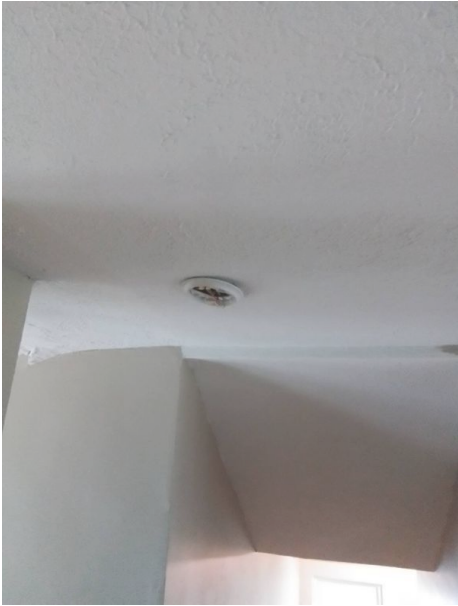
6.19.1 - Interior: Smoke detector
MISSING SMOKE DETECTOR

Missing smoke detector.

Recommendation
Contact a qualified professional.

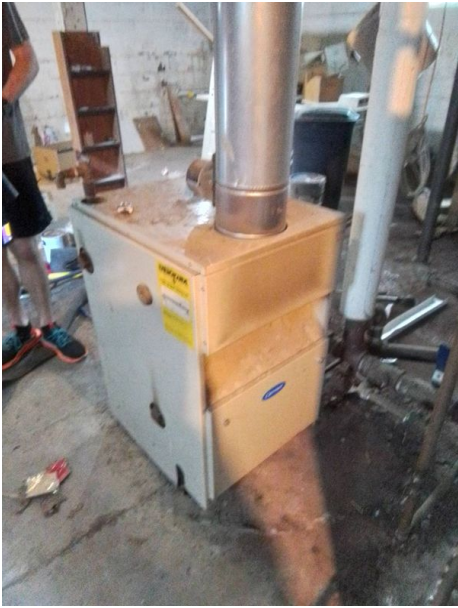
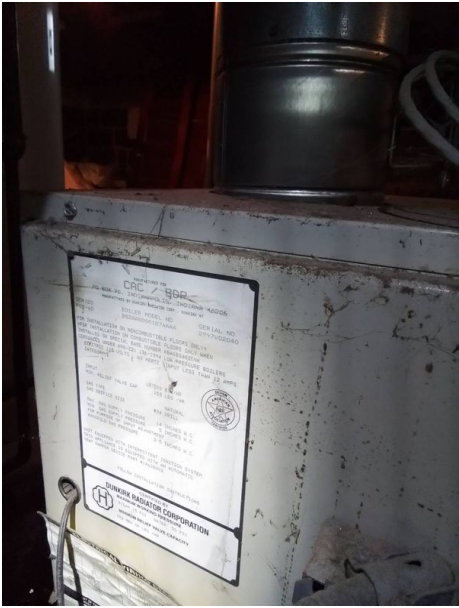
7.2.1 - HVAC: Boiler: Hydronic Heating
BOILER: OLD & DIRTY- QC

The boiler was old and dirty. The Inspector recommends evaluation by a qualified HVAC technician to more accurately determine the boiler's condition. Replacement would be expensive.

Recommendation
Contact a qualified HVAC professional.

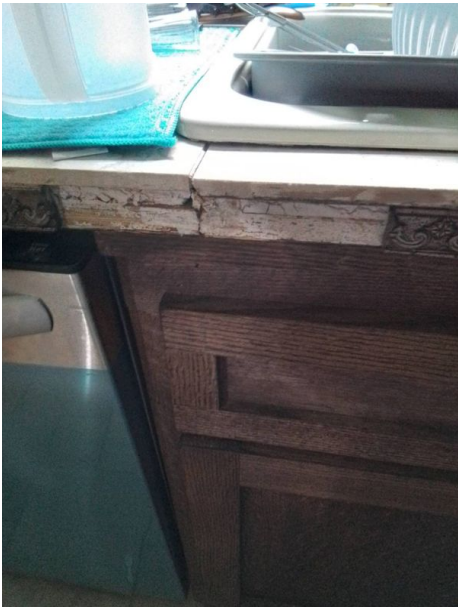
9.3.1 - Kitchen: Countertops
DAMAGE: MODERATE

The kitchen countertops had moderate damage.

Recommendation
Contact a qualified countertop contractor.
