REPAIR REQUEST LIST

1467 Cottonwood Rd
05/28/2024 12:11 pm

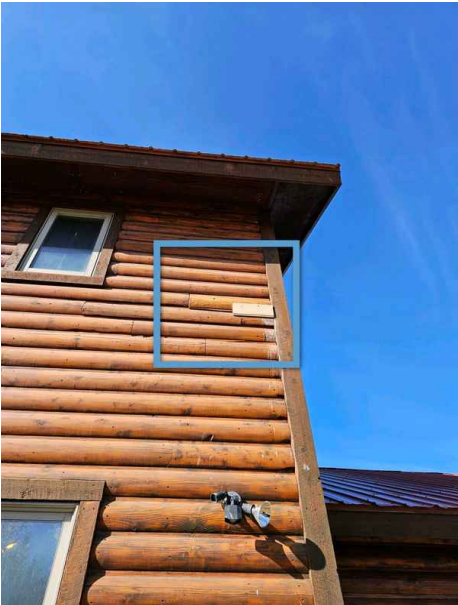
Original Inspection 4/23

Recent or past repairs to the exterior siding was observed. We could not determine the reason for the repairs and recommend asking the seller about repairs and why they were needed.

Old patch was cleaned up as of 5/29

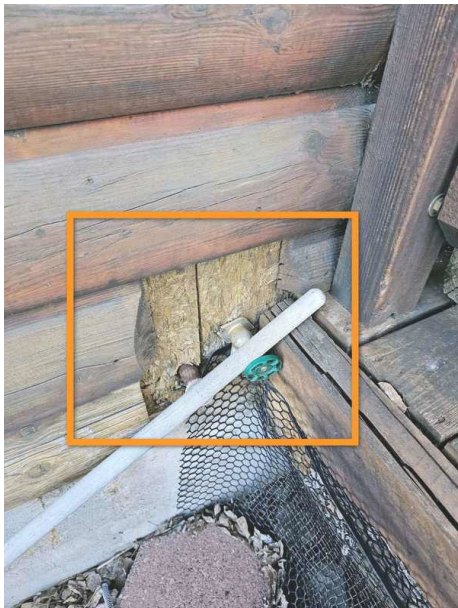
Original Inspection 4/23

Portions of the siding are missing. Recommend repairs.

Repaired.

Repair was done as of 5/29.

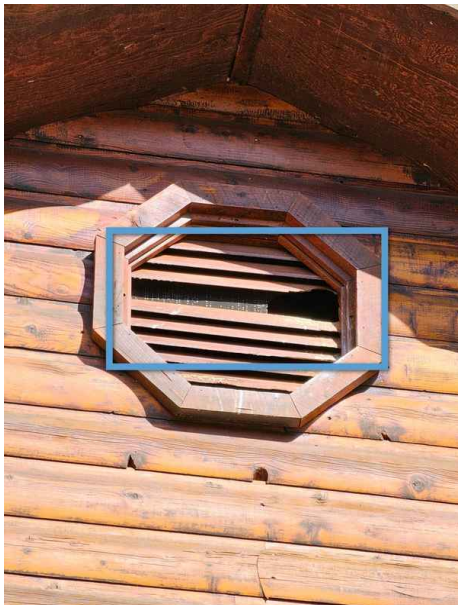
Original Inspection 4/23

One or more gaps were observed. Recommend sealing to prevent pest access.

Repaired

Repair was made as of 5/29

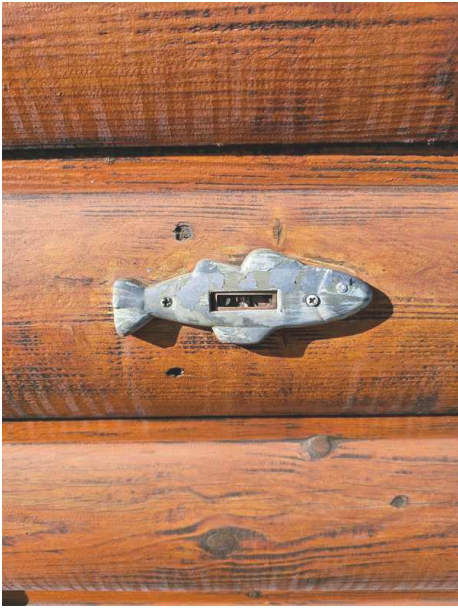
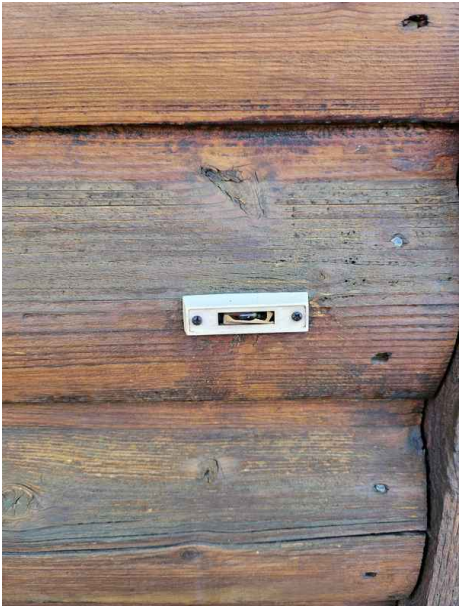
The doorbell button is damaged or missing. You may want to have it replaced.

Replaced

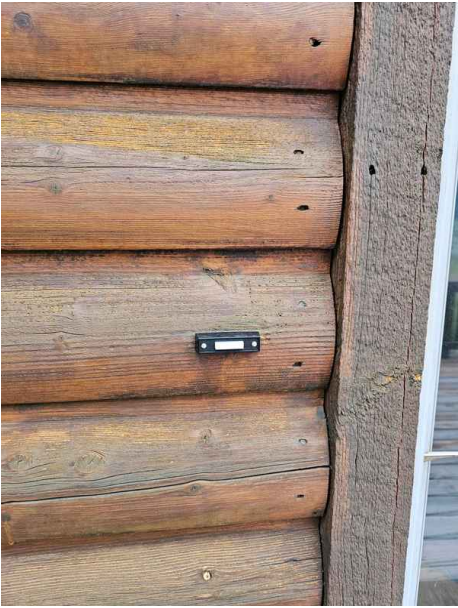
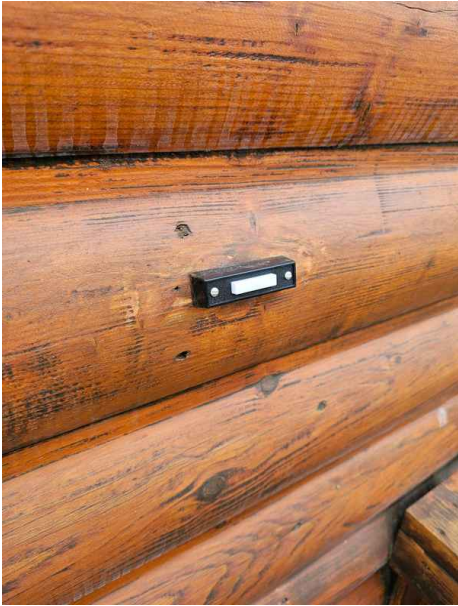
Repaired as of 5/29

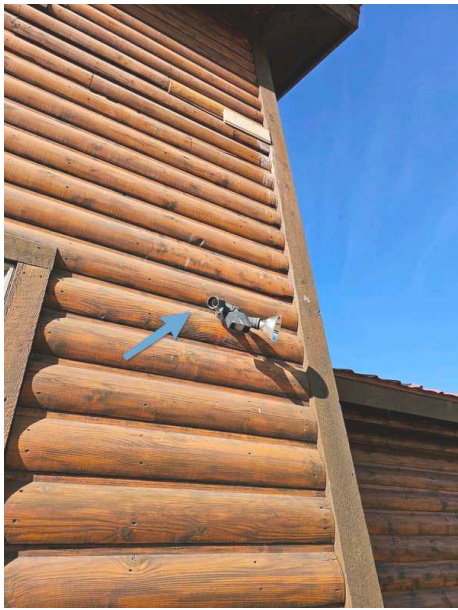
Original Inspection 4/23

Some lights around the residence did not have light bulbs or the bulbs were burnt out. Recommend replacing bulbs and testing.

All new flood lights installed

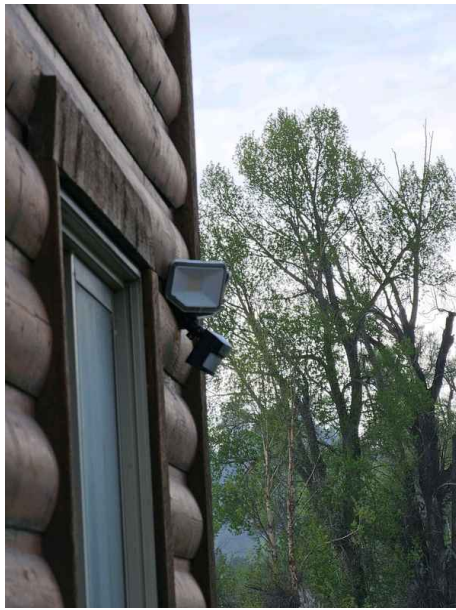
Repaired as of 5/29

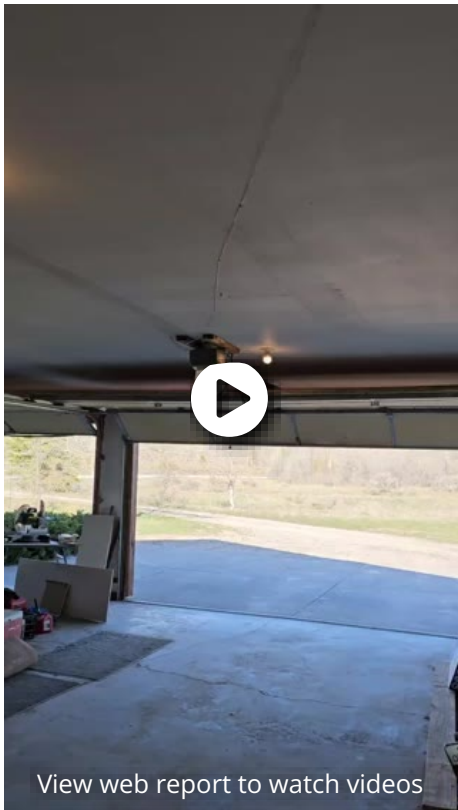
Original Inspection 4/23

The garage door opener does not work as intended. Recommend repair.

All new garage doors installed

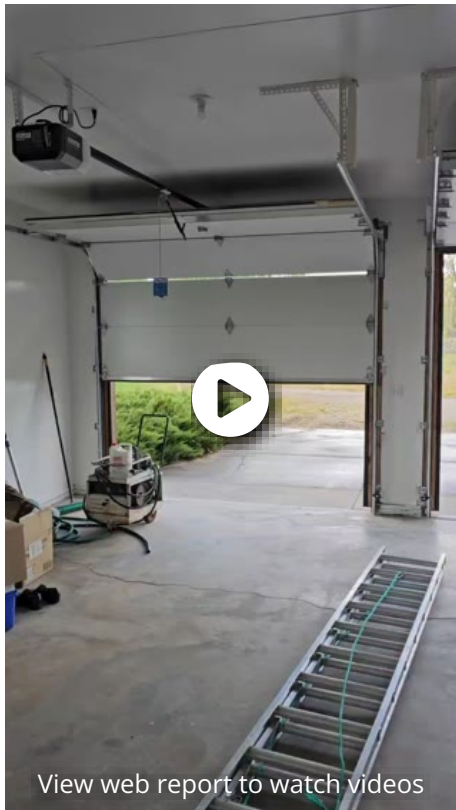
Repaired as of 5/29

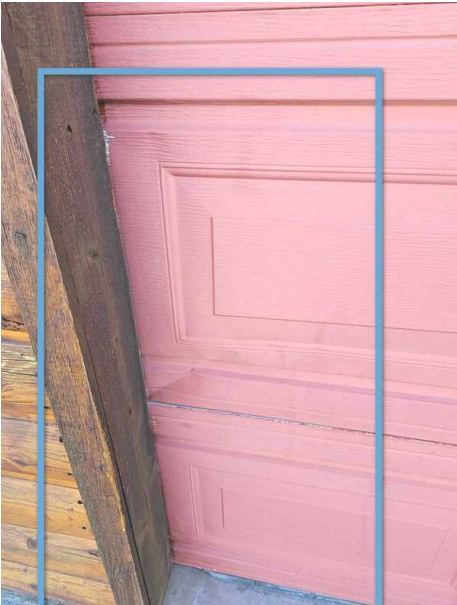
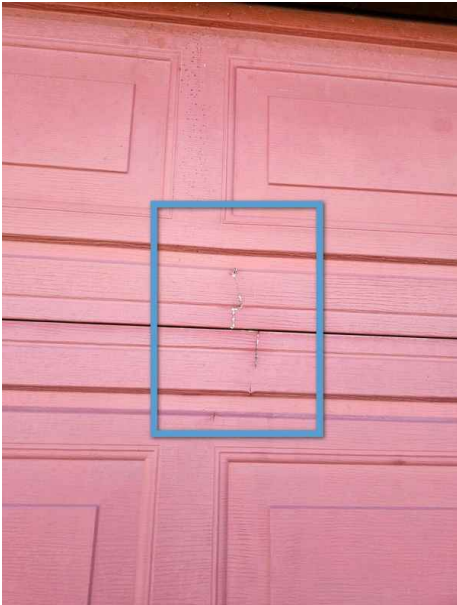
The main garage door is functional, but has cosmetic damage. Recommend repair as needed.

All new garage doors installed

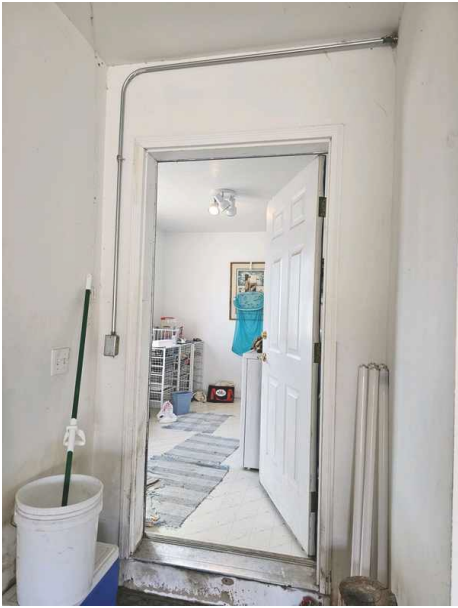
The house garage entry door is functional but does not self-close. This may not have been required when the house was built and you may elect to have self closing hinges installed for modern fire safety.

Still need to add a self closing hinge

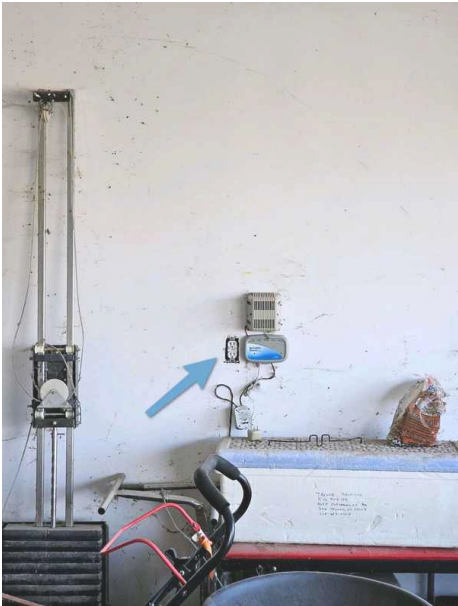
Original Inspection 4/23

Coverplates were missing on outlets, switches or junction boxes. Recommend installing cover plates.
Repaired as of 5/29

Cover plate installed

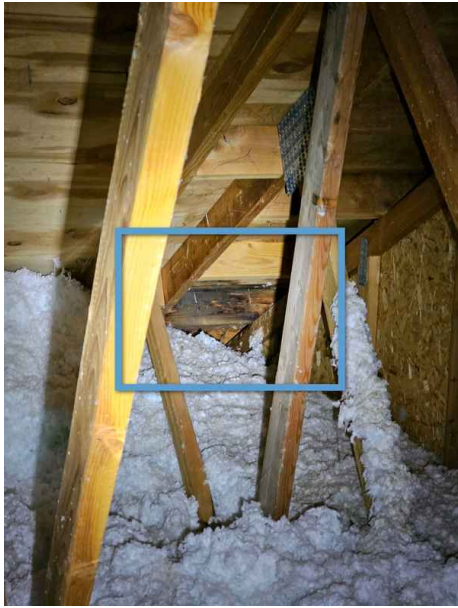
Original Inspection 4/23

There are moisture stains on the underside of some wood decking. Recommend monitoring.
Old stain is still visible but no current moisture as of return visit 5/29 even with current rainfall.

There was a leak, but that has been addressed and repaired by Weddle & Sons Roofing

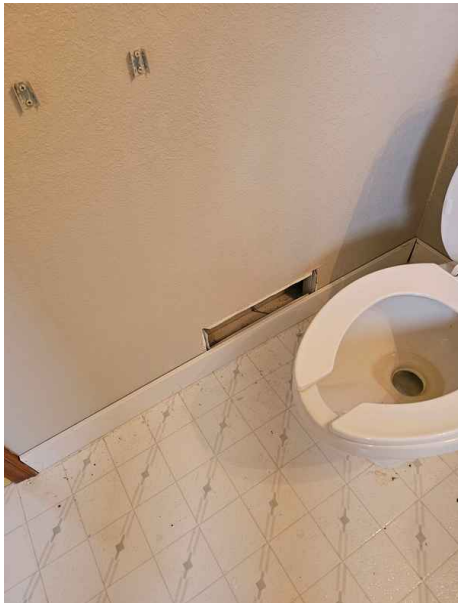
Original Inspection 4/23

One or more register is missing. Recommend installing.

All registers have been replaced if missing

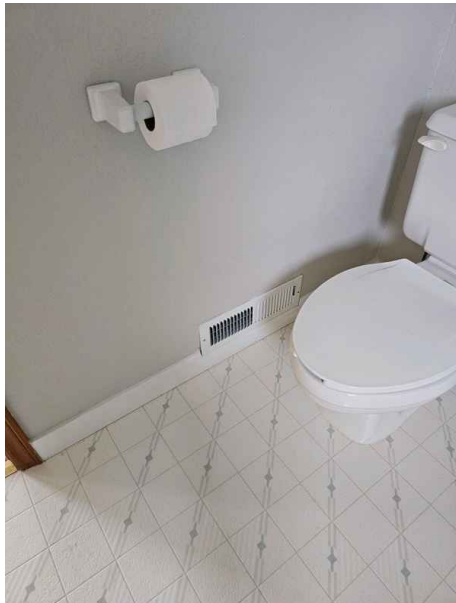
Repaired as of 5/29

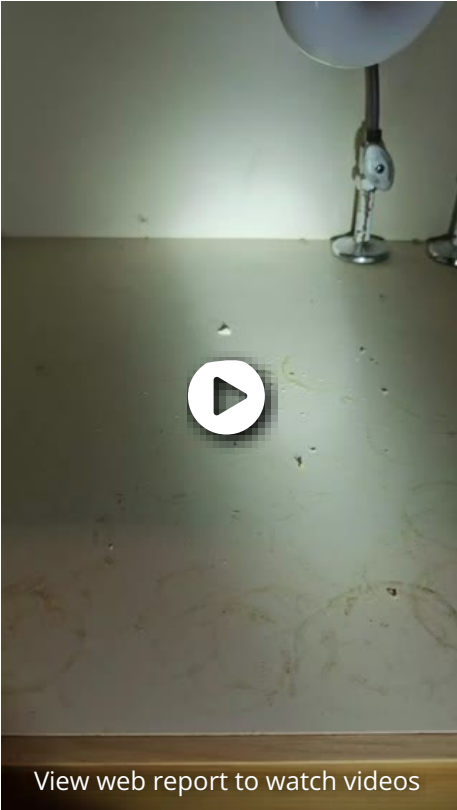
Original Inspection 4/23

There is a leak at the drain line below the sink. Recommend repair.

Leak addressed and tightened

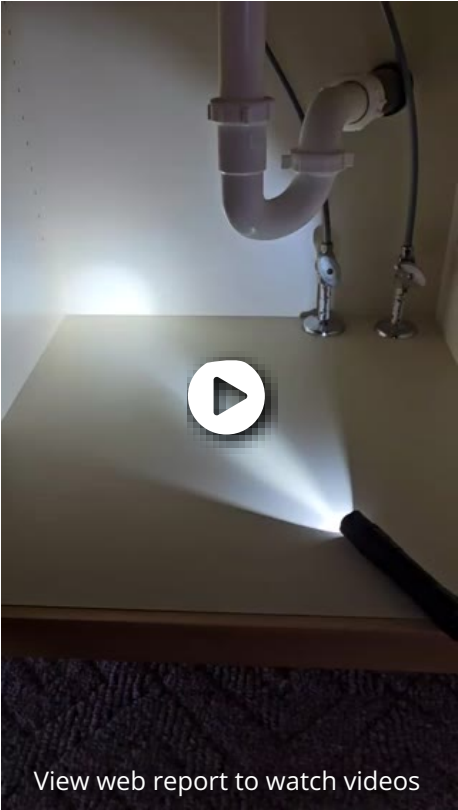
Repaired as of 5/29

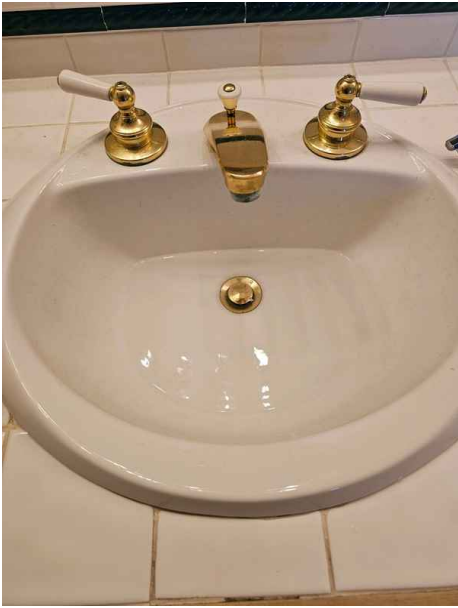
Original Inspection 4/23

The sink drains slowly. Recommend repair.

Repaired

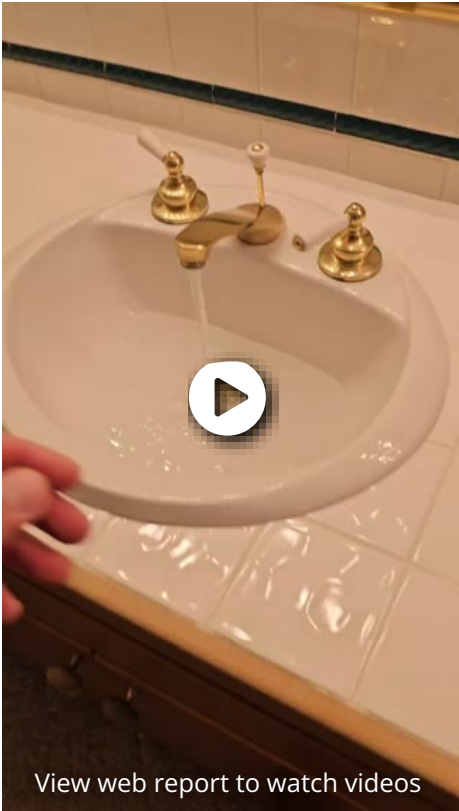
Repaired as of 5/29

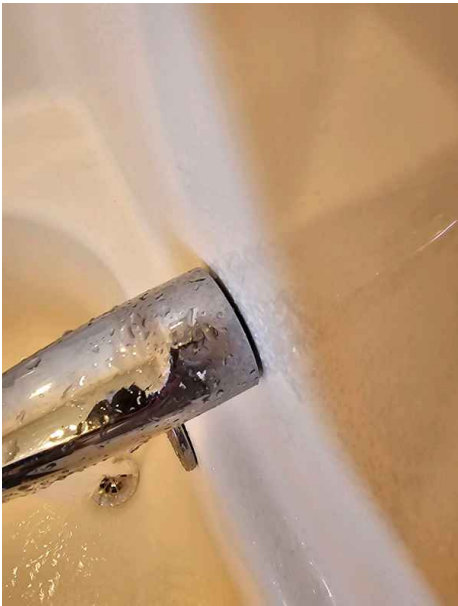
Location
1st Floor Bathroom

Gaps or openings are observed around shower valves and faucet. Recommend sealing.

Caulking was performed

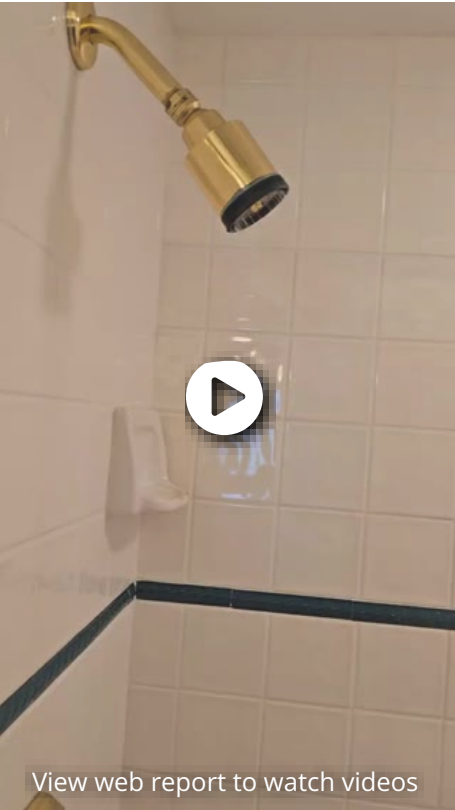
Location
Master Bathroom

There is no hot water supply at the tub-shower faucet. There is cold water supply, but when the handle is turned to the left or hot side, the water supply stops. Recommend further evaluation & repair.

Handle needs to be turned the other direction

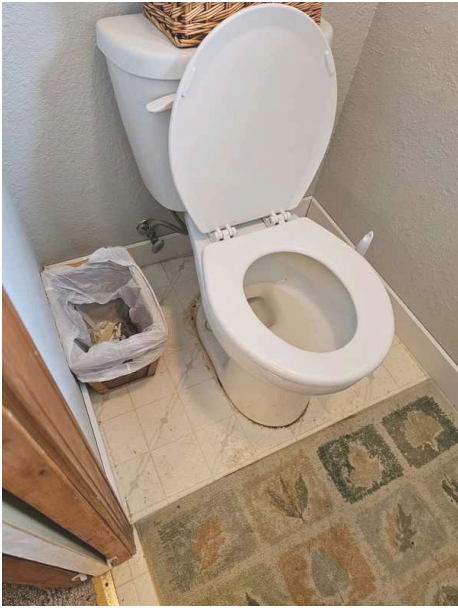
Original Inspection 4/23

Staining and lifted flooring was observed around the base of the toilet. Recommend further evaluation.

Toilet has been thoroughly cleaned. No evidence of leaking

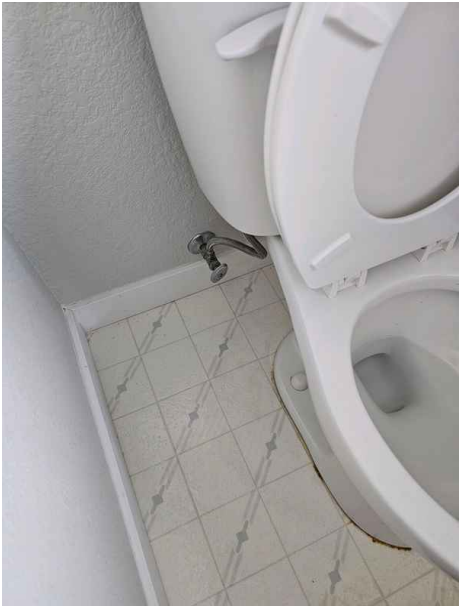
Repaired as of 5/29

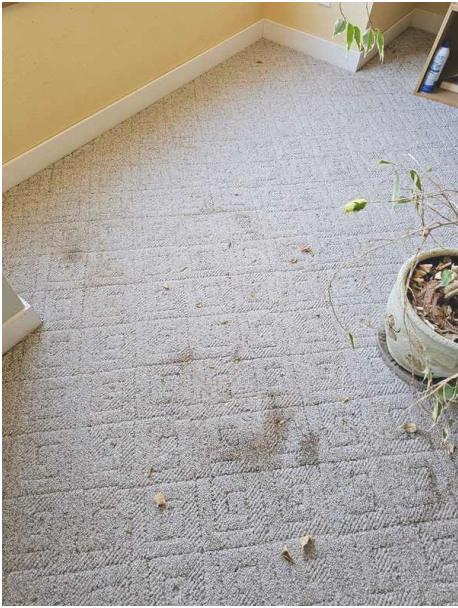
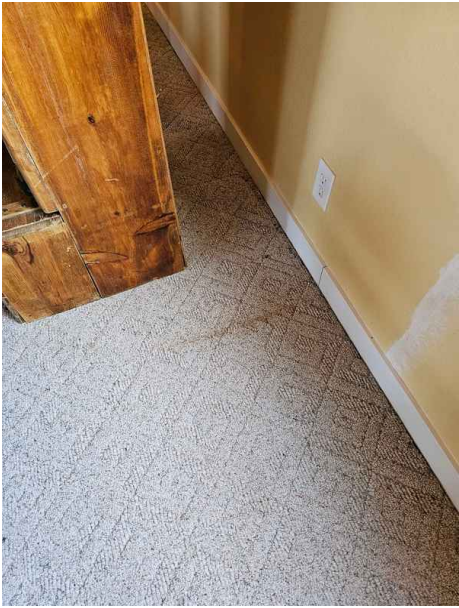
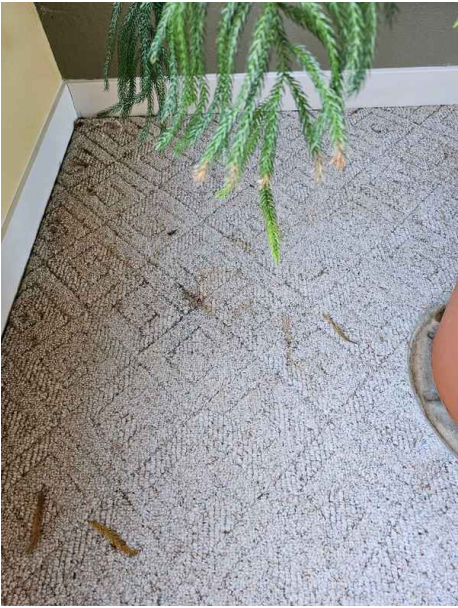
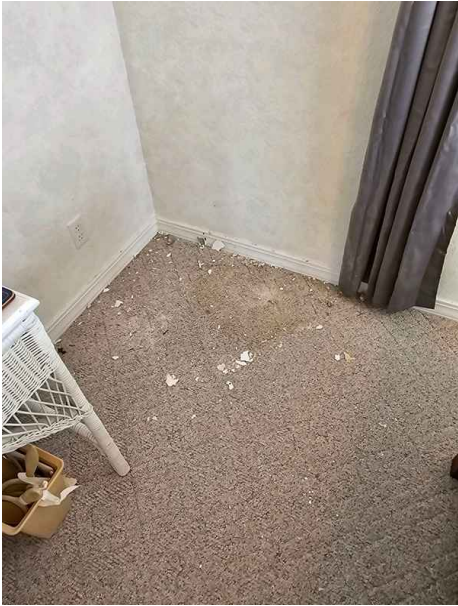
The carpet is stained. Recommend a thorough cleaning or replacement as needed.

Professional carpet cleaners have cleaned the areas of concern

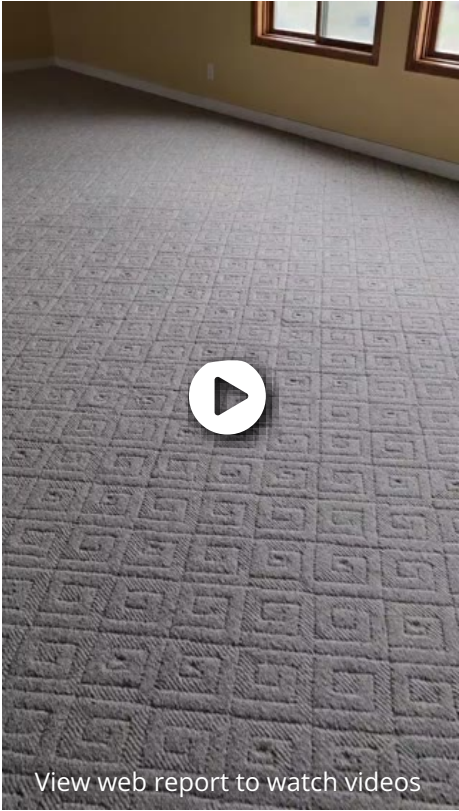
Improvements made as of 5/29

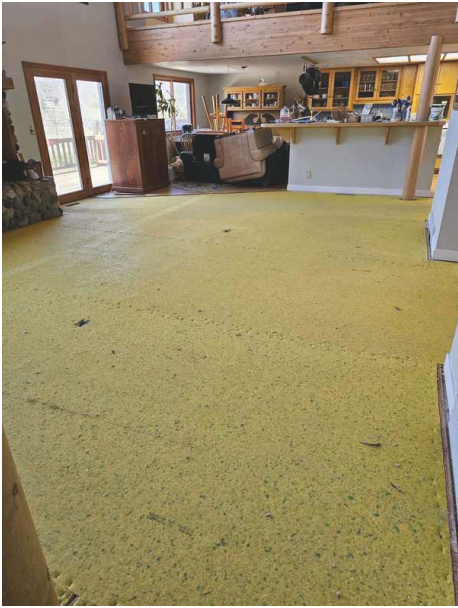
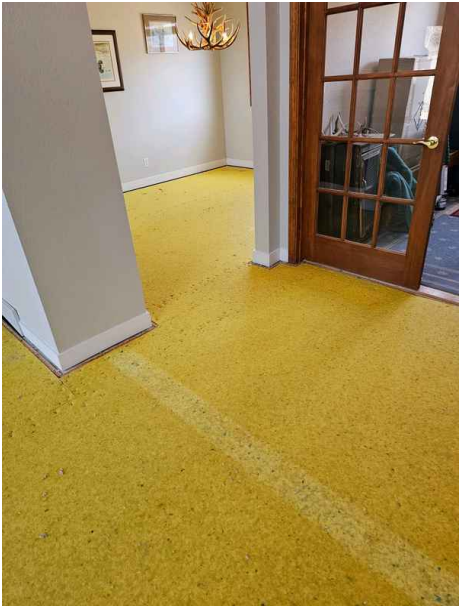
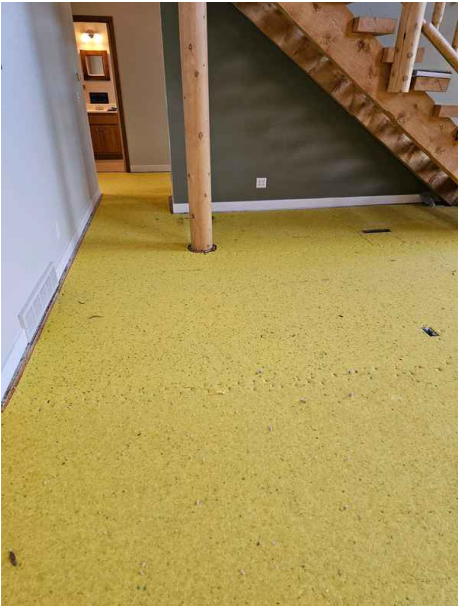
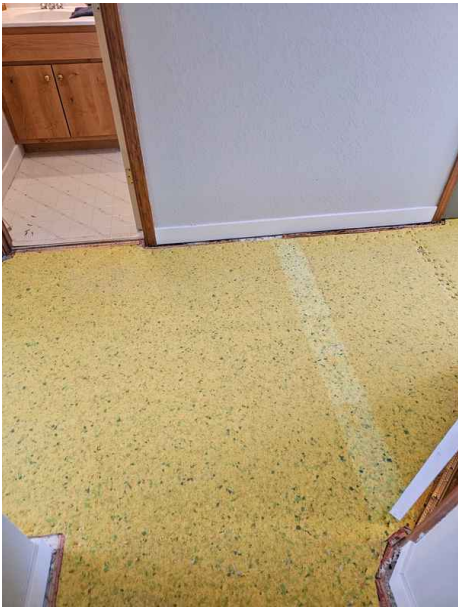
The flooring was removed. Recommend installing.

New carpet has been installed

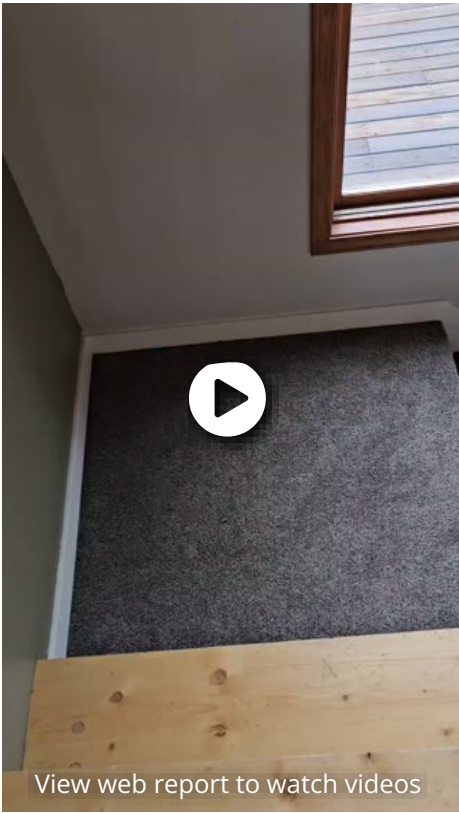
Repaired as of 5/29

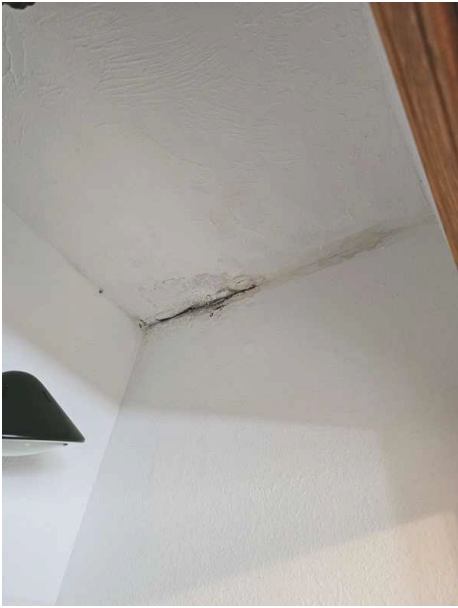
Original Inspection 4/23

There is evidence of moisture intrusion. Recommend further evaluation and repair as needed.

Sheetrock has been repaired

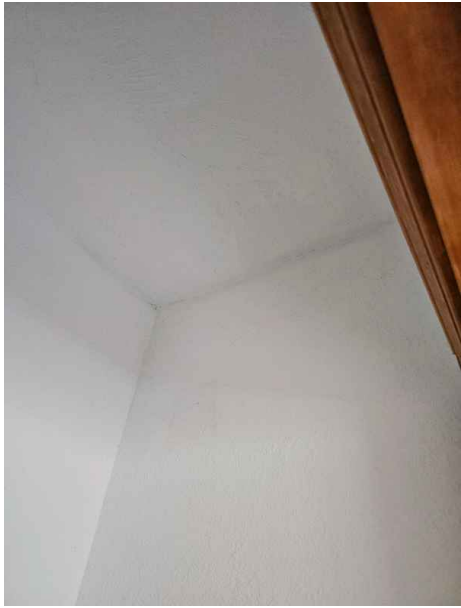
Repaired as of 5/29

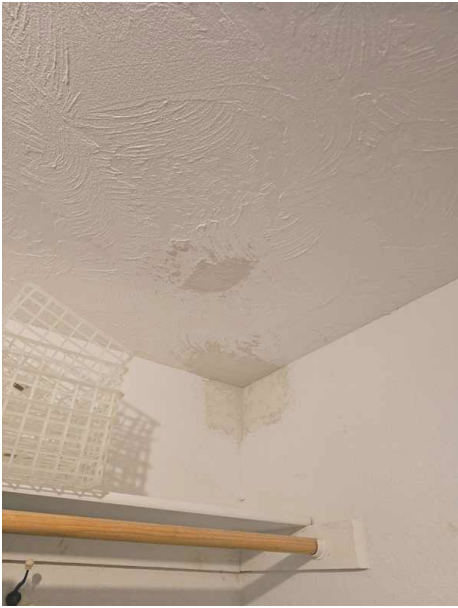
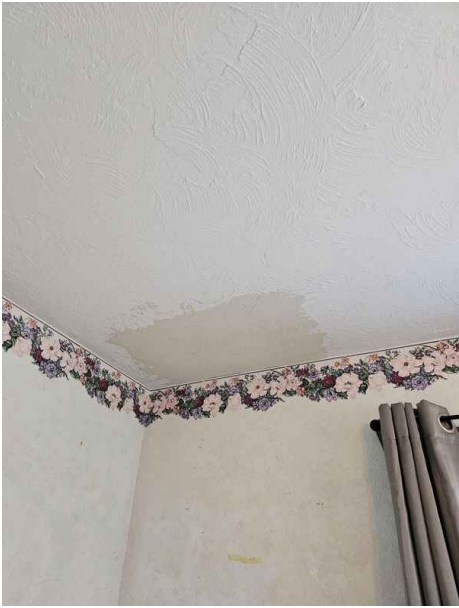
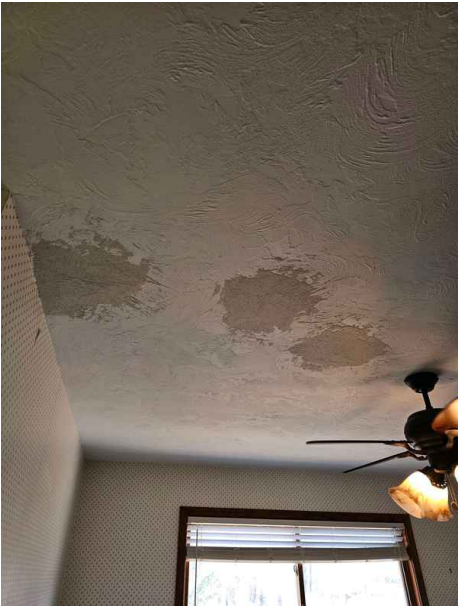
Patches or repairs were observed in the wall or ceiling. We could not determine the reason for the repairs. Recommend monitoring.

Sheetrock has been repaired

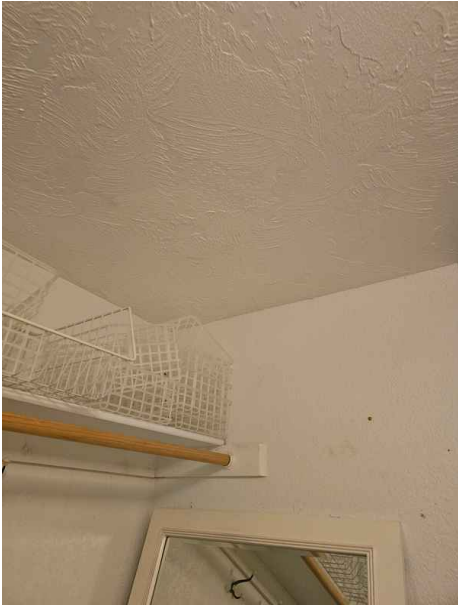
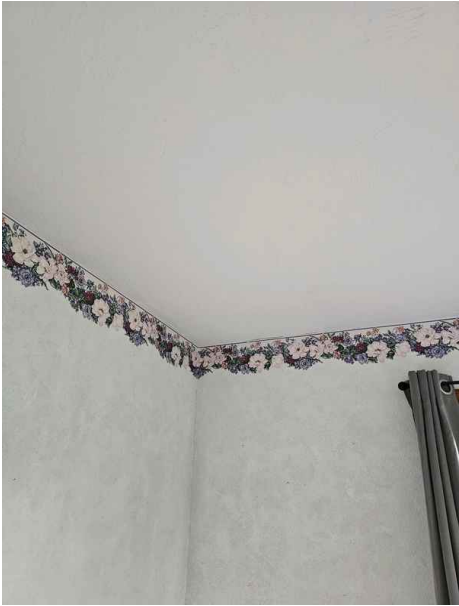
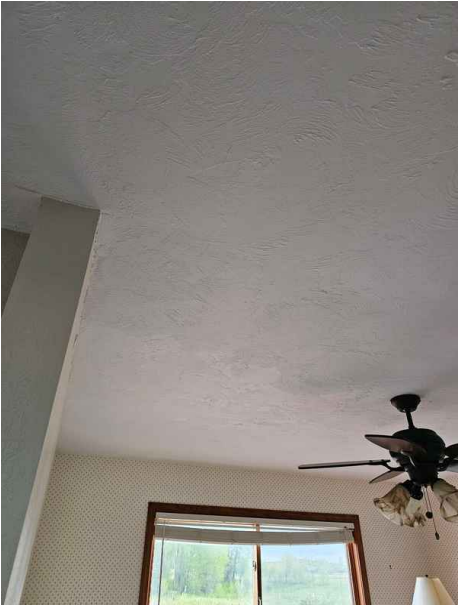
Improvement made as of 5/29

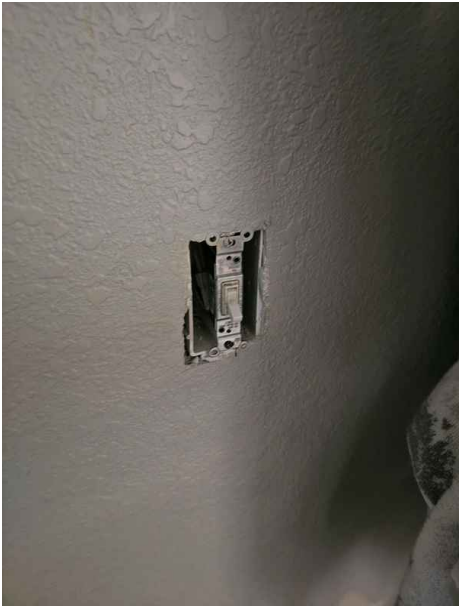
Location
Master Bathroom

There were missing / damaged covers that should be installed

Cover plate installed
