REPAIR REQUEST LIST

1467 Cottonwood Rd
05/28/2024 12:11 pm

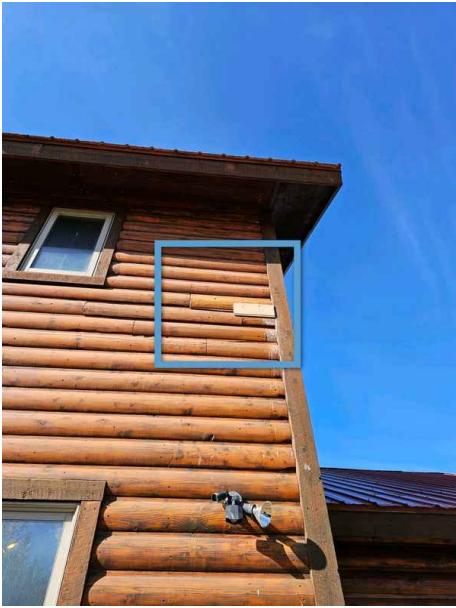
Original Inspection 4/23

Recent or past repairs to the exterior siding was observed. We could not determine the reason for the repairs and recommend asking the seller about repairs and why they were needed.

All bird damage has been repaired.

Old patch was cleaned up as of 5/29

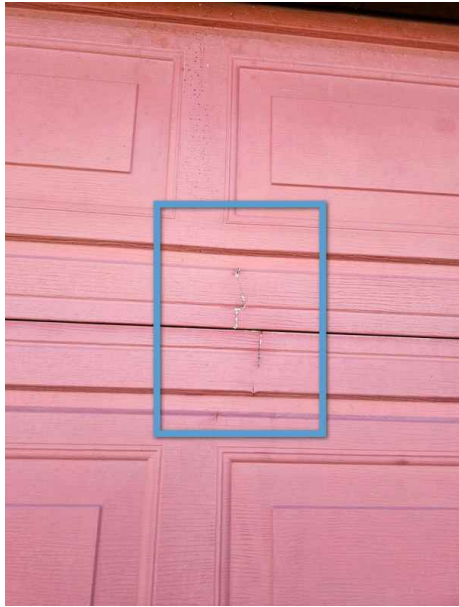
The main garage door is functional, but has cosmetic damage. Recommend repair as needed.

All new garage doors installed

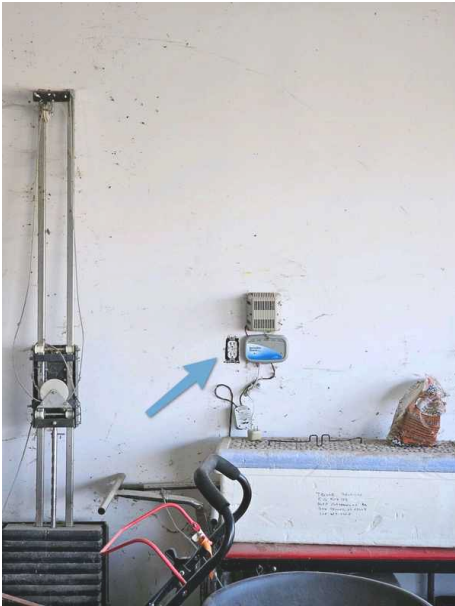
Original Inspection 4/23

Coverplates were missing on outlets, switches or junction boxes. Recommend installing cover plates.

Cover plate installed

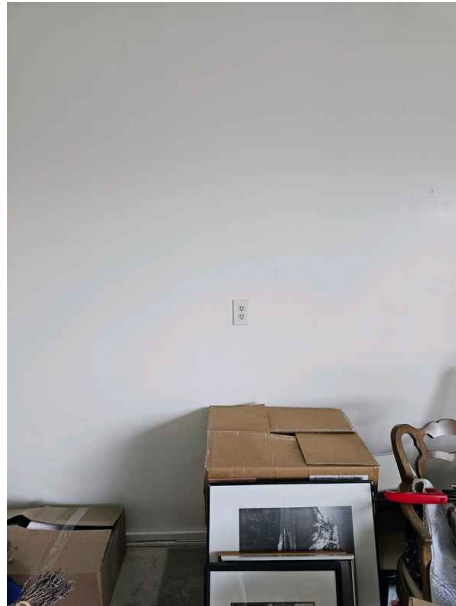
Repaired as of 5/29
