### REPAIR REQUEST LIST

6358 Desert Peak Dr 03/28/2024 10:42 am

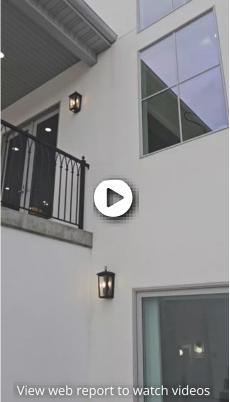
Location

3.5.2 - Exterior: Exterior Siding Notes MOISTURE STAINS

There are visible moisture stains under the eaves at the roof to wall transition near the gutters. Recommend correctionas necessary.

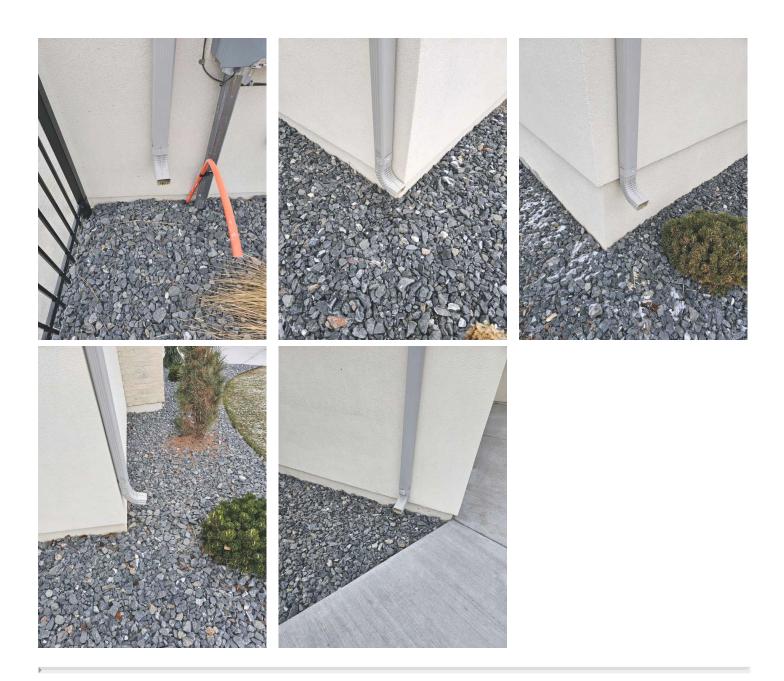
Location

3.9.1 - Exterior: Downspouts SPLASH BLOCKS MISSING

Some downspouts terminated close to, or against the home in one or more locations. We recommend splash blocks, or some other downspout extension, in these areas to ensure water runoff away from the structure.

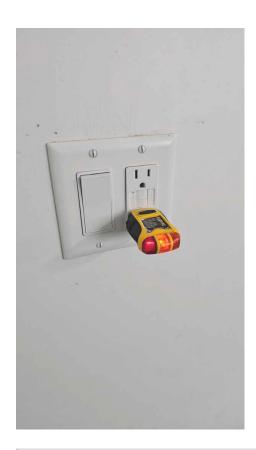
5.12.1 - Garage(s): Outlets, Electrical Observations REVERSE POLARITY

An outlet has reversed polarity. Recommend Repair.

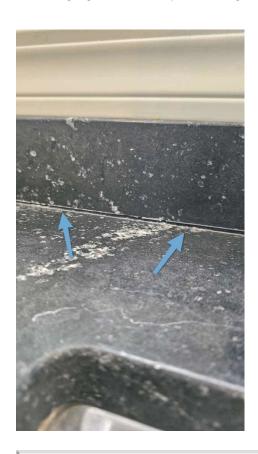
## 12.4.1 - Kitchen: Countertop MISSING OR DETERIORATED CAULK/GROUT

The caulking or grout for the backsplash is missing, has gaps and/or not installed properly. We advise caulking/grout be installed and/or gaps sealed.

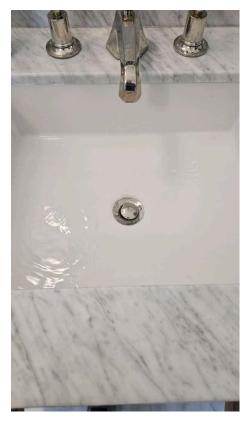
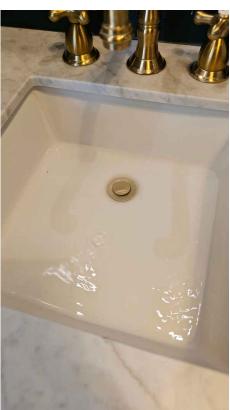
Location

14.2.1 - Bathrooms: Trap and Drain

### SLOW DRAIN

The sink drains slowly. Recommend repair.

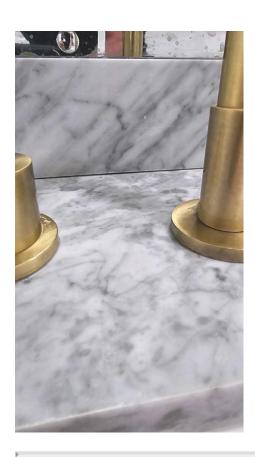
Location

# 14.6.1 - Bathrooms: Countertop MISSING OR DETERIORATED CAULK/GROUT

The caulking or grout for the backsplash is missing, has gaps and/or not installed properly. We advise caulking/grout be installed and/or gaps filled to prevent possible water intrusion.

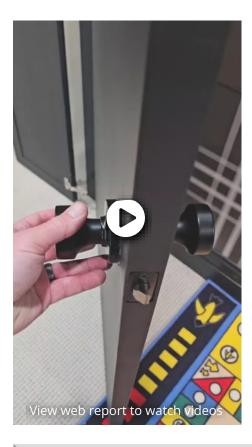
Location

One more doors have hardware that is missing or in need repair or adjustment.

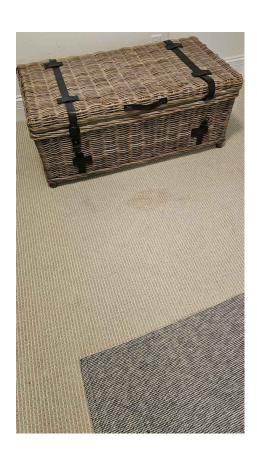
Location

16.3.1 - Interior: Flooring CARPET IS STAINED

The carpet is stained. Recommend a thorough cleaning or replacement as needed.
