REPAIR REQUEST LIST

6358 Desert Peak Dr
03/28/2024 10:42 am

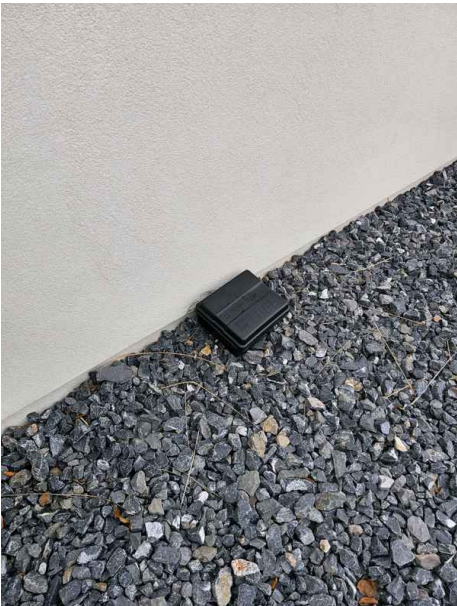
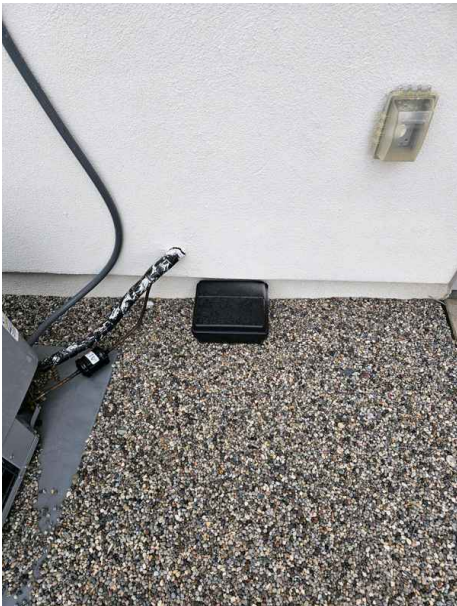
3.3.1 - Exterior: Site & Other Observations RODENT TRAPS OBSERVED

Rodent traps were observed around the exterior of the home. We recommend asking the seller is rodent activity has been observed in the past.

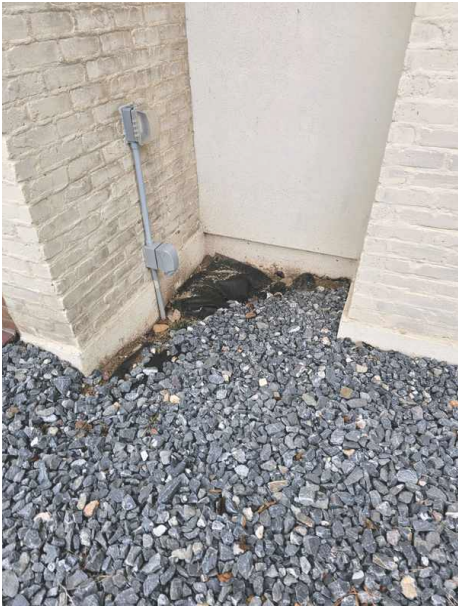
3.4.1 - Exterior: Grading & Drainage GRADING AND DRAINAGE IS NEGATIVE OR NEUTRAL

Grading and drainage is either negative or neutral adjacent to the residence and moisture intrusion will remain a possibility. The soil or the hard surfaces should slope away from the residence to a distance of at least six feet to keep moisture away from the footings. We can elaborate on this issue, but you should seek a second opinion from a geologist or grading and drainage contractor.

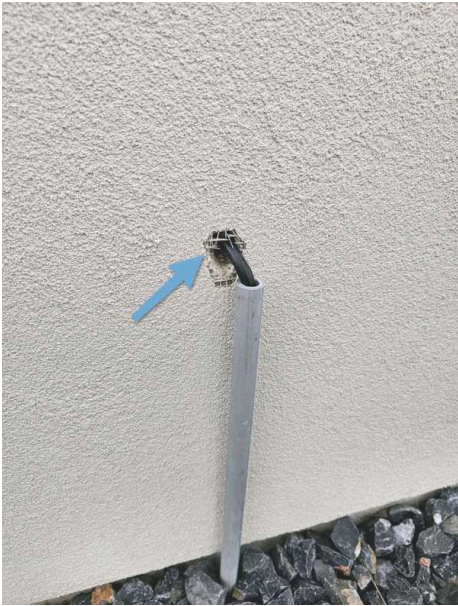
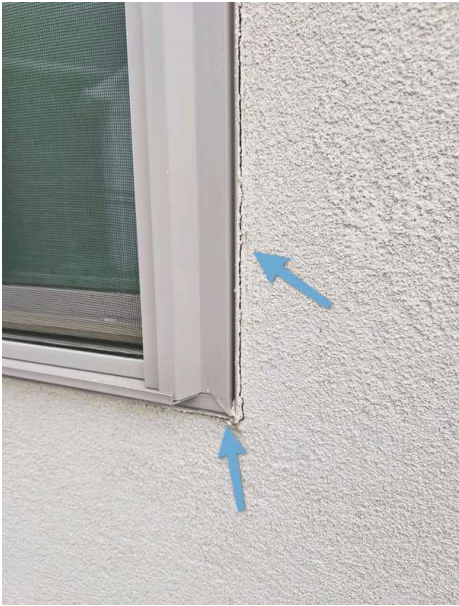
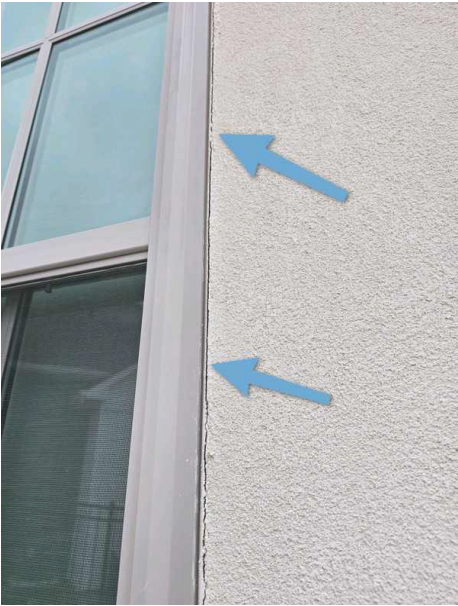
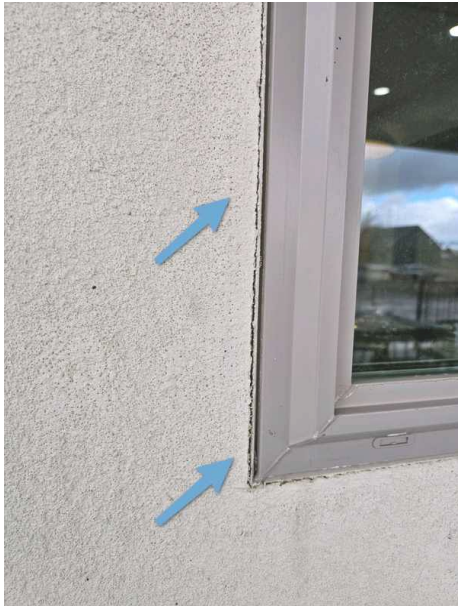
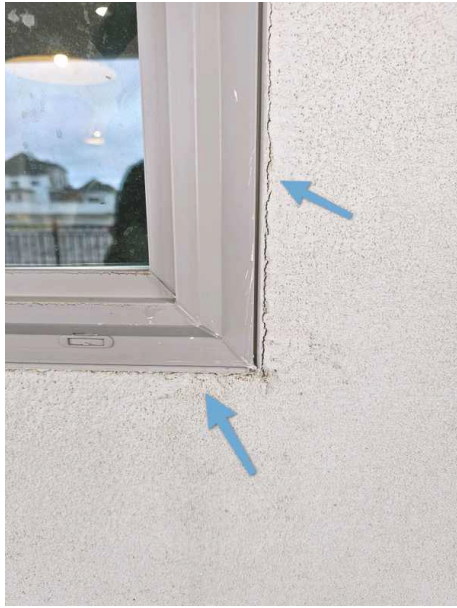
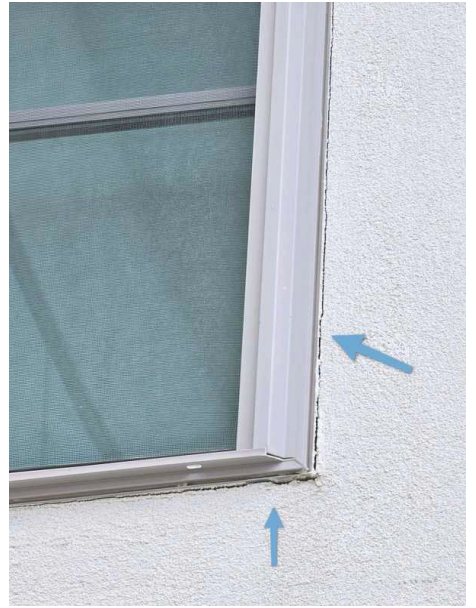
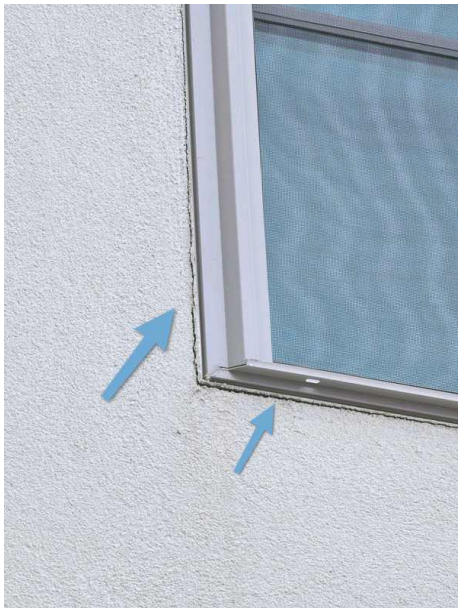
3.5.1 - Exterior: Exterior Siding Notes
SEAL PENETRATIONS/GAPS

Gaps and/or holes were observed on one or more sides in the siding around plumbing, gas, cable, wiring and/or other penetrations. We recommend sealing.

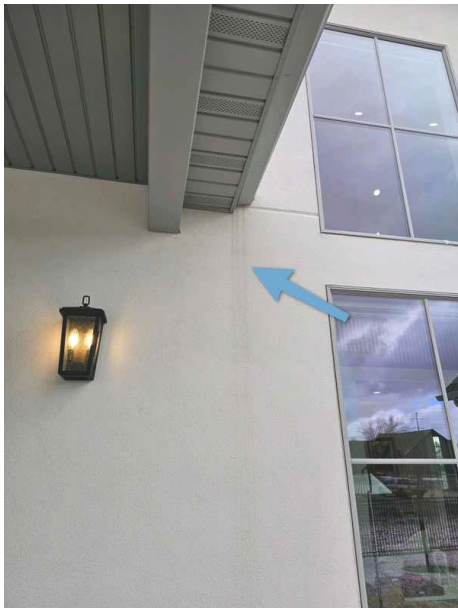
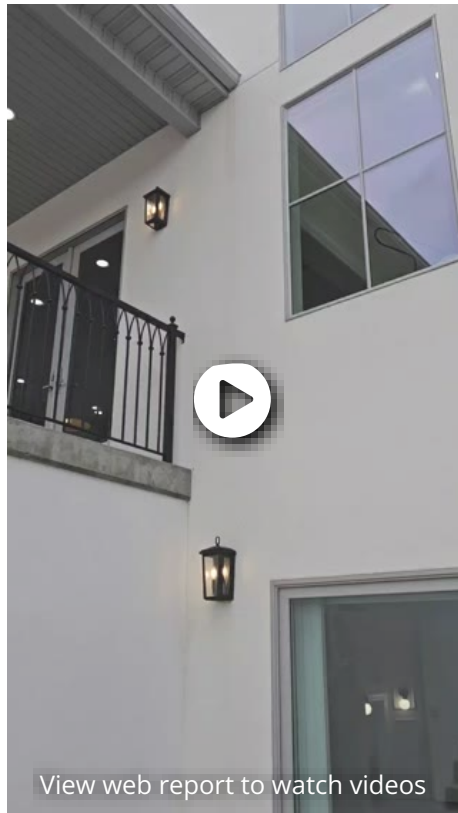
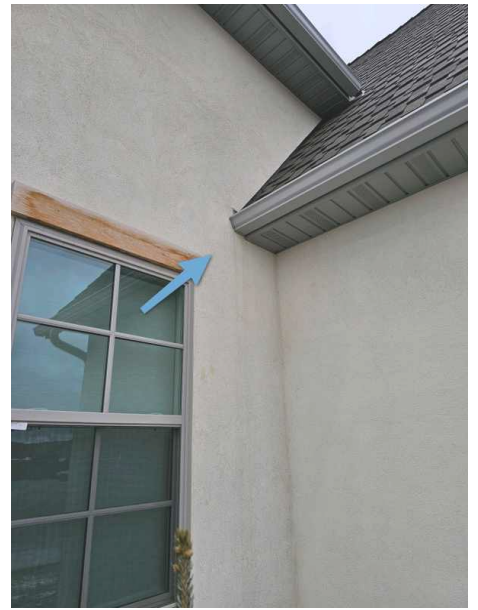
3.5.2 - Exterior; Exterior Siding Notes

There are visible moisture stains under the eaves at the roof to wall transition near the gutters. Recommend correctionas necessary.

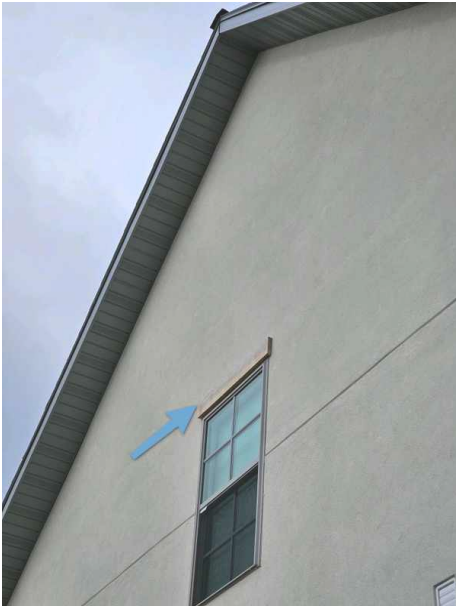
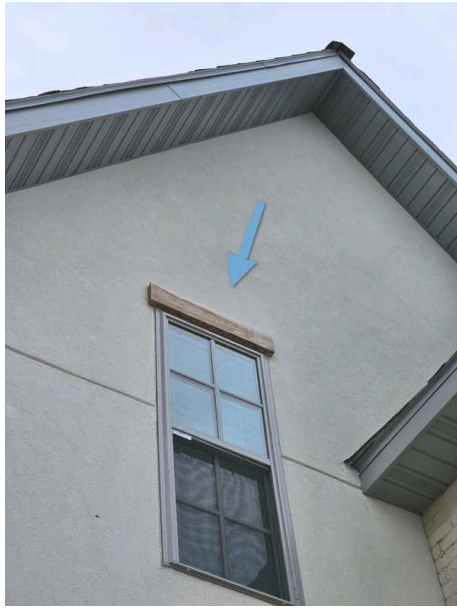
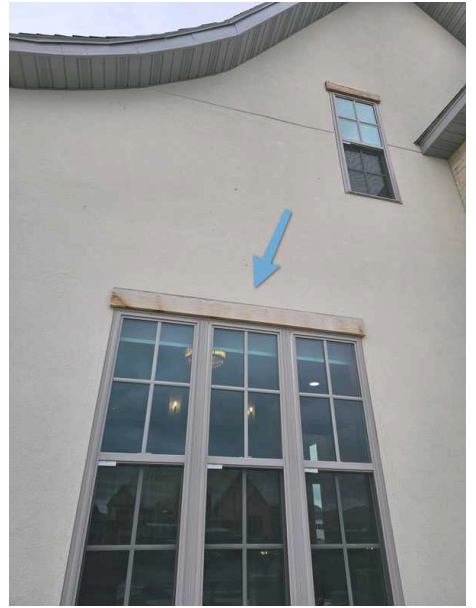
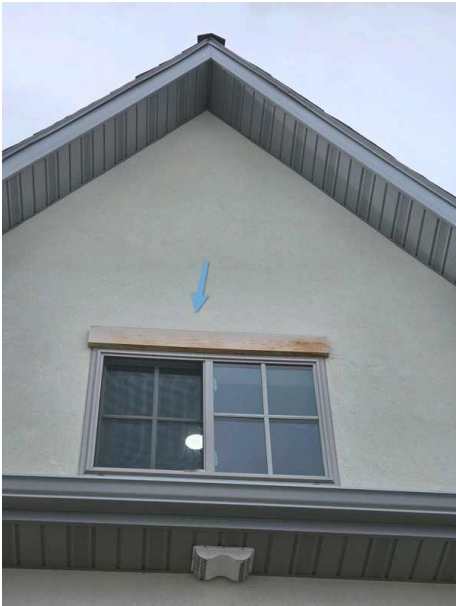
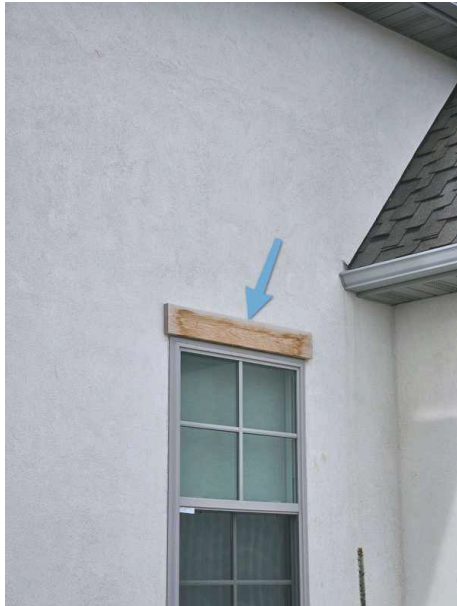
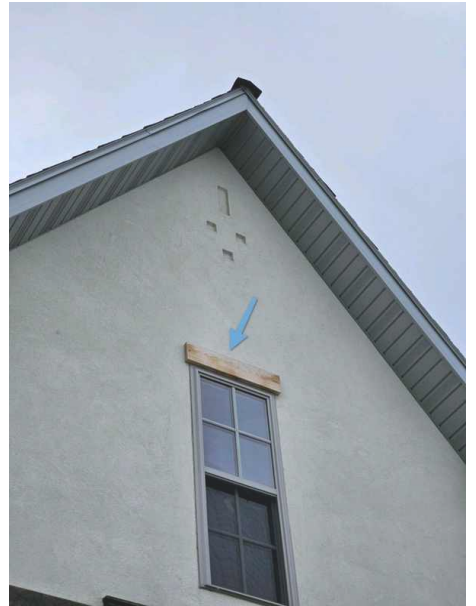
3.7.1 - Exterior: Fascia, Trim & Eaves **WEATHERED FASCIA AND TRIM**

Sections of the fascia and trim are worn or weathered. Recommend maintenance.

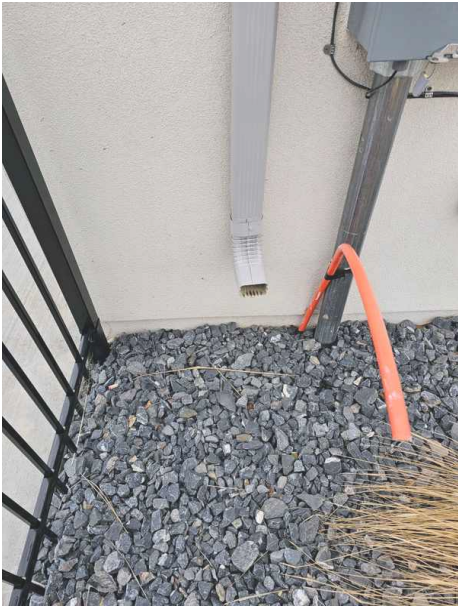
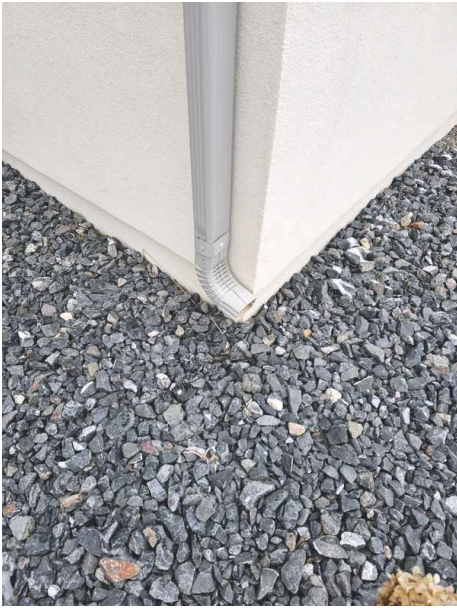
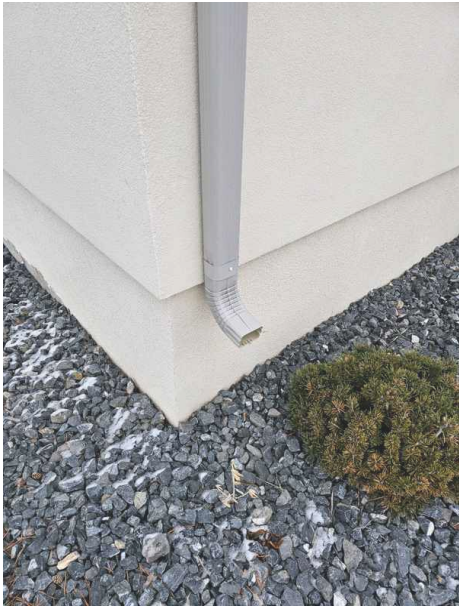
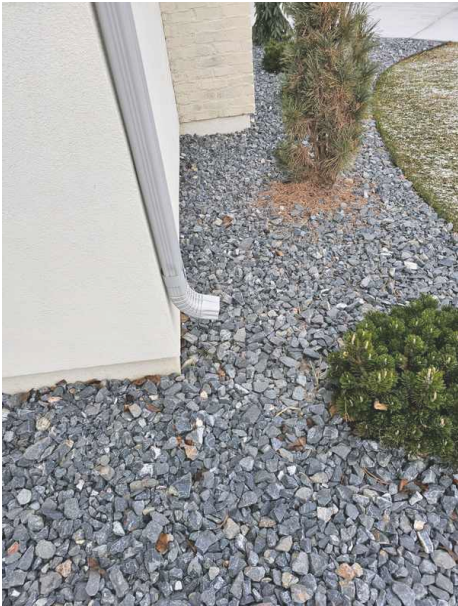
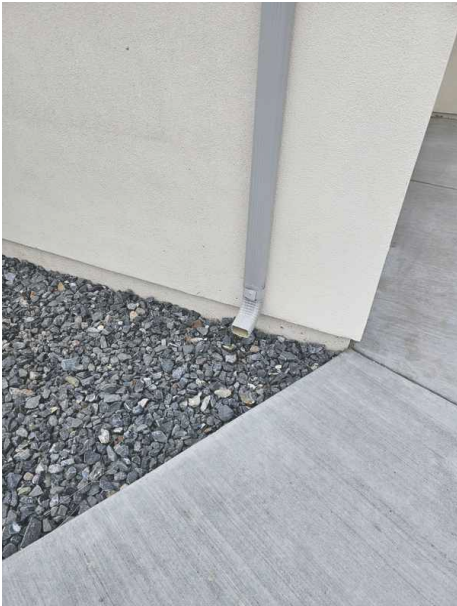
3.9.1 - Exterior: Downspouts SPLASH BLOCKS MISSING

Some downspouts terminated close to, or against the home in one or more locations. We recommend splash blocks, or some other downspout extension, in these areas to ensure water runoff away from the structure.

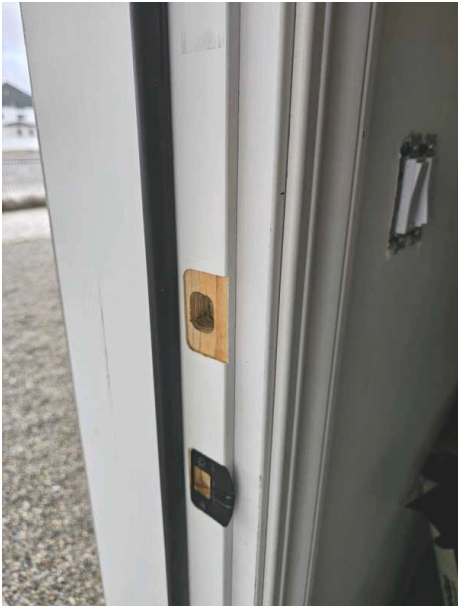
3.10.1 - Exterior: Exterior Doors

A door is missing its deadbolt plate and it should be replaced.

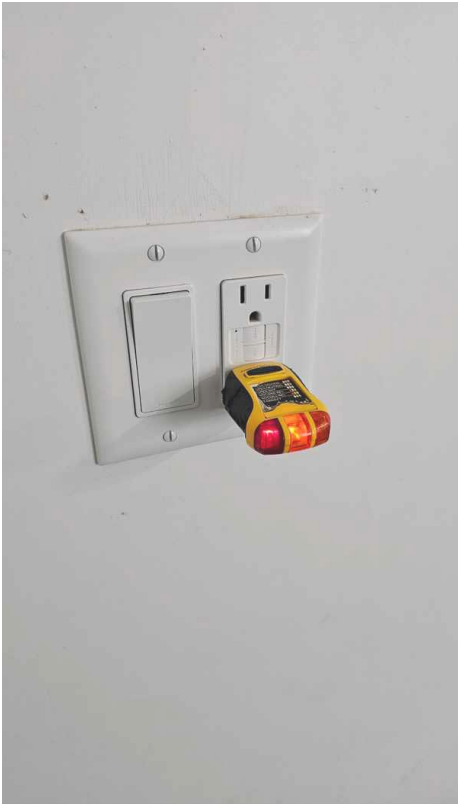
5.12.1 - Garage(s): Outlets, Electrical Observations
REVERSE POLARITY

An outlet has reversed polarity. Recommend Repair.
To learn more why this is dangerous [CLICK HERE](#)

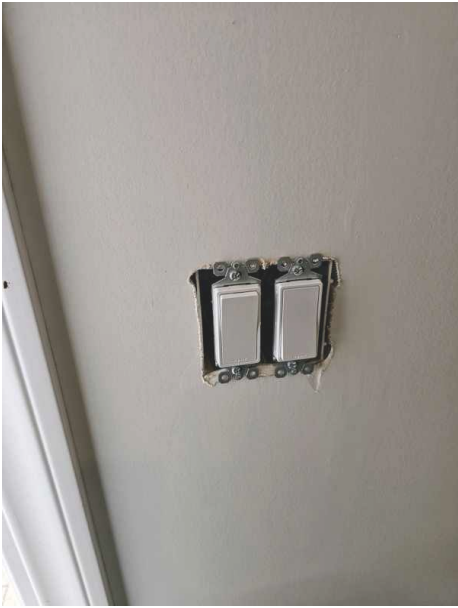
5.12.2 - Garage(s): Outlets, Electrical Observations
COVERPLATE MISSING/DAMAGED

Coverplates were missing on outlets, switches or junction boxes. Recommend installing cover plates.

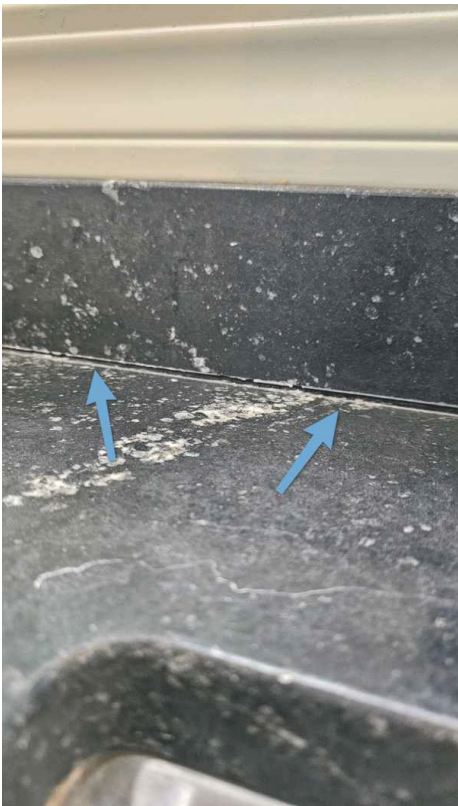
12.4.1 - Kitchen: Countertop
MISSING OR DETERIORATED CAULK/GROUT

The caulking or grout for the backsplash is missing, has gaps and/or not installed properly. We advise caulking/grout be installed and/or gaps sealed.

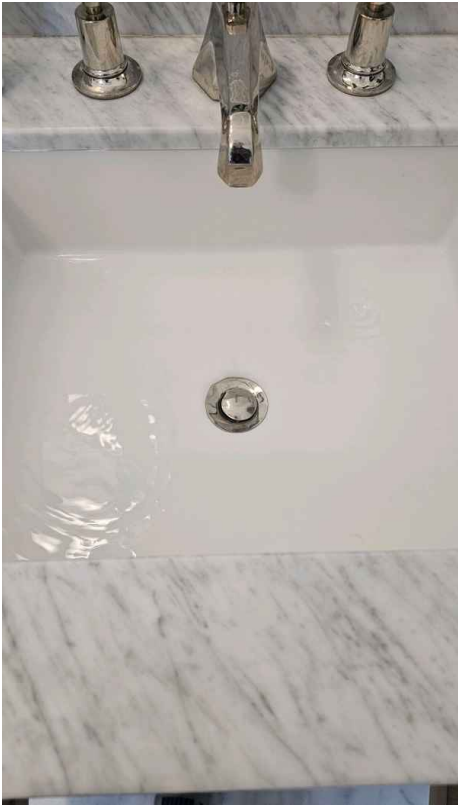
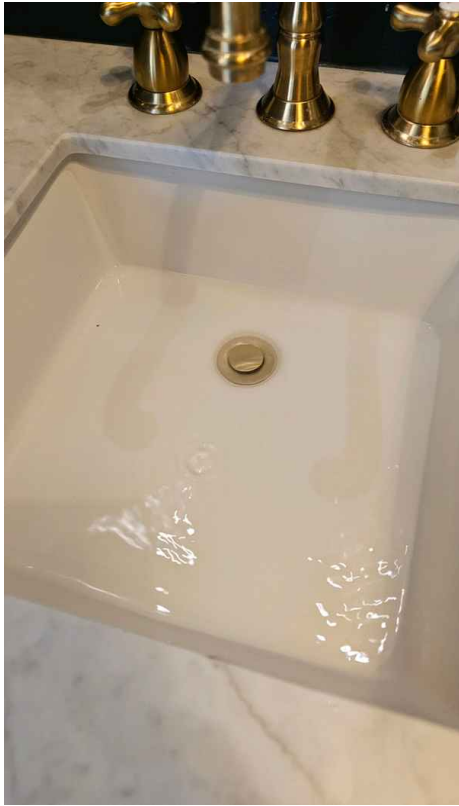
14.2.1 - Bathrooms: Trap and Drain
SLOW DRAIN

The sink drains slowly. Recommend repair.

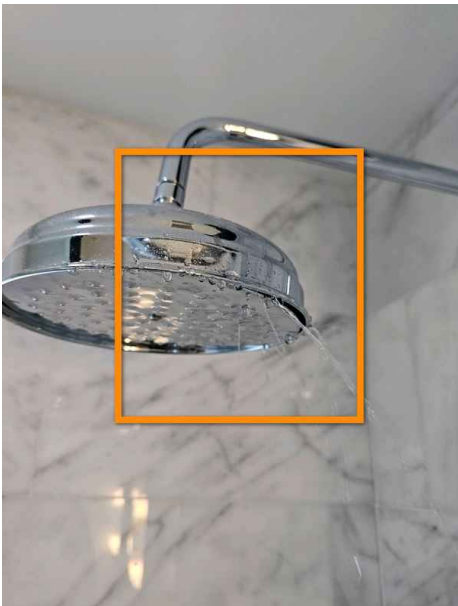
14.4.1 - Bathrooms: Tub-Shower

SHOWER-HEAD SPRAYS EVERYWHERE

The shower head is occluded by minerals, and does not spray uniformly.

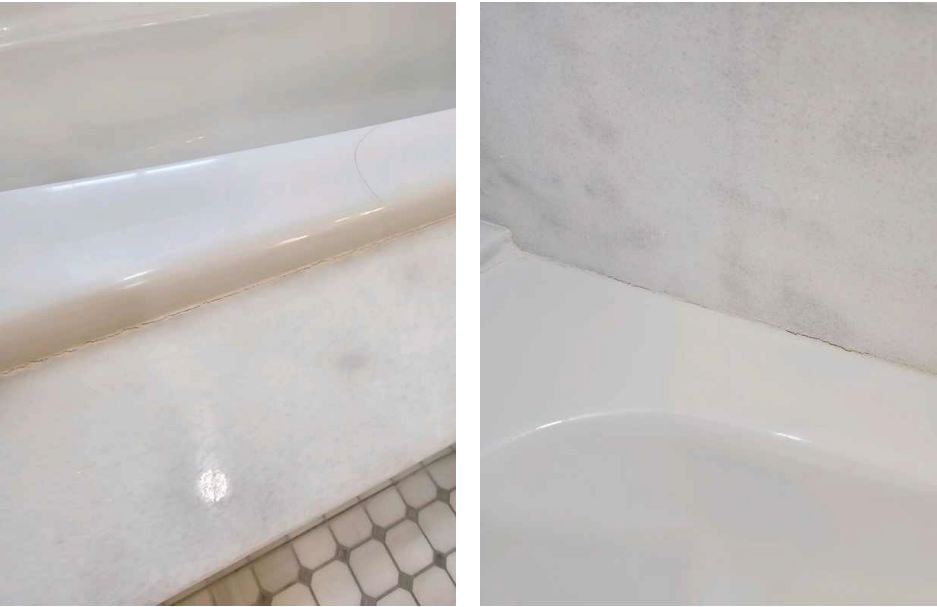
14.4.2 - Bathrooms: Tub-Shower

The tub surround has missing or deteriorated caulk/grout. Recommend caulking or sealing.

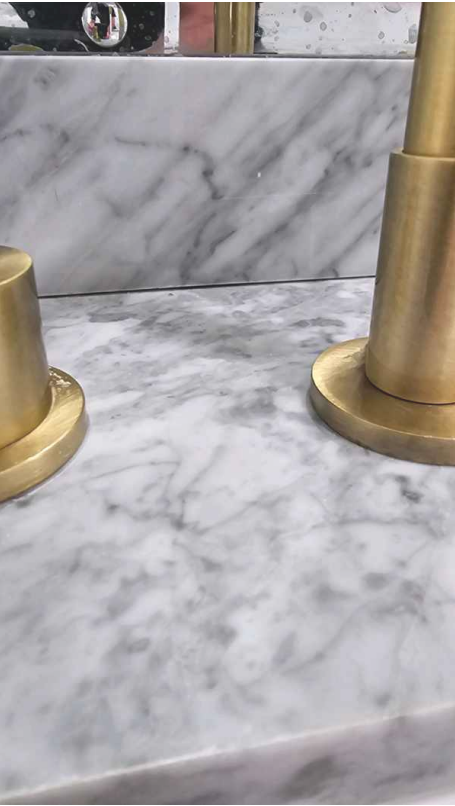
14.6.1 - Bathrooms: Countertop
MISSING OR DETERIORATED CAULK/GROUT

The caulking or grout for the backsplash is missing, has gaps and/or not installed properly. We advise caulking/grout be installed and/or gaps filled to prevent possible water intrusion.

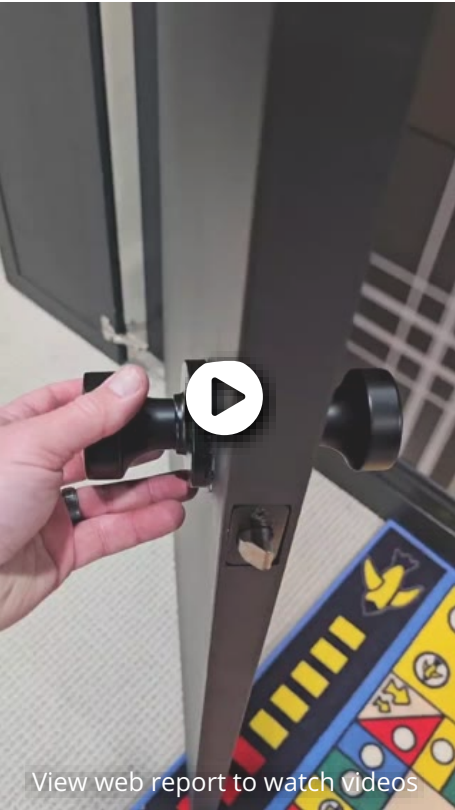
16.2.1 - Interior: Doors
DOOR HARDWARE NEEDS ADJUSTING

One more doors have hardware that is missing or in need repair or adjustment.

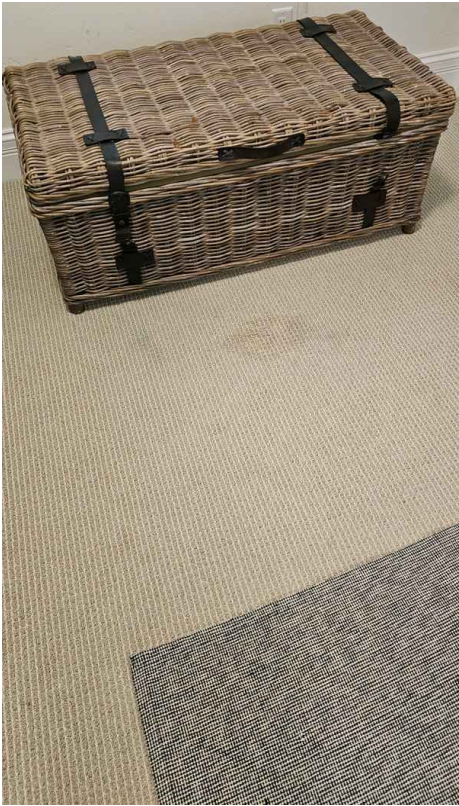
16.3.1 - Interior: Flooring
CARPET IS STAINED

The carpet is stained. Recommend a thorough cleaning or replacement as needed.
