REPAIR REQUEST LIST

4055 S 2000 W 05/11/2024 8:17 am

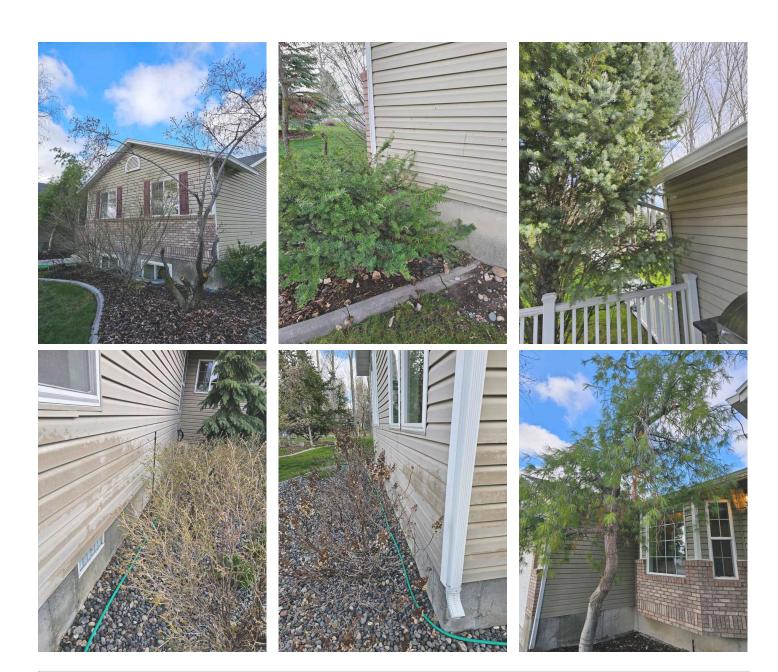
3.5.1 - Exterior: Exterior Siding Notes
VEGETATION IS ENCROACHING
Cosmetic - Monitor - Maintenance

Vegetation is encroaching on the structure. We recommend they be trimmed and kept back at a minimum of twelve inches away the walls and foundation.

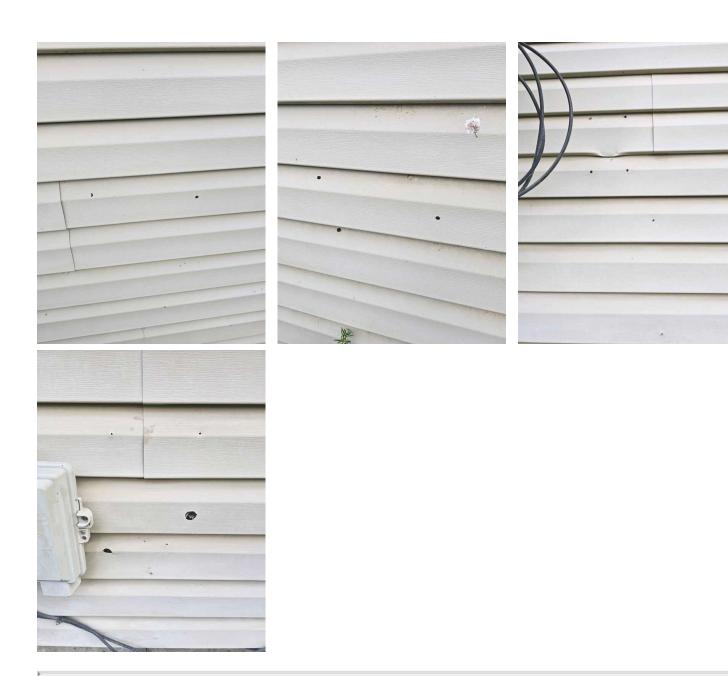
3.5.3 - Exterior: Exterior Siding Notes SEAL PENETATIONS/GAPS

Gaps and/or holes were observed on one or more sides in the siding around plumbing, gas, cable, wiring and/or other penetrations. We recommend sealing. Location

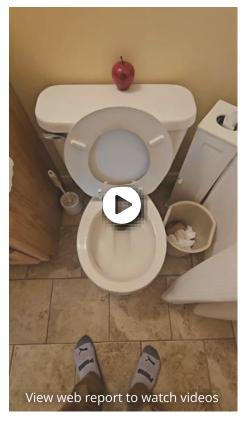
14.5.1 - Bathrooms: Toilet

FUNCTIONAL BUT LOOSE

The toilet is functional, but loose on the floor and should be secured by a qualified technician for safety reasons, and to prevent possible damage or leaking from around the toilet.
