SEWER INSPECTION REPORT

123 Main Street, Philadelphia pa
Philadelphia, PA 19125

FEBRUARY 28, 2023

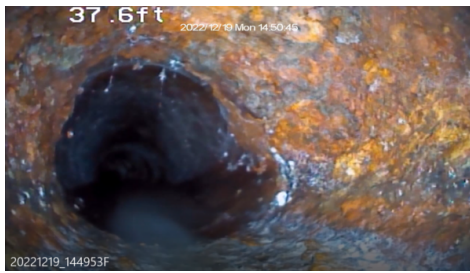
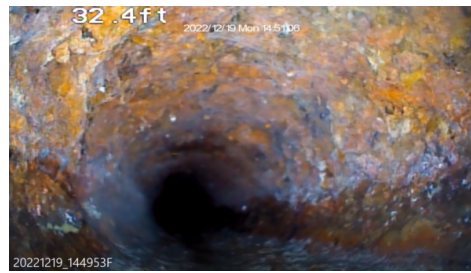
2.2.1 Observations

HEAVY CORROSION

Significant tuberculation was noted. Tuberculation is the development of mounds of corrosion product on the interior of cast iron pipes. This makes the interior surface of the pipes rough, increasing the likelihood of catching solids and debris as they flow through the pipe which can lead to clogs and backups.

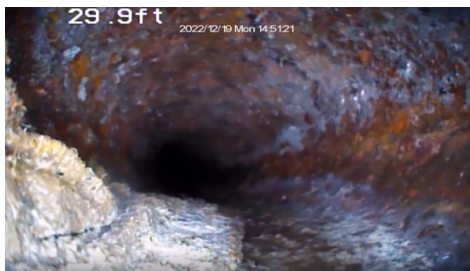
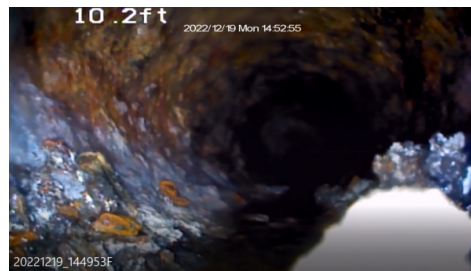
2.2.2 Observations

DEBRIS/SOLIDS

Debris/solids were found in the line. Recommend servicing.

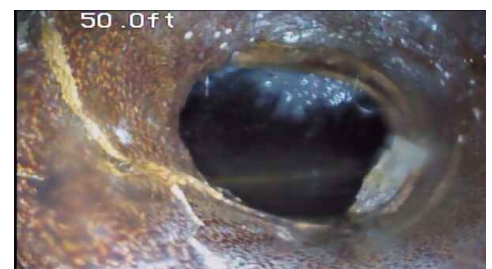
2.2.4 Observations

DAMAGED/CRACKED PIPE

A portion of the sewer line was noted to be cracked/damaged at *(digit)*.*(digit-ft)*. Damaged pipes can leech sewage into the soil and can lead to backups. Repairs are recommended.

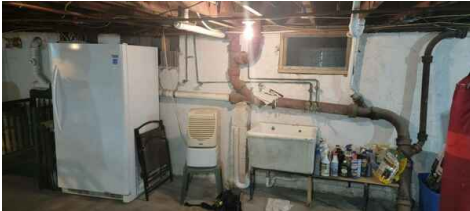
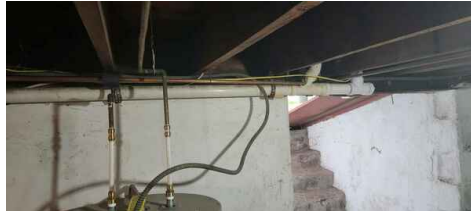
3.1.1 General Pictures

GENERAL WASTE PLUMBING PHOTOS
