EAGER INSPECTIONS, PLLC

PROPERTY INSPECTION REPORT

Concerning: 1000 Sample Report, Dallas TX 75214

Tristan Eager - Texas Professional Engineer #128938 TREC

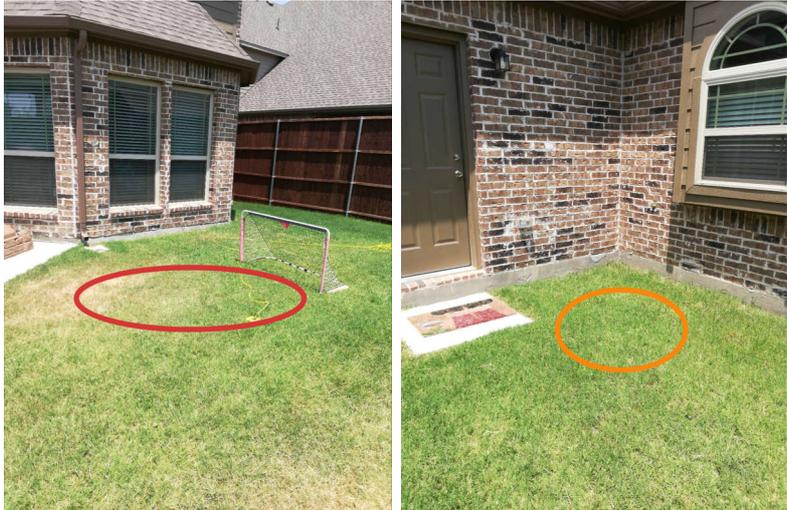
Southeast, South of west garage

1: Insufficient Slope away from Foundation

Insufficient slope away from foundation. The International Residential Code requires a minimum of 6" of fall in 10' away from the foundation. This is to prevent water intrusion during rain events and to prevent soil saturation near the foundation. Foundation performance could be affected by these conditions.

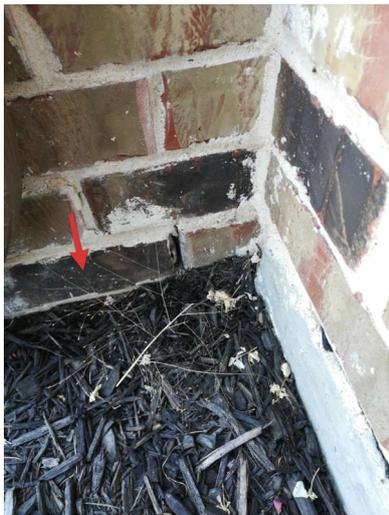
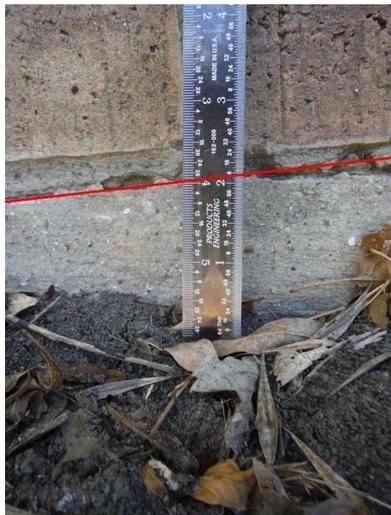
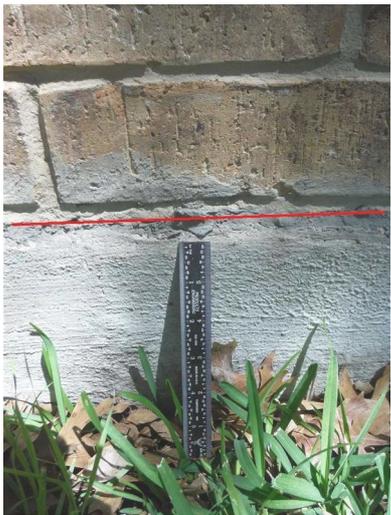
Front entry

2: High Soil Line at Masonry

High soil line at masonry . Soil and landscaping materials need to be a minimum of 4" below the brick ledge (base of bricks) to prevent moisture and insect intrusion into walls. Brick walls are designed to be permeable to moisture and have weep holes (ventilation) at the base of the wall. Soil and plant material near the weep holes will encourage high moisture inside the wall which can lead to deterioration.

Insufficient Clearance to brickledge 2" (EXAMPLE)

Sufficient clearance to brickledge 6"+ (example)

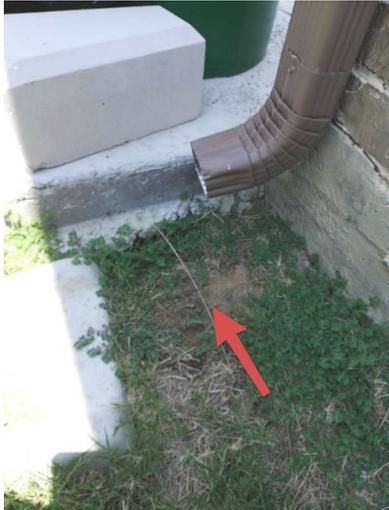
3: Downspout Extensions and Splash Blocks

All downspouts should extend 5' away from the foundation and discharge into splash blocks. Rainwater needs to be directed away from the foundation to prevent erosion and soil saturation. This condition can affect foundation performance.

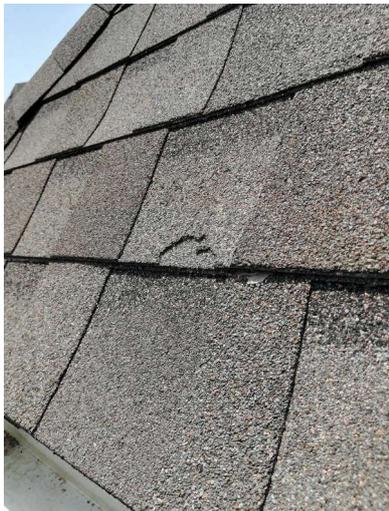
Back patio

2: Damaged shingle observed

This may have occurred during installation or transport of shingles.

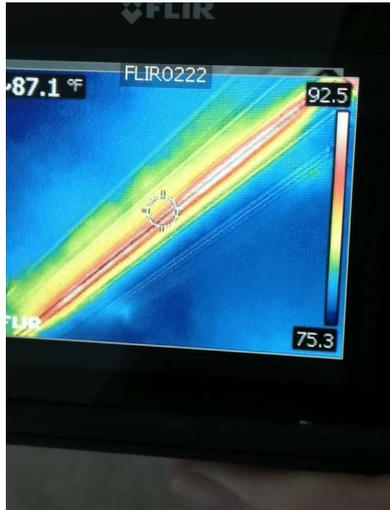
1: Attic Ladder Does not Completely Close

Attic ladder does not completely close. This will allow unconditioned air from the attic into the house.

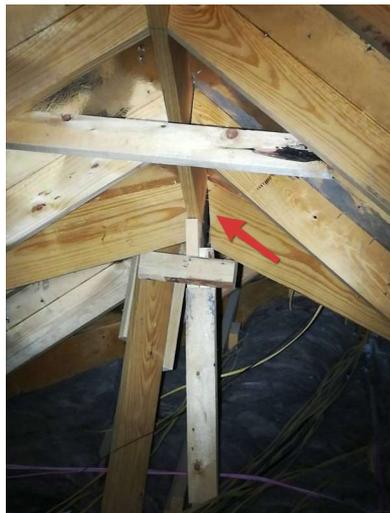
Attic above garage

2: Rafter Separation

Hip rafter is not in contact with ridge beam and is poorly supported by brace to bearing. Roof structure may not be adequately supported.

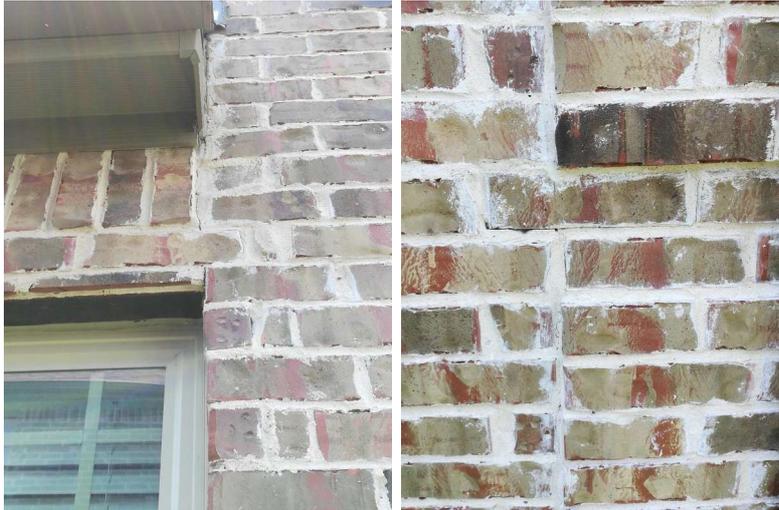
East

2: Masonry Cracking

Minor grout cracking observed. Periodic observation is recommended. If condition worsens, consider professional evaluation.

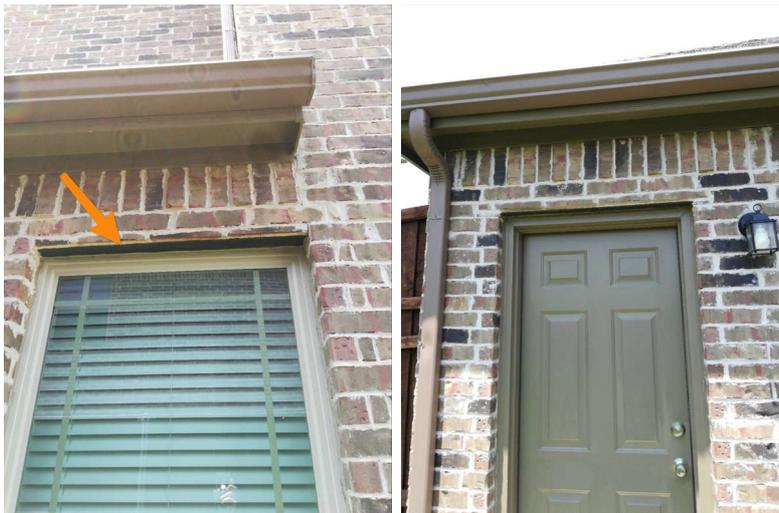
East, South door to garage

3: Weep holes not installed above window

Weep holes help reduce moisture inside the walls and are needed to allow walls to breathe. This is a building code requirement.

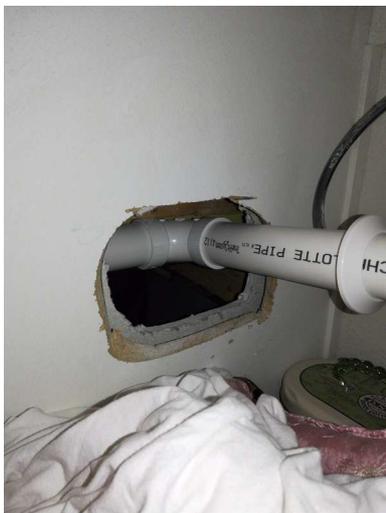
2nd floor jack and jill bathroom under sink

4: Wall penetration not made in workman like manner

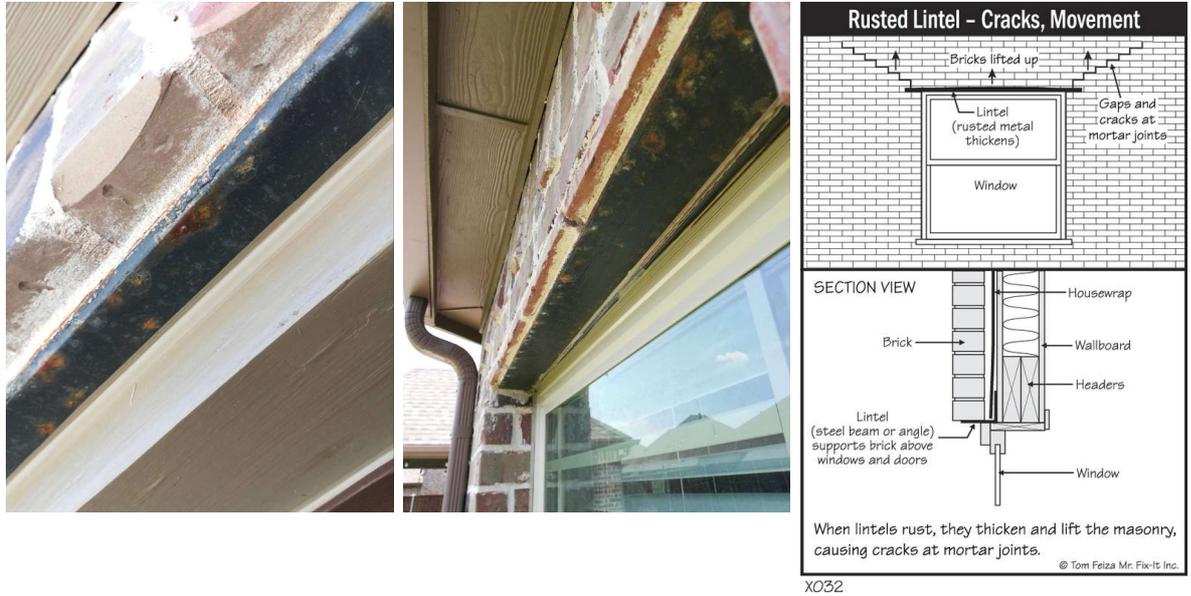
Both garages, multiple windows

5: Rusting Lintels

Rusting observed on lintel. It should be cleaned and painted to prevent further deterioration. Lintels support brick above wall openings. Lintels that rust can expand and cause brick cracking. Rusting lintels will eventually loose strength and can cause damage to the wall.

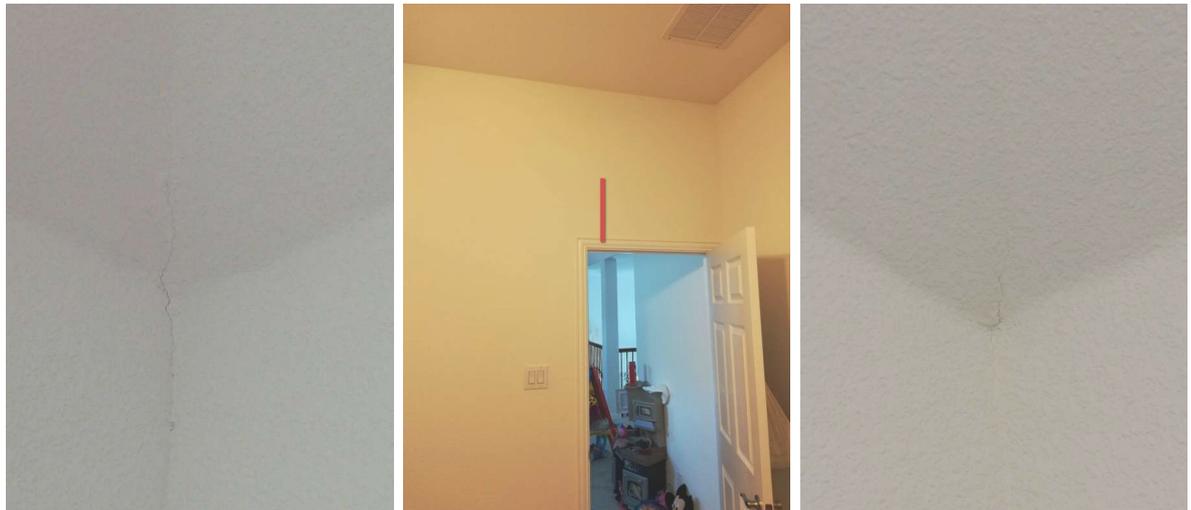
6: Minor interior wall/ceiling cracking

Minor cracking observed drywall on second floor. Periodic observation is recommended and if conditions worsen consider professional evaluation.

2nd floor NW bedroom, NW corner

2nd floor SE bedroom

2nd floor SE bedroom, SE corner

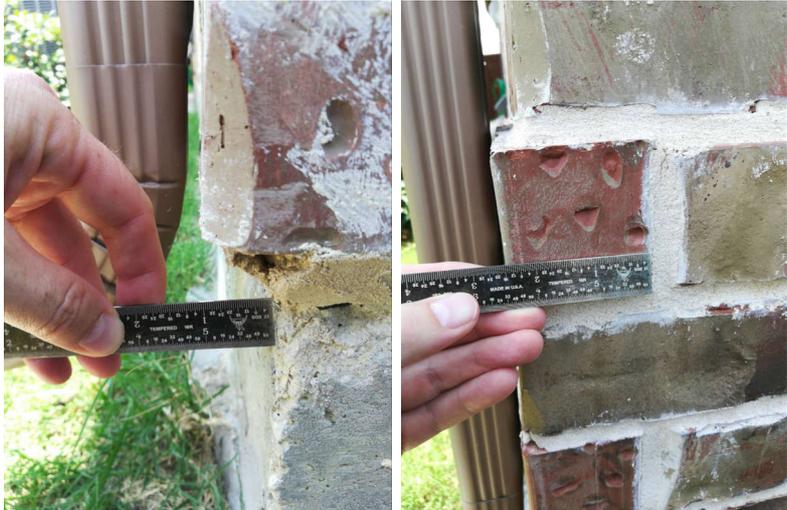
Northeast corner

7: Excessive masonry overhang

Masonry has excessive overhang at brick ledge. Brick Institute of America recommends no more than 1/3 of the width of the brick overhang the edge of the brick ledge (slab). Brick veneer may not be adequately supported in this location.

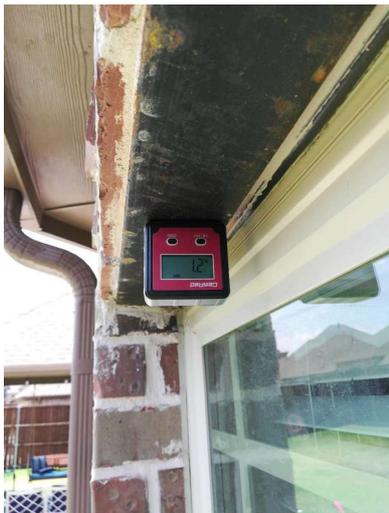
Multiple Locations

8: Lintel is not level

Lintel is sloped so that it will promote water retention. Building code requires wall construction to prevent water accumulation inside of walls.

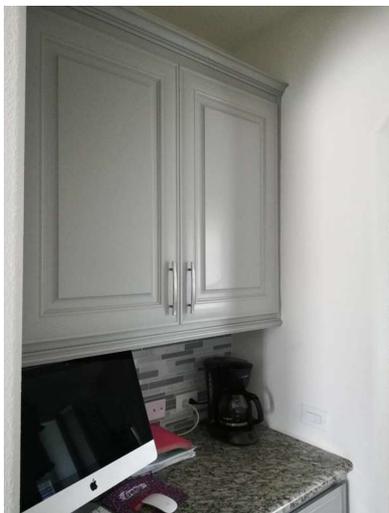
pictured location

9: Cabinet doors bind on each other

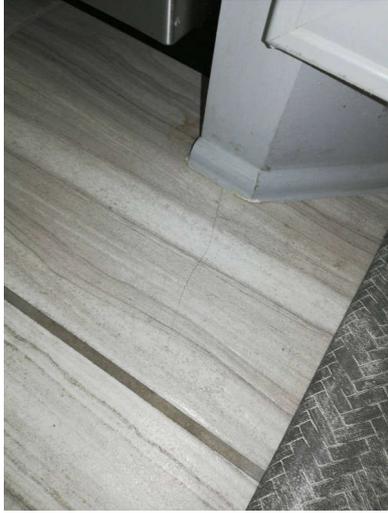
By dishwasher

1: Cracked tile

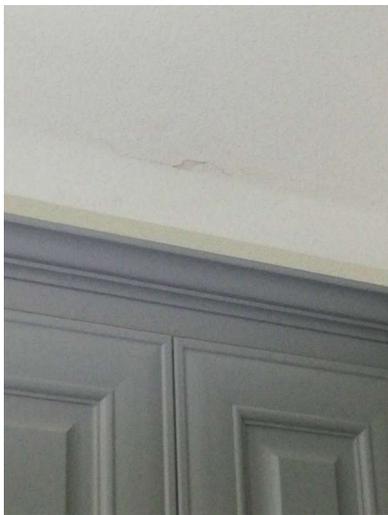
Kitchen

2: Water staining on ceiling

Drywall tape separation. Was not damp at time of inspection. May be due to plumbing vent roof penetration above this location.

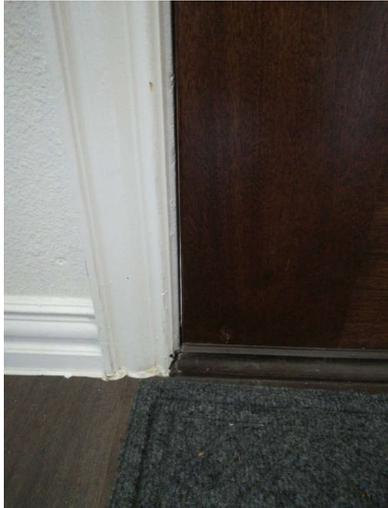
Front and back door

1: Weather stripping needs improvement

Light can be observed around edge of door.

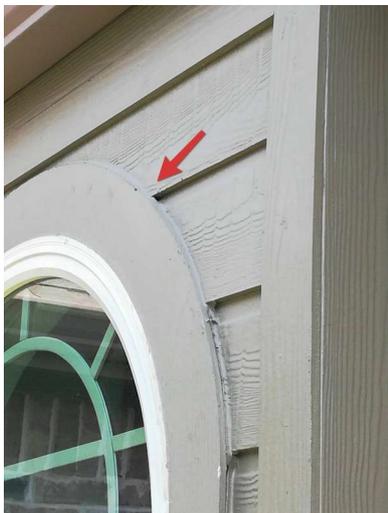
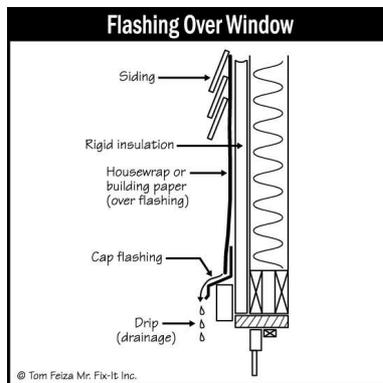
West, east

1: Window does not have cap flashing

Trim above window needs a cap flashing to prevent water intrusion. Caulk is a temporary measure and will require observation and maintenance to prevent water intrusion. See attached drawing.

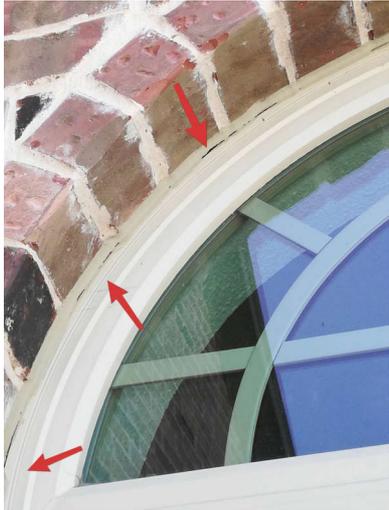
Window by front entry

2: Caulking update

Window need caulking updated to prevent water penetration.

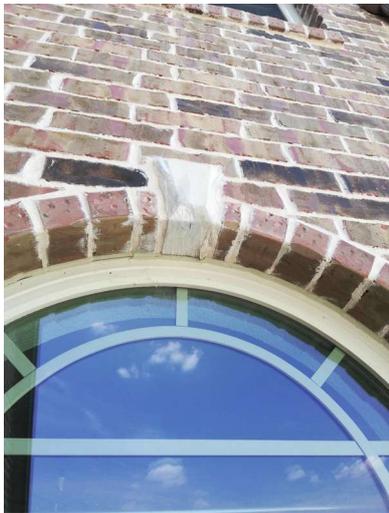
3: Bag is wrapped around keystone
near front entry

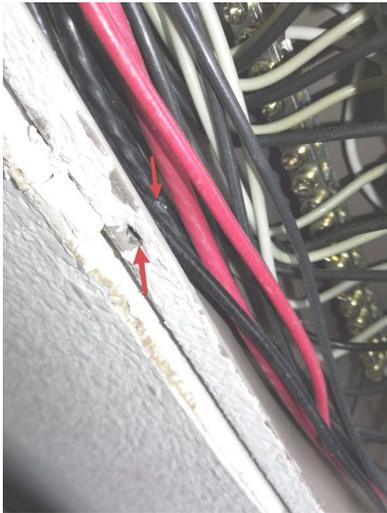
both sides of cover

1: Dead front cover screw in contact with conductors

▲ Safety Hazard

Screw was not replaced to prevent further damage to conductor insulation. Conductors should not be behind screw holes.

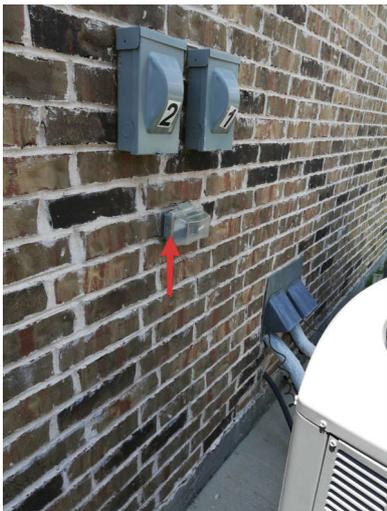
East

1: GFCI has been tripped and will not reset

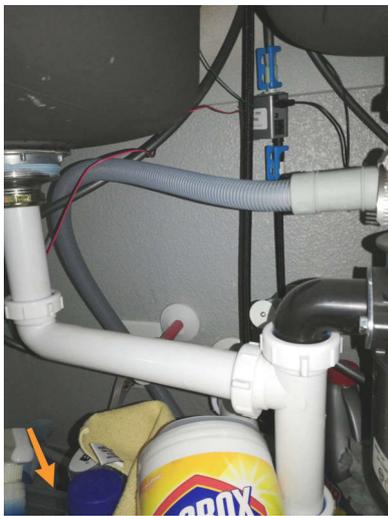
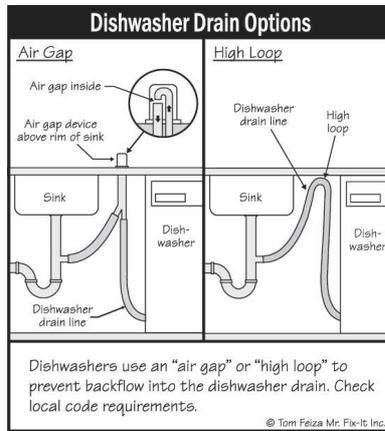
1: Dishwasher does not have a high loop or air gap

This is a code requirement that prevents the flow of water from the sink drain into the dishwasher.

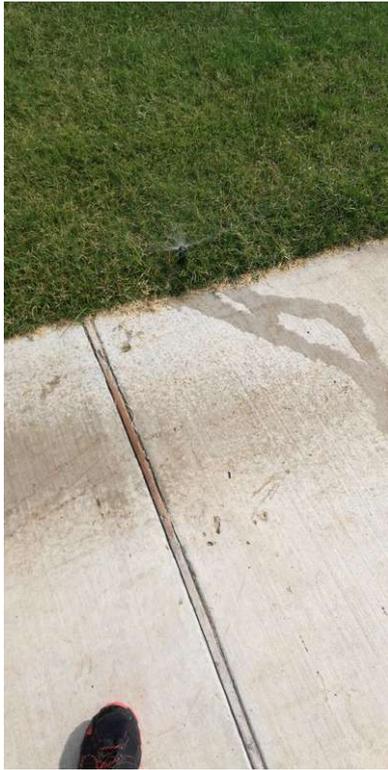
Zone 4

1: Sprinkler leaking from base
