CHESTER COUNTY HOME INSPECTIONS

RESIDENTIAL INSPECTION

917 Roundelay Dr
West Chester PA 19382

JULY 18, 2018

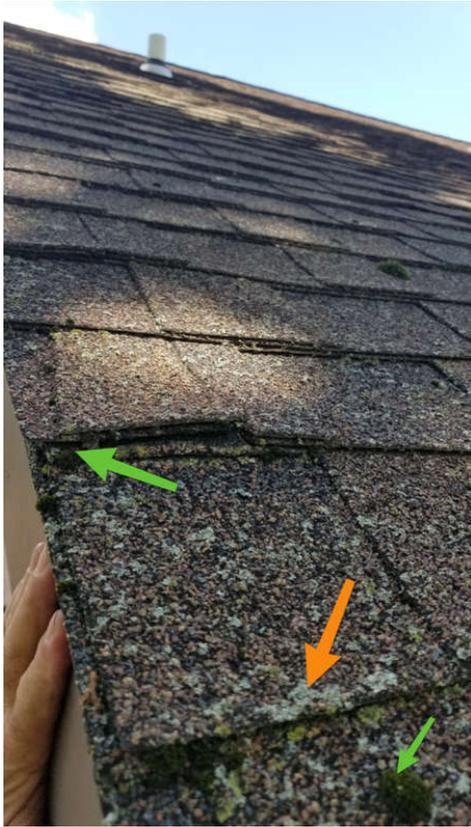
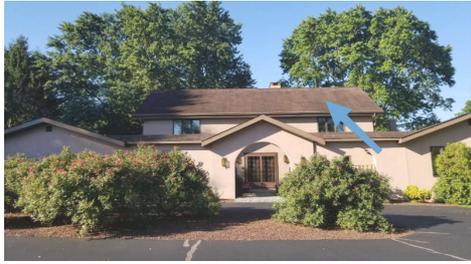
2.2.1 Coverings

ORGANIC GROWTH

Moss, lichen and algae is visible on parts of the roof, mostly in shaded areas at the back of the house. Moss hold water which softens the wood and accelerates decay. Lichen penetrates the granules, they are hard to remove and can damage the shingles over time. Algae is what causes the darker areas more noticable at the front of the house. Overall it is minimal and considered cosmetic. It can be cleaned to improve appearance if desired. There are companies that specialize in roof cleaning.

Algae causes the dark stains

Contact a qualified roofing professional.

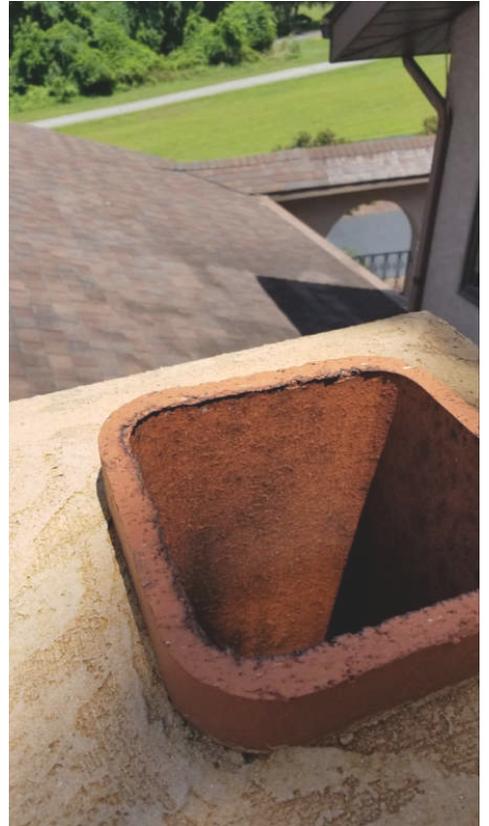
2.6.1 Chimney

CHIMNEY CAP MISSING

The boiler chimney did not have a cap. This is important to protect from moisture intrusion and protect the chimney. Rain and snow that gets in here in ends in the boiler, rusting it out. Recommend installing a chimney cap.

Contact a qualified roofing professional.

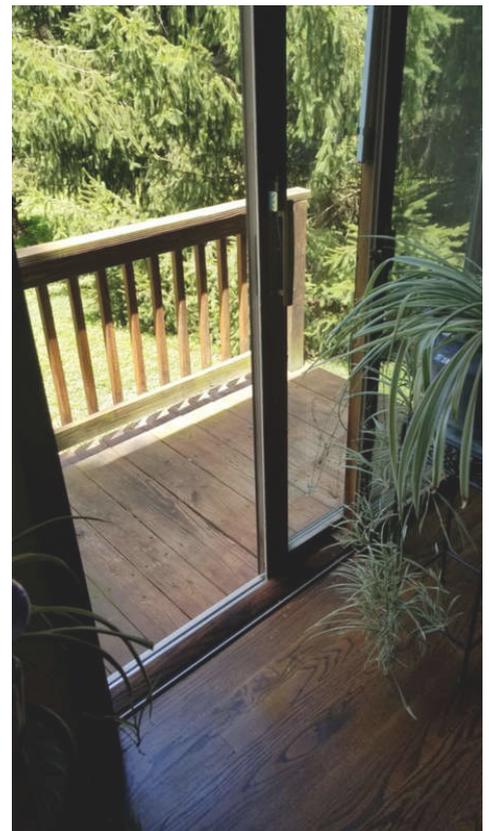
3.3.1 Doors

SLIDER STUCK

Sliding glass door in office was difficult to open or close. There is a high spot in the track - the door opens freely to the left or to the right of it but right in the middle of gets stuck. This often indicates a door structure issue or walls that have slightly moved. Also the screen door was off the track and not sliding properly either. Exact same issue with slider glass door in piano room, and slider to back deck from living room. Recommend fixing all sliding doors to open and close properly.

Contact a qualified door repair/installation contractor.

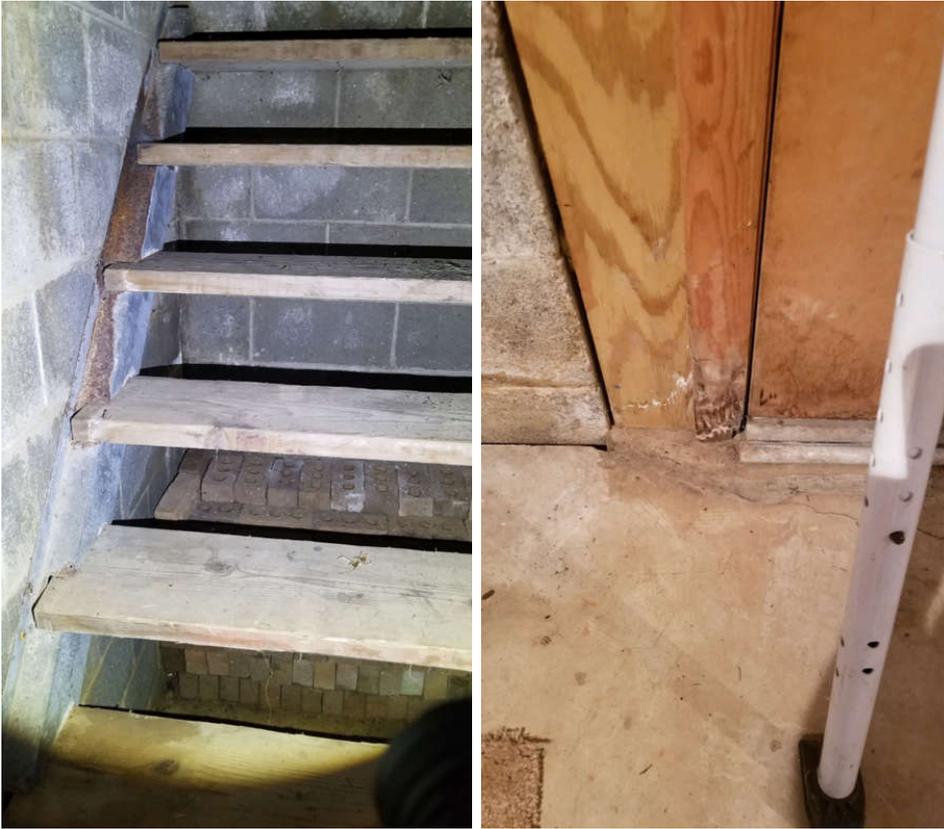
3.3.2 Doors

EXIT DOOR TO BILCO

Exit door to Bilco door has few small issues - frame is loose causing the latch to bind up a bit, trim had wood rot and door got wet at some point. Steel frame of steps to outside is rusted a bit. No repairs warranted, mentioned as FYI only.

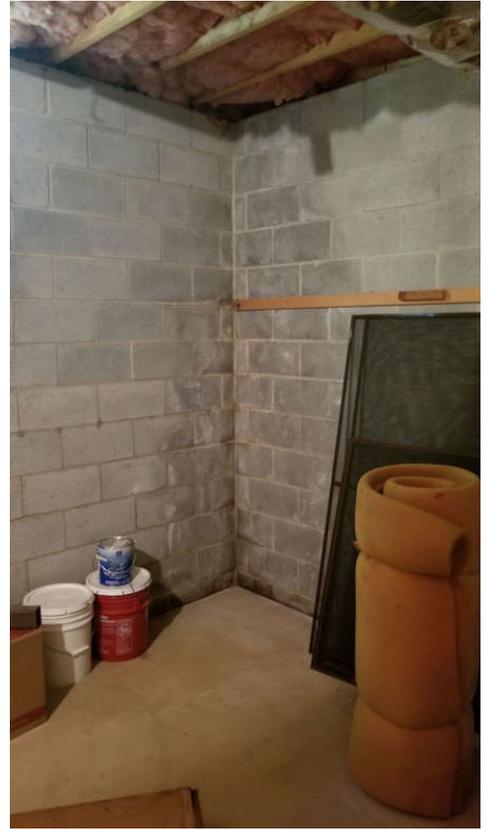
3.8.1 Vegetation, Grading and Drainage

NEGATIVE GRADING

Grading is sloping towards the home in some areas. This leads to saturation at the foundation with consequent water intrusion. Recommend landscaper or foundation contractor regrade so water flows away from home. This basement is deeper than usual so the grading should take that into account. Photo show sample of water penetrating through the foundation wall.

Contact a qualified landscaping contractor

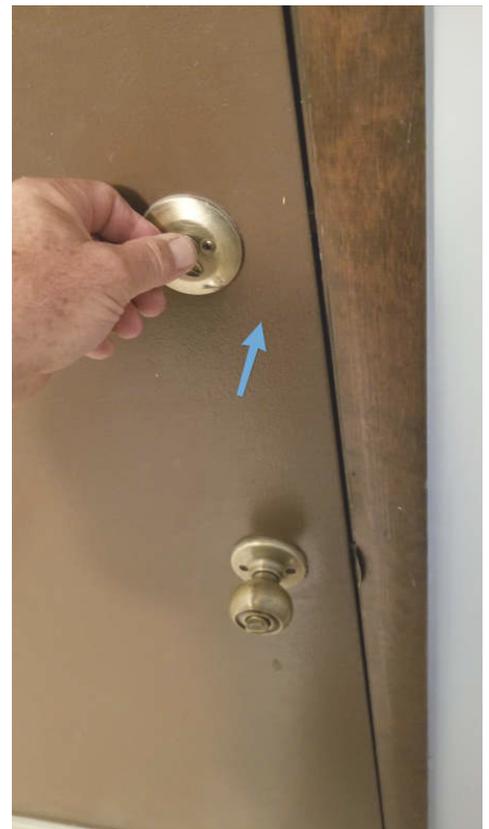
5.6.1 Doors

DEADBOLT NOT OPERATIONAL

The deadbolt of the exterior door by the laundry room could not be locked.

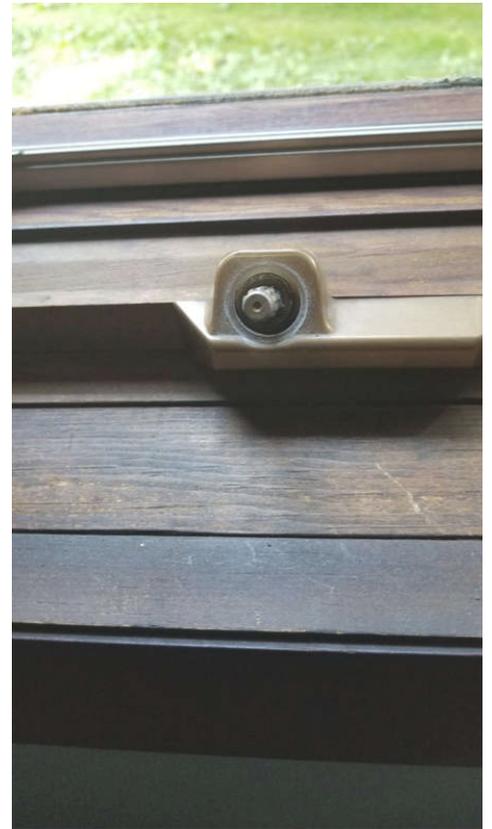
5.7.1 Windows

MISSING CRANK

A window crank mechanism is missing in the room with the big safe.

Contact a qualified window repair/installation contractor.

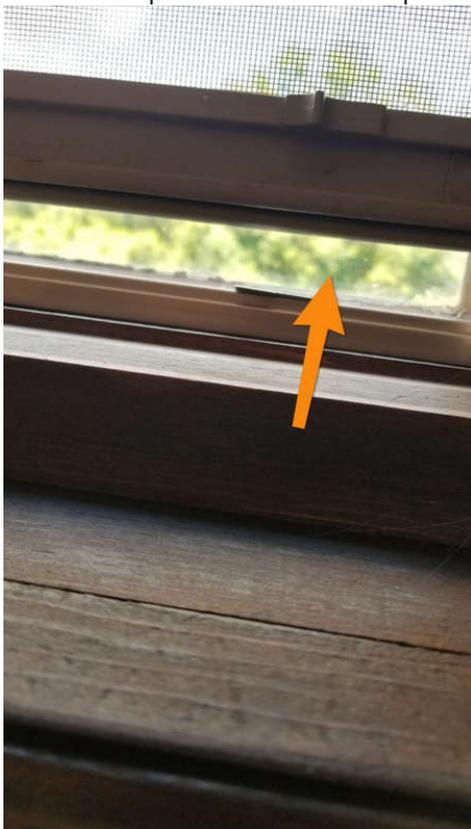
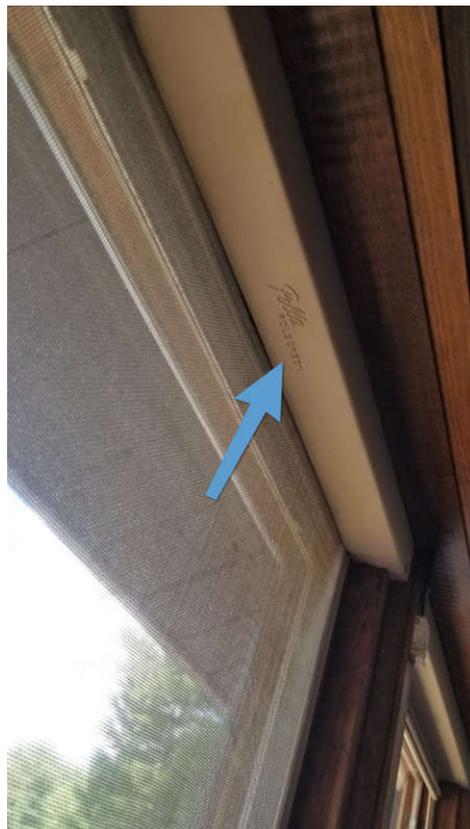
5.7.2 Windows

ROLL-UP SCREENS

Most of the roll-up insect screens were stiff and would not go down all the way. Recommend repairs.

Contact a qualified window repair/installation contractor.

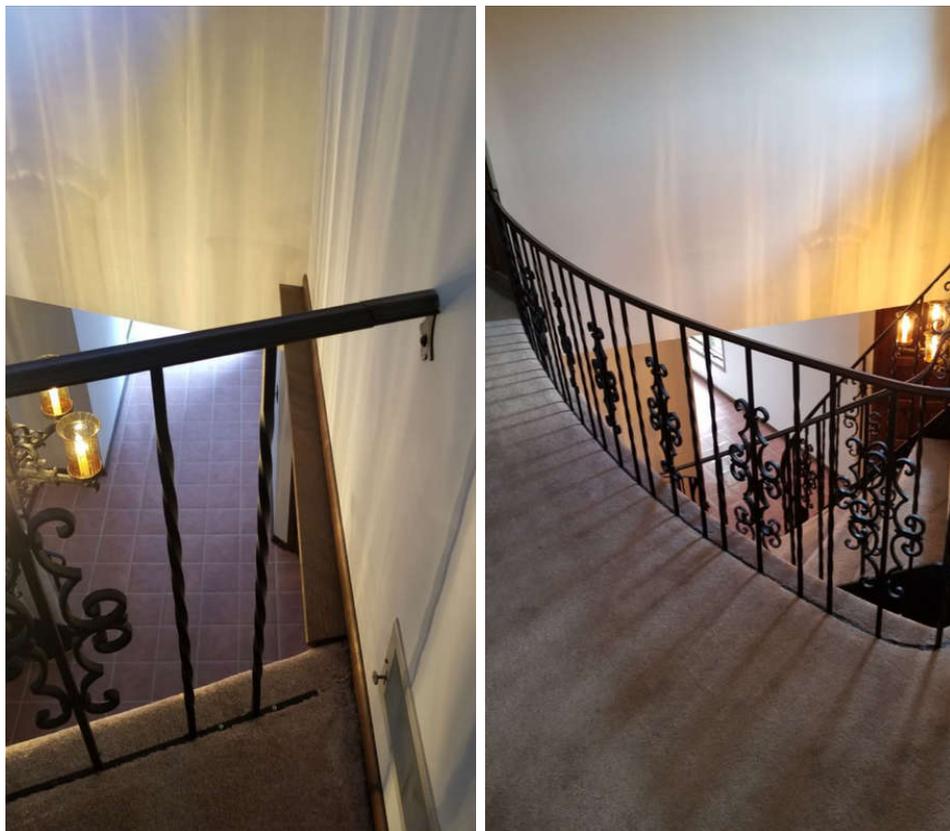
5.8.1 Steps, Stairways & Railings

**BALUSTER SPACES TOO WIDE**

The beautiful guardrails at the steps are considered too low by modern standards. They offer foothold for a child climbing up, and the spacing between the balusters is too wide. This was not a requirement when this house was built, however it is a safety concern for pets and children that I recommend buyers address. Original builder had the forethought to make the guardrails removable which will make it easier to replace the rails. Consult with companies that specialize in gaurdrails for options.

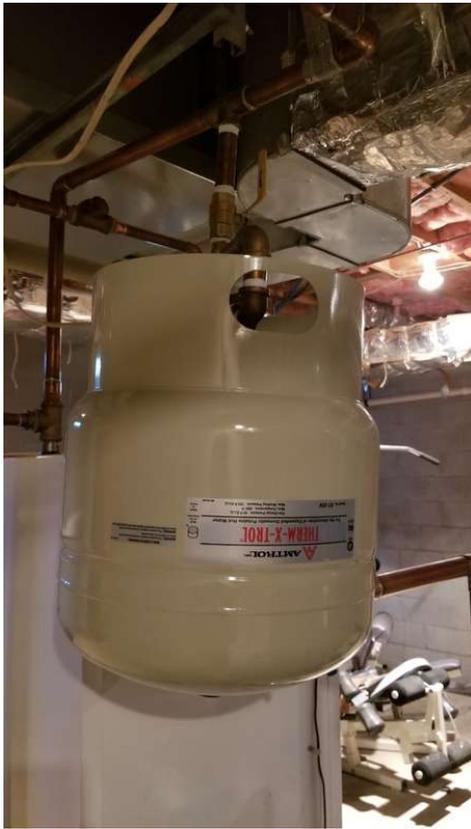
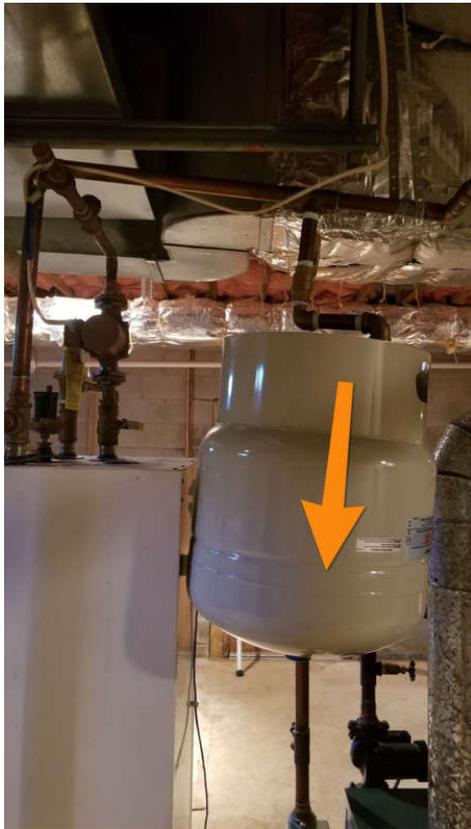
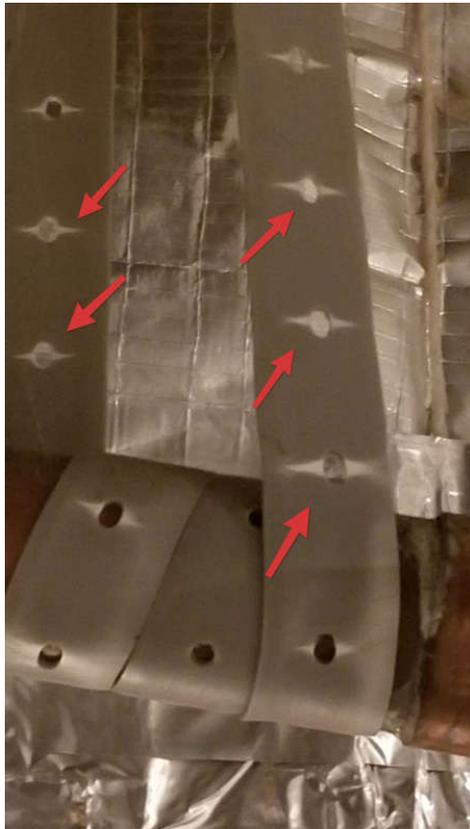
6.2.1 Heating Equipment

WEIGHT SUPPORT

The water expansion tank for the cistern is heavy, being a steel tank holding probably 10 gallons of water. The plumbing for the section is supported only with plastic straps. Those are generally strong but they are stretched to the breaking point to support this amount of weight. There's already a substantial amount of sagging in that line where the rest of the plumbing is properly supported and installed straight. Recommend replacing with metal straps.

Contact a qualified HVAC professional.

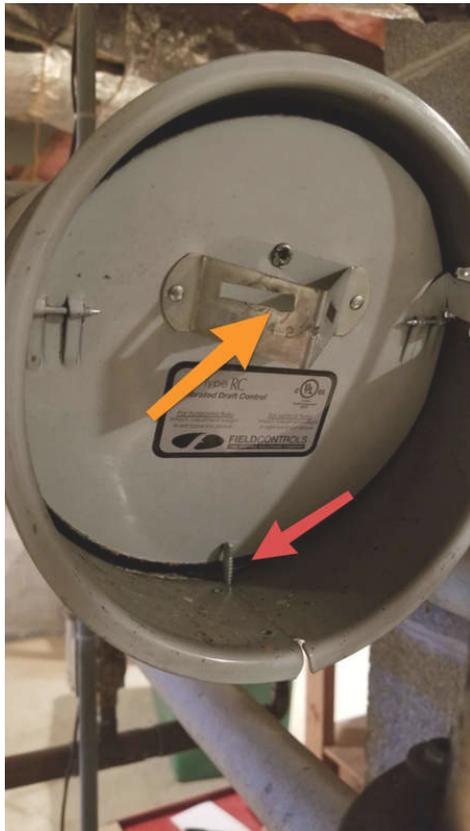
6.2.2 Heating Equipment

ATMOSPHERIC DAMPER

The atmospheric damper is not properly installed - there is a screw at the bottom to force it in the open position (red arrow). It's supposed to have an adjustable weight (yellow arrow) to control the amount of air that is allowed to enter the flue. This is so that it can be adjusted for proper emissions control. Recommend repairs for efficiency, emissions control and system longevity.

Contact a qualified HVAC professional.

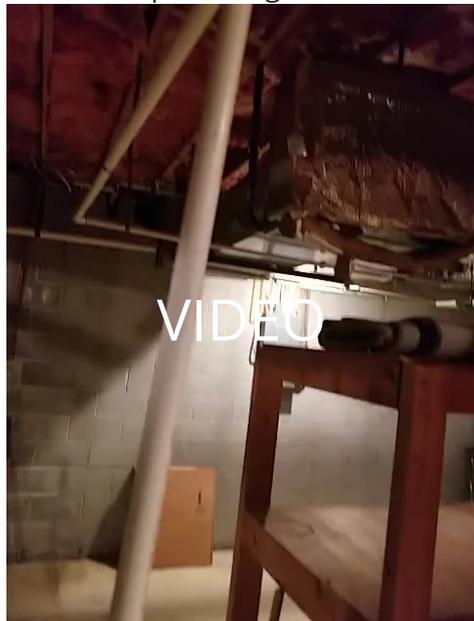
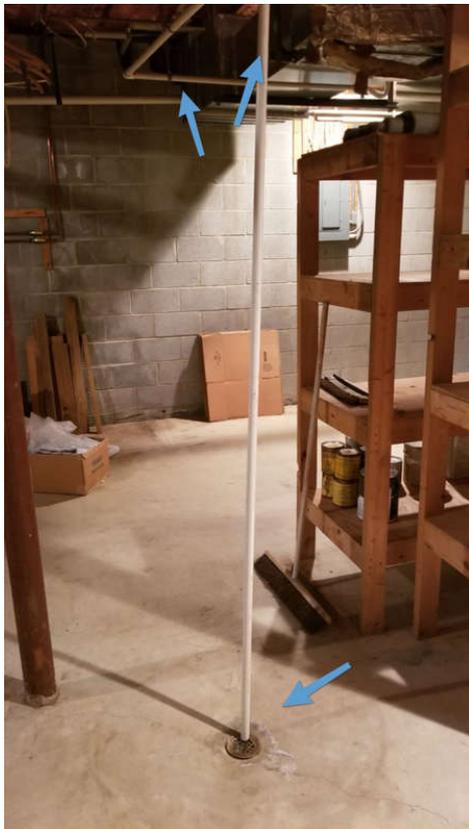
8.1.1 Equipment

CONDENSATION DRAIN

Condensation drain for HVAC in the basement is just resting loose on top of a drain that leads to the sump. This is unusual installation in that it would be very easy for that pipe to be knocked off the drain or broken off accidentally. It is not properly supported. Consider rerouting that so that the drain pipe could be attached to the steel post nearby.

Contact a qualified general contractor.

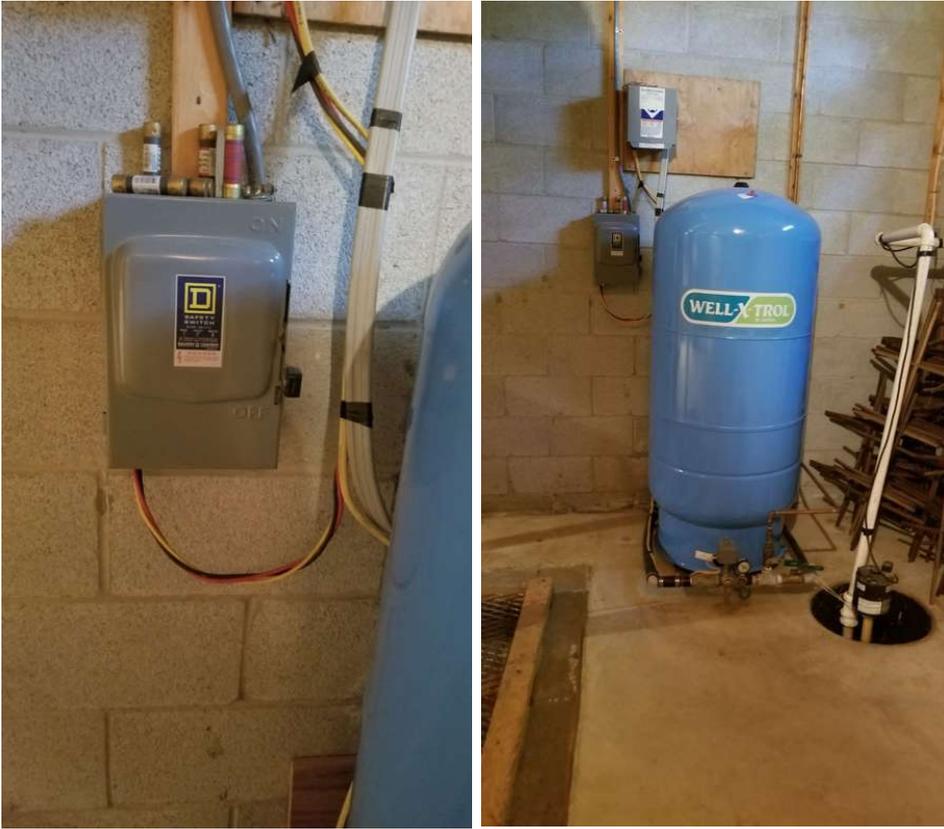
9.2.1 Service

SYSTEM NOT OPERATIONAL

The well pump was not turned on.

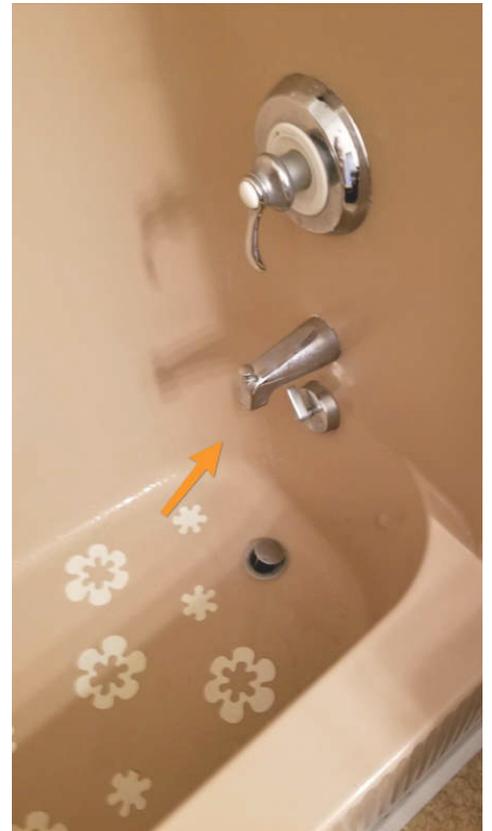
9.3.1 Bathtub & Shower

DIVERTER NOT OPERATIONAL

The diverter pull was not functioning properly. Water flow reduced but no water was diverted to the shower head. It could be that the shower head is simply blocked, or that there's a problem with the plumbing behind the wall that I could not see. Recommend repair.

Contact a qualified plumbing contractor.

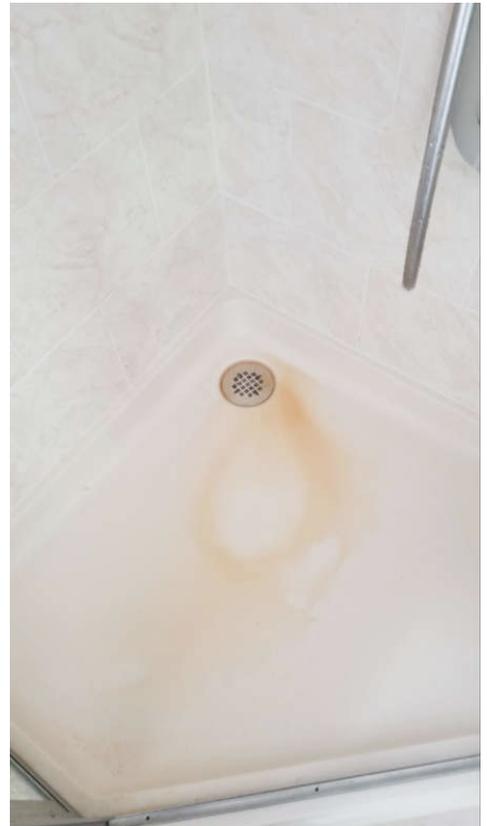
9.3.2 Bathtub & Shower

RUST IN LINE

A rust came out of the master shower when it was first turned on. No rust was seen elsewhere so it appears localized. It may be an improper fitting at the shower valve such as a steel nipple instead of a galvanized nipple. Recommend fixing.

Contact a qualified plumbing contractor.

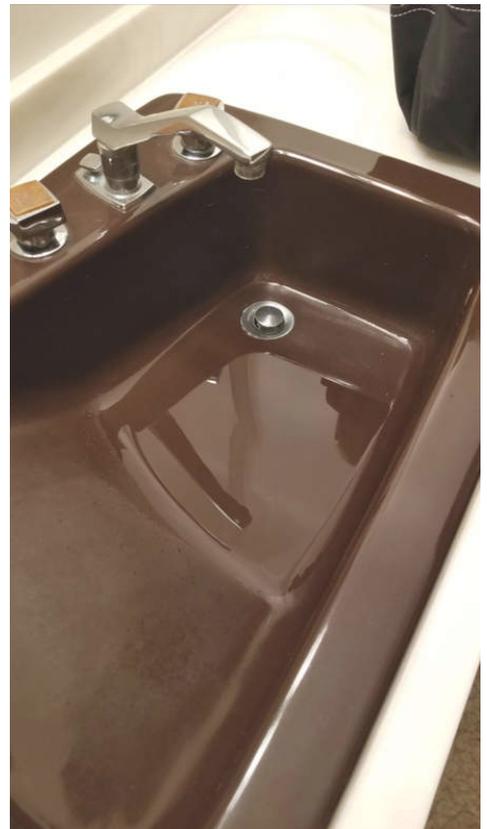
9.10.1 Water Supply Fixtures

SINK DRAINED SLOWLY

The brown sink drained slowly. Recommend clearing drain and/or having a plumber repair if necessary.

Contact a qualified plumbing contractor.

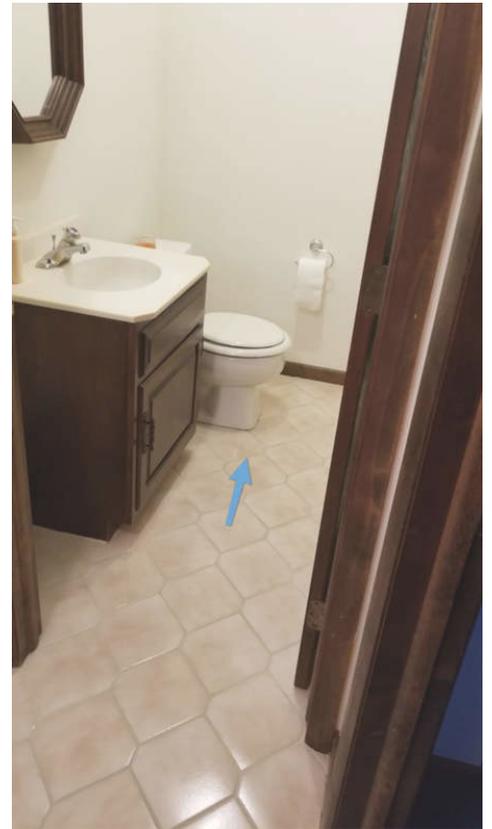
9.10.2 Water Supply Fixtures

TOILET LOOSE

Toilet was loose from the floor. Leaks can occur. A new wax ring should be installed and toilet should be securely anchored to the floor to prevent movement and leaking.

Contact a qualified plumbing contractor.

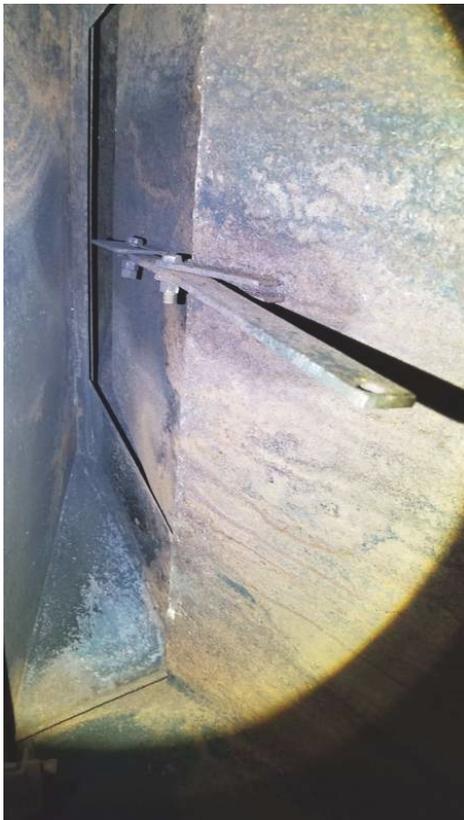
Fireplace: Bedroom fireplace

The bedroom fireplace is similar to the basement fireplace except for this one the damper is rusted and does not close fully. This will cause energy lost both in summer and winter. Recommend fixing the damper to close properly. Consider using fireplace inserts for best use of heat energy.
