MOUNTAINS TO SOUND HOME INSPECTION LLC

HOME INSPECTION REPORT

6134 147th Pl SE
Bellevue WA 98006

Moin Shaikh
JUNE 11, 2019

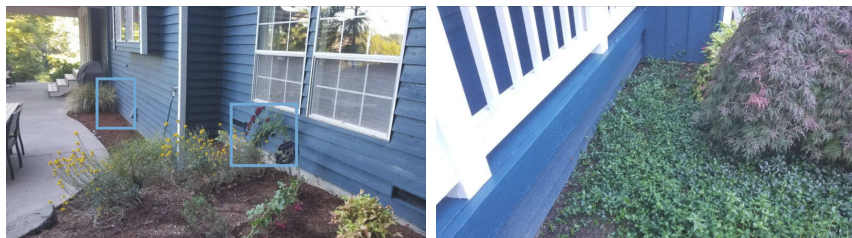
3.5.1 Exterior Siding Notes

VEGETATION IS ENCROACHING

Vegetation is encroaching on the structure, and should be kept a minimum of twelve inches away for the general welfare of the walls and foundation.

Contact a qualified landscaping contractor

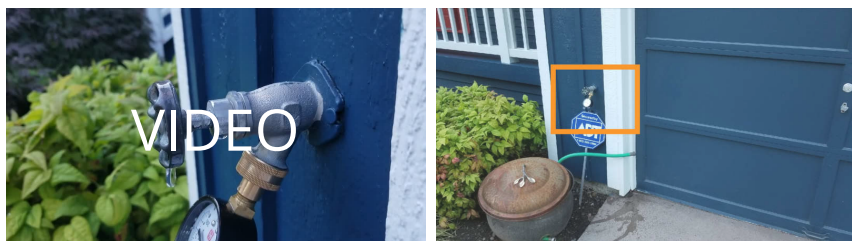
3.8.1 Exterior Plumbing

HOSE BIB LEAKS WHILE IN USE

The hose bib leaks at the handle while in use and you may want to have it repaired or replaced by a licensed professional. Sometimes they just need to be tightened.

Contact a qualified handyman.

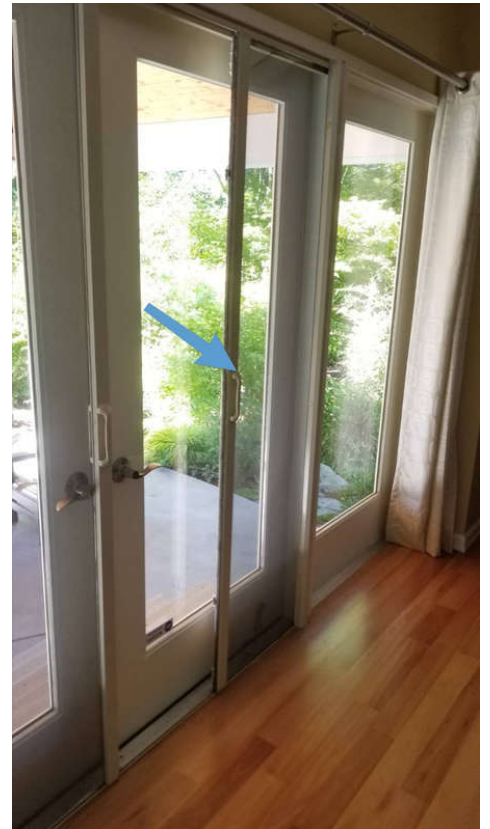
3.11.1 Exterior Doors

SLIDING DOOR SCREEN DIFFICULT TO OPEN

The rear sliding screen is damaged or needs work. Have it repaired by a qualified contractor.

Contact a qualified handyman.

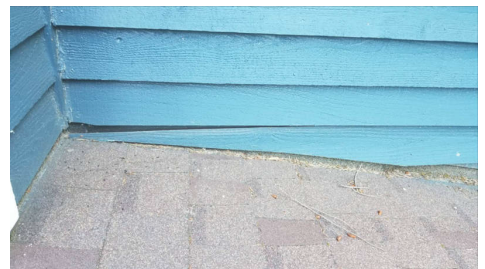
4.4.1 Vents & Flashings

SIDEWALL CONTACT

The siding or trim material is in contact with or very close to the roof surface. This may lead to water damaged siding. Recommend proper installation by leaving a 1-1.5' roof/siding gap and use of sidewall flashing.

Contact a qualified roofing professional.

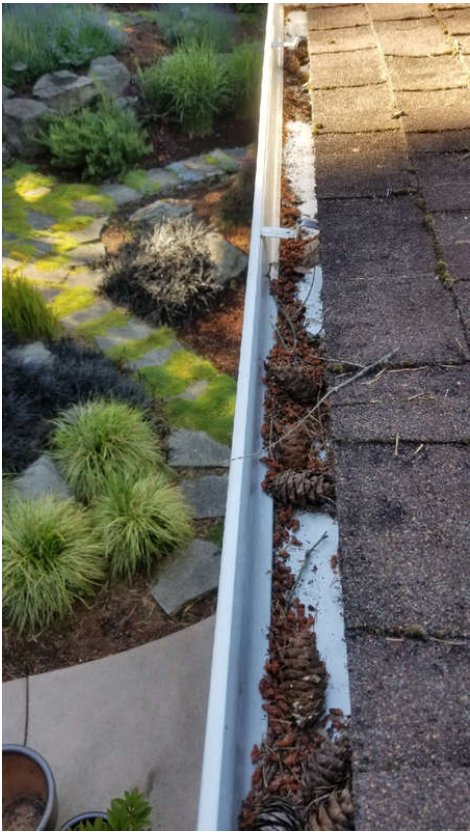
4.5.1 Gutters & Drainage

GUTTERS NEED TO BE CLEANED OF DEBRIS

Contact a qualified roofing professional.

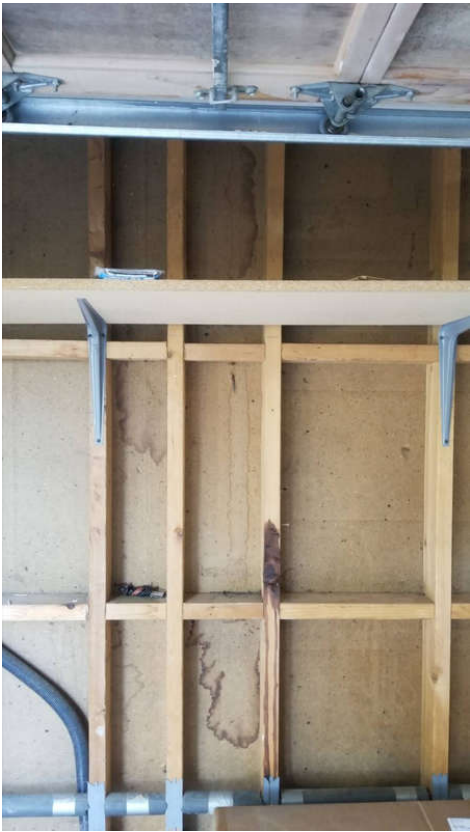
PRIOR MOISTUE STAINS
LEFT SIDE GARAGE WALL
Prior moisture stains were observed but appeared to be dry at the time of the inspection. Recommend monitoring.
Recommendation
Recommend monitoring.

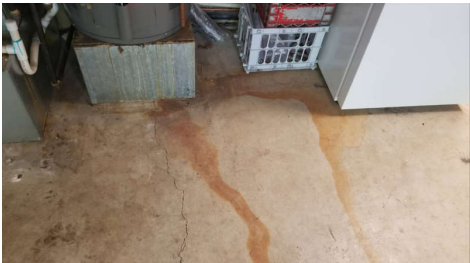
WATER STAINS-LEAKAGE

Water stains were observed beneath water heater, indicating a past or present leak.

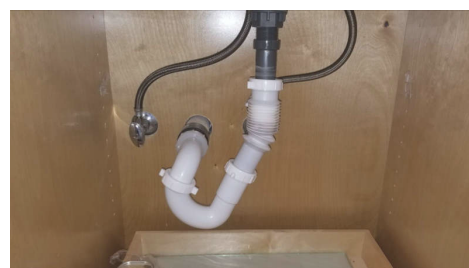
11.2.1 Trap and Drain

Flexible drainpipes clog more often than traditional rigid piping. I recommend monitoring and repairing as needed.

Contact a qualified professional.

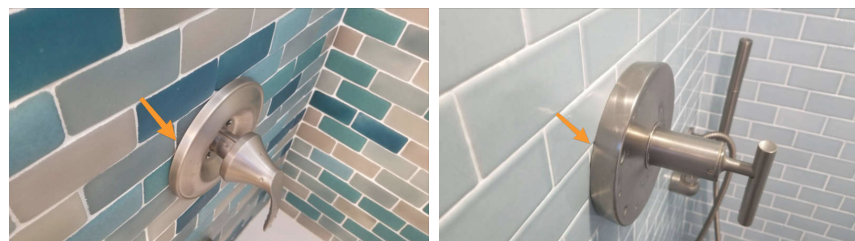
11.4.1 Tub-Shower

CAULKING OR SEALING

I recommend caulking or sealing around shower valves and faucets etc to help prevent moisture intrusion behind or into the walls. Monitoring these areas is also recommended to help ensure an adequate seal is in place.

Contact a qualified handyman.

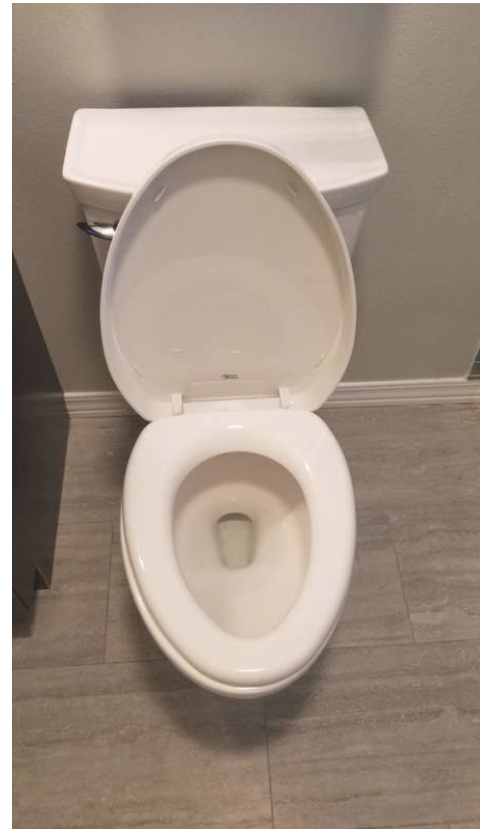
11.5.1 Toilet

FUNCTIONAL BUT LOOSE

The toilet is functional, but loose on the floor and should be secured by a qualified technician, for safety reasons and to prevent possible damage or leaking from around the toilet.

Contact a qualified plumbing contractor.

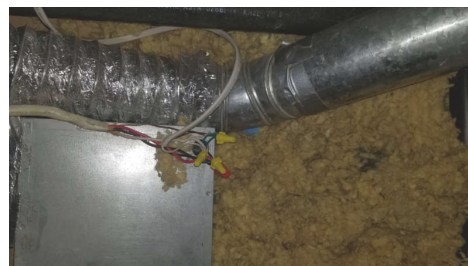
An electrical connection or "splice" has been incorrectly made outside of a junction box, which is a potential fire-hazard. All such connections should be made inside a junction box, in order to contain any arcing or sparking within the box.

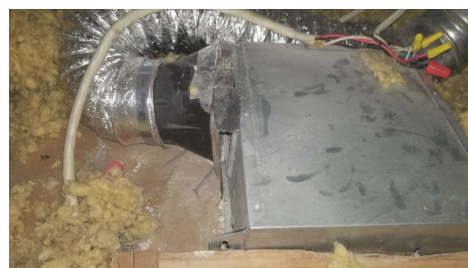
14.7.1 Exhaust Ducts

The bathroom exhaust duct is separated, and should be repaired.
