MOVE OUT INSPECTION REPORT COPY

1234 Main St - Turn Inspection Sample
Arvada, CO 80004

Chris Scott
AUGUST 5, 2023

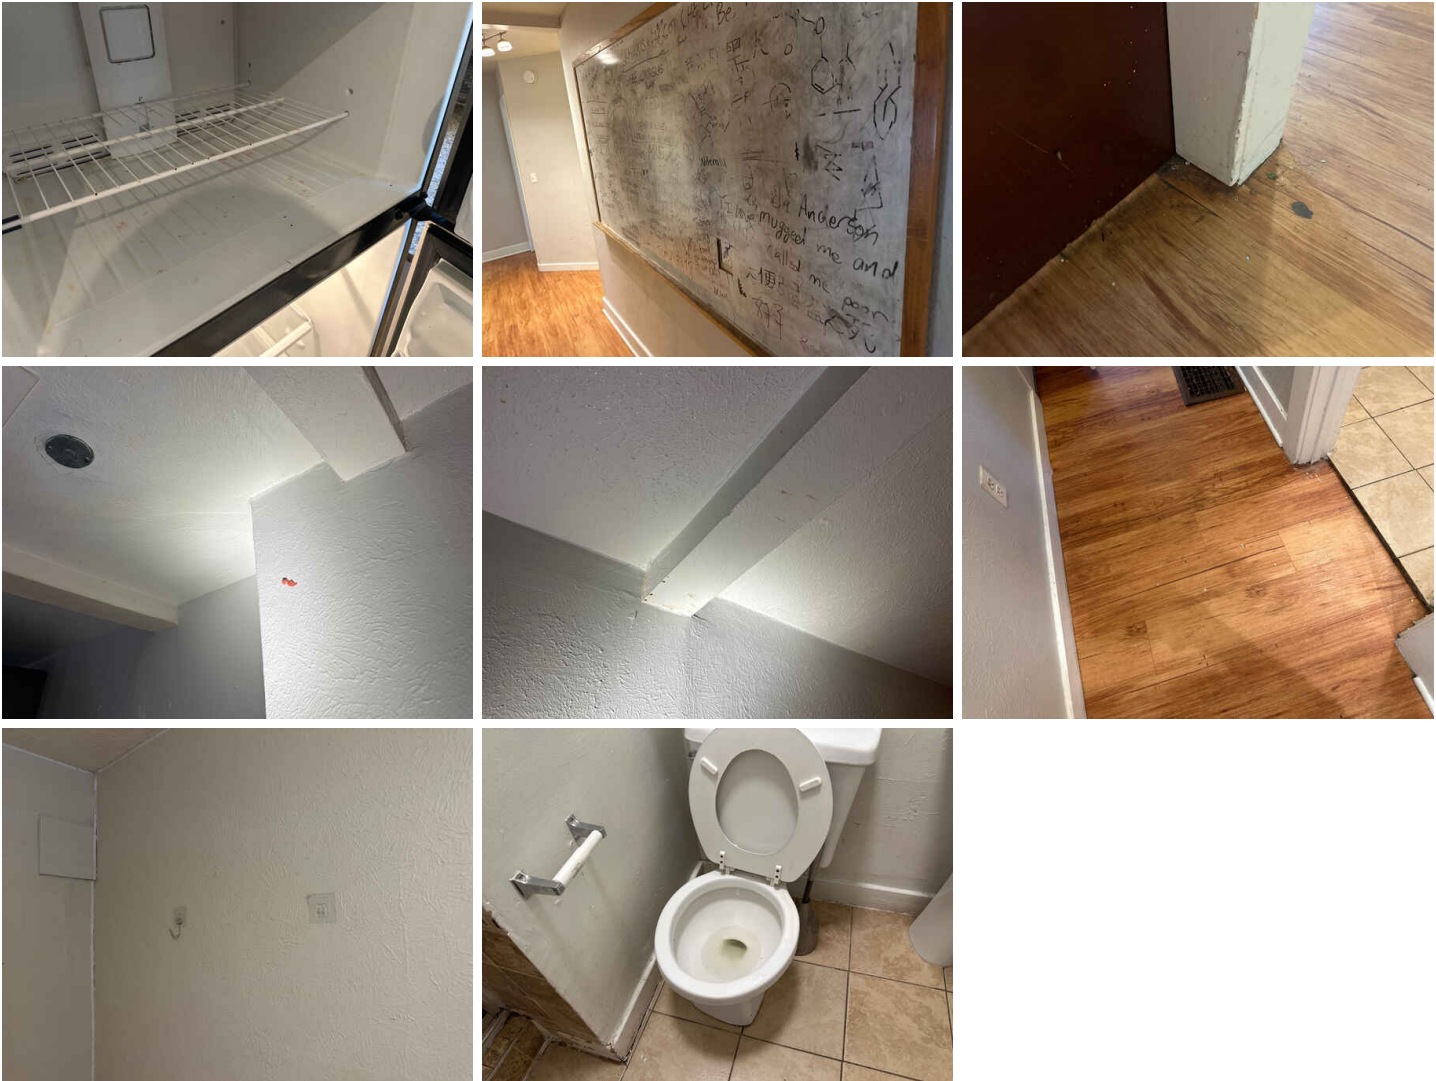
2.1.1 Overview

GENERAL CLEANING NEEDED THROUGHOUT

The unit was left dirty at the time of the inspection. General cleaning is needed throughout the unit and it noted in the corresponding pictures and locations.

Contact a qualified professional.

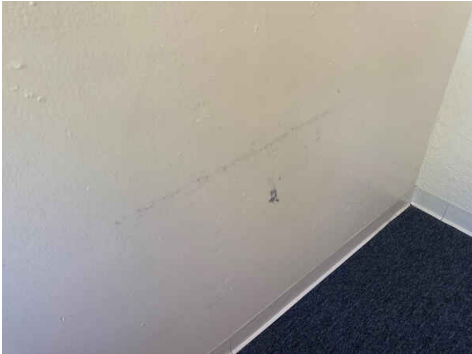
North Bedroom

PAINTING NEEDED - MINOR TOUCHUPS

Minor paint touch ups are needed throughout the unit. The locations are noted under each photo.

Recommendation
Contact a qualified professional.

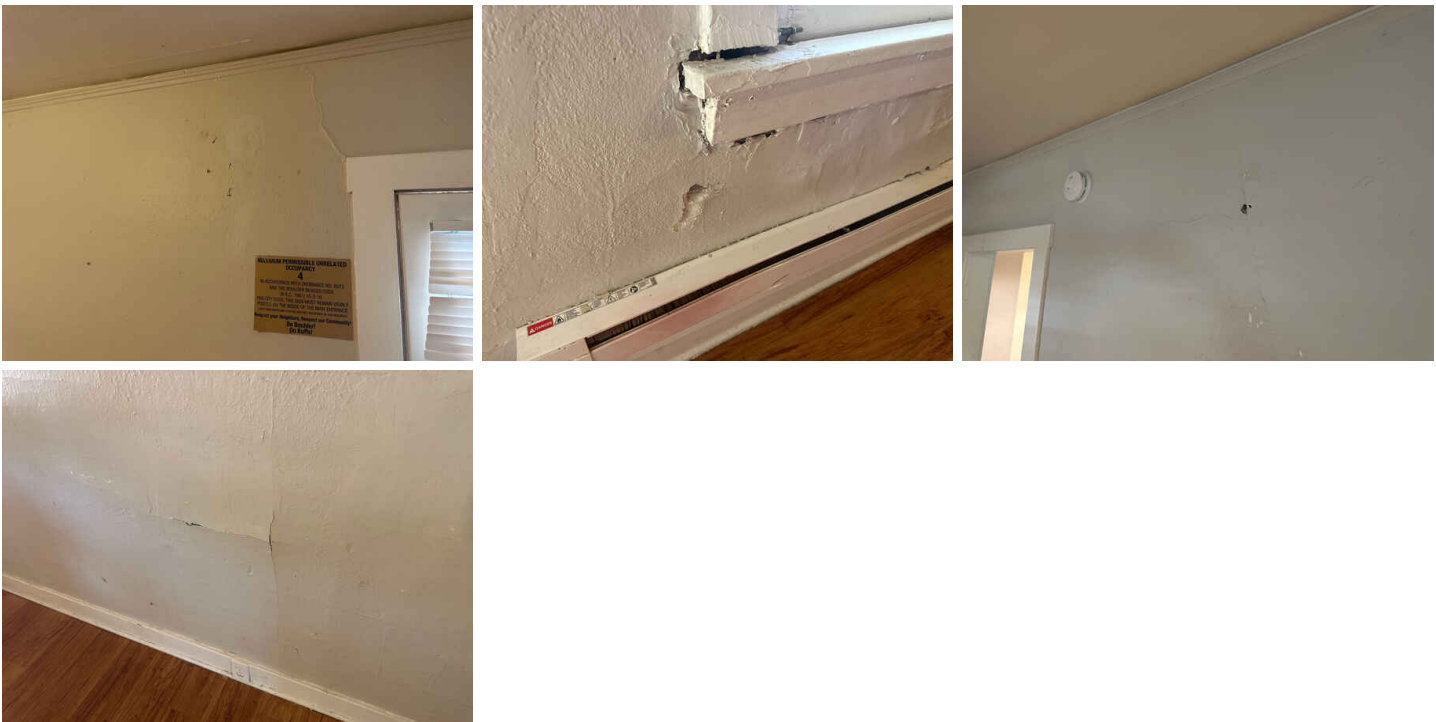
3.3.1 WALLS

DRYWALL DAMAGE

Damaged drywall is present that needs repaired and re-painted.

Contact a qualified drywall contractor.

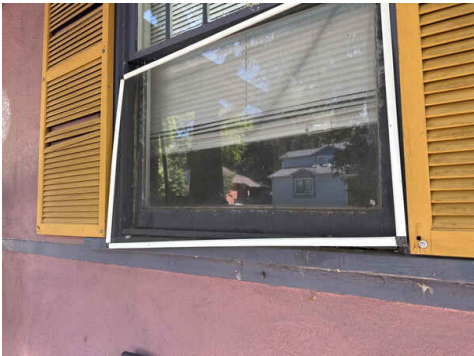
3.6.1 WINDOWS

DAMAGED SCREEN(S)

There was a damaged screen at the noted location. This will need to be replaced.

Contact a qualified professional.

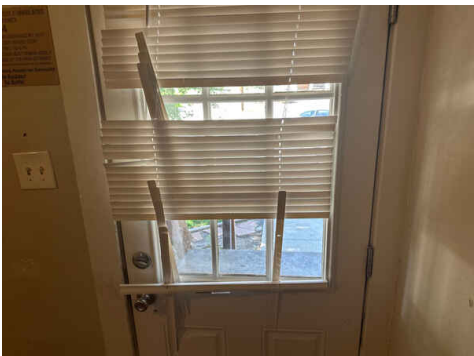
3.6.2 WINDOWS

BLINDS DAMAGED

The window blinds are damaged and need replaced.

Contact a qualified handyman.

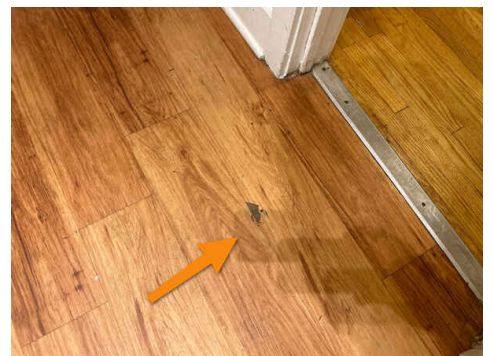
4.5.1 FLOORS

FLOORING DAMAGED

The flooring material is damaged and needs to be repaired or replaced.

Contact a qualified flooring contractor

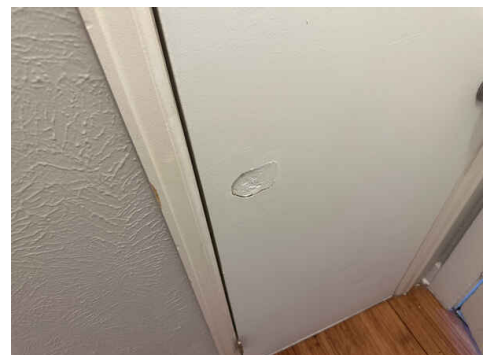
4.6.1 DOORS

DOOR DAMAGE

Cosmetic damage is present where the door is dented/damaged. The door should be repaired or replaced as desired.

Contact a qualified door repair/installation contractor.

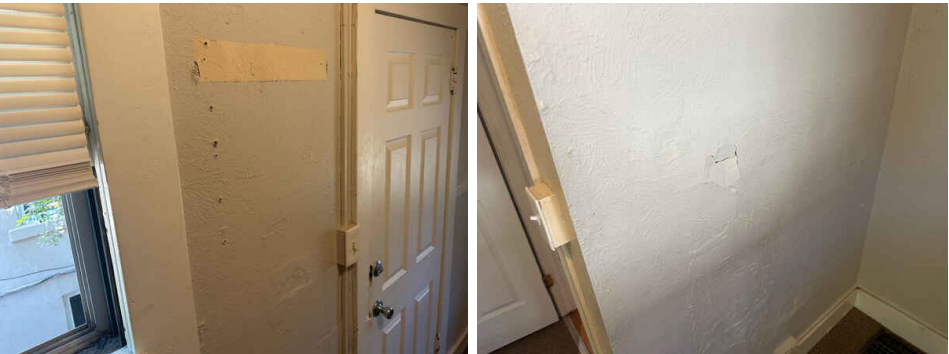
North west

DRYWALL DAMAGE

Damaged drywall is present that needs repaired and re-painted.

Contact a qualified drywall contractor.

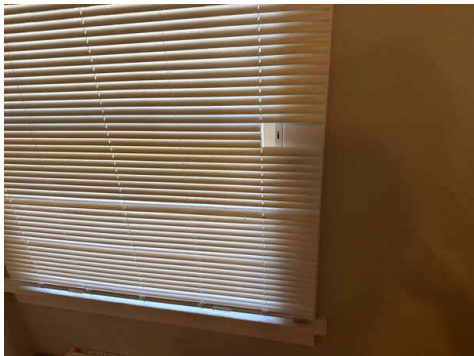
South west

BLINDS DAMAGED

The window blinds are damaged and need replaced.

Contact a qualified handyman.

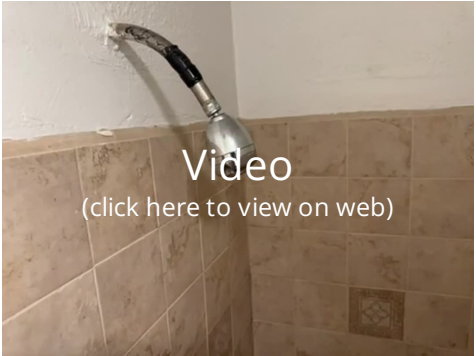
7.11.1 PLUMBING FIXTURES, FAUCETS, DRAINS

SHOWER LEAKS

HALL BATH

The shower leaks when operated. Repairs are needed to prevent leaking water from potentially running back and damaging the interior of the wall.

Contact a qualified plumbing contractor.

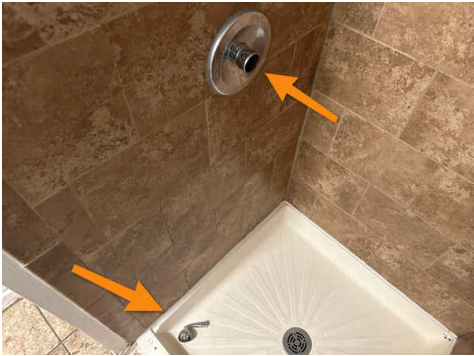
7.11.2 PLUMBING FIXTURES, FAUCETS,
DRAINS

SHOWER DAMAGED

The shower was damaged during the time of the inspection.

Contact a qualified professional.

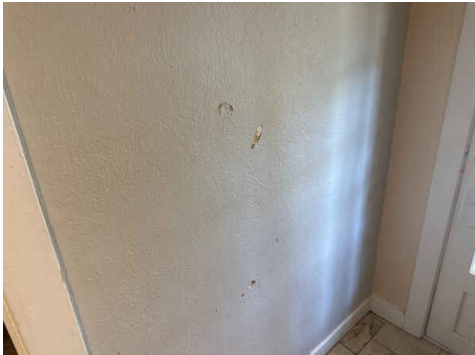
8.3.1 WALLS

DRYWALL DAMAGE

Damaged drywall is present that needs repaired and re-painted.

Contact a qualified drywall contractor.

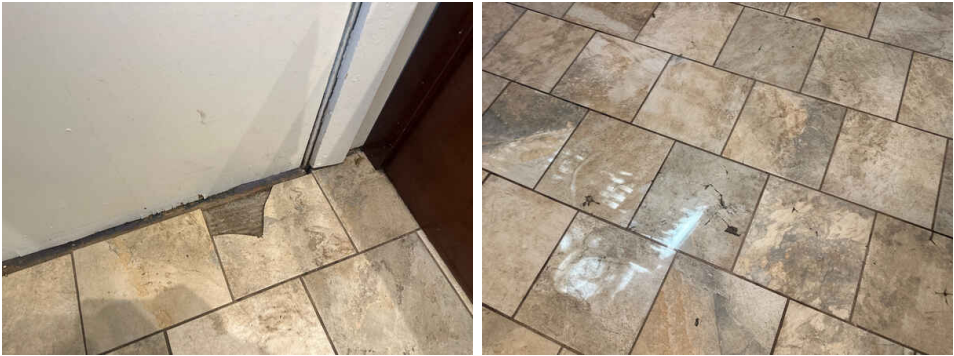
8.4.1 FLOORS

FLOORING DAMAGED

The flooring material is damaged and needs to be repaired or replaced.

Contact a qualified flooring contractor
