## PRE-DRYWALL INSPECTION REPORT

1010 New Homesite  
Denver CO 80538

Leon Homebuyer  
AUGUST 5, 2019

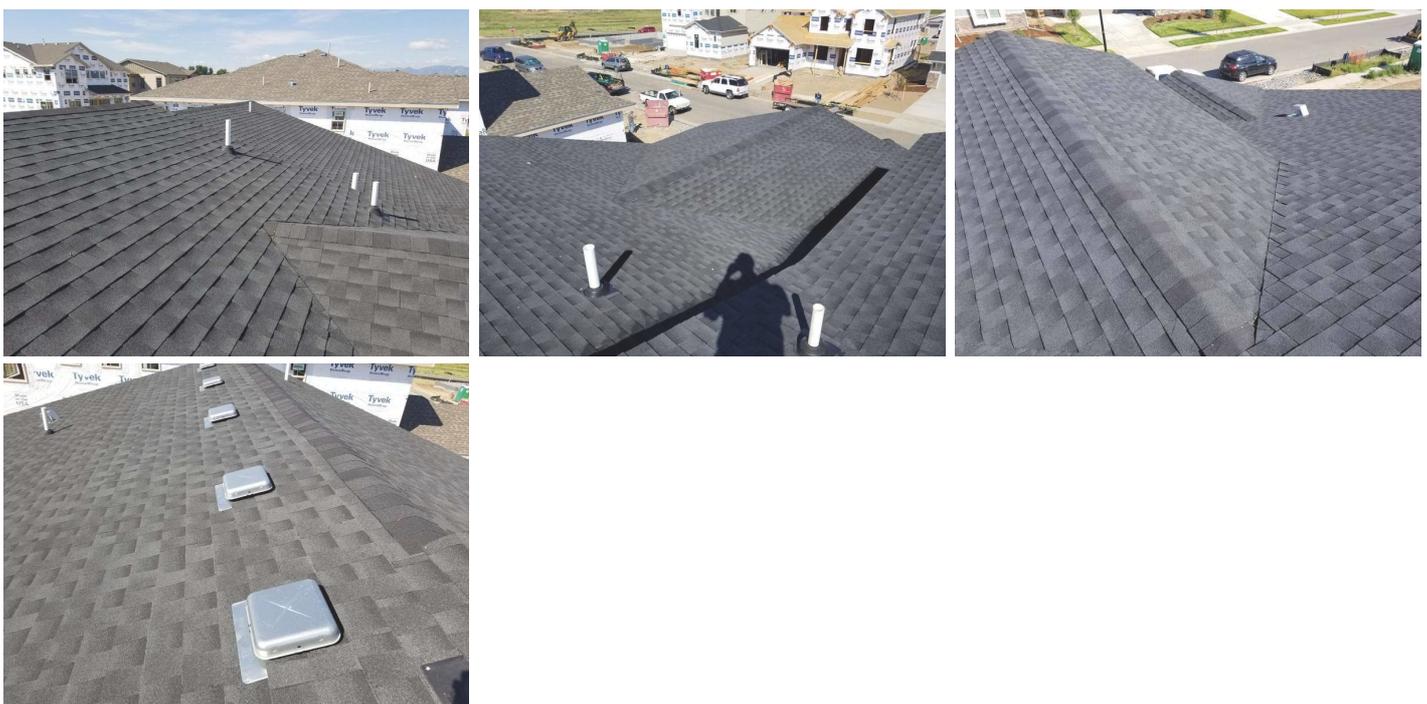
#### Roof Coverings and Flashings: Roof walked - no concerns noted

The roof was walked and fully inspected. No concerns or defects were noted at this time.

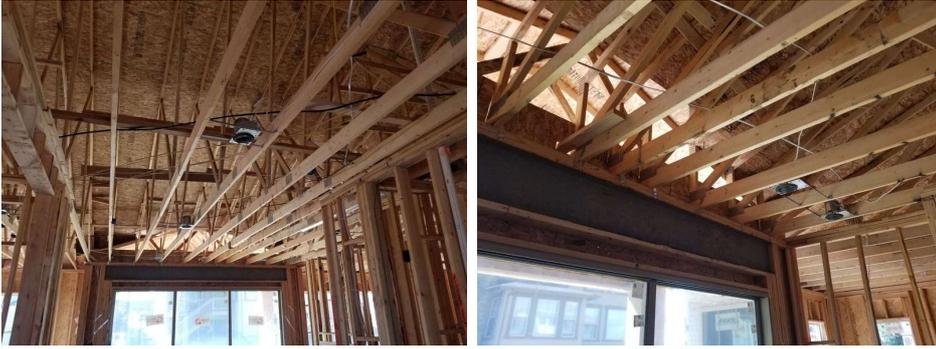
### Roof Structure: No concerns noted

The roof trusses and/or rafters and sheathing were visually inspected with no concerns noted.

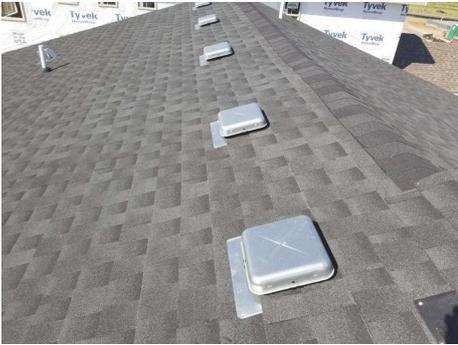
### Ventilation: Ventilation appears adequate

The attic system appears to be adequately ventilated.

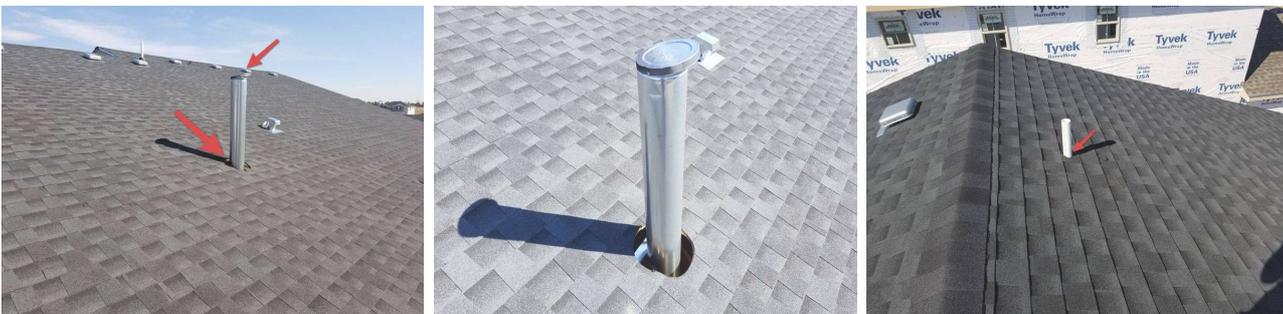
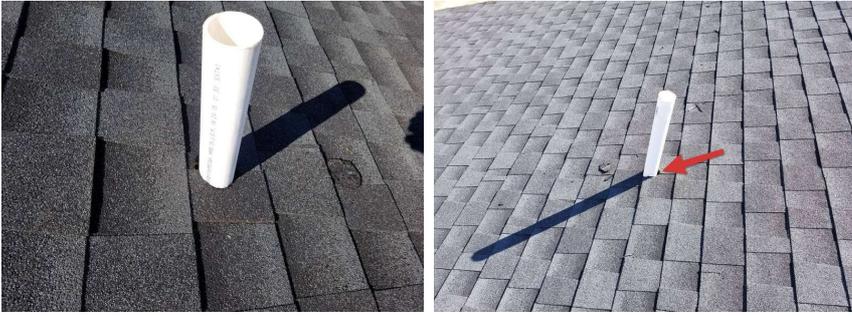
### 2.1.1 Roof Coverings and Flashings

#### ROOF FLASHING INCOMPLETE

The flashing boot, collar, and cap for the fireplace vent at the roof is not yet installed. There are also 2 missing plumbing vent pipe boot flashings. These items need to be completed before drywall can be installed, to prevent moisture damage. A roofing professional should properly install the correct flashings.

Contact a qualified roofing professional.

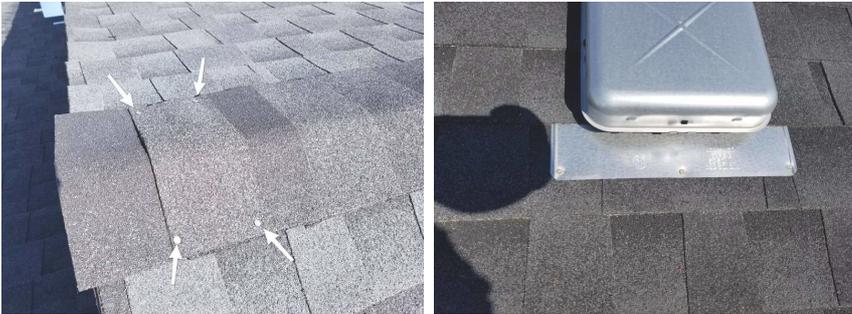
### 2.1.2 Roof Coverings and Flashings

#### **NAIL SEALING**

There are several exposed nails at the roof flashings and at the cap shingles that should be sealed over with roofing sealant, to prevent leaking from developing.

Contact a qualified roofing professional.

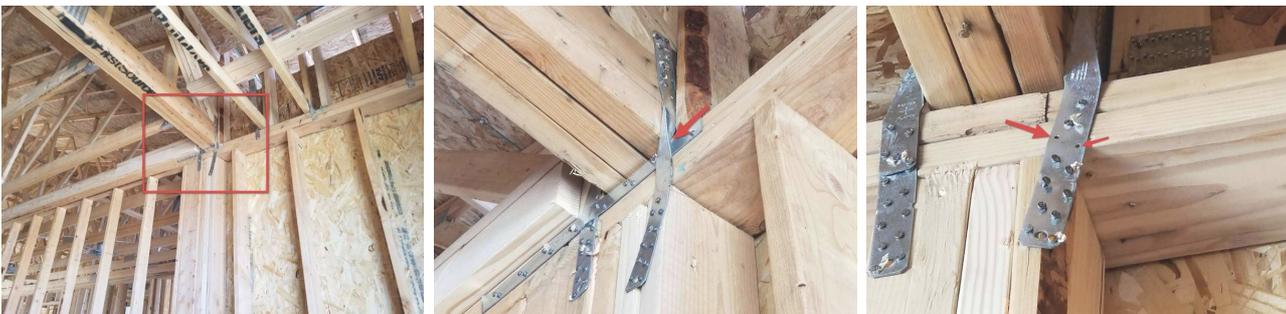
### 2.2.1 Roof Structure

#### **GIRDER STRAPS POORLY INSTALLED**

The straps at the girder truss are poorly secured to the studs, are missing nails in areas, and one protrudes outward from the framing, which will cause the drywall to not lay flush to the framing. It appears likely that an additional stud will need to be installed under each side of the girder to allow for proper fastening of these straps. The builder should evaluate and correct as needed.

Contact a qualified professional.

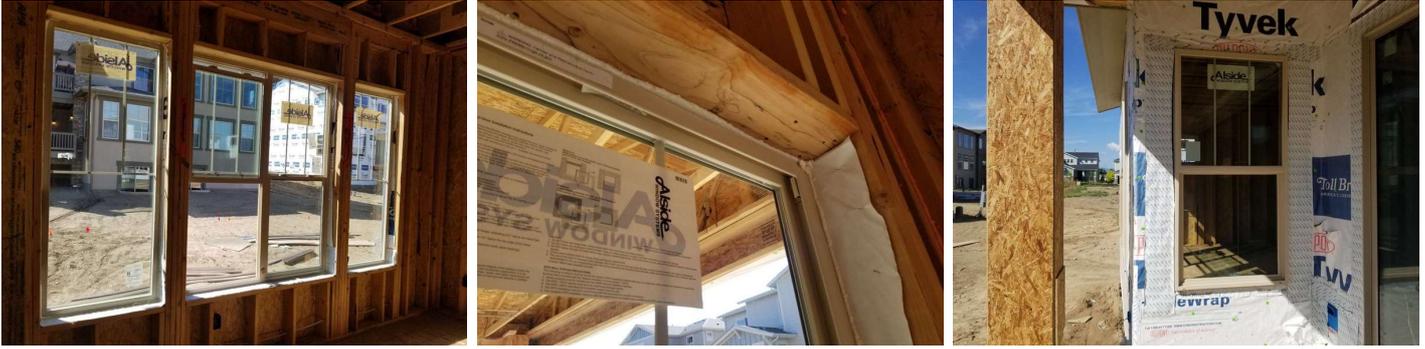
### Windows and Doors: Window installation

The windows are installed, and appear to be properly sealed and flashed.

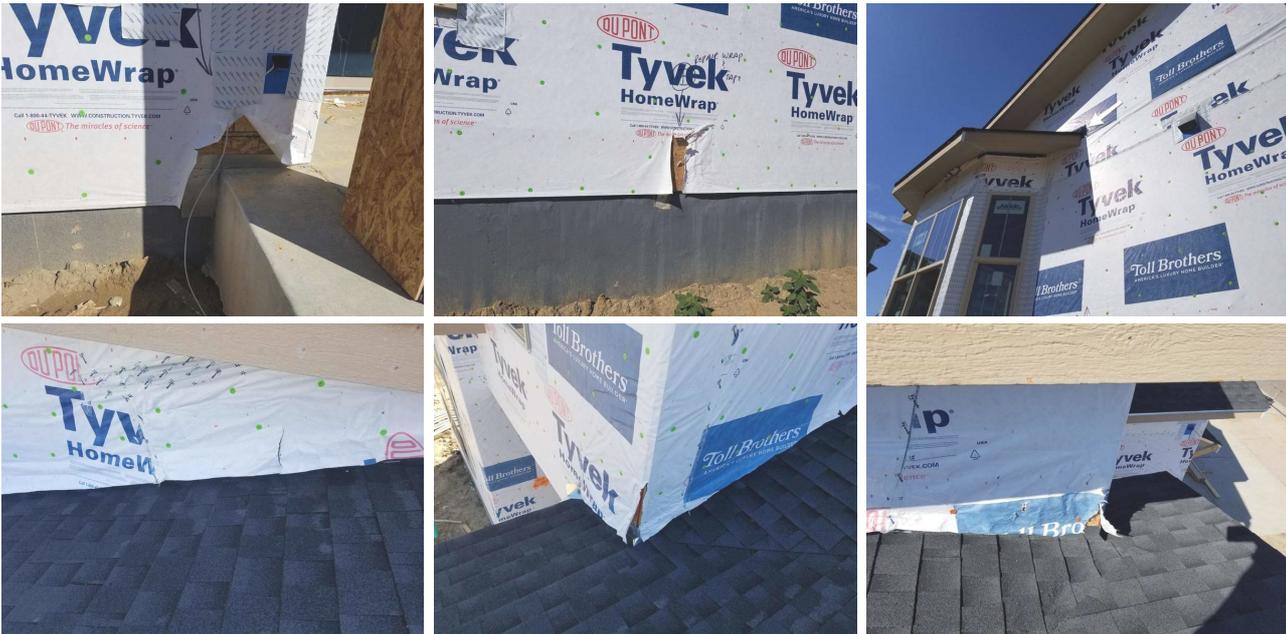
### 3.1.1 Exterior Wall Coverings, Flashings, and Fasteners

#### HOUSE WRAP REPAIR

The house wrap is torn or damaged in areas, and should be repaired and taped as needed before siding is installed.

Contact a qualified professional.

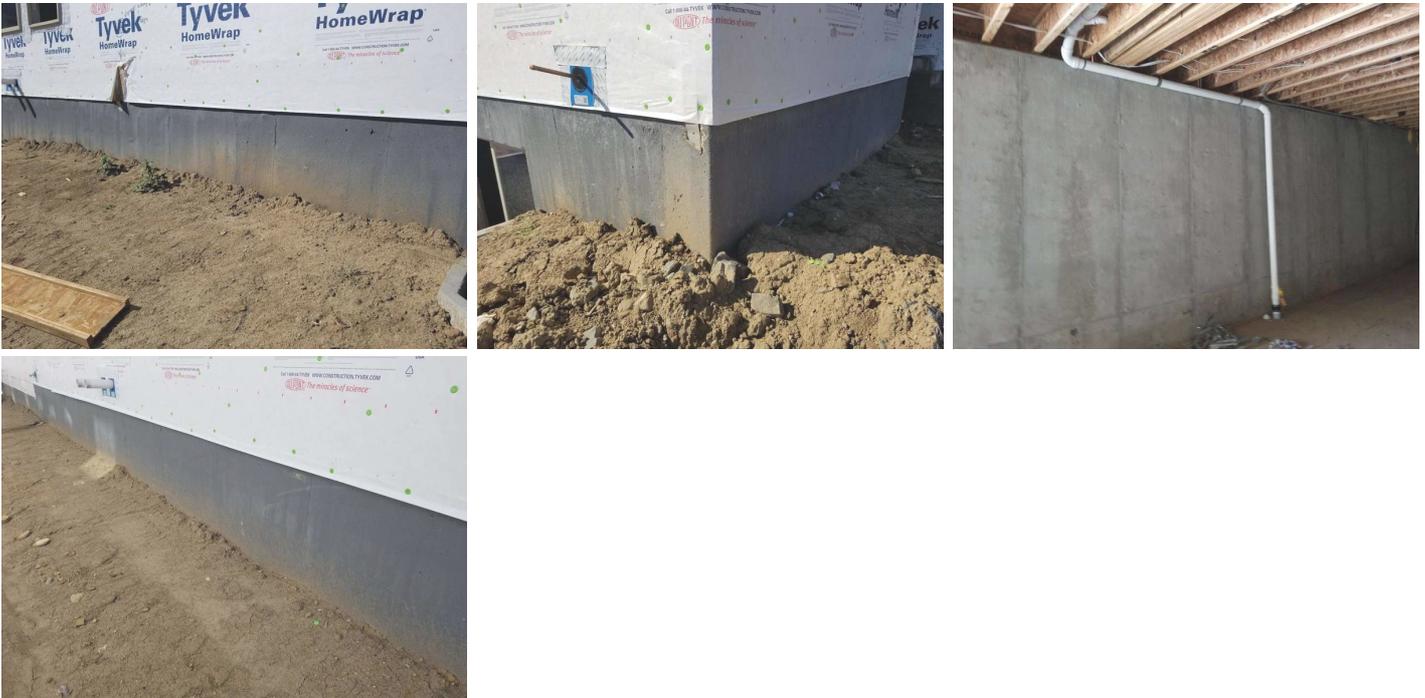
**Foundation Walls: No foundation concerns**

The structure and foundation of the home were visually inspected where readily accessible for signs of problems or concerns. No indications of significant structural concerns were observed at the time of the inspection.

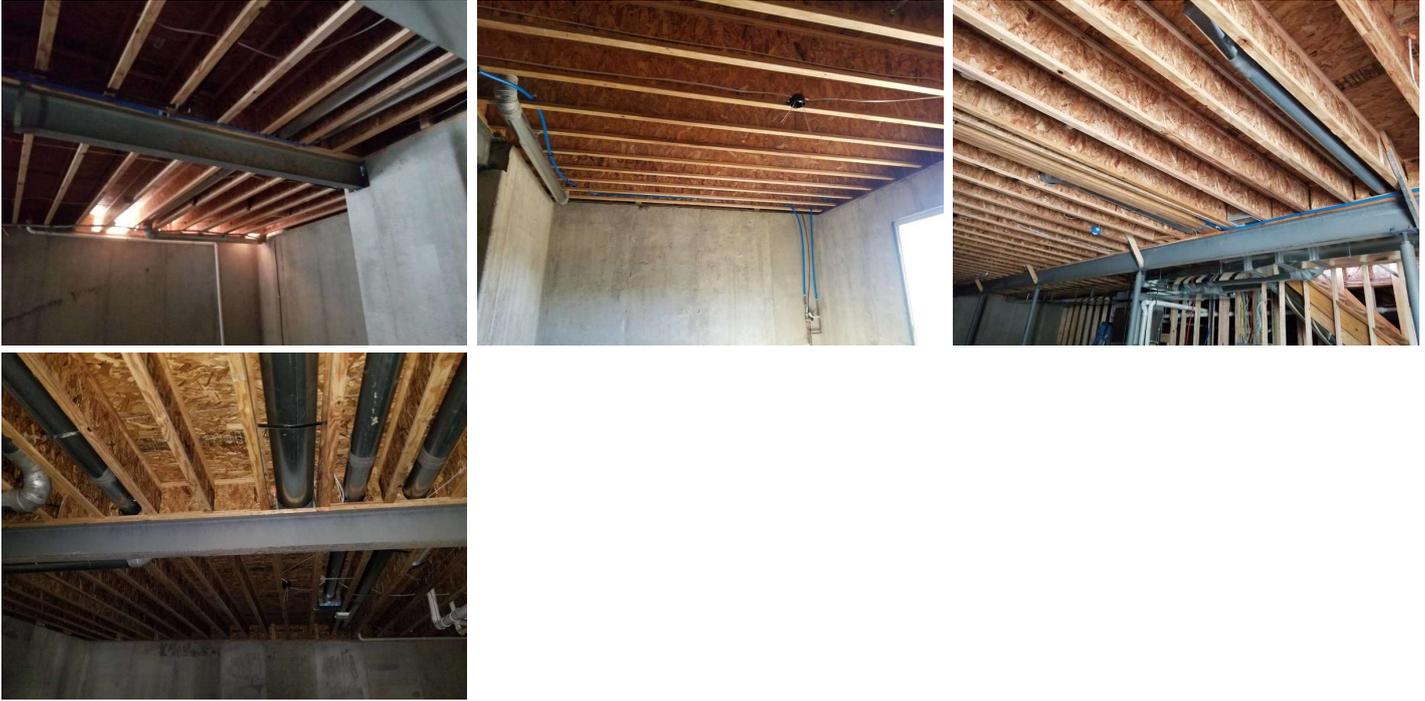
## Floor System: Floor system inspected

The floor system was visually inspected. No deficiencies were noted in the visible areas.

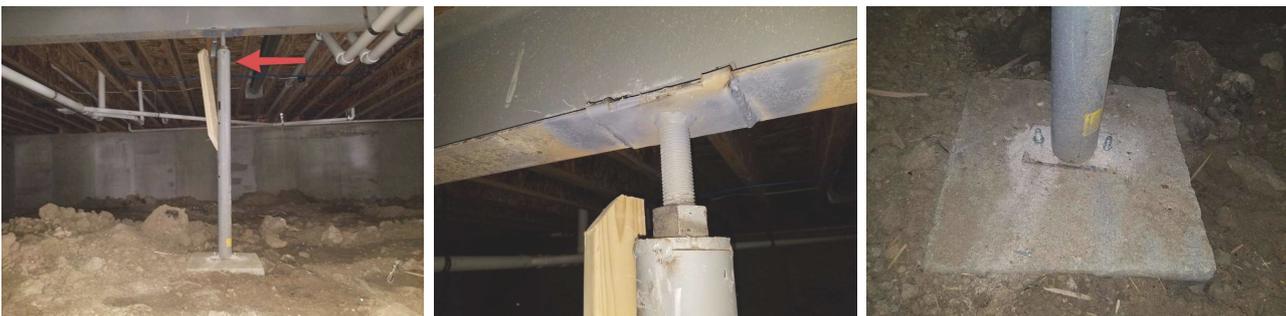
### 4.3.1 Structural columns

#### **POST NOT LEVEL**

The steel support post is visibly out of plumb. The post appears to provide adequate support, but support posts such as these should be installed as plumb as possible. The builder should repair and level the post as needed.

Contact your builder.

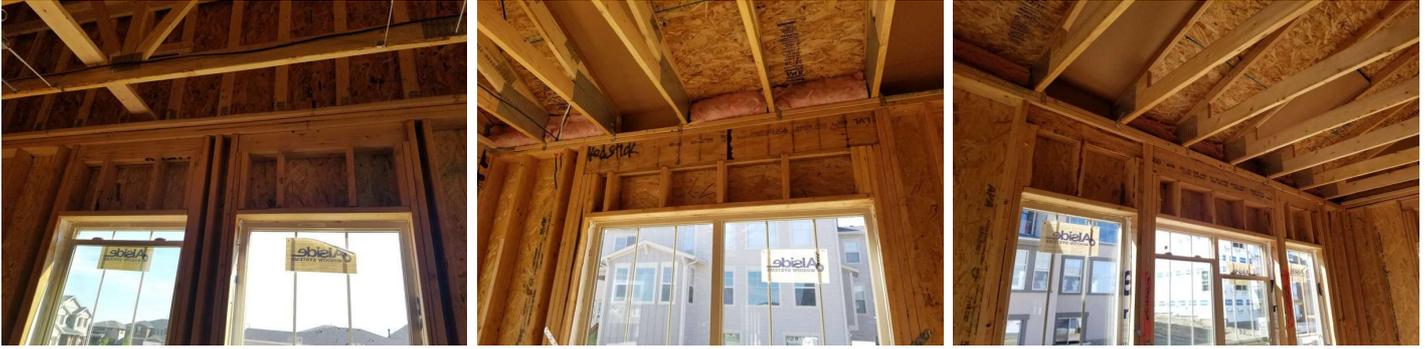
### Header and Window Framing: Headers - No concerns noted

The window and door headers appear to be properly sized and supported.

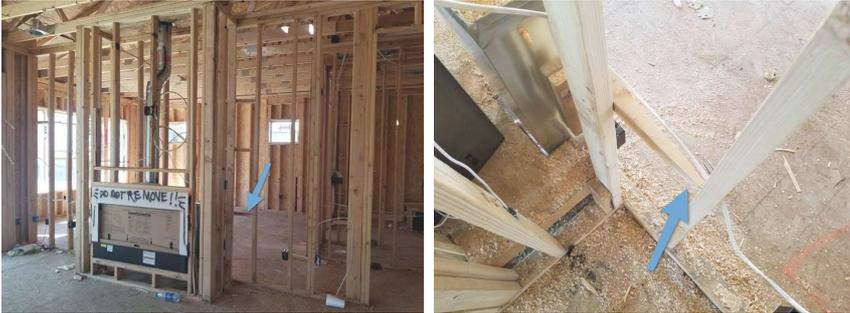
### 5.1.1 Wall framing

#### **ADDITIONAL BACKING NEEDED**

The drywall backing is damaged and loose, and is inadequate, and additional backing is needed to allow the drywall to be properly secured at the corner.

Contact a qualified professional.

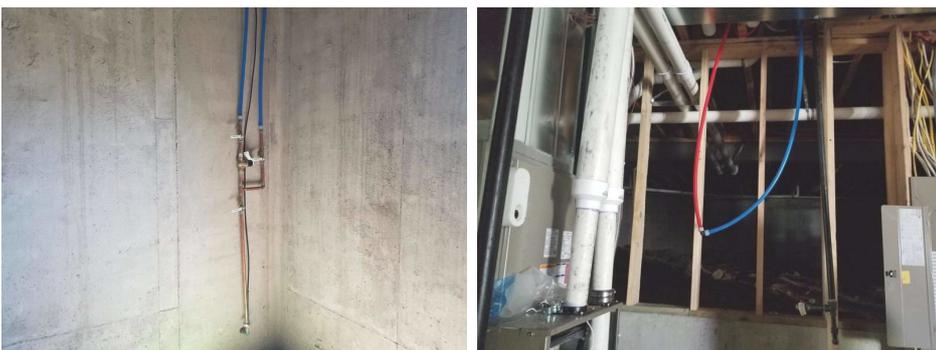
#### Water supply and distribution systems: Supply plumbing inspected

The visible parts of the rough in water supply distribution plumbing was inspected, with no concerns noted.

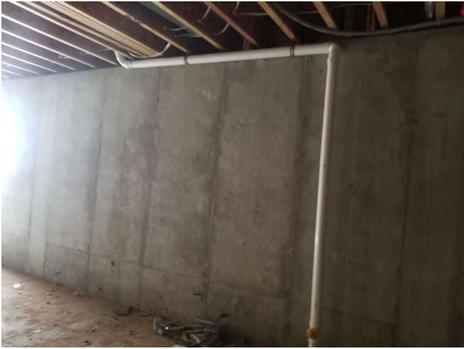
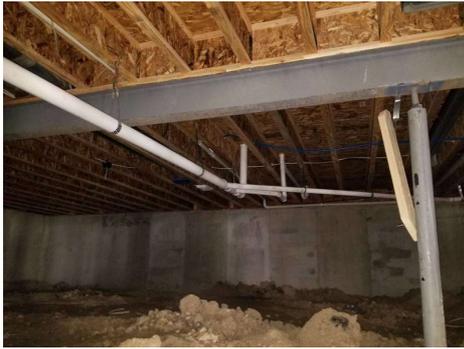
**Drain, Waste, and Vent Systems: Waste lines inspected**

The waste line plumbing was inspected, and appears to be properly installed, with visible fall in the drain lines as required.

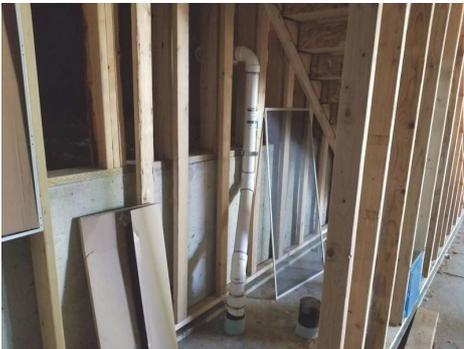
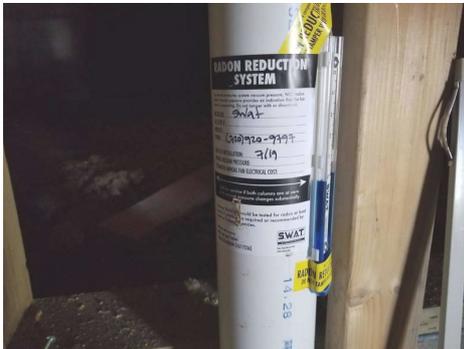
Basement

**Radon Vent: Radon vent present**

There is a rough in vent pipe installed for a future radon reduction system. No concerns were noted with the rough in installation.

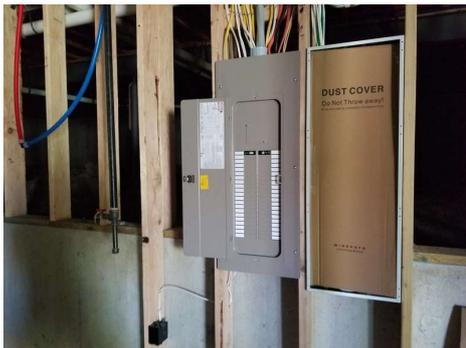
Basement

## Main and Distribution Panels: Panel set

The main panel box is set, and wiring is roughed in, but the power is not yet on. No concerns were noted.

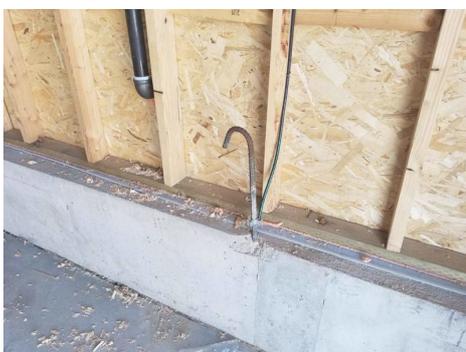
## Grounding Connection: Grounding OK

The electrical grounding connection to the grounding rod was visually inspected, with no concerns noted.

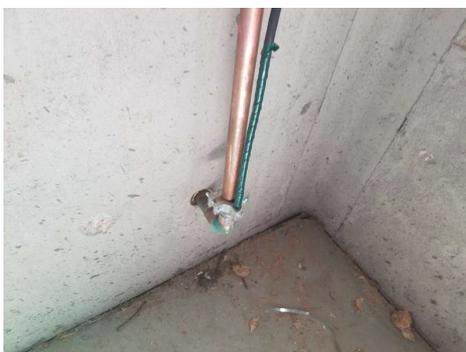
## Bonding Connection(s): Bonding OK

The electrical bonding connection to the plumbing supply was visually inspected, with no concerns noted.

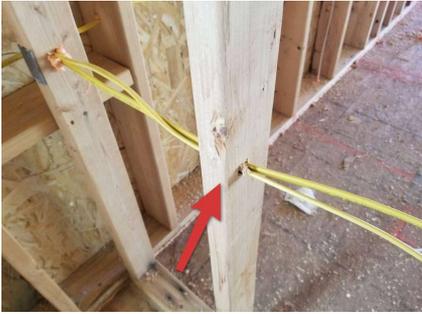
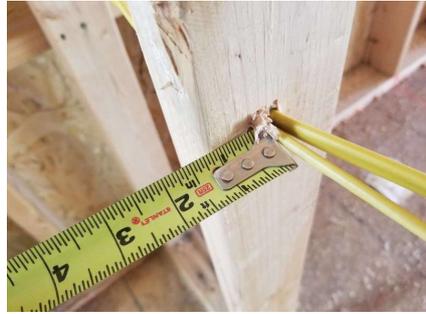
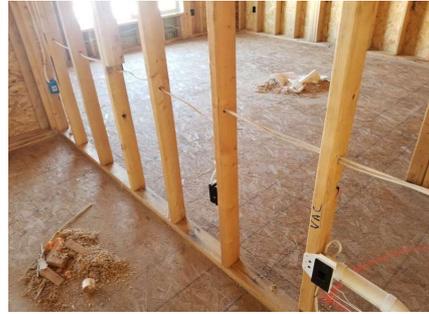
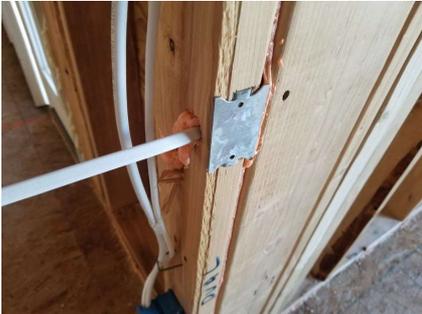
### 7.7.1 Nail Guards

#### **NAIL GUARDS NEEDED**

Nail guards were missing in various locations at the time of inspection. These are required to protect the wiring when less than 1 1/4" from the face of the framing. An electrician should evaluate and install nail guards where needed.

Contact a qualified electrical contractor.

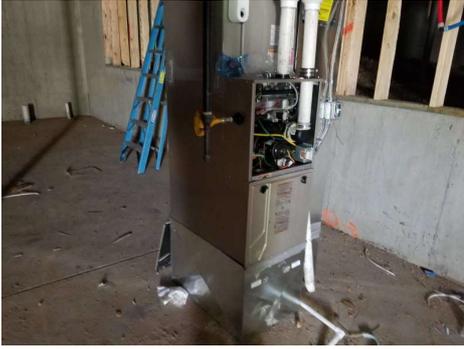
### Heating Equipment and Venting: Heating equipment visually inspected

The heating equipment is present but is not yet complete, but all components that were present were visually inspected.

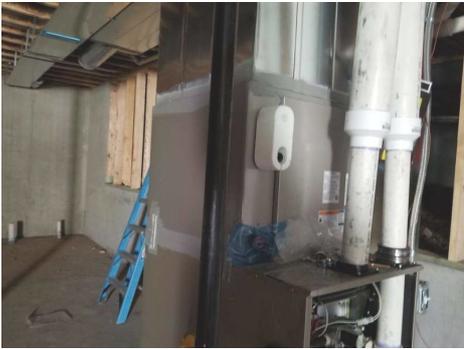
### Cooling Equipment: Cooling equipment not yet installed

The cooling equipment is not yet installed or complete, but all components that were present were visually inspected.

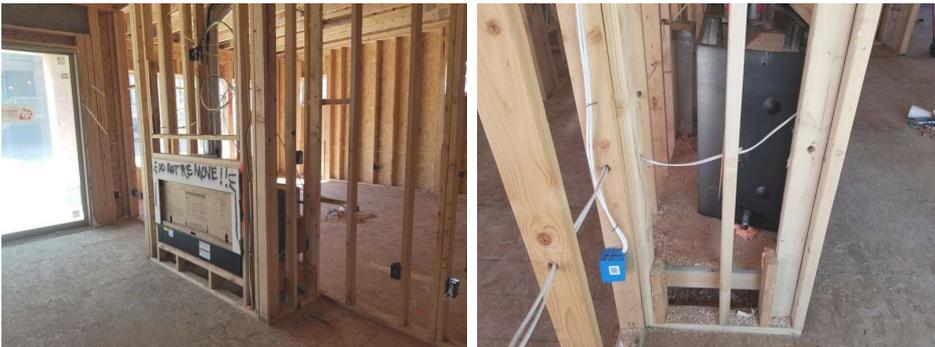
#### Fireplace and Vent Components: Gas fireplace visually inspected

The gas fireplace enclosure and installation was visually inspected, with no concerns noted.
