PROPERTY INSPECTION REPORT

Concerning: 123 Lucky Loop, Round Rock, Texas 78665

11/19/2019 8:30 am

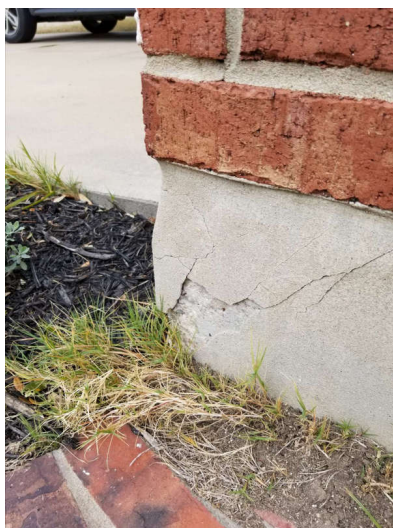
Southwest Corner

One or more of the corners of the foundation had cracking and/or damage commonly called as corner pops or spalling. This is a common condition and is do to thermal expansion and contraction of the masonry wall that rests on the slab. This condition does not adversely affect the foundations performance, however it is recommended having corner pops repaired to prevent moisture intrusion, insect penetration and to prevent damage to the masonry siding that rests above the corner of the foundation.

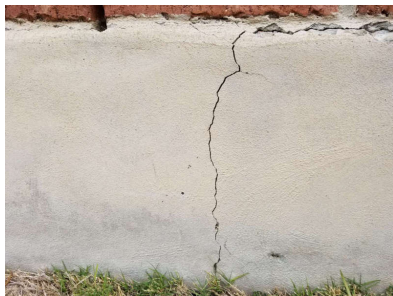
South Side

2: Cracking of skim coat

Cracks were observed in the cosmetic skim coat covering the concrete perimeter beam of the foundation. Cracks in the cosmetic skim coat should be repaired as this allows moisture penetration, can create conducive conditions for wood destroying insects and allow further deterioration of the cosmetic skim coat. This should be closely monitored and repaired as needed.

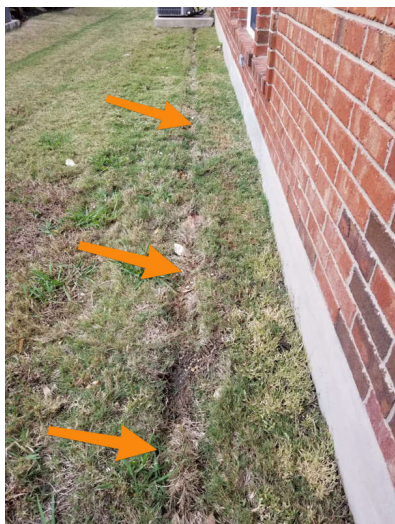
South Side

A drip line was observed to be developing along the house. A drip line is the result of erosion from storm water running off the roof. Drip lines may result in negative drainage or related issues. Any area where the ground or grade does not slope away from the structure is to be considered an area of improper drainage. The ideal slope is 6 inches per 10 feet. It is recommended to monitor the drip line and if negative grade begins occurring, contact a qualified landscaper or qualified contractor to regrade so water flows away from home.

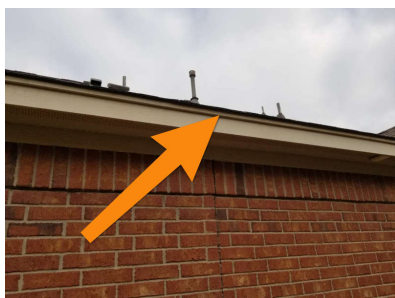
Drip edge flashing was missing at one or more location. Drip edge is a metal flashing that helps to alleviate water from running behind the fascia and other building material.

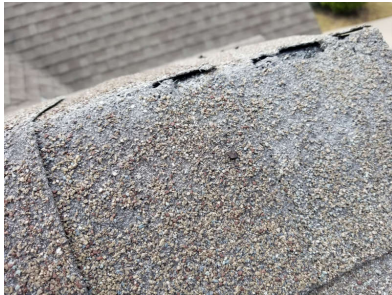
West Ridge

2: Torn shingle

Torn composition shingles were observed in one or more location. This can cause damage to the roof decking material and can also allow access for water to penetrate. It is recommended that a qualified roofing specialist further evaluate and repair or replace as needed.

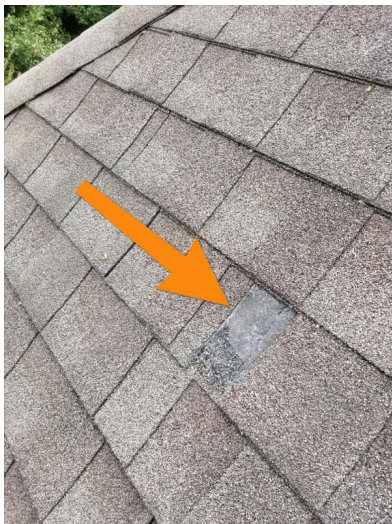
Northeast Side

3: Missing shingles

Composition shingles were observed missing at one or more location. This can cause damage to the roof decking material and can also allow access for water to penetrate. It is recommended that a qualified roofing specialist further evaluate and repair or replace as needed.

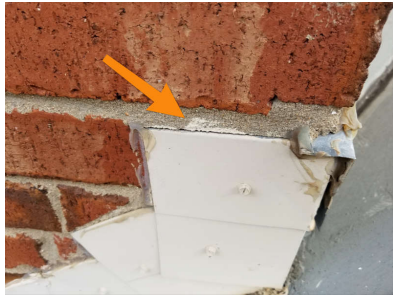
Above Entryway

4: Missing caulking/sealant on flashing

Caulking/sealant on the flashing was missing or in need of repair at one or more location. A proper seal is needed to help prevent water penetration at these locations.

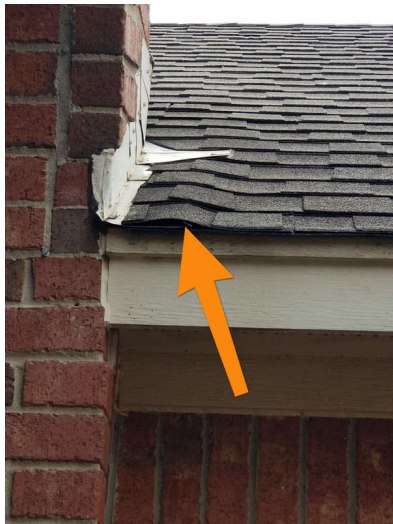
Front Entryway

Sections of the roof flashing were observed to be lifting, damaged or improperly installed. Lifting, damaged or improperly installed flashing may allow for water to penetrate in these areas. It is recommended that a qualified roofing specialist further evaluate and repair or replace as needed.

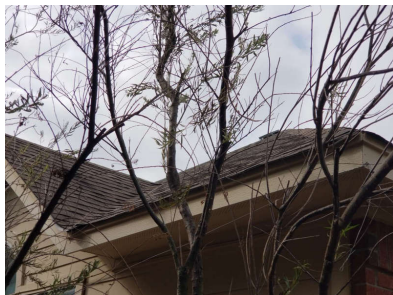
Northeast Side

Foliage was observed touching or in close proximity to the roof covering material. Foliage should be trimmed away from the roof covering material at all times as this can easily damage the roof covering material and exterior wall veneer.

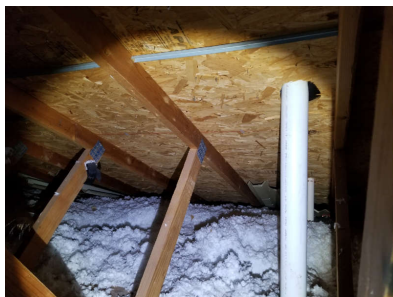
Northeast Corner

1: Missing baffles

Missing baffles were observed at one or more location in the attic. Baffles are used to help prevent insulation or other materials from blocking the soffit vents. Blocked soffit vents restrict the attic ventilation.

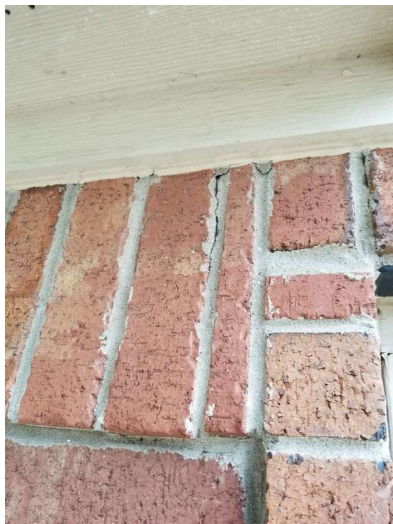
Top Left Garage Door

1: Minor cracks in masonry veneer

Minor cracks were observed in the exterior brick/stone veneer walls. Cracks in exterior brick/stone veneer can be indications that some movement or settlement has occurred. It is recommended that cracks in exterior walls be repaired and closely monitored. If concerns about the current or future foundation performance exist, it is also recommended to have a licensed structural engineer further evaluate prior to closing.

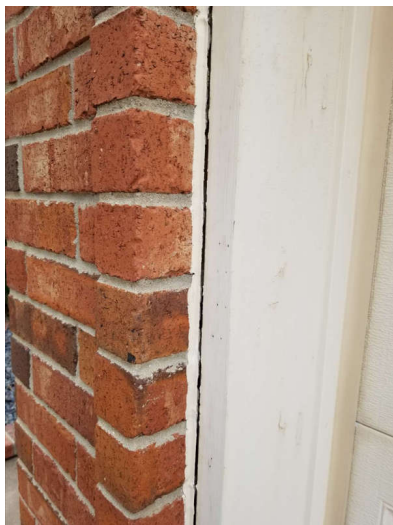
Garage Trim

Exterior sealants/caulking was deteriorated and/or missing in one or more location. Sealants/caulking help to reduce moisture penetration and insect intrusion.

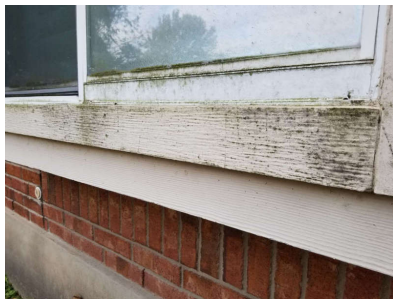
North Side

Fungal growth was observed on the exterior veneer of the structure and should be removed.

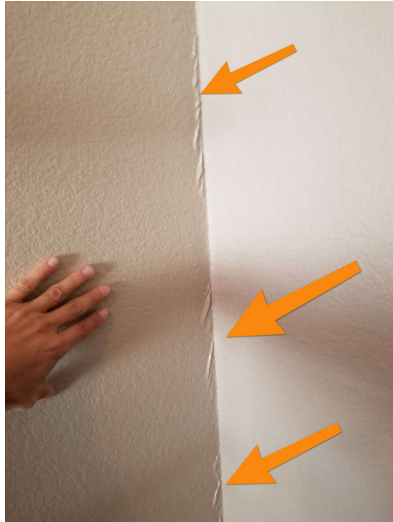
8: Loose drywall tape

The drywall tape was coming loose and/or twisting in one or more location. This can be an indication of poor installation, expansion and contraction of building materials or that there is and/or was some degree of movement or settling occurring in the structure. It is recommended to monitor these areas and if the condition worsens, contact a licensed structural engineer to further evaluate or if concerns arise.

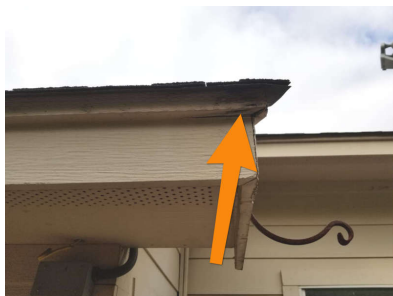
East Trim

9: Deteriorated or damaged wood trim

The exterior wood trim was deteriorated and/or damaged in one or more location. Deteriorated or damaged exterior wall veneer should be repaired to prevent further damage, reduce moisture penetration and reduce insect intrusion.

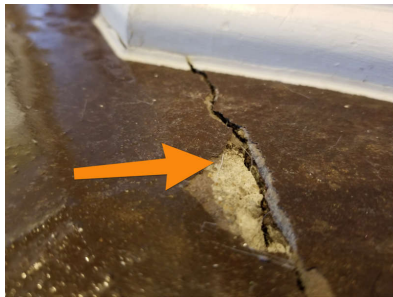
Main Hallway

Small cracks in the concrete floor were observed in one or more location. Small cracks (shrinkage cracks) in concrete are typically normal due to the nature of concrete, however it is recommended that cracks in the concrete floor be closely monitored and if there are concerns about the current or future foundation, it is also recommended that there be a further evaluation by a licensed structural engineer prior to closing.

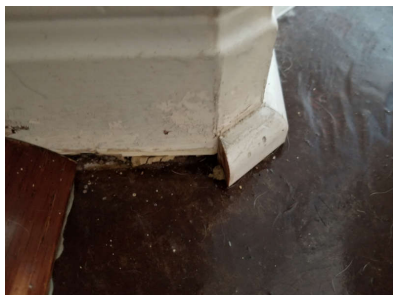
Formal Dining Room

Trim was found to be missing and/or damaged in one or more location.

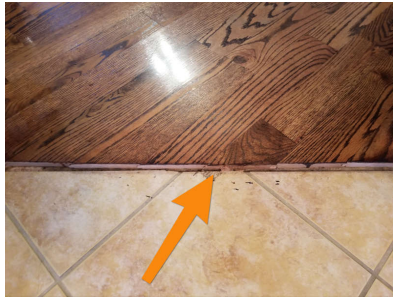
Master Bathroom

The transition piece at one or more location was found to be missing and/or damaged.

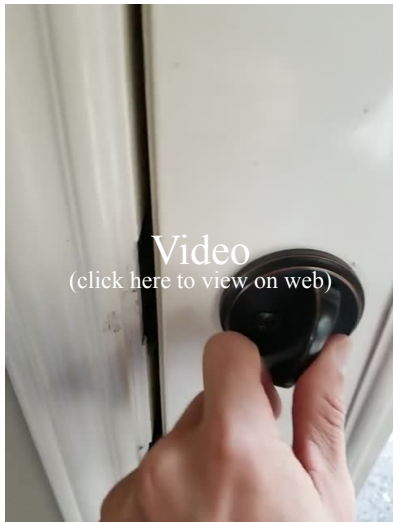
The deadbolt lock throw-out bolt(s) for the backdoor was found to not fully throw and extend into the door jamb all the way. Adjustments should be made to the deadbolt locking mechanism or door jamb to ensure that the dead bolt(s) can fully extend.

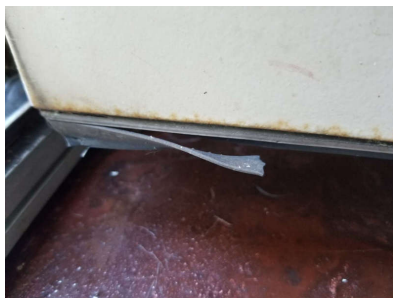
Back Door

The door sweep was damaged and/or missing at the back door. Damaged or missing door sweeps may reduce energy efficiency and allow water penetration.

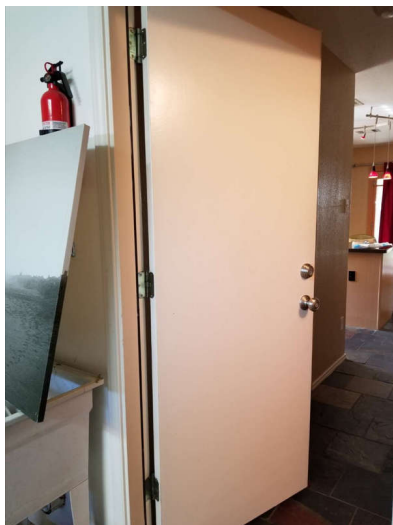
Door to Garage

The self close hinge for the door at the garage was missing or not functioning. The garage door that provides access to the conditioned dwelling must be fire-rated, have weatherstripping and have a self-close mechanism for safety purposes. This is considered to be a SAFETY HAZARD.

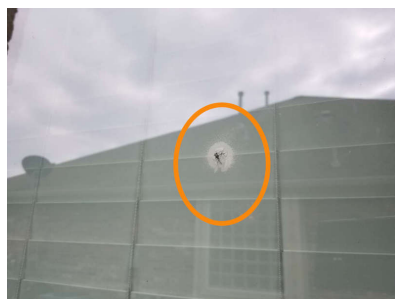
Southwest Window

One or more window pane was observed to be cracked and/or broken. It is recommended that a qualified window specialist or qualified contractor further evaluate and repair or replace as needed.

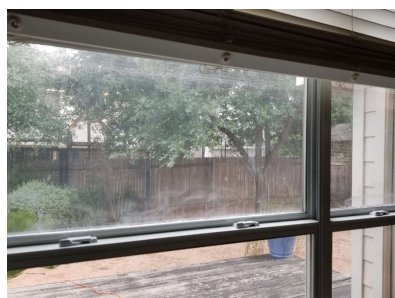
2: Lost thermal seal in window

One or more of the windows appear to have lost its thermal seal between the two glass panes. When a thermal seal is lost, condensation will typically develop between the panes of glass which can cause discoloration or fogging. Discoloration or fogging may appear and disappear as humidity and temperature change during the seasons. It is recommended that a qualified window specialist or qualified contractor further evaluate and repair or replace as needed.

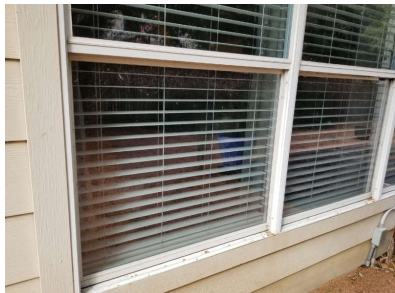
3: Missing window screens

Window screens were observed missing at one or more of the windows. Window screens help prevent insect penetration and can also prevent minor impact damage to the window.

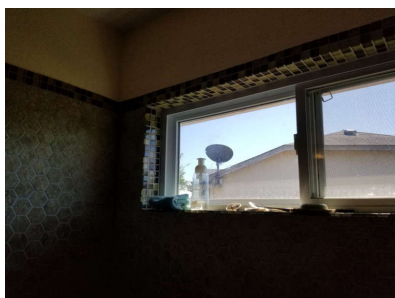
Full Bathroom

4: Window(s) in bathroom shower enclosure

One or more window was found installed in the bathroom shower enclosure. Windows in a bathroom enclosure can be susceptible to water penetration. It is recommended to monitor these areas and repair as needed.

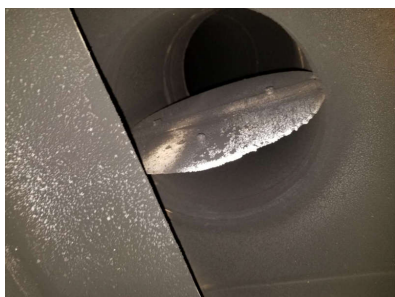
A missing or damaged blocking mechanism was observed at the fireplace damper. A damper blocking mechanism (such as a clamp) assists in preventing the damper from completely closing and leaking harmful gasses, fumes or smoke into the interior of the structure. This is considered to be a SAFETY HAZARD and should be repaired.

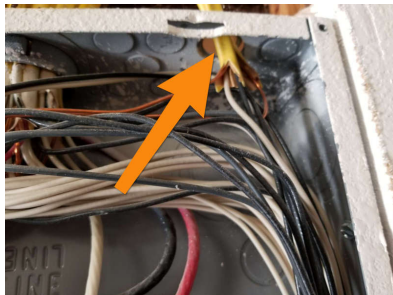
Subpanel

The wires entering the electrical panel box were not properly protected from the sharp edges within the panel. Where wires enter an electrical panel box, bushings should be installed to help protect wires from sharp edges. It is recommended that a qualified, licensed electrician further evaluate and repair or replace as needed.

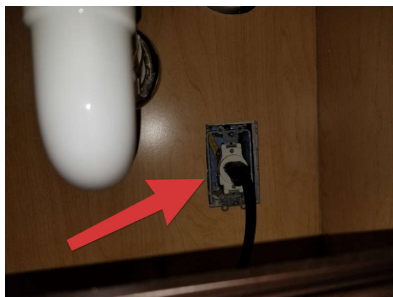
Kitchen Sink

Missing or damaged faceplate was observed below the kitchen sink. Faceplates that are missing are considered to be a SAFETY HAZARD and should be repaired.

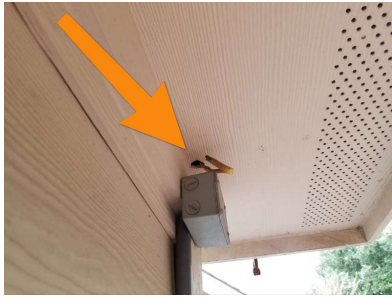
South Eave

Unprotected or exposed exterior wiring was observed that is not located in a protective conduit.

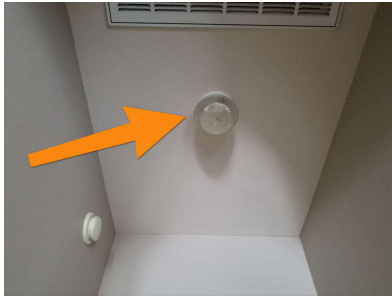
Hallway Near Master

Lights were observed to not be operating in one or more location. This condition may need a bulb replacement, fixture repair or a fixture replacement.

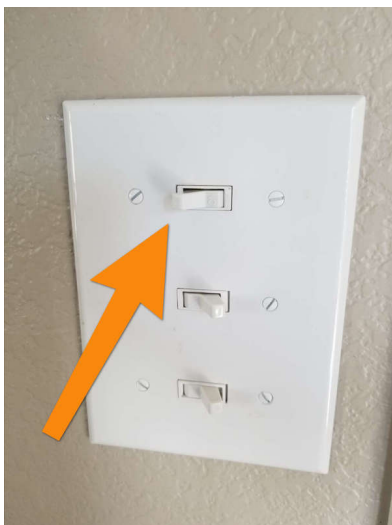
Near Back Door

One or more light switch was found to be non-functioning and the inspector was not able to determine the function of light switch.

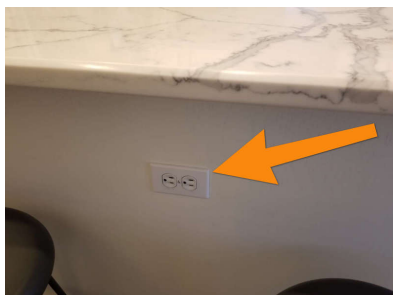
Kitchen Island

One or more receptacle in the kitchen was observed to not be ground fault circuit interrupter (GFCI) protected. Under current building standards, all kitchen electrical receptacles should be GFCI protected.

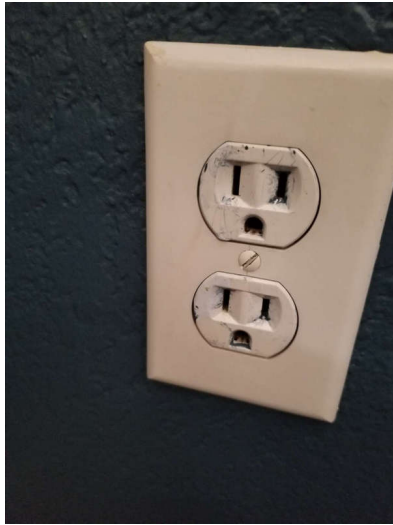
Front Bedroom

One or more electrical receptacle was observed to be painted. Painted electrical receptacles are considered damaged and should be replaced by a qualified, licensed electrician.

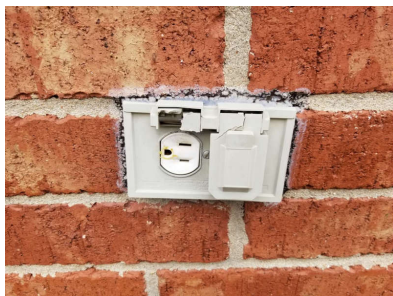
North Side

One or more outdoor electrical receptacle cover was observed to be damaged. Missing or damaged electrical receptacles covers should be repaired by a qualified, licensed electrician.

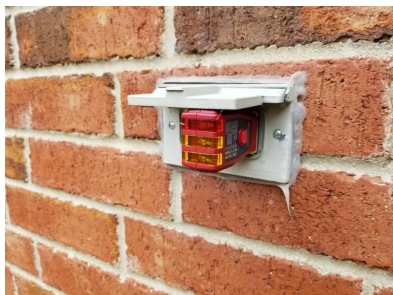
North Side

One or more electrical receptacle was found to not function. It is recommended to have a qualified licensed electrician further investigate and repair or replace as needed.

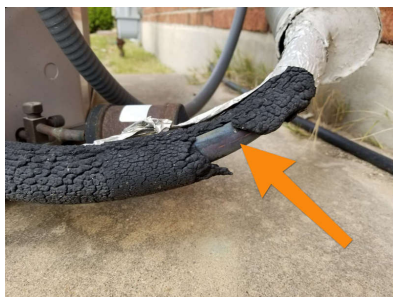
Outside Condensing Unit

Damaged, deteriorated and/or missing insulation on the refrigerant line was observed. Properly insulating the refrigerant line can improve performance, help to prevent moisture from building on the exterior of the line and help reduce the chances of leaking condensate. The refrigerant line should be repaired as needed.

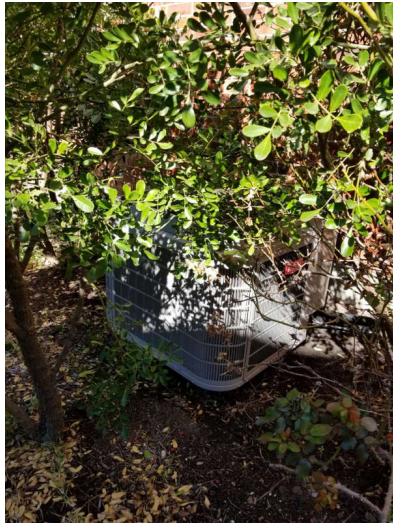
The outside condensing unit was found to not have adequate clearance. Condensing units should have enough clearance from exterior walls and foliage to allow for proper air flow around the unit.

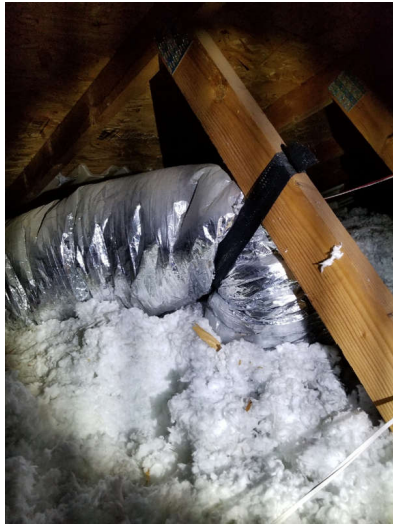
Right of Walkway

Observed ducts that were improperly routed due to sharp and abrupt bending. Under current building standards, the radius at the centerline of the bend should be no less than the diameter of the duct. Sharp and abrupt bending can restrict the airflow and affect the airflow balance in certain areas of the house.

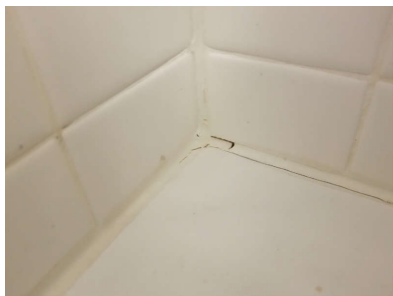
Front Bathroom

Missing or damaged caulking was found in the front shower/tub enclosure. These areas should be repaired to prevent water penetration.

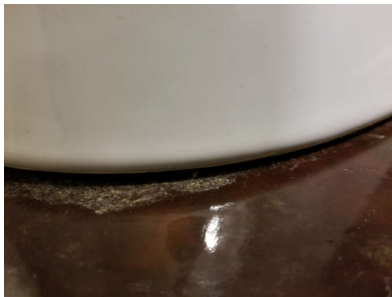
Half Bathroom

The toilet in the half bathroom was found to have missing or damaged caulking at the base of the toilet. The base of the toilet should be sealed to the floor to help prevent bacteria and sewer gasses from the toilet drain entering the house.

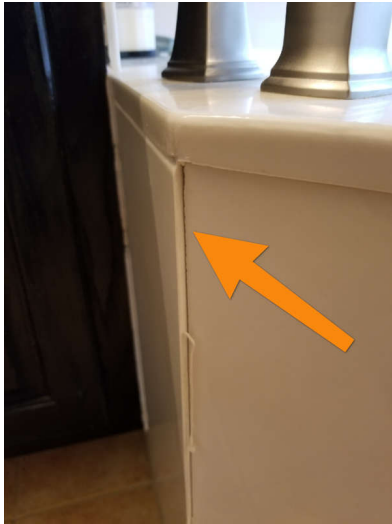
Master Bathroom

The bathtub in the master bathroom was observed to be damaged.

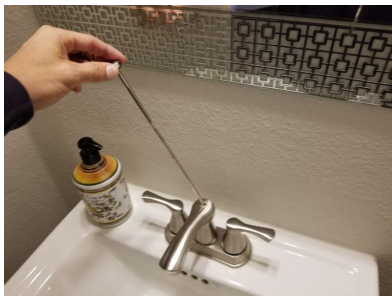
The stopper in the half bathroom sink was found to not be connected.

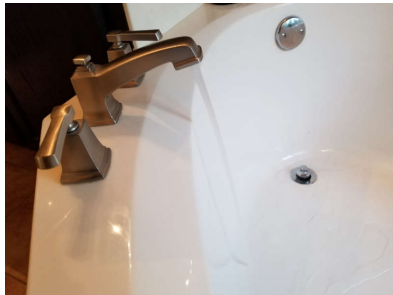
Master Bathroom

Slow flow was observed for the master tub.

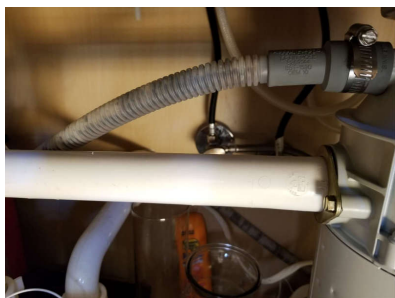
A high loop or air gap was observed to be missing for the dishwashers drain line. High loops or air gaps help in separating waste water from the supply water and also helps to prevent the flow of drain water from coming back into the dishwasher.

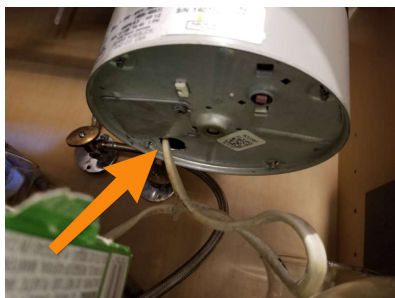
The electrical conductor entering the food waste disposer was found to not be properly protected. A bushing with a clamp should be installed to help minimize the food waste disposers housing from cutting the electrical conductor.

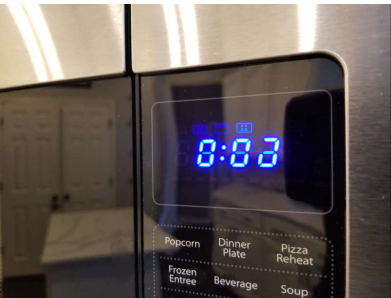
The digital display was found to be damaged and/or not displaying correctly.

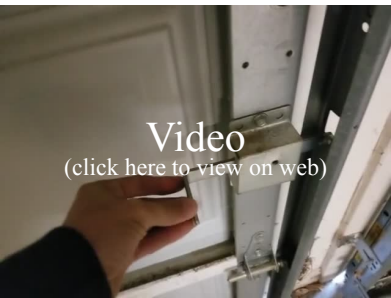
The manual locks for the garage door were found to not be disabled. When an automatic garage door opener is installed, the manual door locks should either be disabled or removed. This is to prevent damage to the garage door, garage door hardware and automatic garage door opener in the event that the door was locked and the garage door opener engaged.
