MOUNTAINS TO SOUND HOME INSPECTION LLC

HOME INSPECTION REPORT

120 NW 43rd St
Seattle WA 98107

MARCH 12, 2018

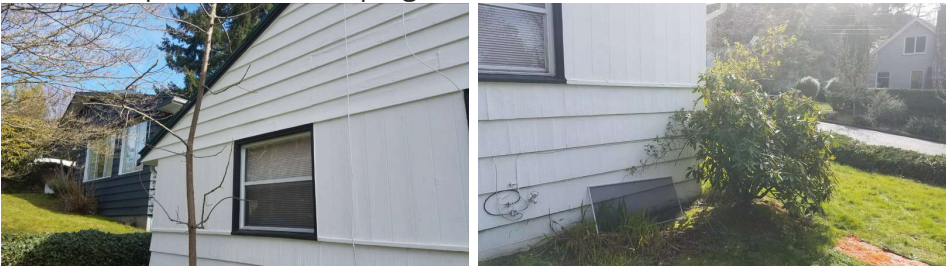
Vegetation is encroaching on the structure, and should be kept a minimum of twelve inches away for the general welfare of the walls and foundation.

Contact a qualified landscaping contractor

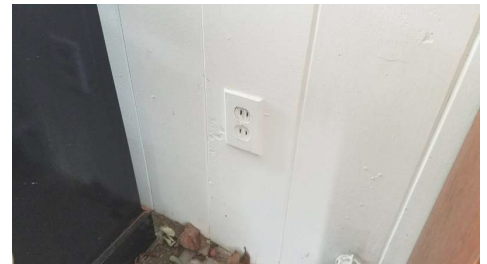
MISSING WEATHER SEALS

There is at least one exterior outlets that are missing weather seals or covers which are recommended for safety and to keep moisture from damaging the outlet.

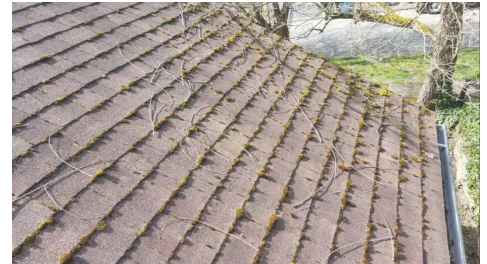
Parts of the roof needs to be cleaned of moss and/or debris. This can restrict drainage and lead to moisture intrusion and moisture damage if not corrected.

Contact a qualified professional.

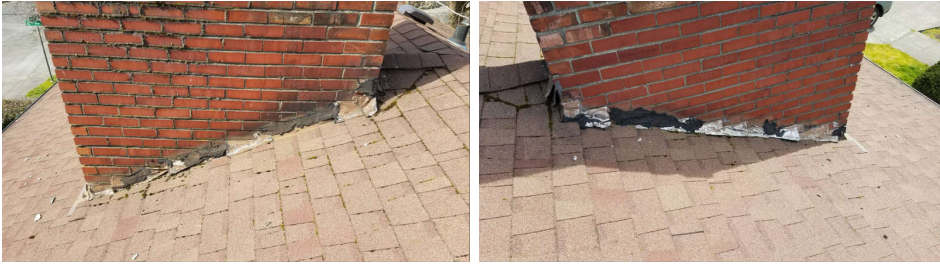
4.6.1 Chimney On Roof & Photo

THE VERTICAL WALL FLASHINGS OF THE CHIMNEY NEED TO BE RESEALED TO HELP KEEP MOISTURE OUT

The vertical wall flashings of the chimney is substandard. Recommend repair.

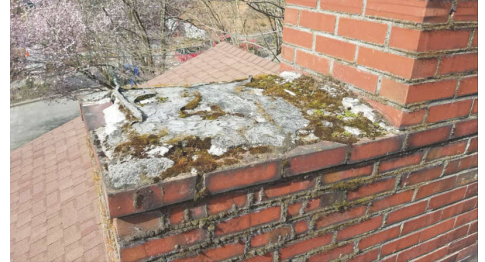
4.6.2 Chimney On Roof & Photo

CROWN DETERIORATED

The crown, which is designed to seal the chimney wall and to shed rainwater, is washed out or deteriorated and should be repaired or replaced.

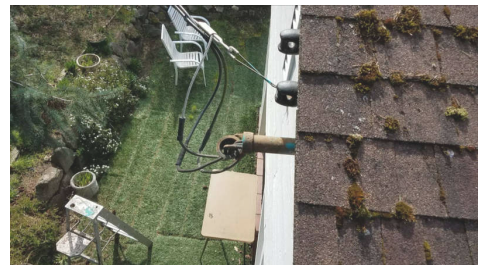
4.7.1 Roof Electrical

NEEDS REPAIR

The cap on the electrical strike is missing. Recommend replacing to prevent water from entering.

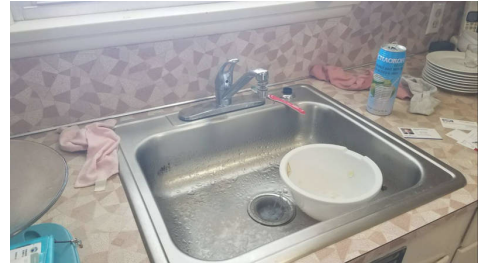
The kitchen faucet drips or runs continuously and should be repaired or replaced as necessary.

Contact a qualified handyman.

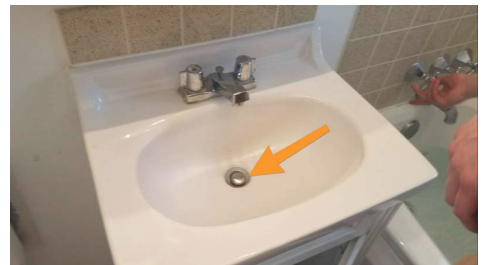
The sinkstopper does not work properly and repair is recommended.

Contact a qualified handyman.

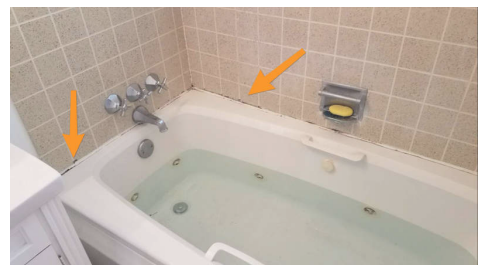
11.7.1 Tub-Shower

The enclosure needs to be cleaned and caulked, to forestall moisture damage.

Contact a qualified handyman.

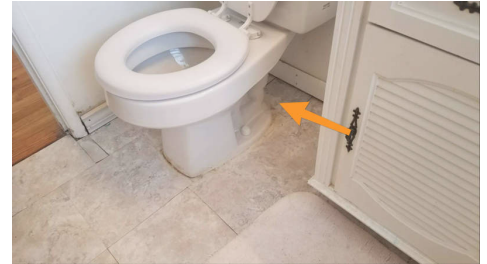
11.11.1 Flooring

FLOOR WORN OR COSMETICALLY DAMAGED

The floor is worn or cosmetically damaged, which you should view for yourself and correct as desired.

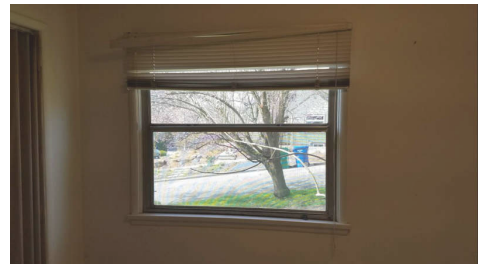
One or more windows were difficult to open or close and may need maintenance or repair.

Contact a qualified window repair/installation contractor.

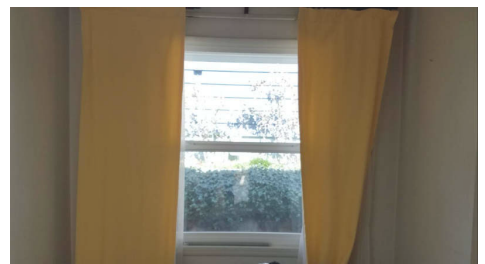
13.5.2 Windows

MISSING OR DAMAGED HARDWARE

The window is missing or has damaged hardware and is in need of service to be functional.

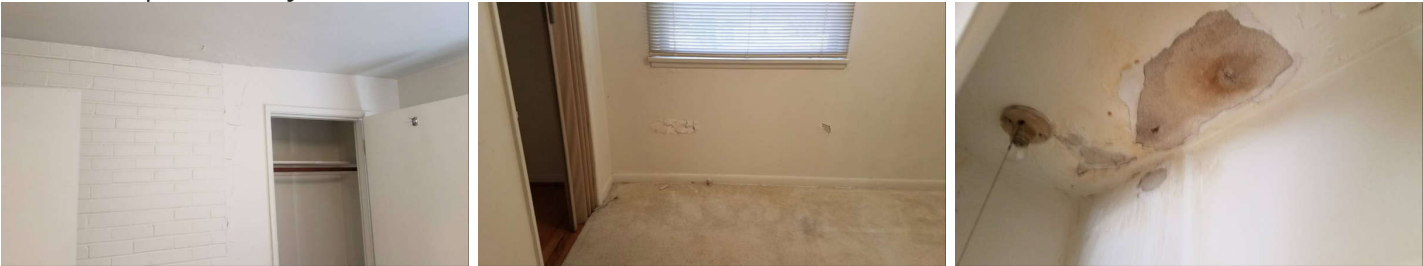
WALL/CEILING DAMAGE

The walls have some damage and repair is recommended. Possible water damage.

Contact a qualified drywall contractor.

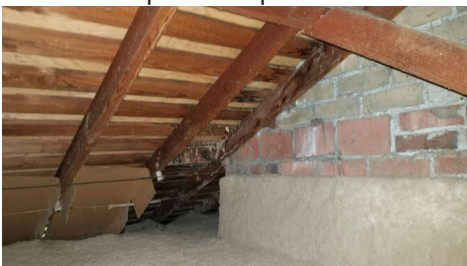
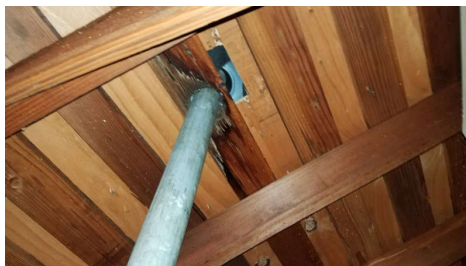
**Cosmetic - Monitor - Maintenance****DECK STAINING**

Discoloration and dark staining was observed on the roof sheathing. This is often caused by poor ventilation and is commonly considered a microbial growth. Recommend improving ventilation and cleaning.

Contact a qualified professional.

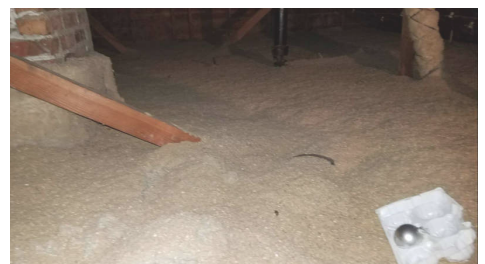
15.8.1 Insulation Notes

The residence has minimal batt insulation and adding more is recommended to conserve energy. There is currently only about 4-5 inches at most areas.

Contact a qualified handyman.

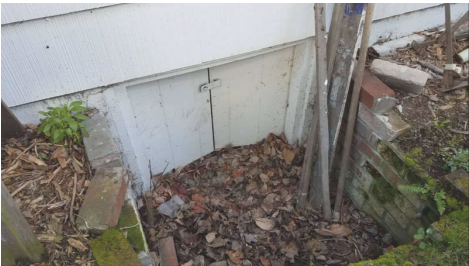
The crawl space hatch is damaged or does not seal. This may allow passage to rodents. We recommend necessary repairs to seal.

Recommendation
Contact a qualified professional.
