# MOUNTAINS TO SOUND HOME INSPECTION LLC

## HOME INSPECTION REPORT

6206 75th St W  
Lakewood WA 98499

Trong Dang  
MARCH 2, 2019

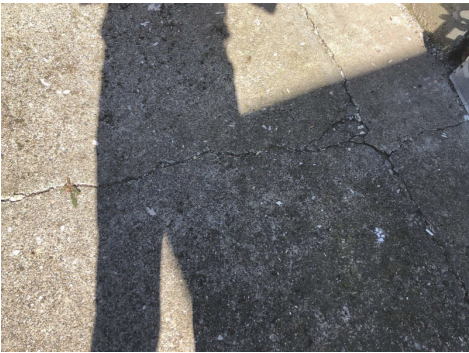
## PATIO FLOOR CRACKS

There are cracks in the rear patio floor that you should view for yourself and correct as desired.

Recommendation  
Contact a qualified concrete contractor.

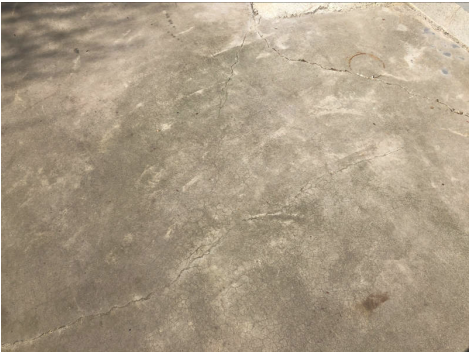
3.2.2 Driveway, Walkways & Patio

**SMALL CRACKS IN DRIVEWAY**

There are common cracks in the driveway that would not necessarily need to be serviced.

Recommendation  
Recommend monitoring.

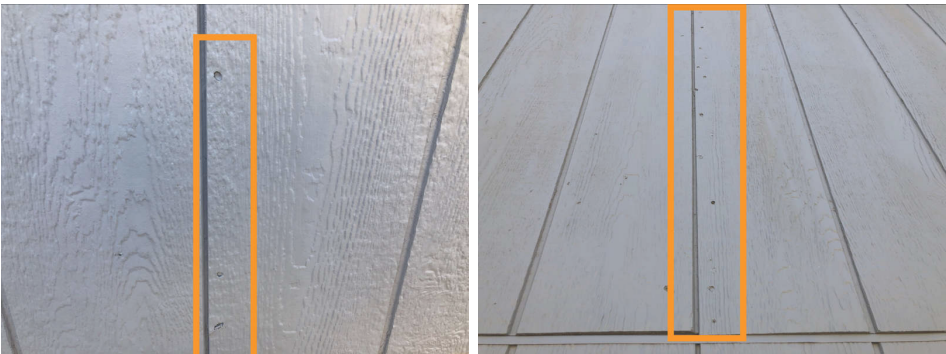
3.5.1 Exterior Siding Notes

**COUNTER-SUNK NAILS**

A number of holes or deflections through the surface of the siding material were not properly caulked and sealed. These were caused by driving nails deep into the siding material. This can cause accelerated deterioration of the siding from moisture. Caulking and painting of all nail heads, surface breaks and depressions that have broken through the siding surfaces is recommended.

See Invoice For Repairs.

Recommendation  
Contact a qualified professional.

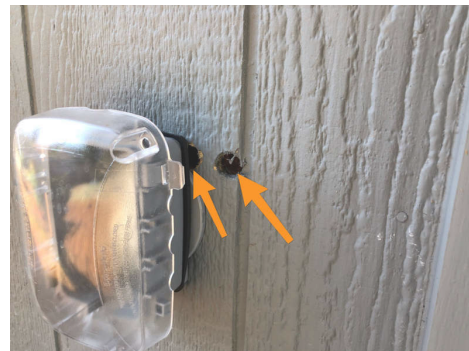
3.5.2 Exterior Siding Notes

**SEAL PENETRATIONS/GAPS**

Gaps and/or holes were observed on one or more sides in the siding around plumbing, gas, cable, wiring and/or other penetrations. We advise that all the holes and the gaps be caulked and/or sealed to prevent moisture and/or pest intrusion.

See Invoice For Repairs.

Contact a qualified professional.

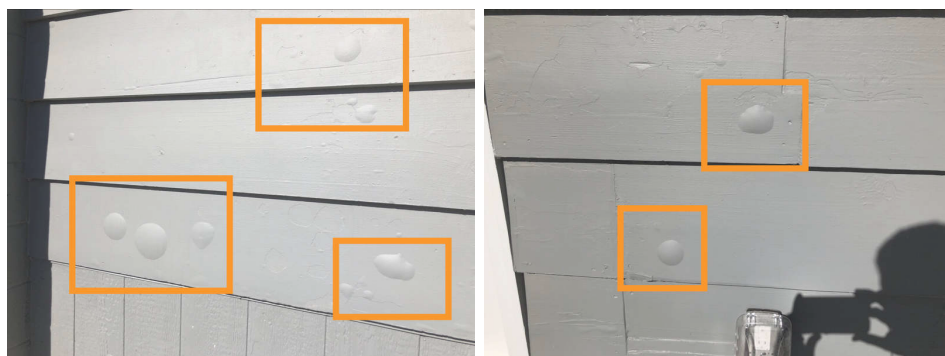
### 3.5.3 Exterior Siding Notes

#### **BUBBLING PAINT**

There are areas of the siding that have bubbling paint. Recommend repairs.

Contact a qualified professional.

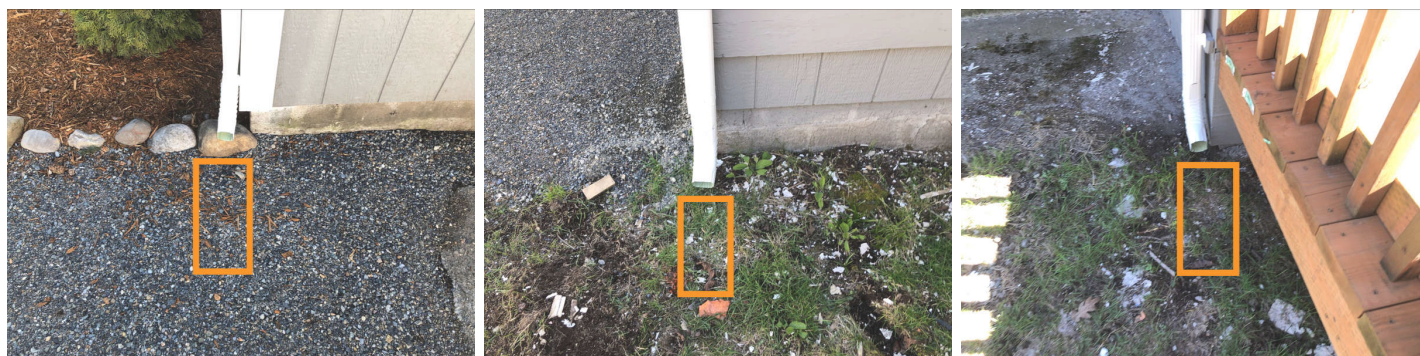
### 3.9.1 Downspouts

#### **DOWNSPOUTS MISSING COMPONENTS**

The downspout are missing parts. Recommend repairs to allow for proper drainage away from the structure.

Contact a qualified professional.

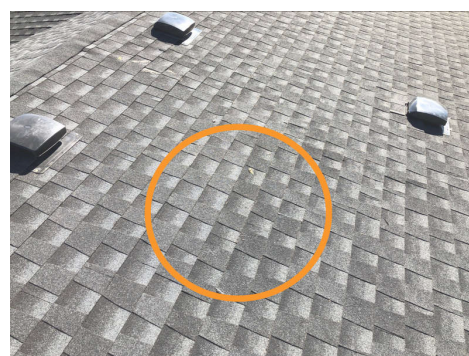
Soft spots in the sheathing was observed in one or more areas. For the revaluation and repairs are recommended as needed to.

See Invoice For

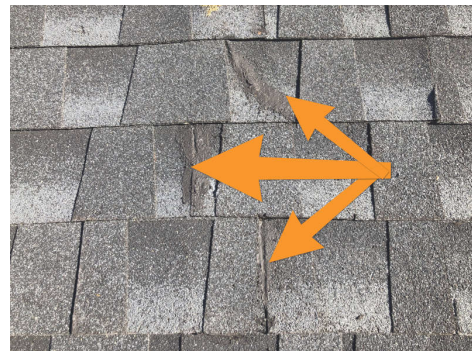
#### 4.3.1 General Observations

Repairs and/or patches have been made to the roofing material in several areas. We cannot determine the reason or condition of the repairs. Monitoring is advised for future issues or conditions. An additional evaluation of the roof would be appropriate.

Contact a qualified professional.

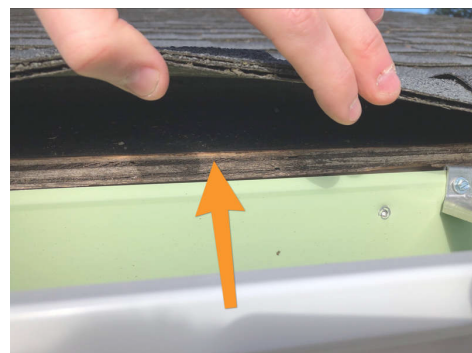
## 4.4.1 Vents &amp; Flashings

**DRIP EDGE FLASHING MISSING**

A drip edge flashing was not installed around the perimeter of the roof edges. Recommend that drip edge flashing be installed to prevent deterioration of the roof sheathing or exposed fascia boards.

See Invoice For Repairs.

Contact a qualified roofing professional.

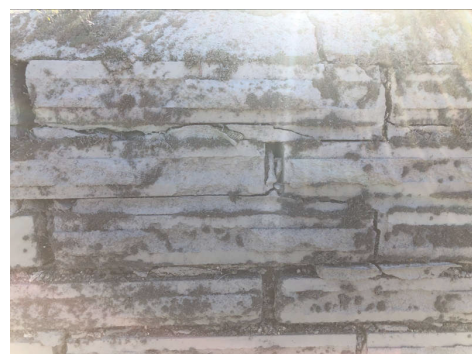
## 4.6.1 Chimney On Roof &amp; Photo

**MINOR CHIMNEY CRACKING**

Minor chimney cracking was observed. Recommend monitoring and packing as needed.

Contact a qualified professional.

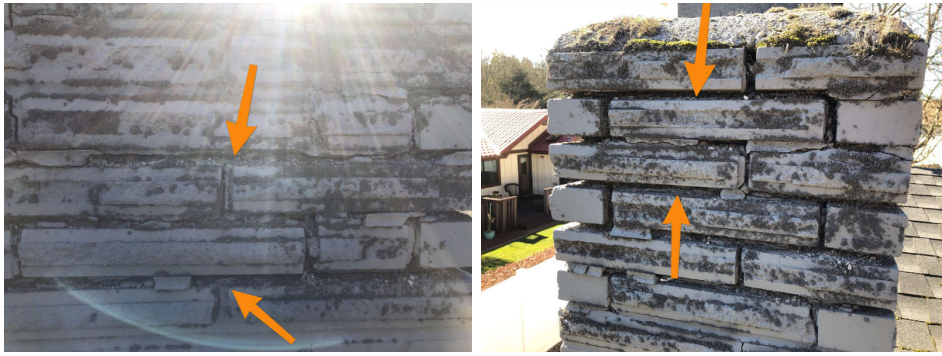
## 4.6.2 Chimney On Roof &amp; Photo

**LOOSE MORTAR**

The exposed sections of the exterior of the chimney needs re-pointing (tuck-pointing) due to having loose or deteriorated mortar joints. Repair of old and or eroded mortar joints is known as re-pointing and is recommended.

See Invoice For Repairs.

Contact a qualified professional.

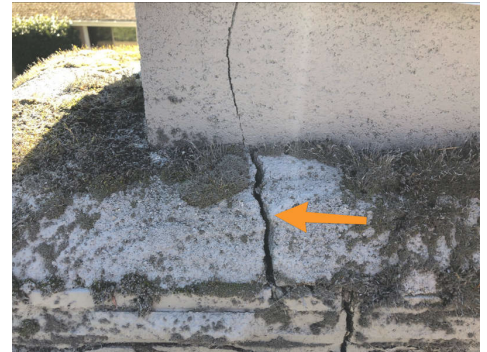
#### 4.6.3 Chimney On Roof & Photo

### **THE CROWN IS CRACKED AND SHOULD BE SEALED TO HELP PREVENT FURTHER WEAR AND MOISTURE INTRUSION**

The crown, which is designed to seal the chimney wall and shed rainwater, is cracked and should be sealed to help prevent further wear and moisture intrusion.

See Invoice For Repairs.

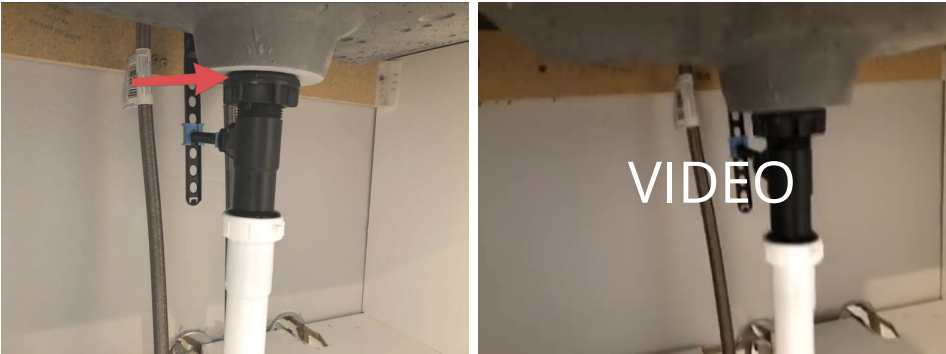
**LEAK AT DRAIN LINE BELOW THE SINK**

There is a leak at the drain line below the sink which should be repaired as necessary.  
See Invoice For Repairs.

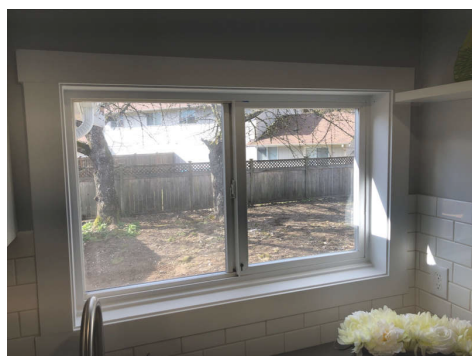
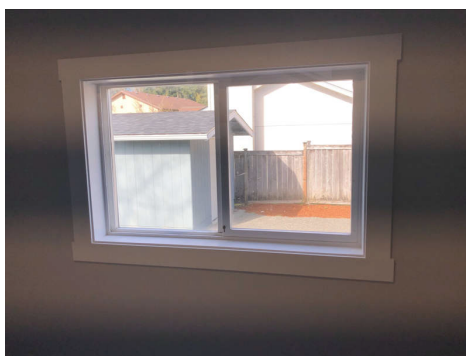
#### SCREENS DAMAGED/MISSING

Window screens were missing or damaged in one or more areas. We recommend repair or replacement as needed.

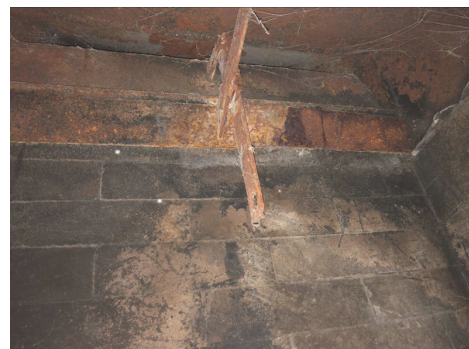
### 12.8.1 Fireplace Notes

#### THE DAMPER IS STUCK

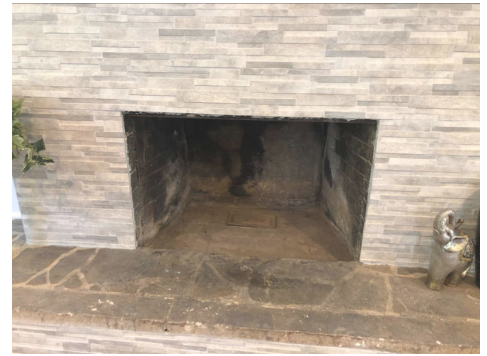
## 12.8.2 Fireplace Notes

**DOORS/SCREEN MISSING**

Contact a qualified professional.

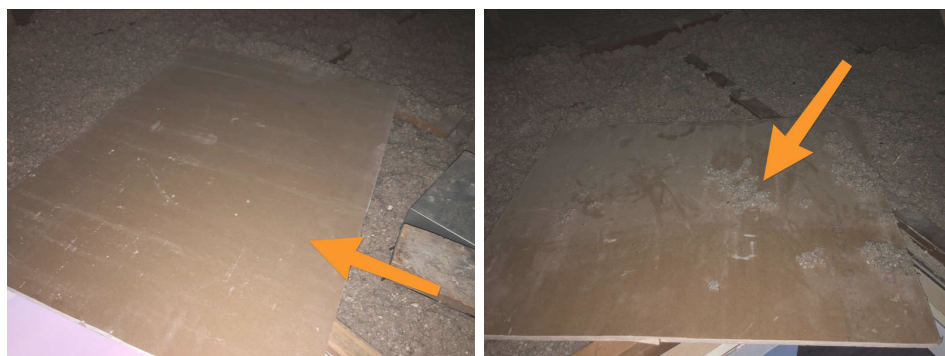
**HATCH MISSING INSULATION**

The attic access hatch was missing insulation. We recommend installing.  
See Invoice For Repairs.

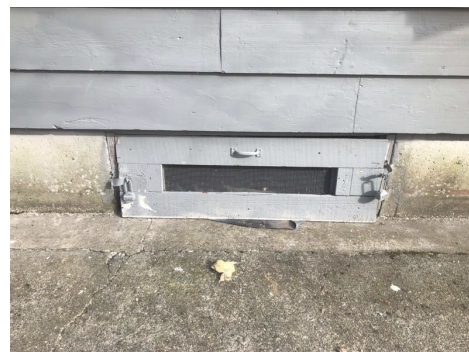
14.1.1 Crawlspace, Foundation, Structure & Basements - Crawlspace Notes: Hatch Doesn't Seal

Contact a qualified professional.

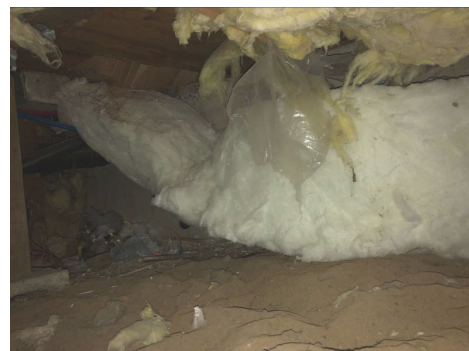
### 14.1.2 Crawlspace Notes

#### INSULATION-FALLING DOWN

Contact a qualified handyman.

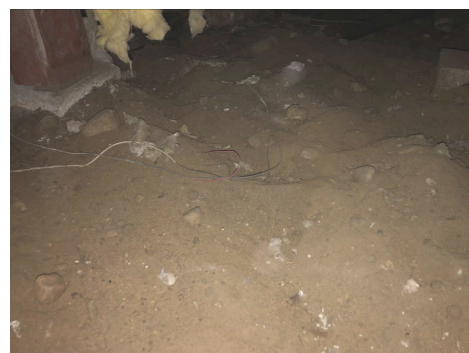
### 14.1.3 Crawlspace Notes

#### VAPOR BARRIER MISSING

Contact a qualified professional.
