# MOUNTAINS TO SOUND HOME INSPECTION LLC

## HOME INSPECTION REPORT

2715 103rd Ave Ct E  
Edgewood WA 98372

Daleen & Justin Lyle  
DECEMBER 6, 2019

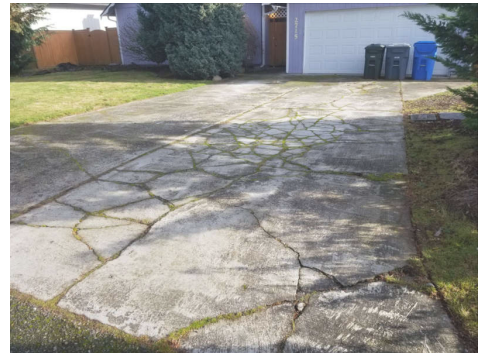
#### **MODERATE CRACKS IN DRIVEWAY**

There are a few cracks in the driveway which is mostly cosmetic but you may want to view for yourself and repair as necessary.

Recommend monitoring.

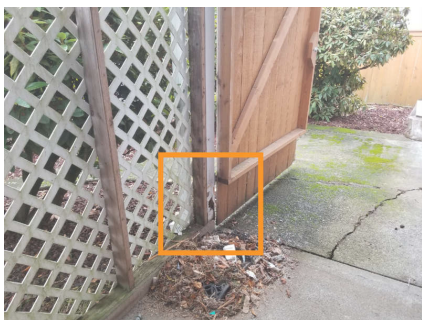
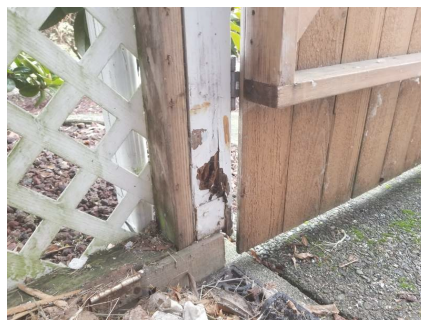
### 3.3.1 Site & Other Observations

#### **WALKWAY ENCLOSURE DETERIORATED**

One or more sections of the walkway enclosure structure had damage. Recommend evaluation and repair.

Contact a qualified professional.

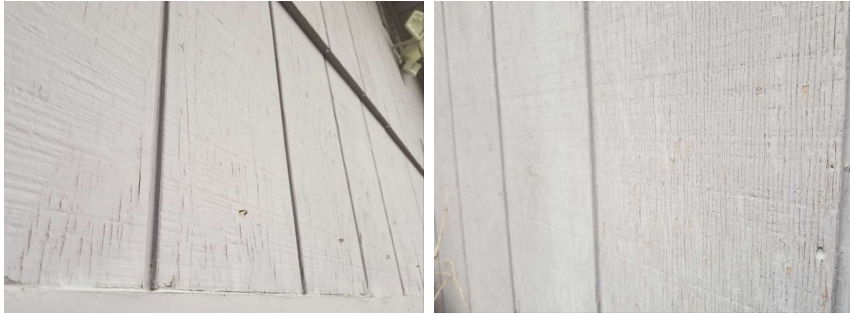
### 3.5.1 Exterior Siding Notes

#### **WEATHERED SIDING**

The exterior siding is slightly weathered in sections. Maintenance and minor repairs are recommended.

Contact a qualified professional.

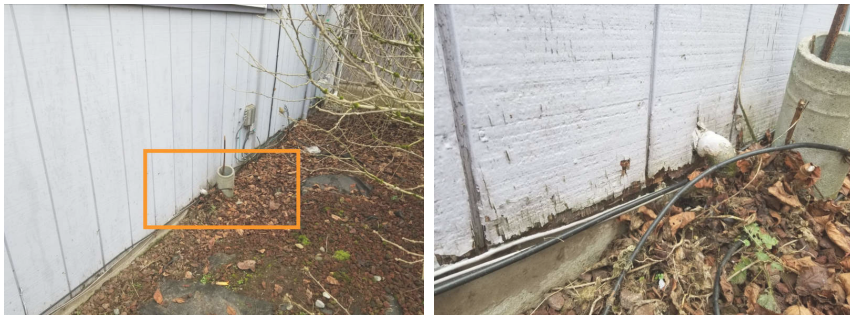
### 3.5.2 Exterior Siding Notes

#### MOISTURE DAMAGE

Portions of the siding were previously moisture moisture damaged and should be further evaluated by a contractor.

Contact a qualified siding specialist.

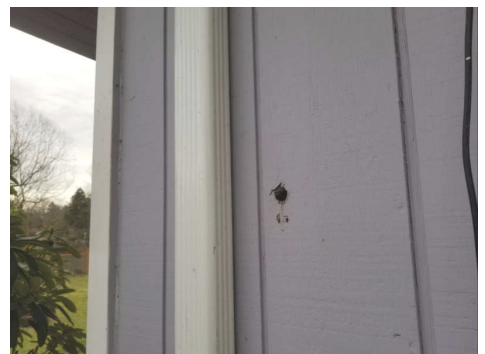
### 3.5.3 Exterior Siding Notes

#### SEAL PENETRATIONS/GAPS

Gaps and/or holes were observed on one or more sides in the siding around plumbing, gas, cable, wiring and/or other penetrations. We advise that all the holes and the gaps be caulked and/or sealed to prevent moisture and/or pest intrusion.

Contact a qualified professional.

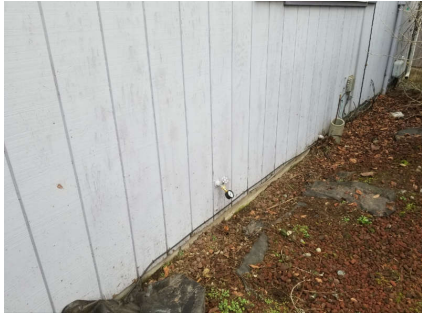
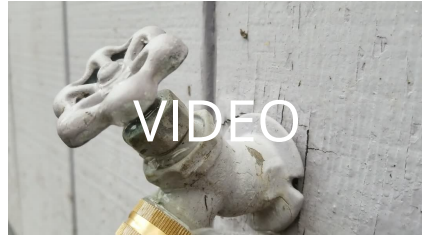
### 3.8.1 Exterior Plumbing

#### HOSE BIB LEAKS WHILE IN USE

The hose bib leaks at the handle while in use and you may want to have it repaired or replaced by a licensed professional. Sometimes they just need to be tightened.

Contact a qualified handyman.

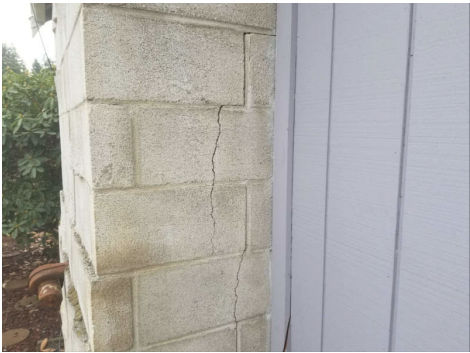
### 3.14.1 Exterior Chimney

#### **LOOSE MORTAR/CRACKS**

The exposed sections of the exterior of the chimney needs re-pointing. We recommend the cracking also be evaluated and patched.

Recommendation  
Contact a qualified professional.

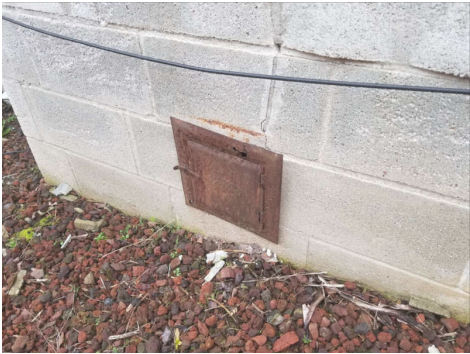
3.14.2 Exterior Chimney

ASH CATCH DOOR ERODED

The metal door for the ash catch basin was eroded. Recommend repair or replacement to prevent pest or weather intrusion.

Recommendation  
Contact a qualified professional.

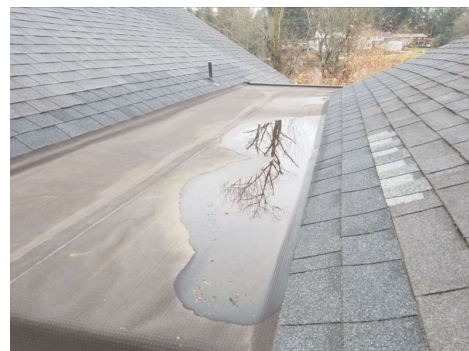
One or more areas of water pooling on the roof was observed. We recommend further evaluation and repairs as needed.

Note: Flat roofed section was covering an exterior walkway.

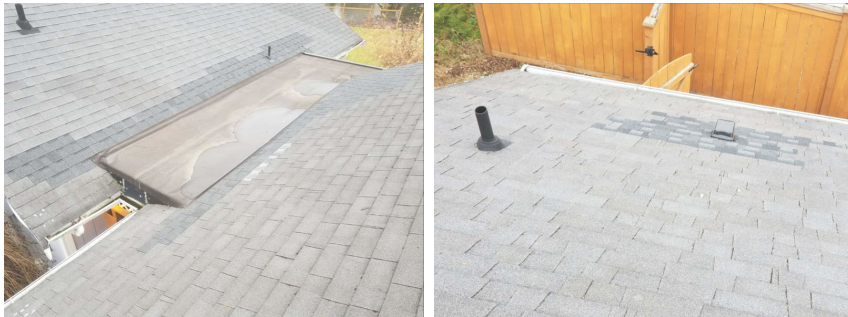
## 4.4.1 General Observations

Repairs and/or patches have been made to the roofing material in several areas. We cannot determine the reason or condition of the repairs. Monitoring is advised for future issues or conditions. An additional evaluation of the roof would be appropriate.

Contact a qualified professional.

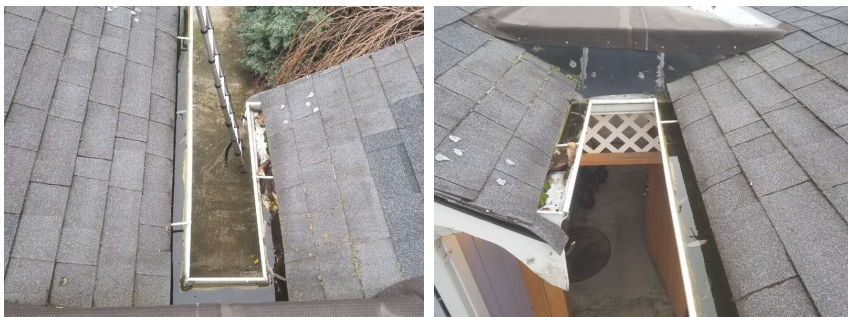
## 4.6.1 Gutters &amp; Drainage

The gutters did not have a proper slope to drain the water towards the downspouts. Recommend repairs to ensure proper drainage.

Contact a qualified professional.

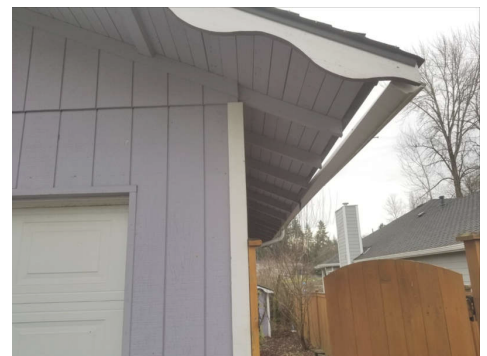
## 4.6.2 Gutters &amp; Drainage

Medium Priority**GUTTERS LOOSE**

A section or sections of the gutter were loose and/or not secured to the fascia board or rafter tails. We recommend that any loose gutters be properly secured.

Contact a qualified professional.

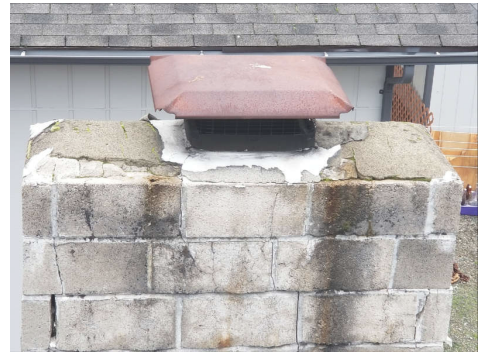
## 4.7.1 Chimney On Roof &amp; Photo

**CROWN DETERIORATED**

The crown, which is designed to seal the chimney wall and to shed rainwater, is washed out or deteriorated and should be repaired or replaced.

Contact a qualified masonry professional.

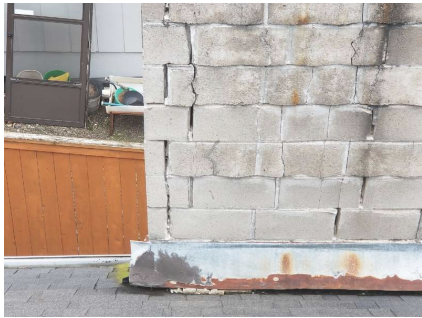
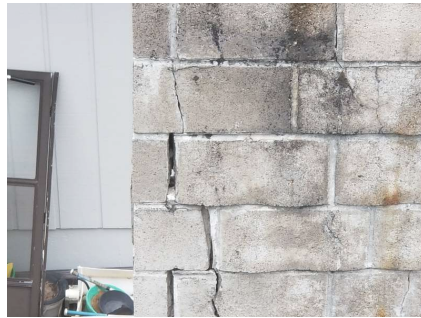
## 4.7.2 Chimney On Roof &amp; Photo

**CHIMNEY CRACKED**

There were moderate cracks observed on the chimney structure. Recommend evaluation and repair by a qualified professional.

Contact a qualified professional.

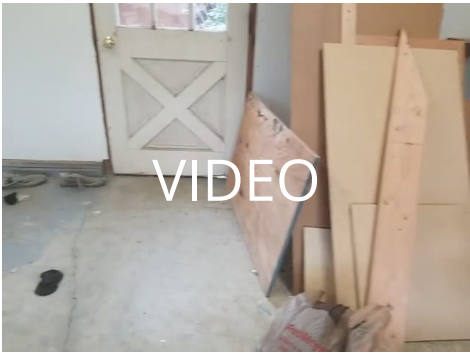
**FULL OF STORAGE SLAB BLOCKED**  
The garage is too full of storage to permit a clear view of the entire slab. I recommend evaluating the floor yourself once the storage is removed.

Recommendation  
Recommended DIY Project

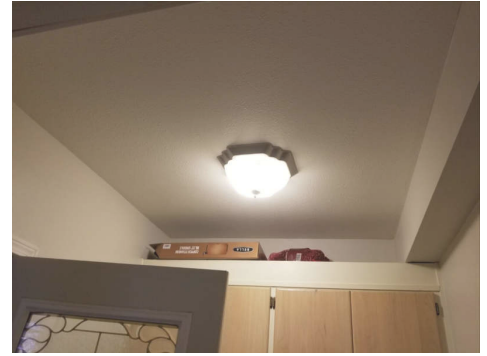
#### **NO EXHAUST FAN OR OPENABLE WINDOW**

There is not a laundry exhaust fan or openable window installed within this laundry room. Adding one is recommended and typically required to help disperse excessive moisture from the laundry room.

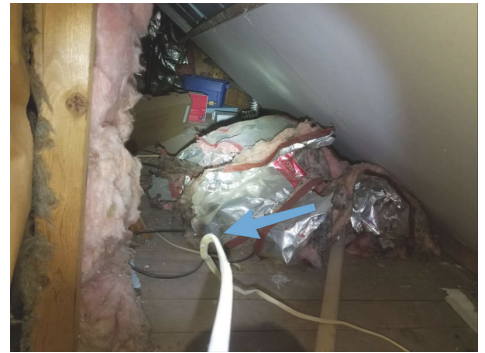
There is unprotected electrical conduit within six feet of the attic access that is typically required to be shielded to prevent damage or a trip-hazard, and which you may wish to have it serviced to comply.
