PRO SPEX RESIDENTIAL FRAMING INSPECTION

15503 Sample Report Rd
LAUREL MD 20707

JULY 10, 2018

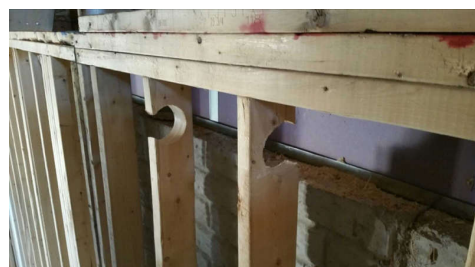
2.1.1 WALLS (Structural) 2

The load bearing wall does not provide adequate support for the load above. Recommend contractor review approved construction drawings and correct as needed.

Contact a qualified professional.

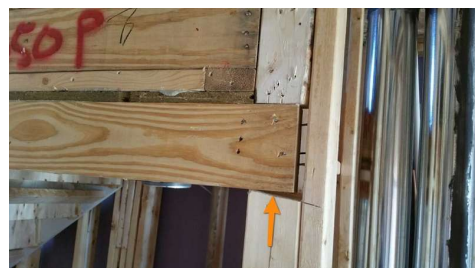
2.2.1 WALLS (Structural) 3

The load bearing wall does not provide adequate support for the load above. Recommend contractor review approved construction drawings and correct as needed.

Contact a qualified professional.

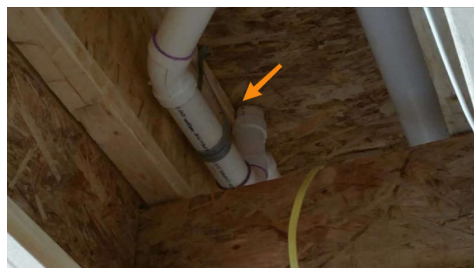
Above door leading to garage

The floor structure has been compromised in 4 locations. The top and bottom of engineered floor joists cannot be modified in any way. These joists must be evaluated by a licensed structural engineer. Adequate documentation of the engineers findings must be provided for each joist.

Contact a qualified professional.

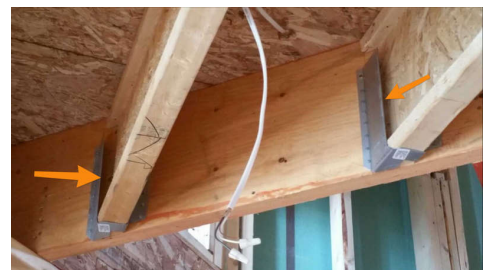
2nd Floor

When joist hanger does not extend to the top flange of an engineering wood I-beam web stiffeners are required

Contact a qualified professional.

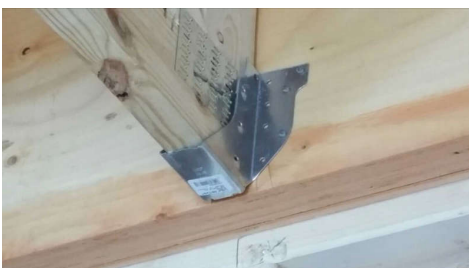
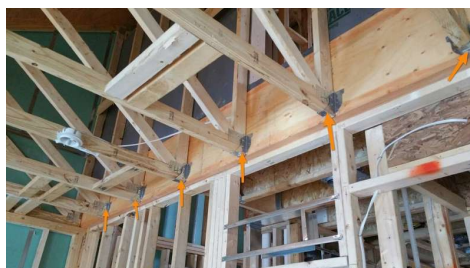
2.8.1 ROOF STRUCTURE AND ATTIC

All truss hangers should be fully nailed.

Contact a qualified professional.

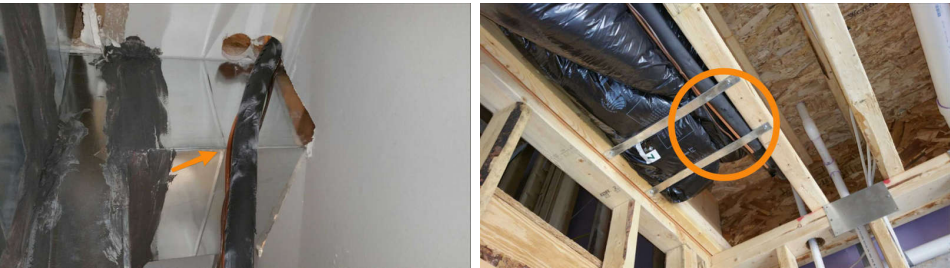
3.1.1 Cooling System

Copper and aluminum when in direct contact can result in degradation of the metals, a process called galvanic reaction. Because of this, copper and aluminum should not make direct contact.

Recommendation
Contact a qualified professional.

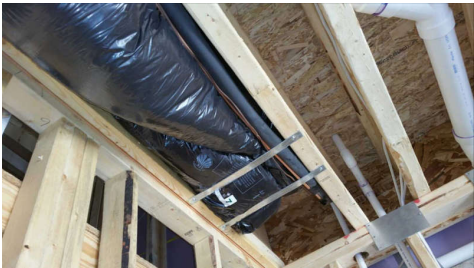
Above first floor storage closet

When installed, flex ducts should not be crimped or squashed and sharp turns should be avoided. Crimping and sharp turn reduce air flow and will affect system performance.

Recommendation
Contact a qualified professional.
