THE SALLADE'S INSPECTION SERVICES

PHASE 2 (PRE INSULATION & DRYWALL)

Phase 2 Example
Godley, TX 76044

Mr & Mrs Texan
JULY 8, 2022

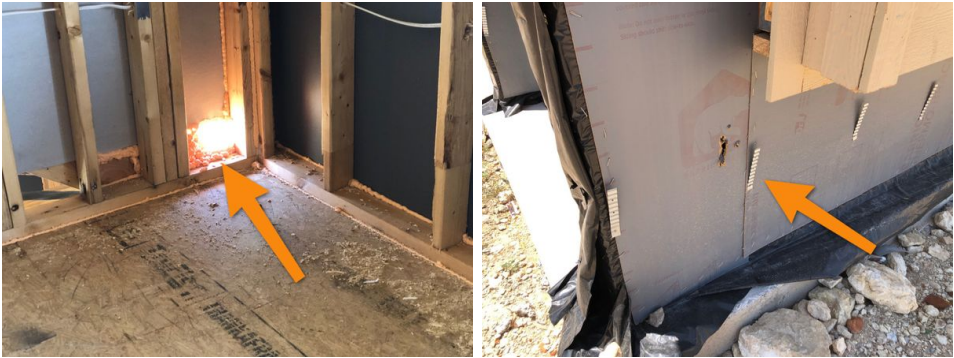
2ND FL GAMEROOM & RIGHT SIDE

HOLES IN SHEATHING

- Holes were observed in the exterior sheathing at the time of inspection. All holes should be repaired to prevent water intrusion into the wall cavity/home.

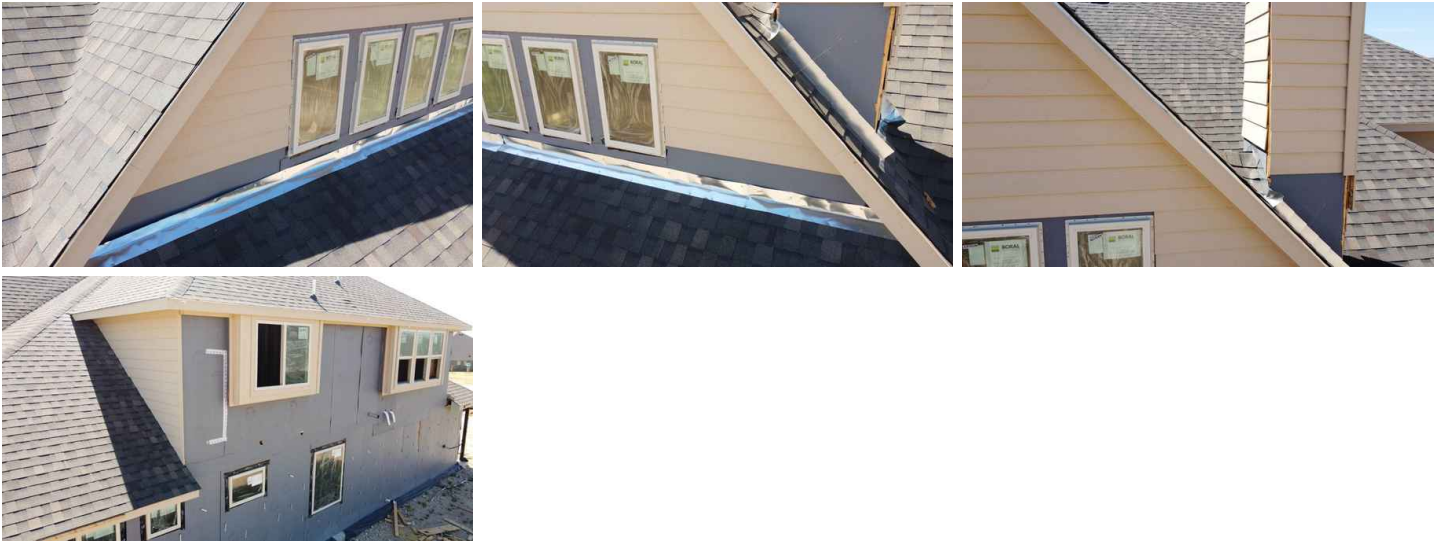
SIDING NOT INSTALLED YET

- Not all of the Siding has been installed yet on the home.

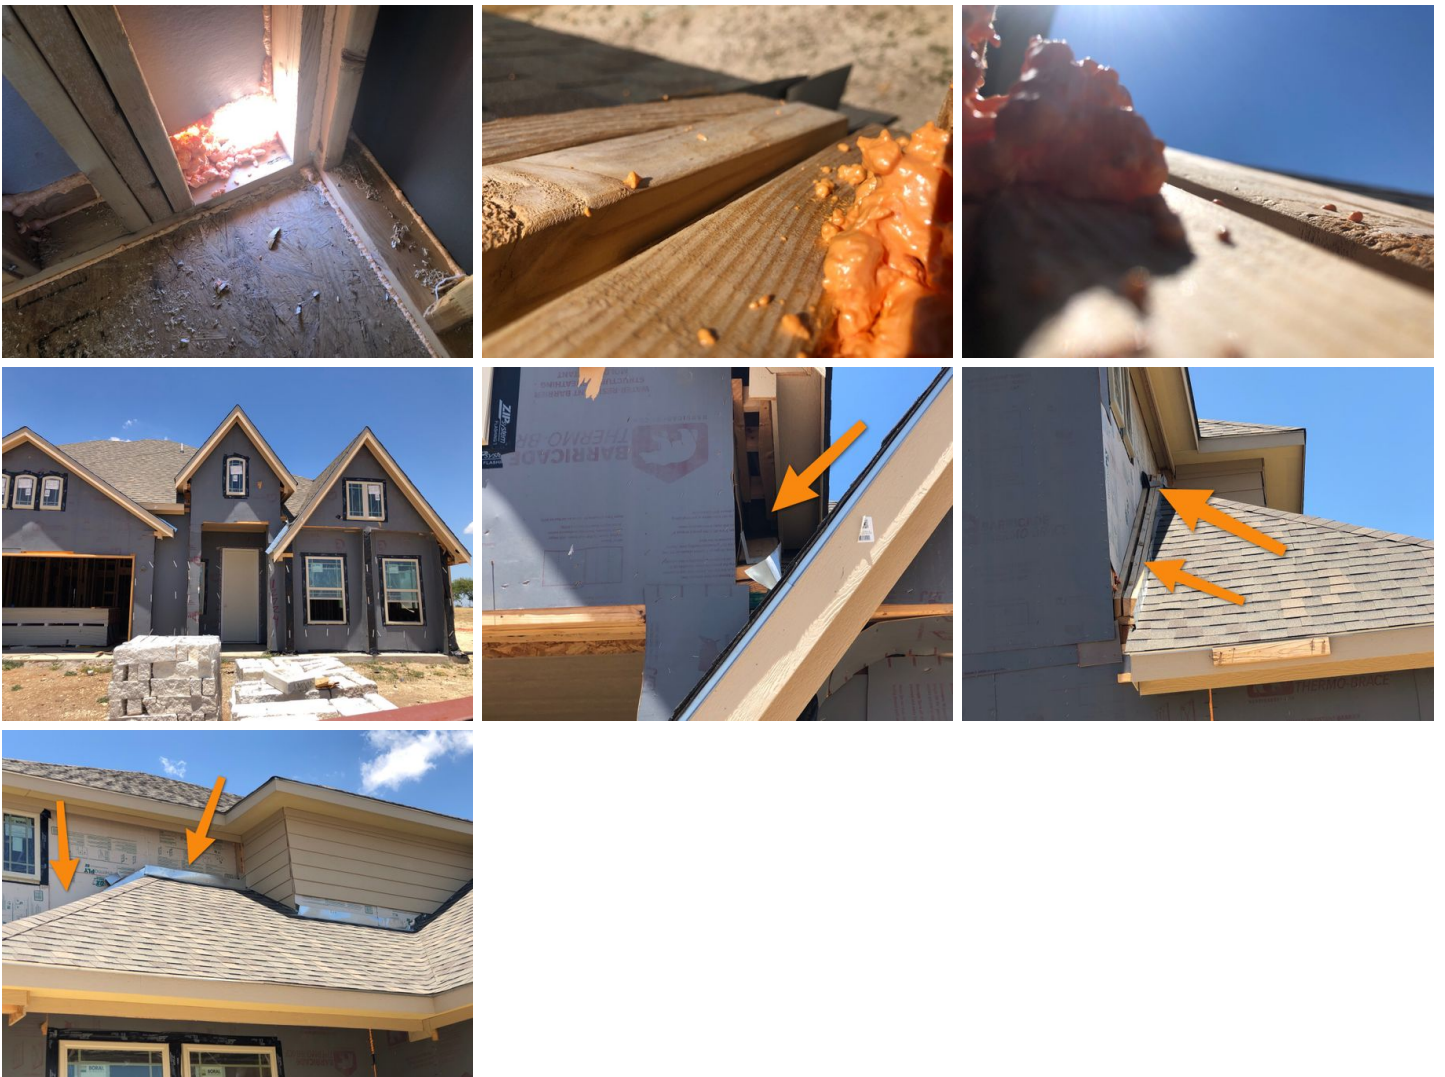
RIGHT OF THE FRONT ENTRY

FLASHING NEEDED FOR WOODEN BRICK LEDGES

A channel type flashing is needed for the triple rafter wooden brick ledges

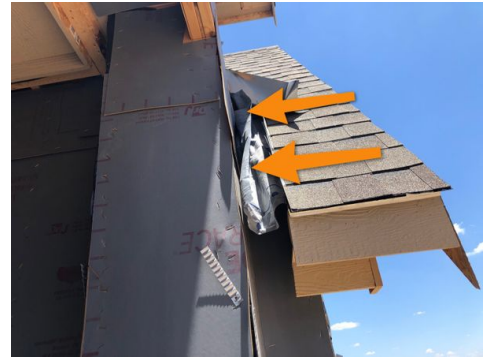
RIGHT OF FRONT ENTRY

FLASHING NOT TAPED TO WALL

The Tyvek type roof flashing used as a Chanel flashing for the triple rafters brick ledge should be taped to the wall.

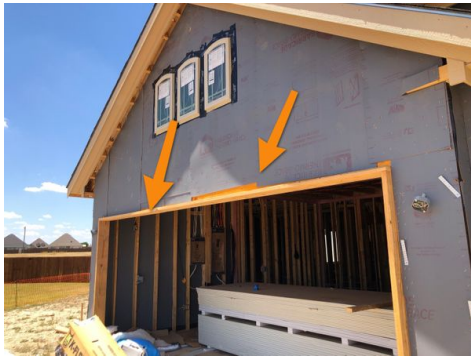
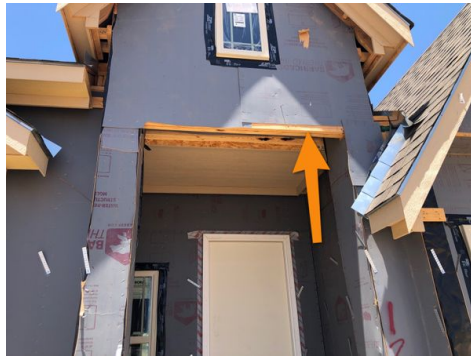
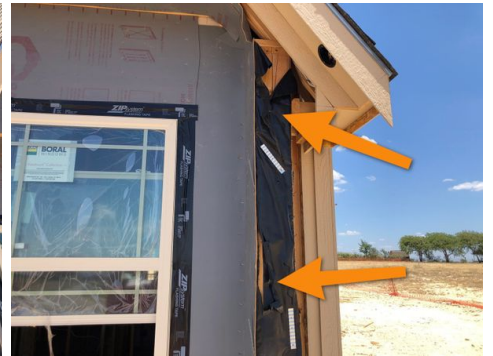
EXPOSED WOOD

Any exposed wood around the exterior of the home should be covered and or taped.

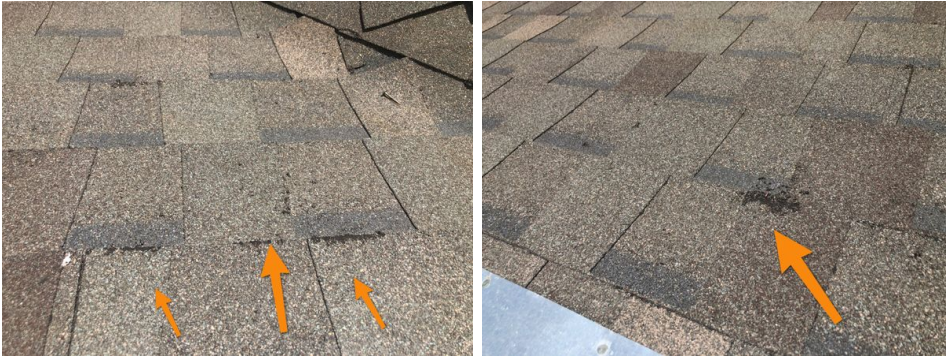
RIGHT SIDE

ABRASION DAMAGE

- Abrasion damage was observed in various locations of the roof covering. Some of this damage occurs during the installation process on Hot days. It is recommended that all damaged shingles be replaced at a time when temperatures are cooler

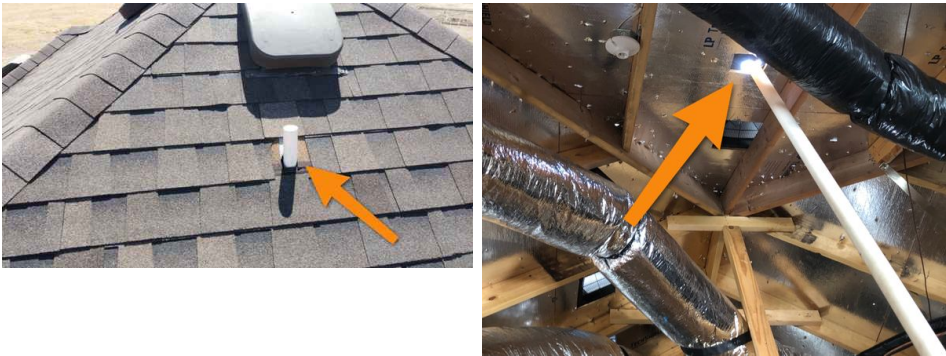
ROOF BOOT NEEDED

- A roof boot is absent or missing and should be installed before it rains.

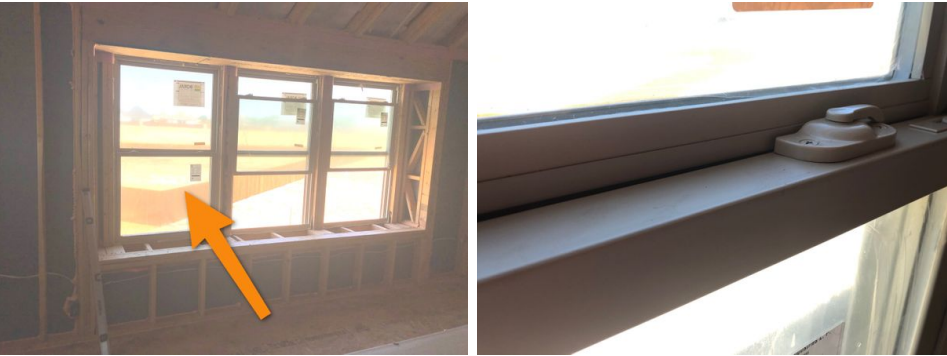
LEFT WINDOW IN SEXOND FLOOR GAMEROOM

WINDOW NOT SQUARE

One or more of the windows were observed to be out of square and not latching properly on one side or the other. The window should be adjusted so that the gap for the window latches is even and the windows are plumb and level.

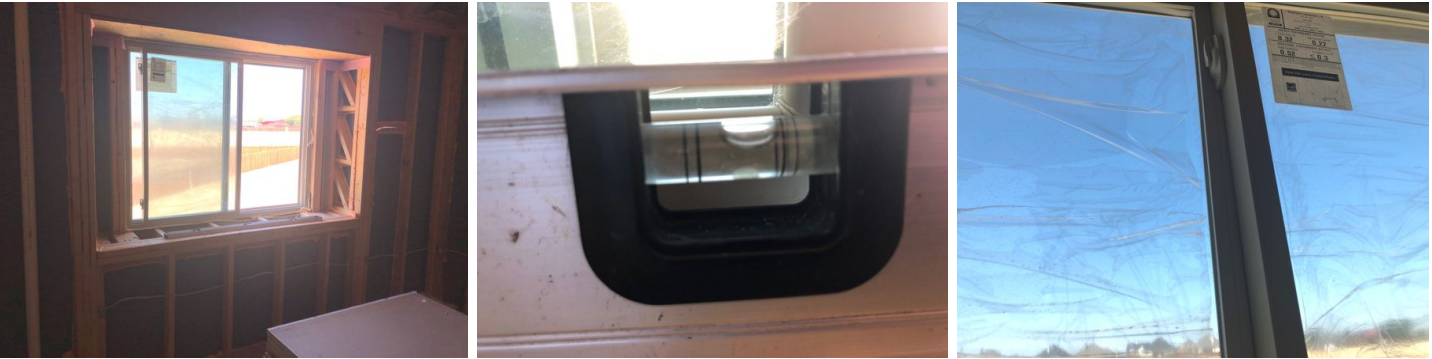
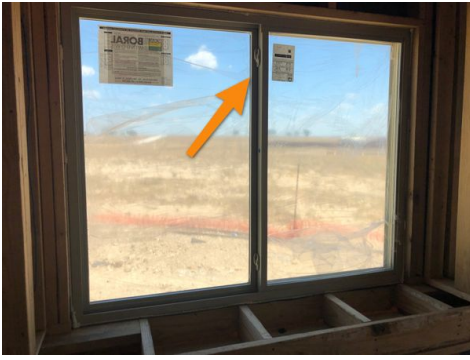
2ND FL LEFT REAR BEDROOM & 1ST FL RIGHT FRONT BEDROOM

WINDOW NOT LEVEL

One or more of the windows were measured to be out of level. The Chanel or gap for the window latches was uneven and the window was difficult to latch. The window should be adjusted so it closes and latches easily and so that the window is level and plumb.

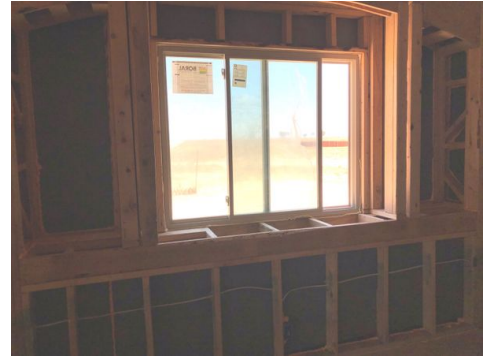
1ST FL RIGHT REAR BEDROOM

DOESNT CLOSE EASILY

One or more of the windows were observed to be difficult to close.

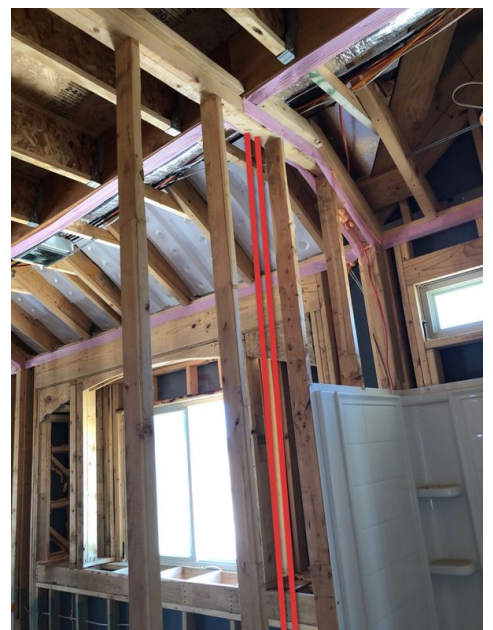
1ST FL RIGHT HALLWAY BATHROOM

DOUBLE BEAM NOT PROPERLY SUPPORTED

- The double beam was not properly supported with double studs. Another stud should be added to complete the load path.

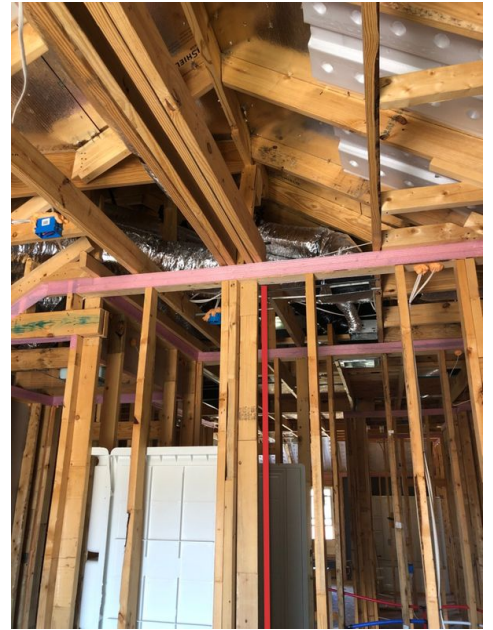
2ND FL RIGHT BEDROOM

DOUBLE BEAM NOT PROPERLY SUPPORTED

- The double beam was not properly supported with double studs. Another stud should be added to complete the load path.

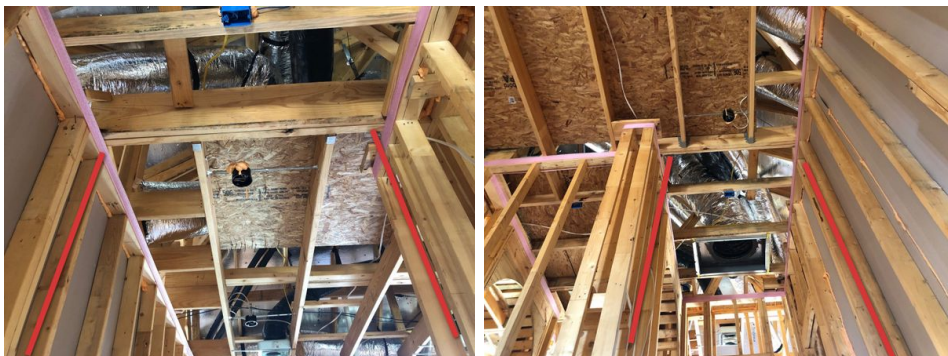
TOP OF THE STAIRWAY

DOUBLE BEAM NOT PROPERLY SUPPORTED

- The double beam was not properly supported with double studs. Another stud should be added to complete the load path.

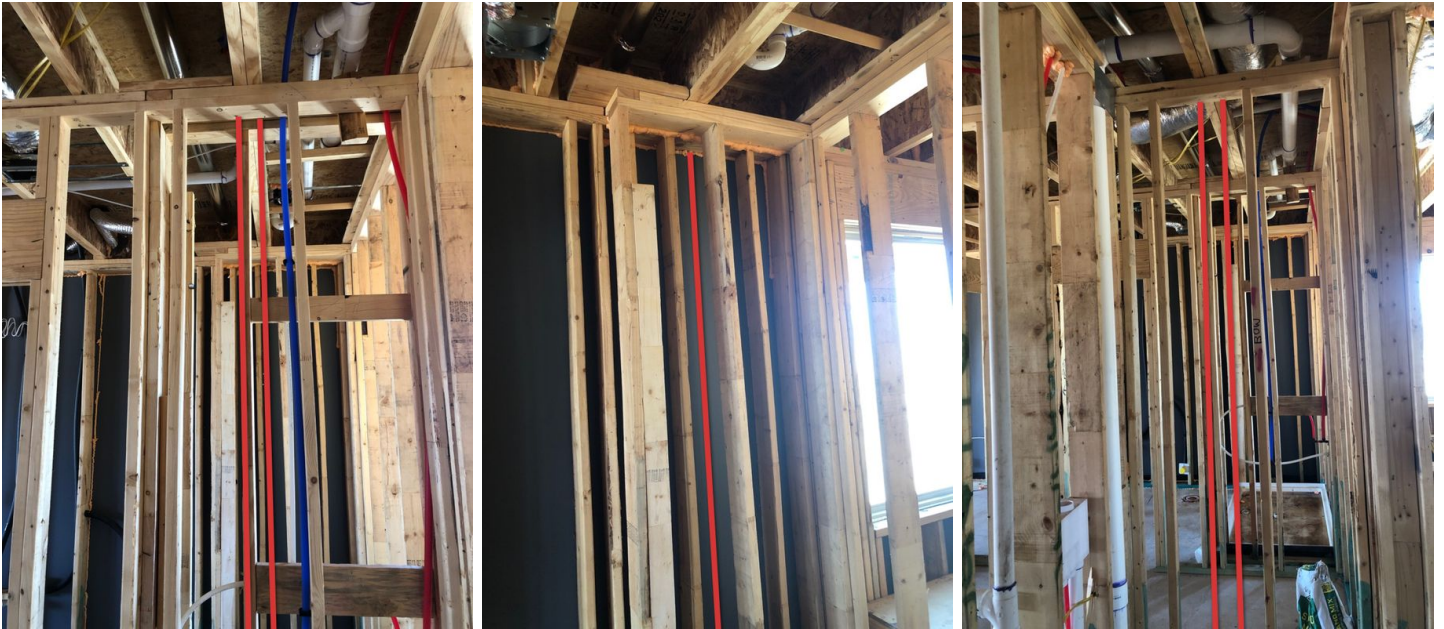
MASTER CLOSET & 1ST FLOOR LEFT SIDE CLOSET AND BATHROOM

DOUBLE BEAM NOT PROPERLY SUPPORTED

- The double beam was not properly supported with double studs. Another stud should be added to complete the load path.

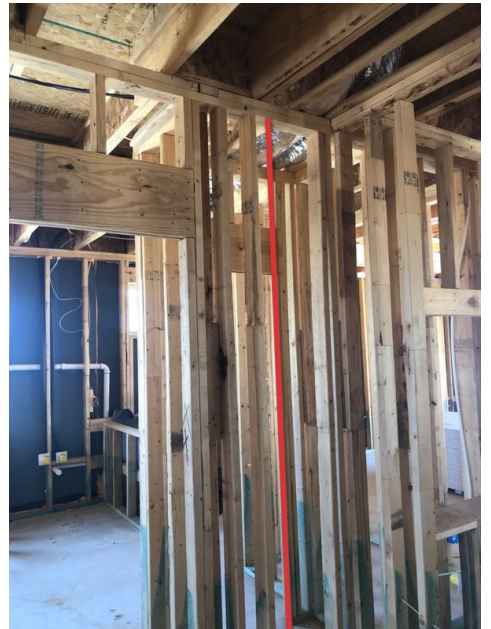
MASTER CLOSET

DOUBLE BEAM NOT PROPERLY SUPPORTED

- The double beam was not properly supported with double studs. Another stud should be added to complete the load path.

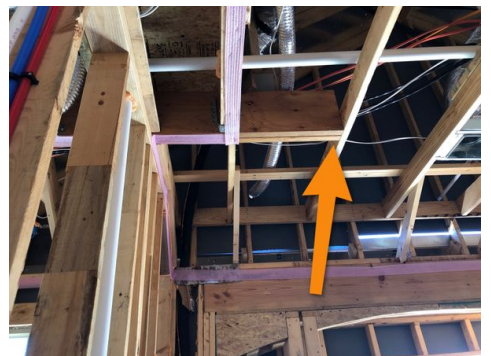
JOIST HANGERS NEEDED

- Joist hangers are needed . The hangers should be properly installed and fully nailed.

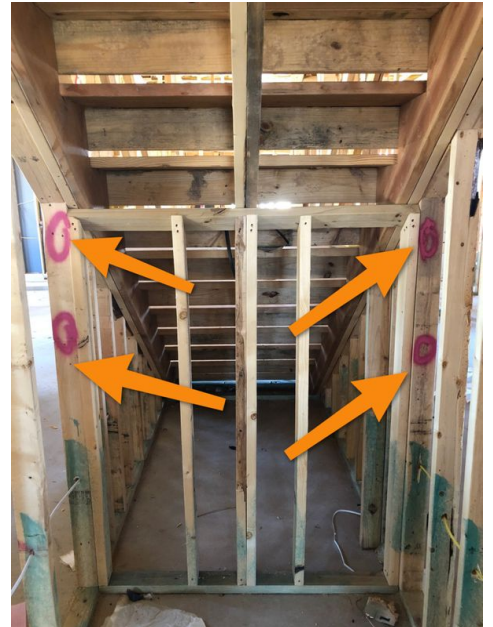
UNDERSTAIR CLOSET

DEAD BLOCKS NEEDED

- Dead blocks are needed in the corners to give a nailing surface for the sheetrock.

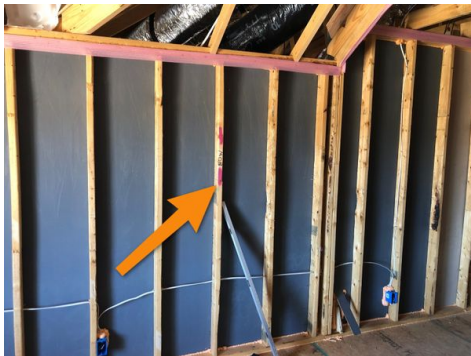
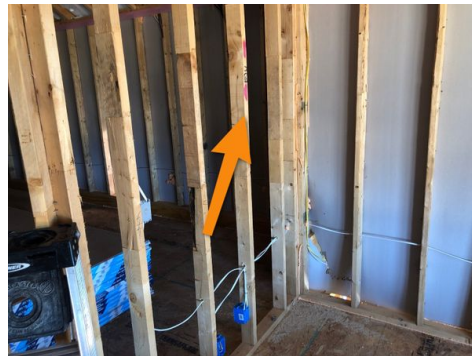
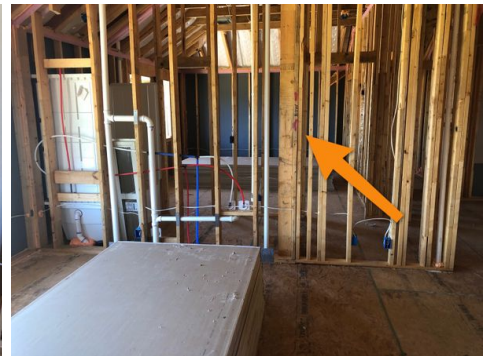
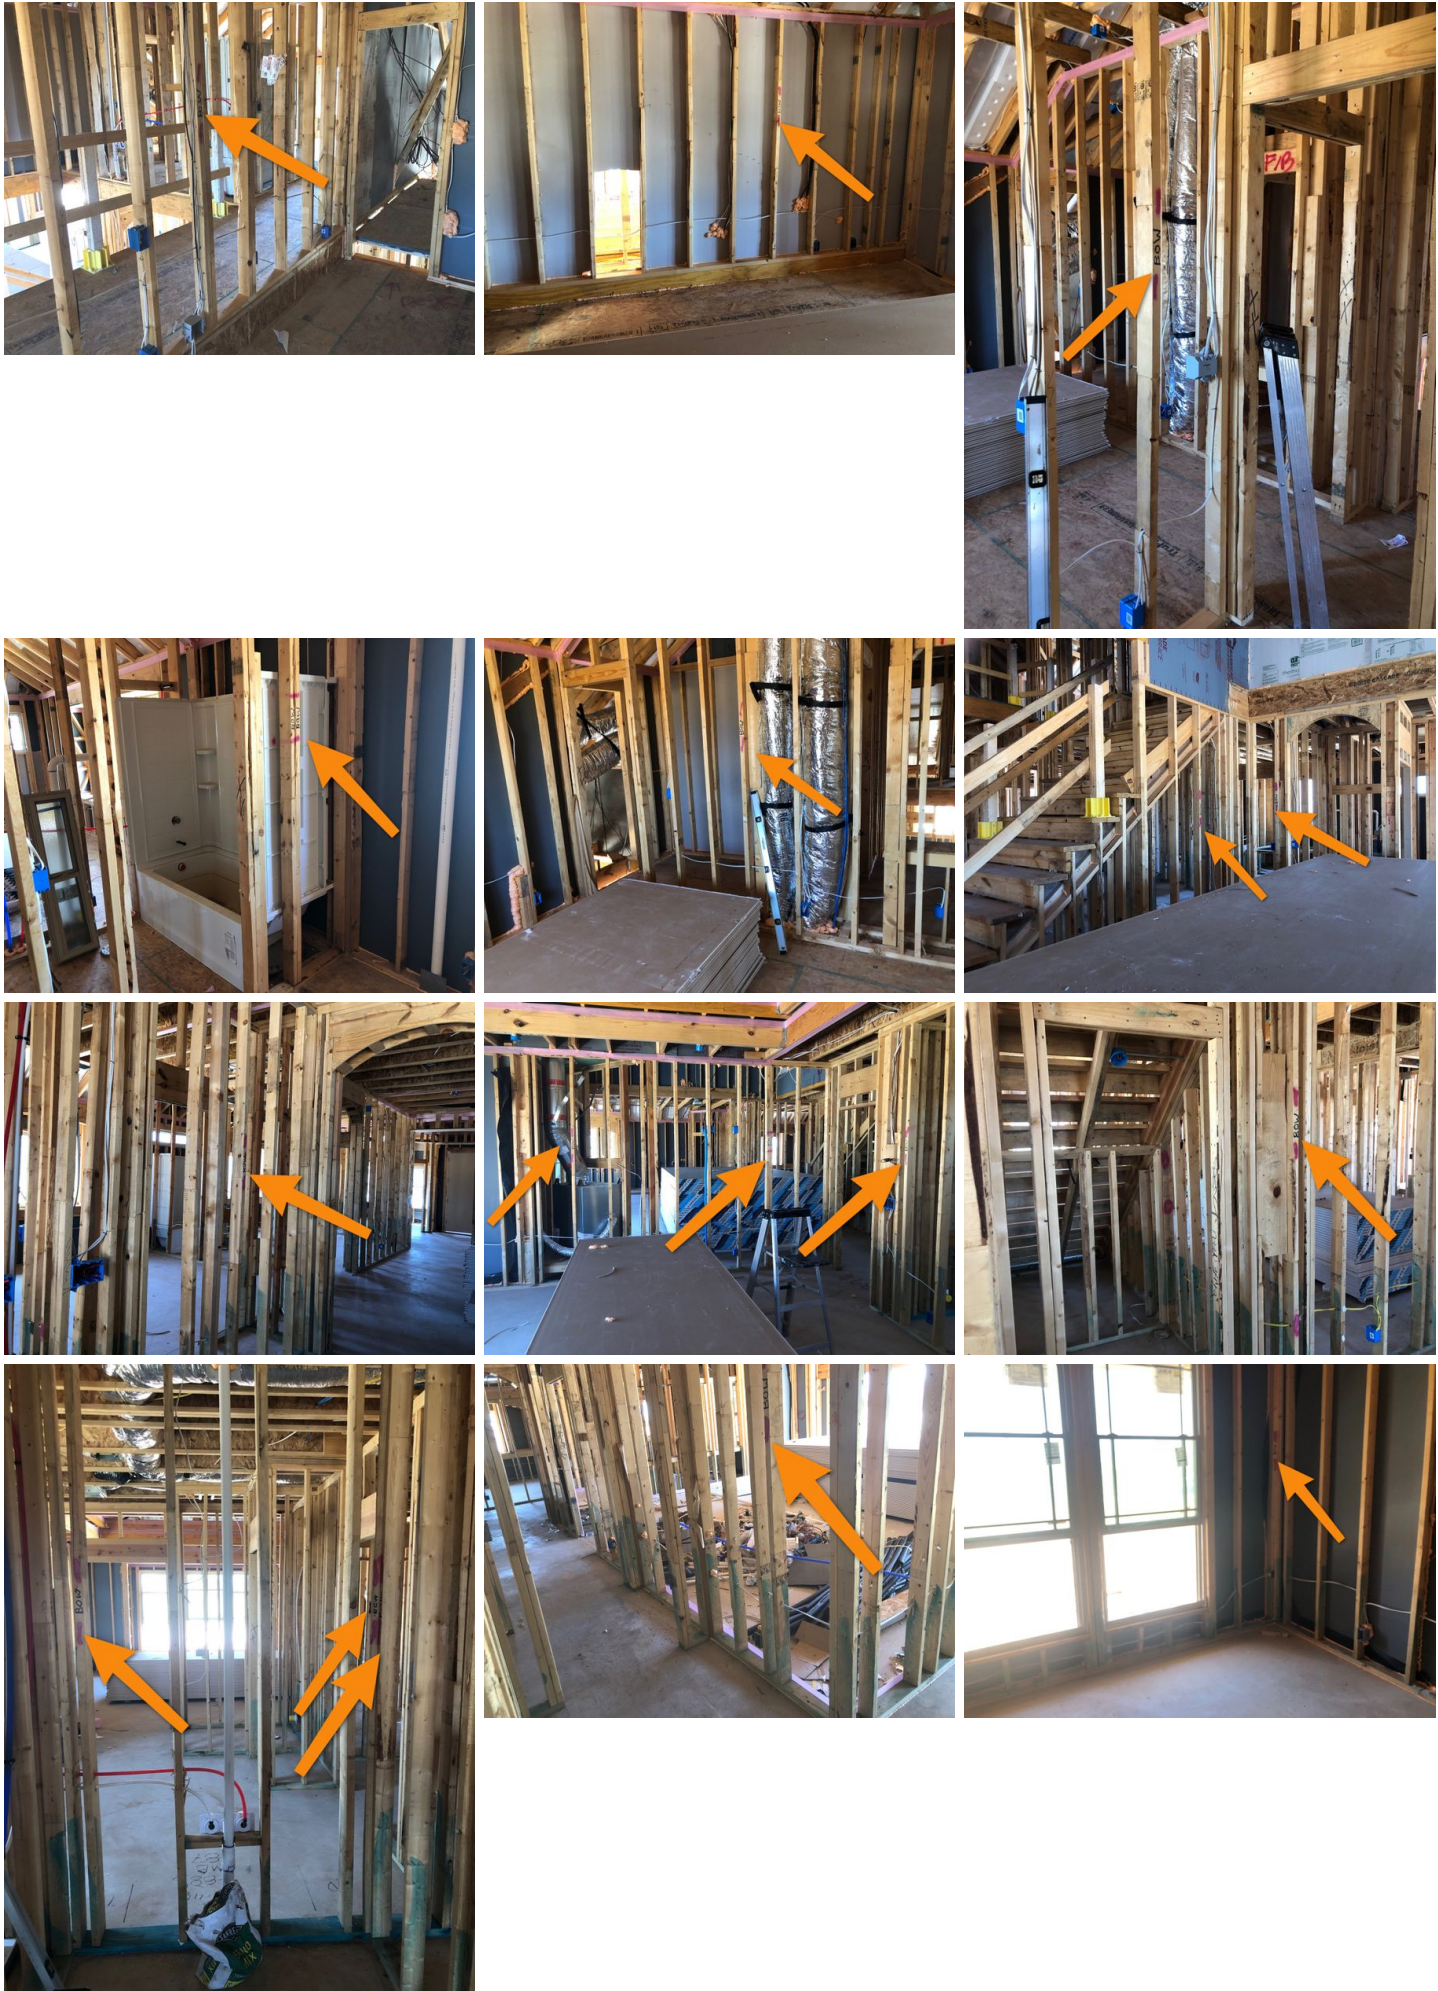
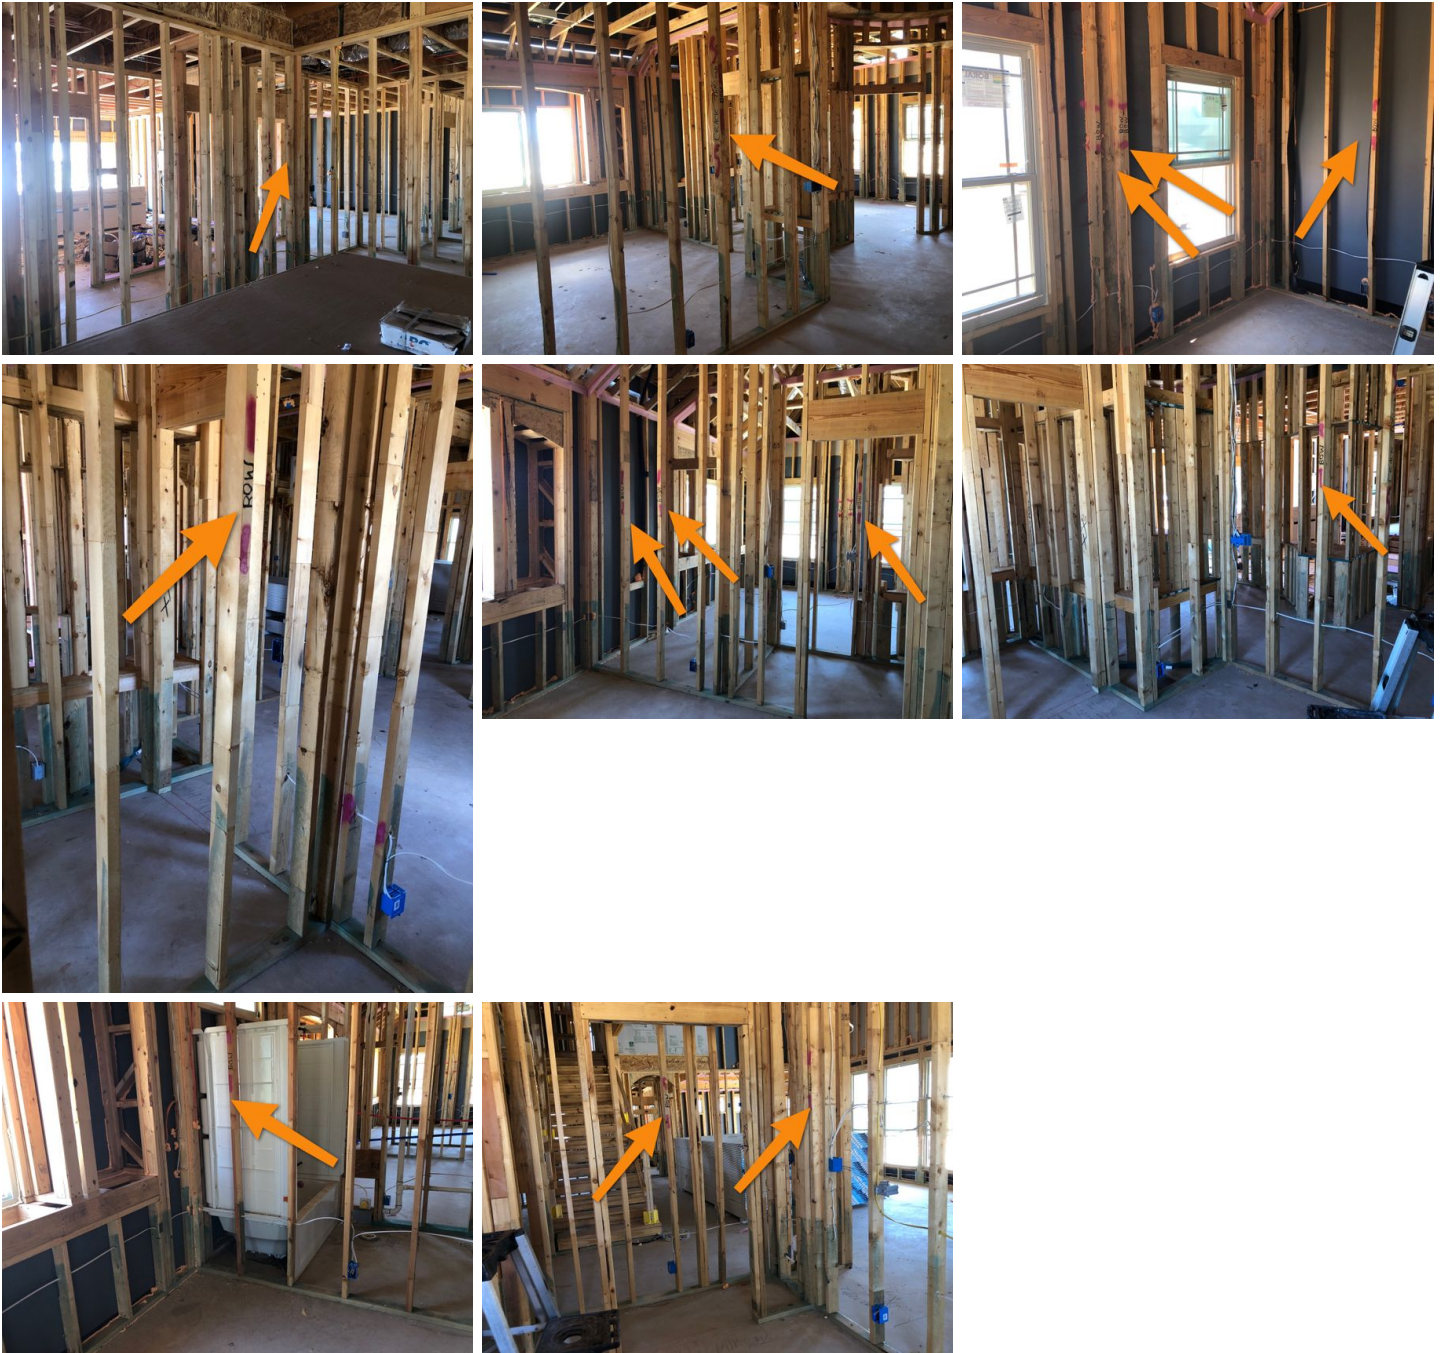
BOWED STUD

Bowed stud observed. The stud should be straightened or replaced as necessary.

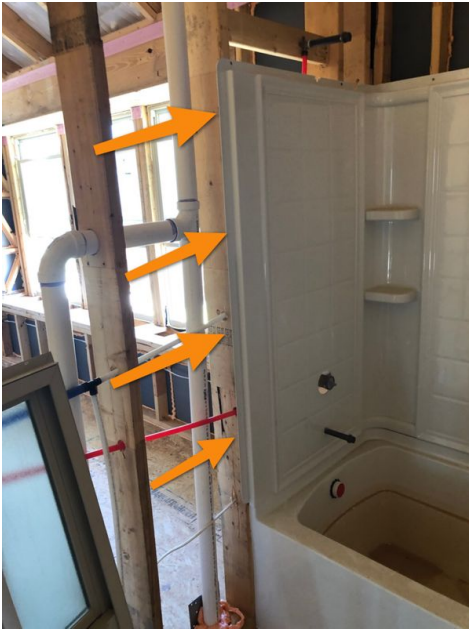
2ND FL LEFT HALLWAY BATHROOM

TUB BLOCKS NEEDED

Studs are needed at the edge of the tub / tub walls to better support the drywall that will be installed.

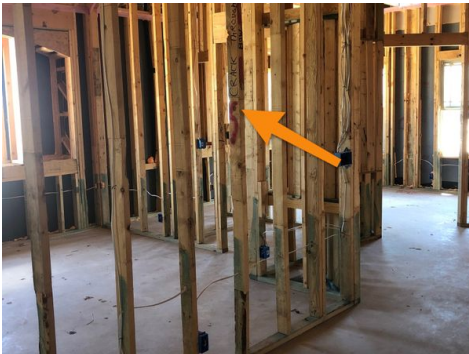
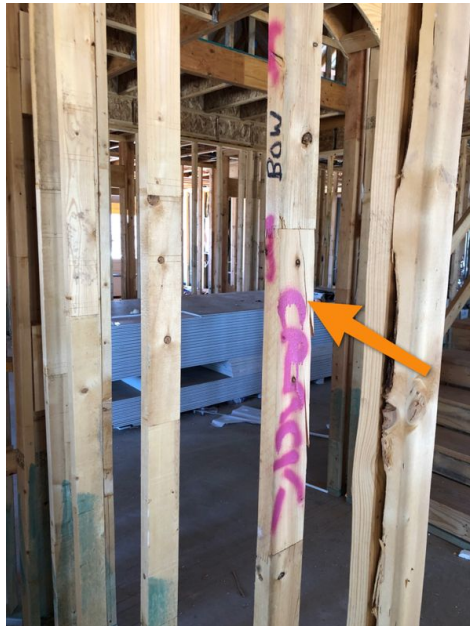
ENTRY HALLWAY & 1ST FL FRONT REAR BEDROOM

STUD CRACKED THROUGH

One or more studs were cracked through and should be replaced or sisters for strength reasons.

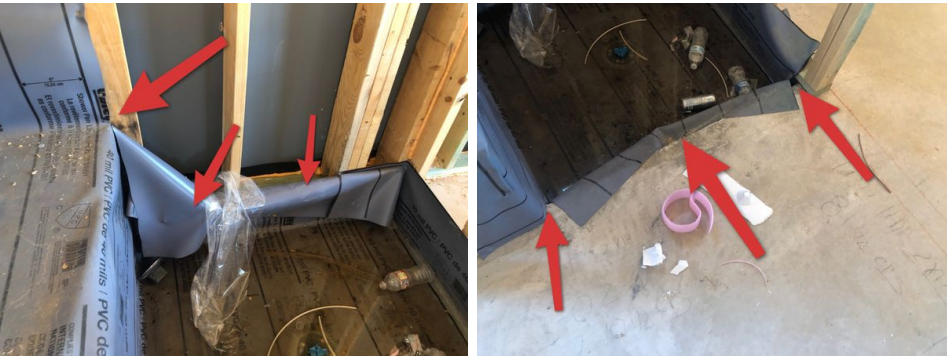
MASTER BATHROOM

SHOWER LINER DAMAGED

The shower pan liner was observed to be torn or damaged and should be repaired / re-sealed to help prevent future water intrusion.

Safety Hazard

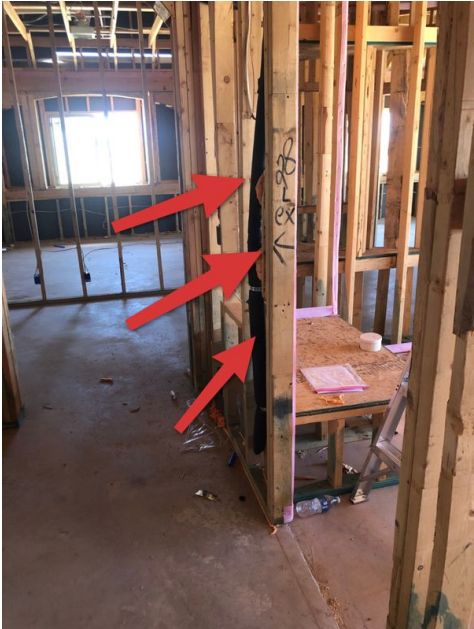
GARAGE HALLWAY

PROTRUDING PIPES

One or more plumbing pipes were observed to be sticking out of the wall cavity and should be corrected.

Safety Hazard

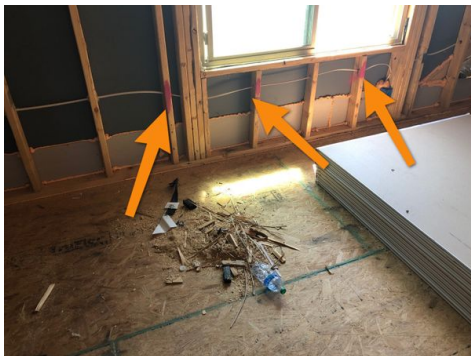
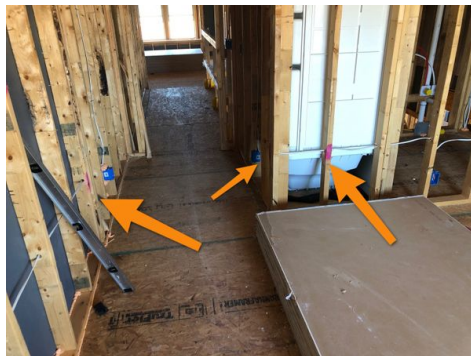
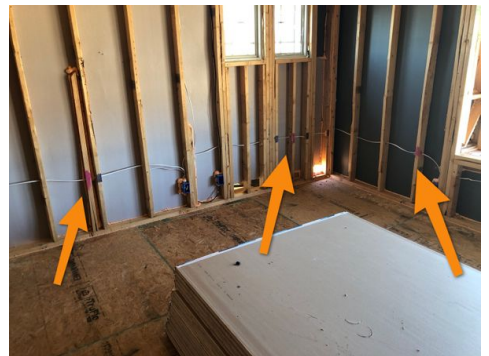
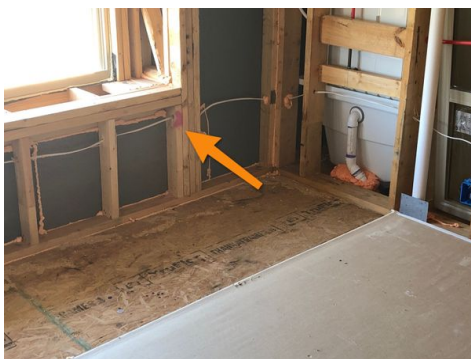
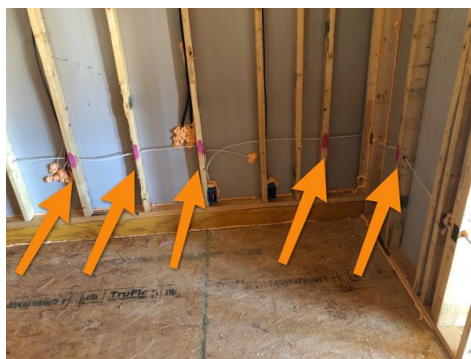
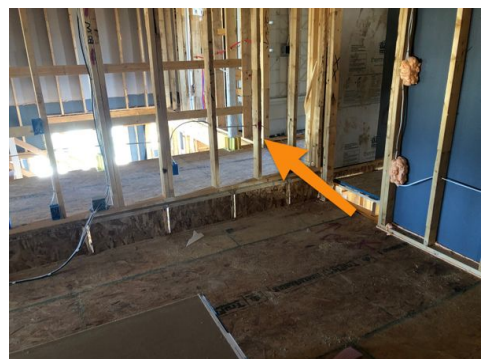
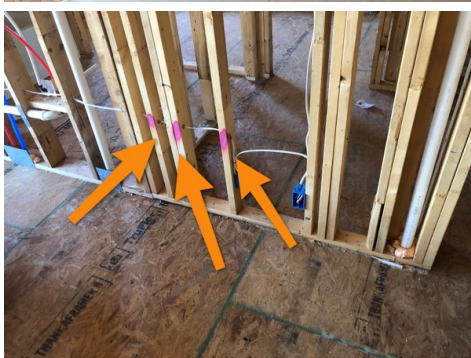
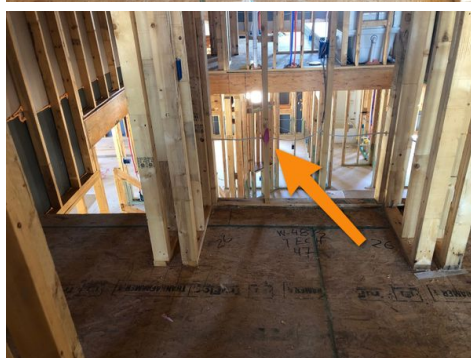
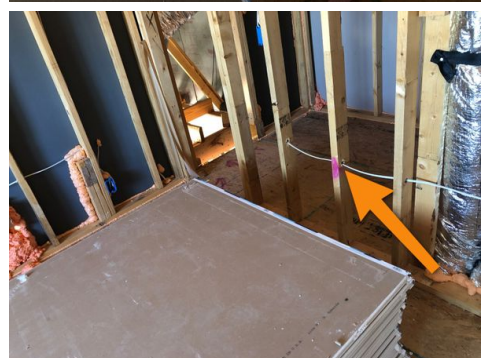
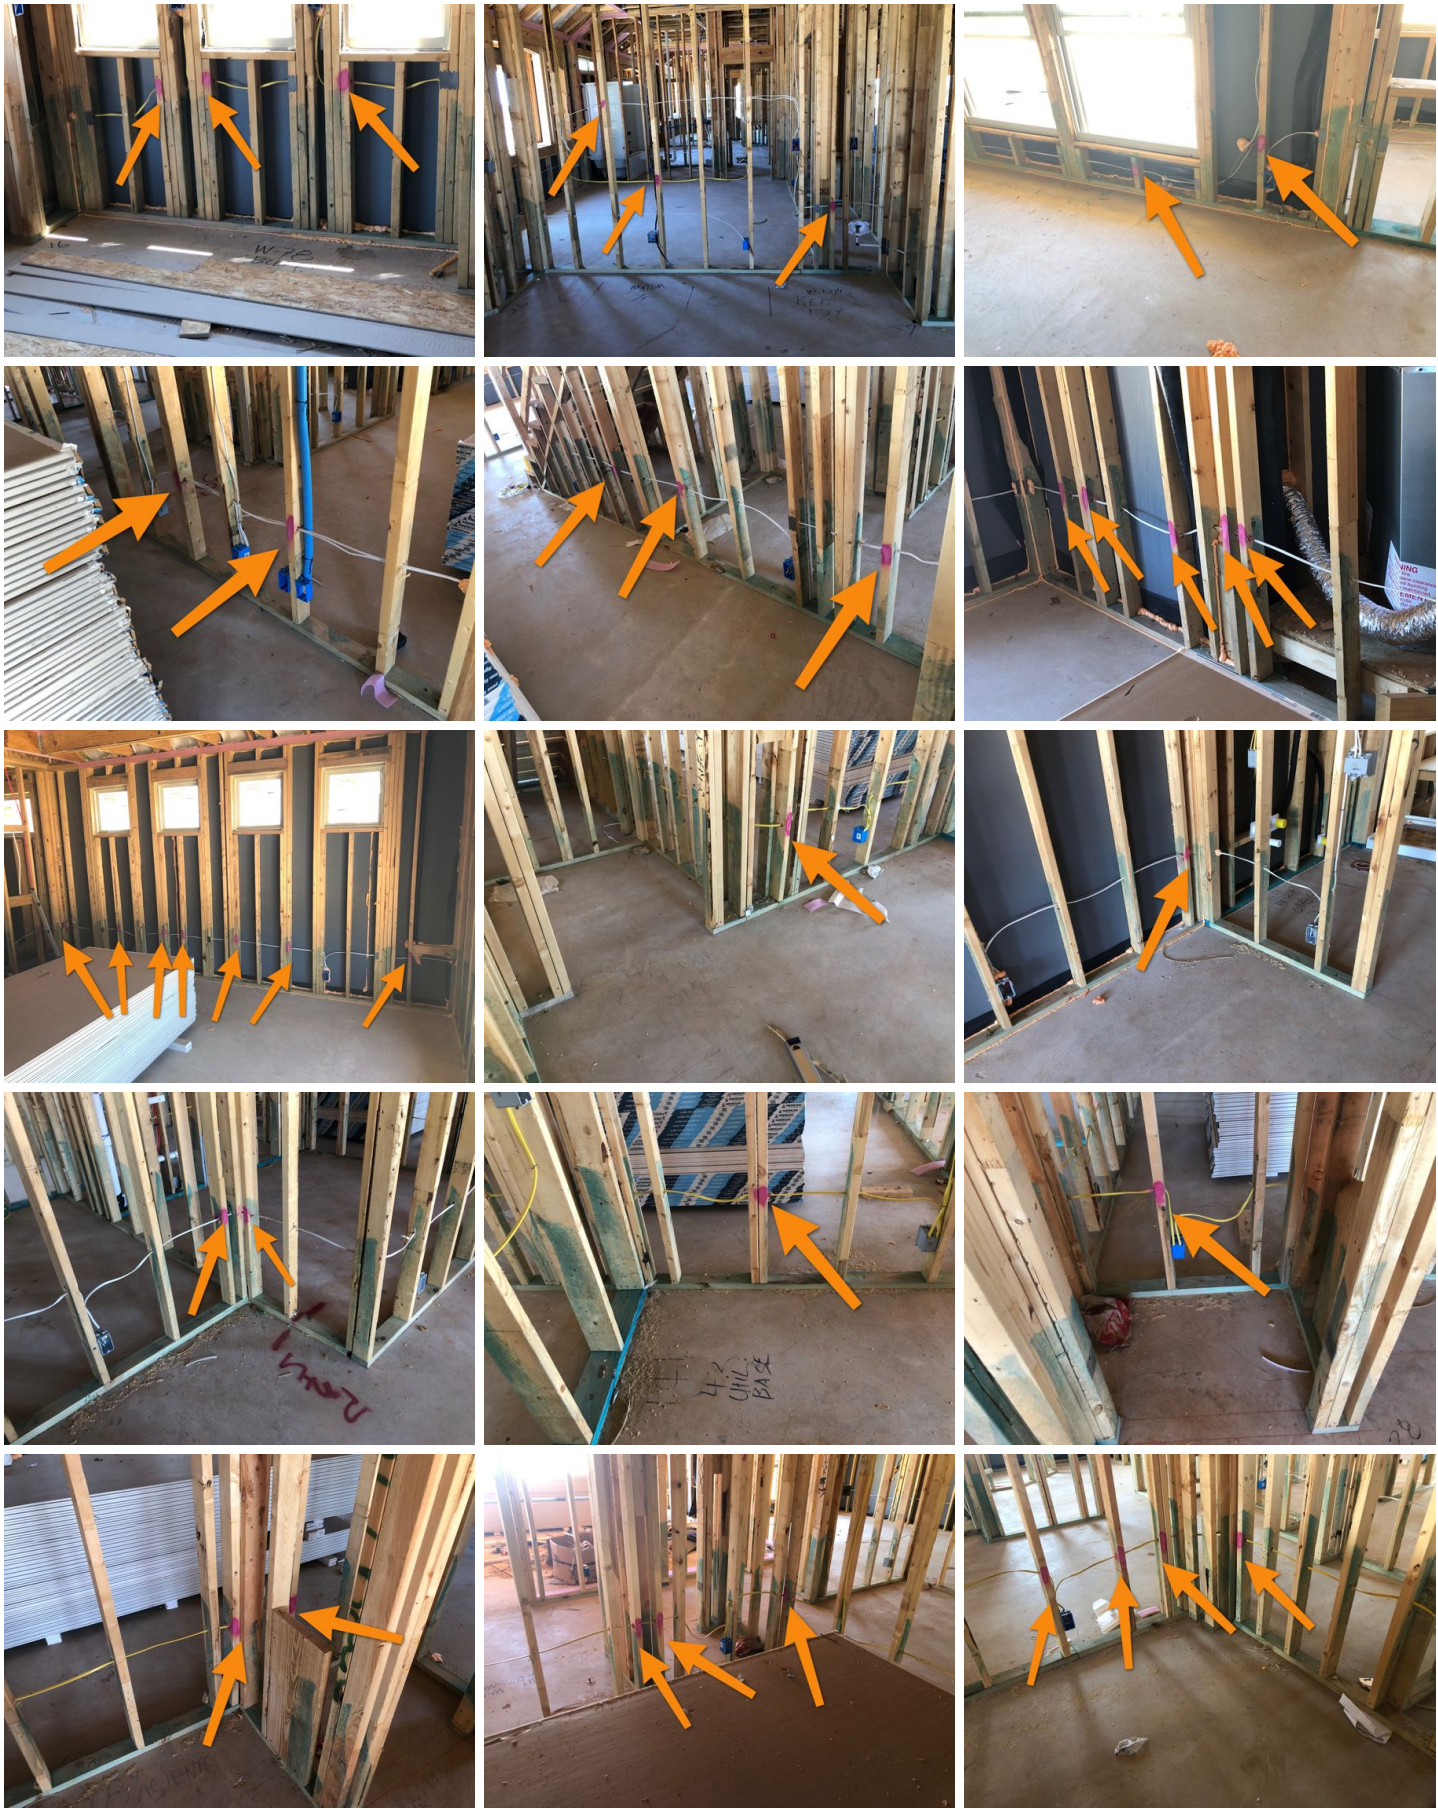
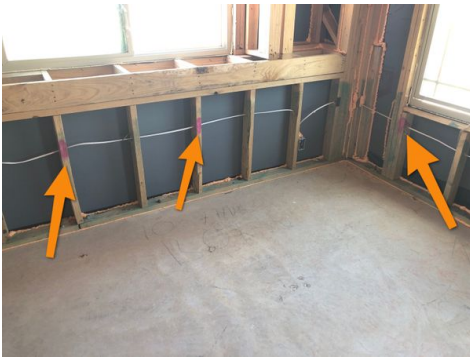
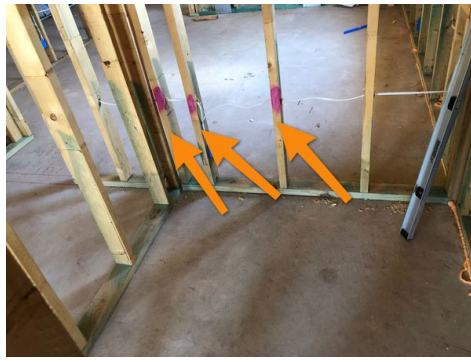
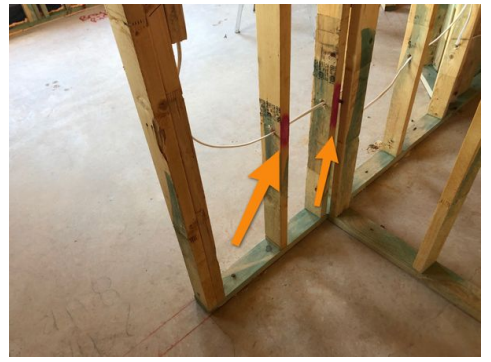
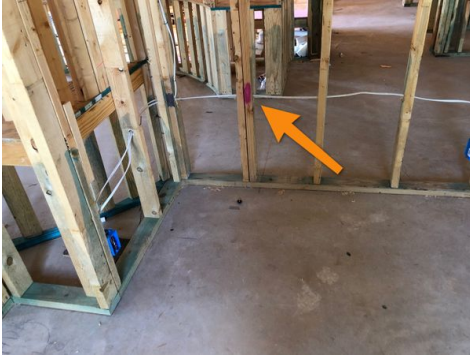
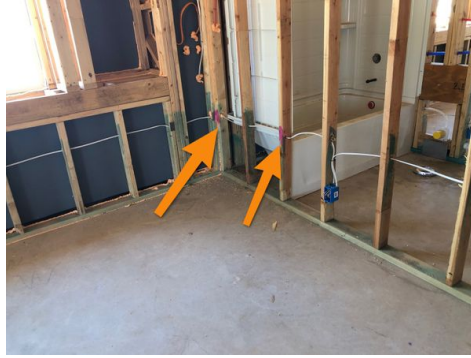
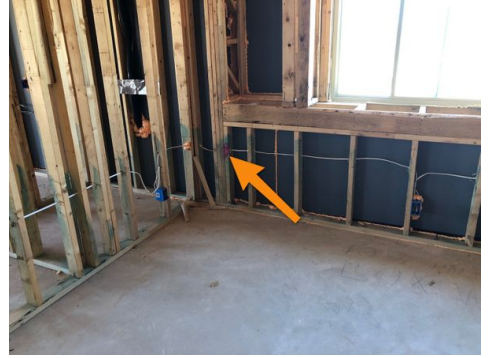
1ST FL RIGHT REAR BEDROOM & RIGHT CENTER BEDROOM & RIGHT FRONT BEDROOM & DINING ROOM & GARAGE HALLWAY & LAUNDRY & 1ST FL LEFT BEDROOM & MASTER CLOSET & LIVINGROOM & KITCHEN & 2ND FL LEFT REAR BEDROOM & 2ND FLOOR HALLWAY & MEDIA ROOM & 2ND FLOOR GAMEROOM & 2ND FL RIGHT BEDROOM & MASTER BEDROOM

NAIL PLATE NEEDED

- The electrical wires are not protected where they pass through one of the framing members in the study. A nail plate should be installed to protect the wires.

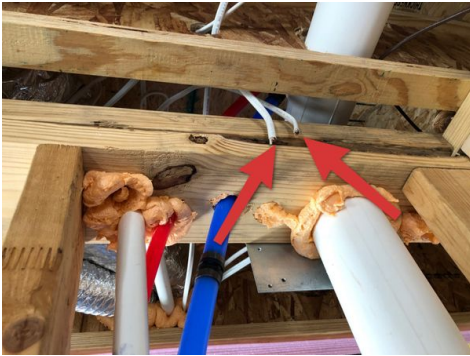
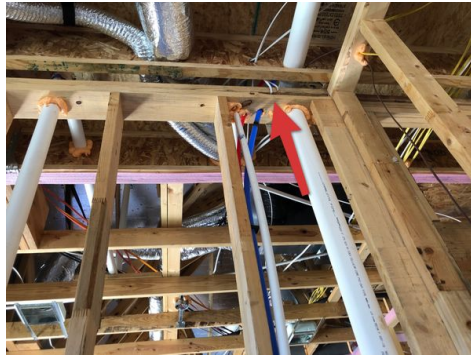
1ST FL RIGHT HALLWAY BATHROOM

CUT WIRES

Wires were observed to be cut and hanging out of the ceiling and or wall cavity.

Safety Hazard
