PEST INSPECTION

18 Crestmont Cir
Bloomsburg PA 17815

MAY 9, 2019

Wood Destroying Organism Inspection

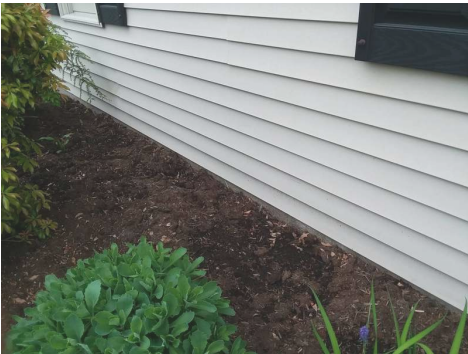
2.1.1 Findings

EXTERIOR SIDING TOO CLOSE TO SOIL

Front garage wall siding is very close to the top of the mulch bed and makes it easy for termites to travel the short distance to the wood framing of the structure. The siding should be maintained 6" above the ground surface to help limit insect entry. The distance may discourage termites but will also make it easy to see termite tubes extending up to the siding.

Contact a handyman or DIY project

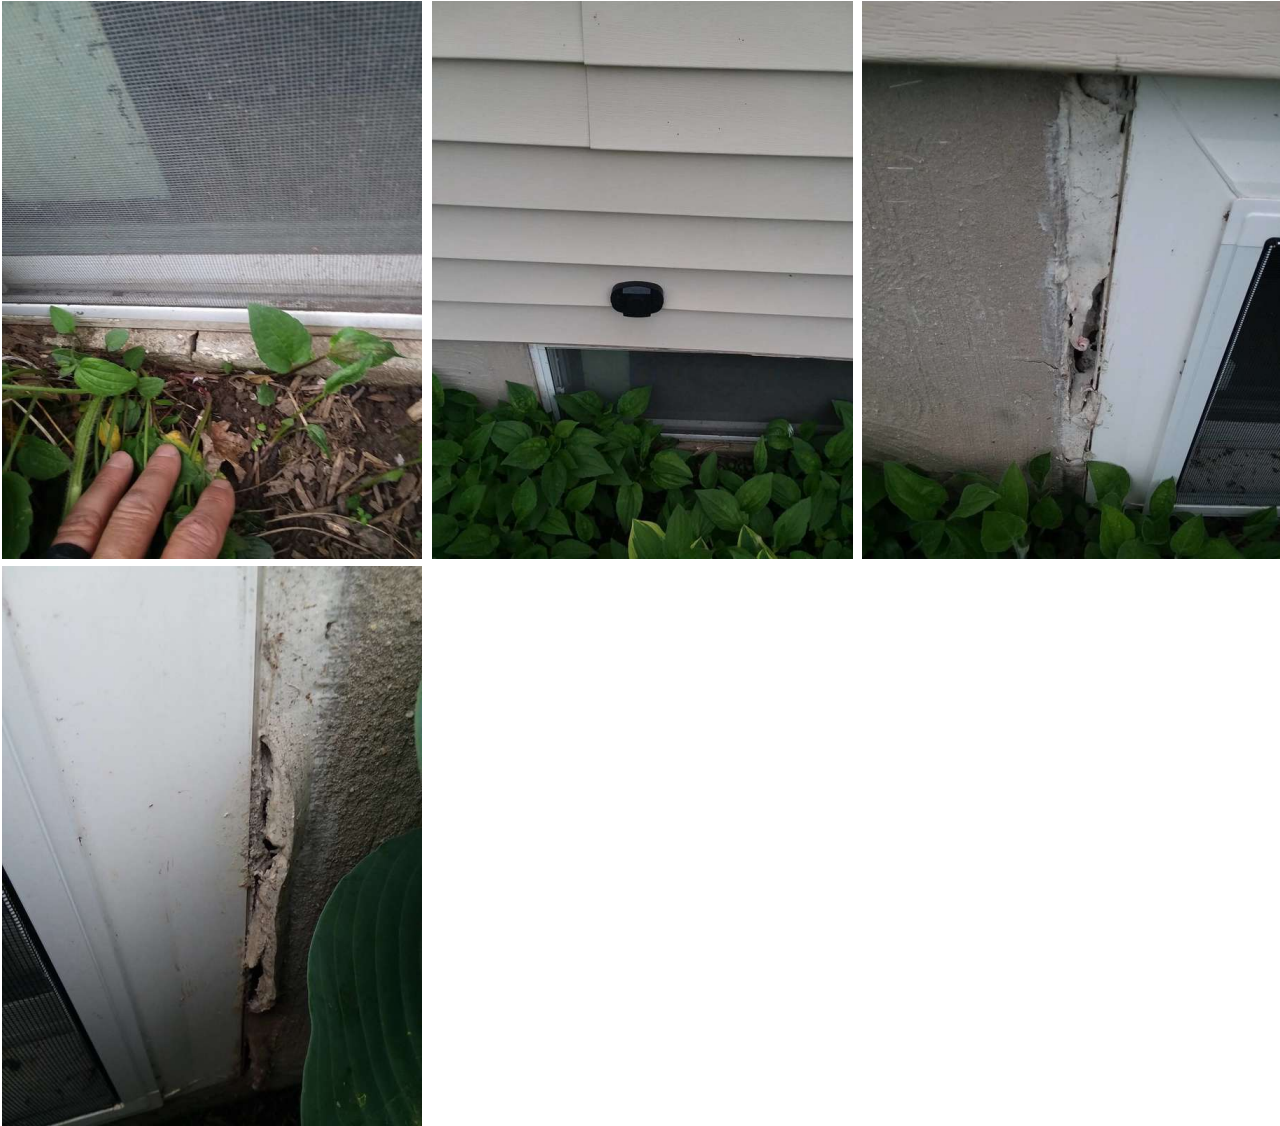
2.1.2 Findings

LEFT END BASEMENT WINDOWS

The two left end basement windows can allow termites and other insects easy access to wood structure and entry to the interior of the home. Recommend installing window wells to allow a greater distance from ground to windows. Also at the windows, a crack in the mortar sill and deteriorated caulking should be repaired or replaced to stop insect entry at these points.

Contact a handyman or DIY project

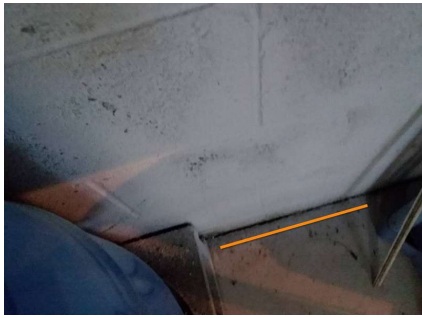
GAP AT BASEMENT CONCRETE FLOOR SLAB/WALL INTERSECTION

A gap exists and is viewable at the basement floor slab to block wall intersection at/near the water heater. There is also the appearance of minor surface mold or algae in this area. The presence of the gap and the moisture is an ideal location for termites to enter. The gap makes easy entry and the moisture is the ideal termite environment.

Seal gap

Recommend sealing as much of the gap as possible with a good grade sealant, clean the mold with a bleach or mold cleaning solution and monitor this area for excess moisture/water. It is advised to maintain low humidity in the basement.

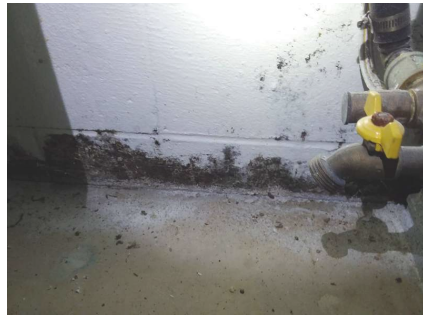
Clean Mold-like substance

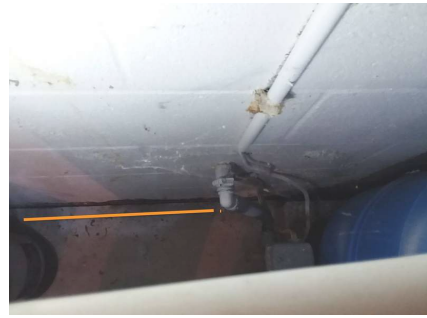
Seal Gap

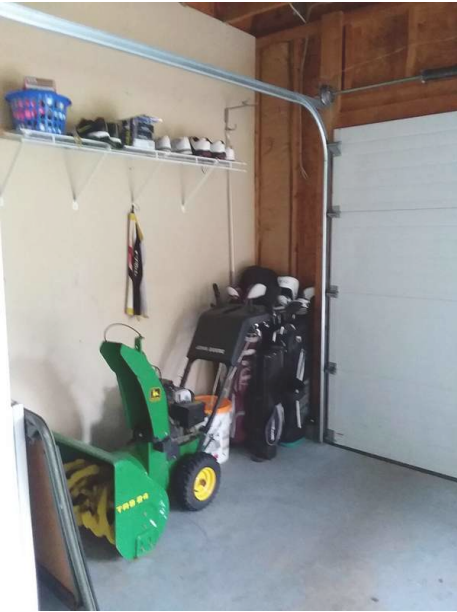
Garage: Reason
Drywall extends to CMU, leaving wood unexposed

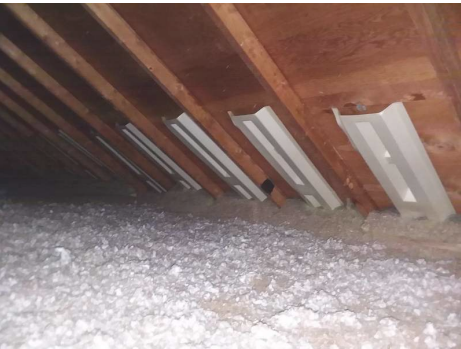
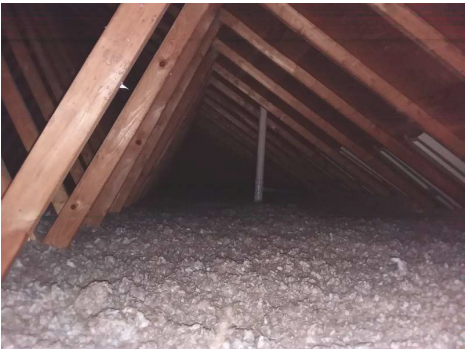
Attic: Reason
Attic space is not walkable without disturbing the blown-in insulation.
