FOUR POINT INSPECTION FINAL

3251 NW 66th St
Fort Lauderdale FL 33309

Keith Grant
JANUARY 12, 2019

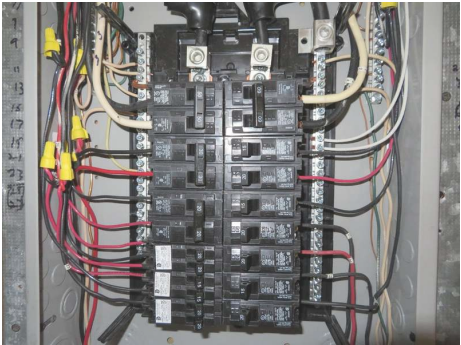
Separate documentation of any aluminum wiring remediation must be provided and certified by a licensed electrician.	Main Type Circuit breaker	Main Total Amps 150
Is amperage Sufficient for current usage?(Main) Yes	Indicate presence of any of the following: N/A	Hazards Present N/A
General Condition of the Electrical system Satisfactory	Main Panel age Less than 1 year	Main Panel brand Siemens
Wiring Type Copper	Main Feed Wire Material Multi-Strand Aluminum	Panel without cover

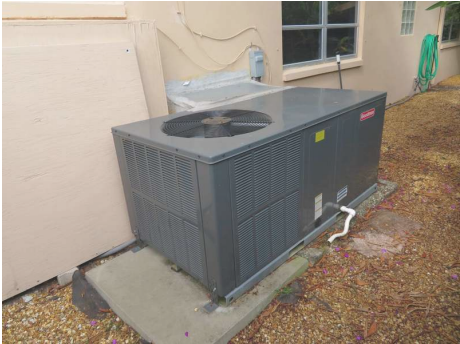
Central AC Yes	Central Heat Yes	HVAC systems in good working order? Yes
Date of Last HVAC service or inspection: Unknown	Wood-burning stove or central gas fireplace not professionally installed? N/A	Space heater used as primary heat source? No
Is the source portable? No	Does the air handler/condensate line or drain pan show any signs of blockage or leakage, including water damage to the surrounding area? No	Age of system 3 Years
Year last updated 2016	Package Unit	Deficiencies

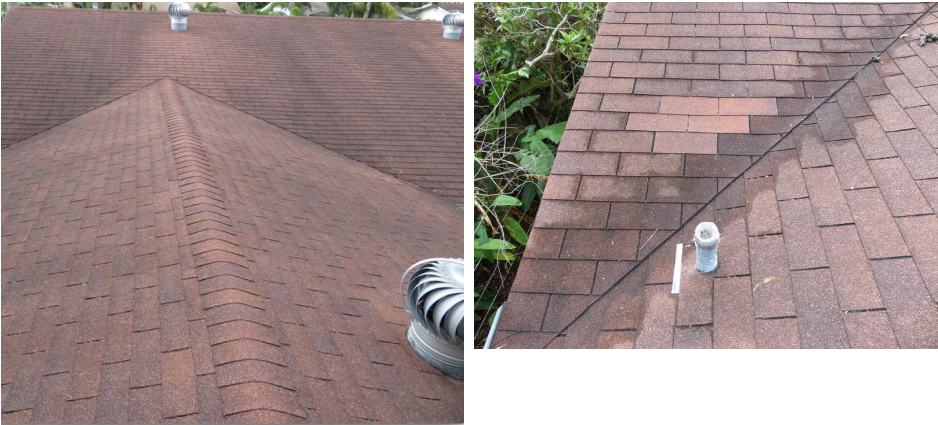
Rear Slope

Covering Material 3-Tab	Roof Age 13	Remaining useful life (years) 10 years
Date of last roof permit 4/18/2005	Date of last update Unknown	Any visible signs of leak Interior ceilings? No
If updated(Check one) Full replacement	Overall Condition Satisfactory	Any visible signs of leaks? No
Any visible signs of leak Attic/underside of decking? No	Covering Material Modified Bitumen	Roof Age 13
Remaining useful life (years) 4 years	Date of last roof permit 4/18/2005	Date of last update Unknown
Any visible signs of leak Interior ceilings? No	If updated(Check one) Full replacement	Overall Condition Satisfactory
Any Visible signs of damage/deterioration?(explain below) N/A	Any visible signs of leaks? No	Any visible signs of leak Attic/underside of decking? No
