BOGGS INSPECTION SERVICES

BOGGS INSPECTION REPORT

1234 W Main St
Olympia, WA 98513

MARCH 18, 2023

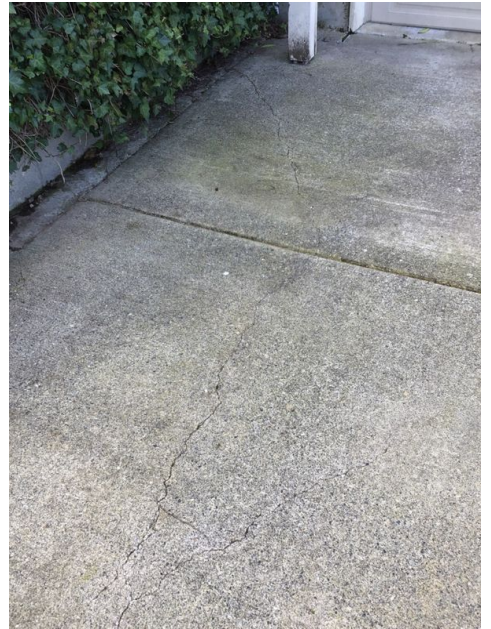
CRACKS - TYPICAL

Some small driveway cracks noted: This is a common finding, particularly with older homes, which usually relates to normal settling and expansion/contraction which occurs in every driveway over time. There are no recommendations.

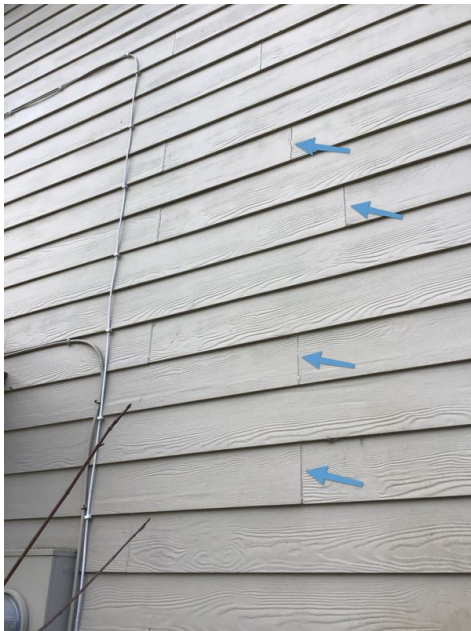
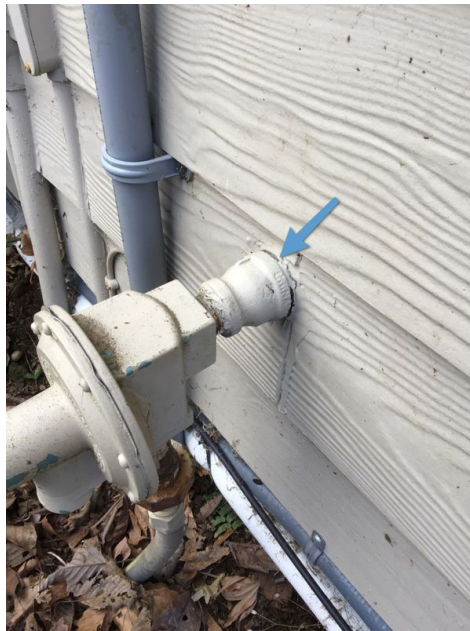
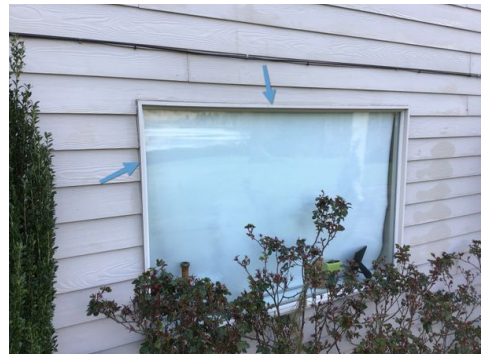
5.4.1 Siding And Trim

Caulk is missing or deteriorated in some areas and should be replaced and/or applied where necessary.

Contact a qualified general contractor.

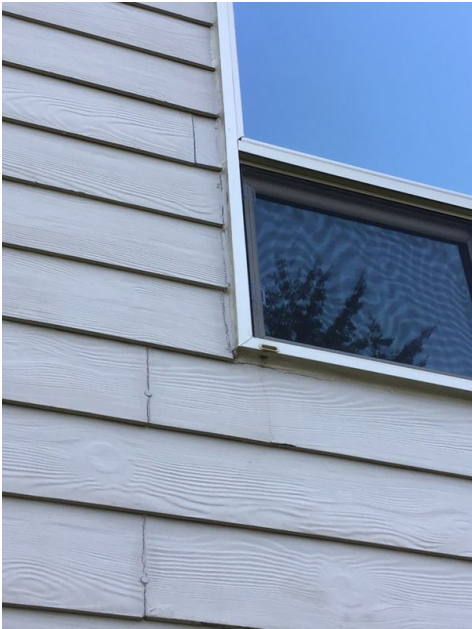
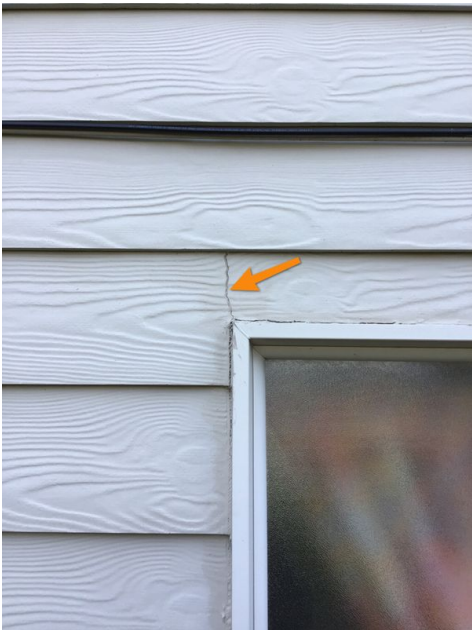
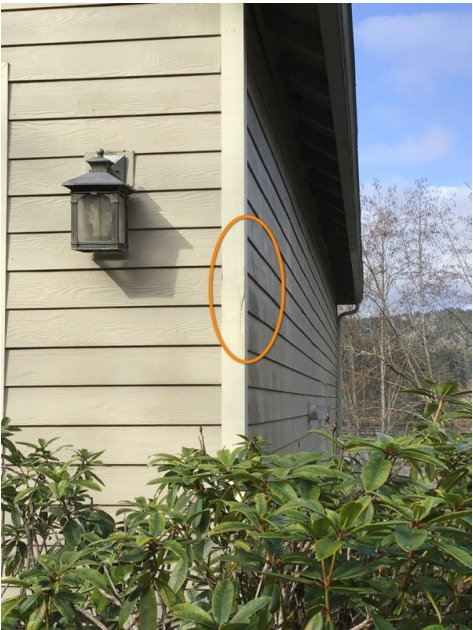
5.4.2 Siding And Trim

SIDING - DAMAGE

There is mechanical damage to the siding. Recommend repair.

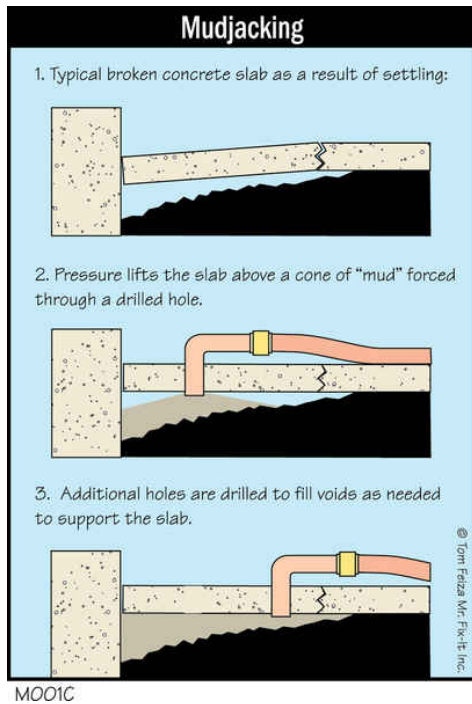
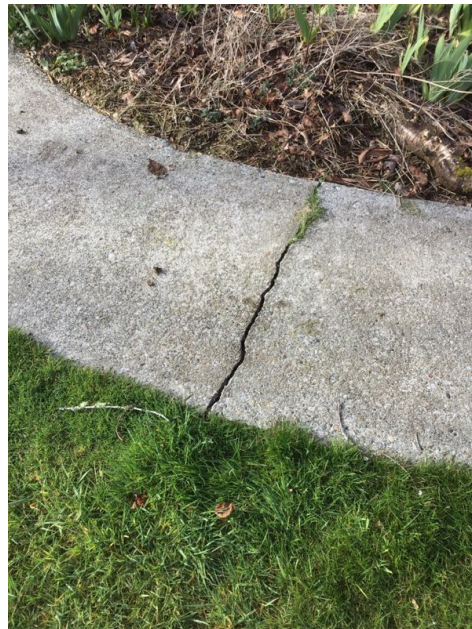
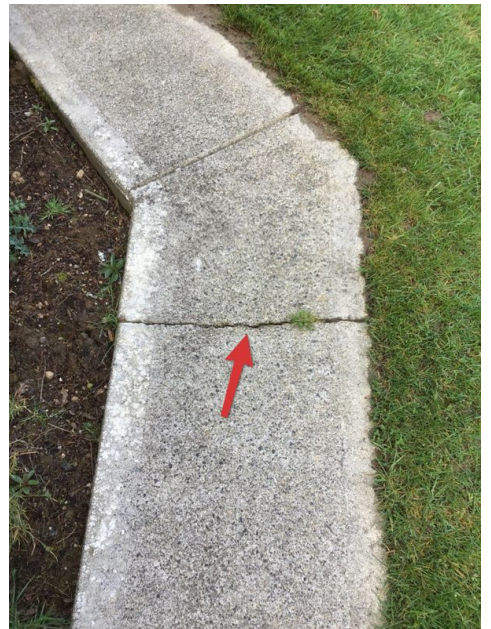
5.6.1 Walkways

CRACKS - LARGE

Large and/or displaced cracks are present in walkway: Exercise caution as trip hazards may exist. Repair/replacement may be necessary. Follow up with a licensed contractor specializing in driveway installation and repair is advised.

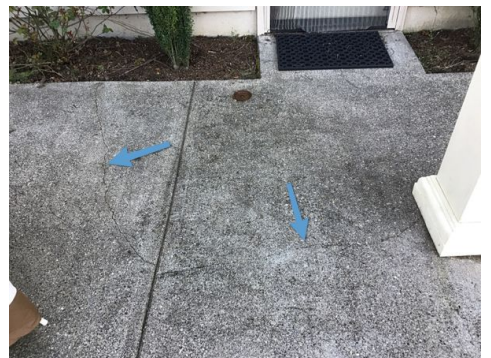
5.7.1 Concrete, Masonry Patio

CRACK - TYPICAL

Some small patio cracks noted: This is a common finding particularly with older homes which usually relates to normal settling and expansion/contraction which occurs in every walkway over time. There are no recommendations.

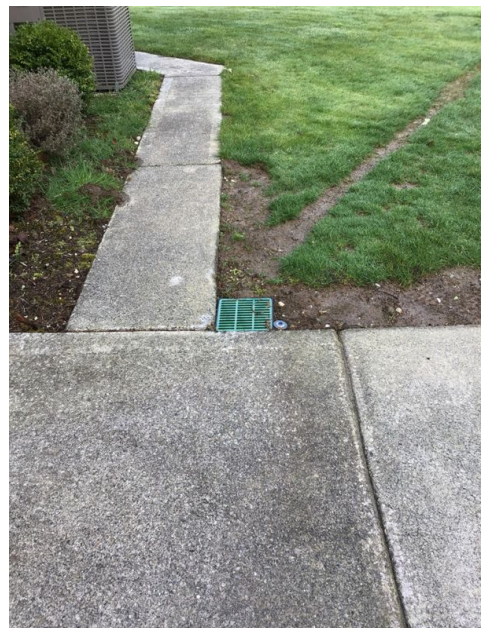
5.11.1 Topography

Exterior drains are present. It is beyond the scope of inspection to verify if installed drainage systems are functioning properly or if any installed sump pumps are working properly or adequately manage water accumulation. If this is a concern, recommend further evaluation.

Contact a qualified professional.

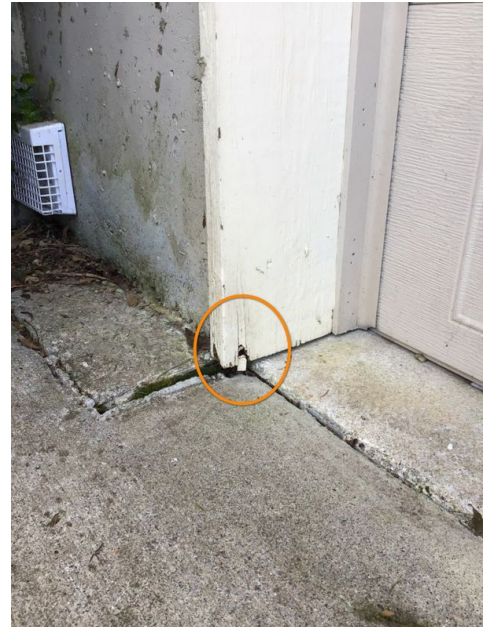
5.13.1 Damage/WDO

Damage/decay is present on the exterior garage door jamb leg(s).

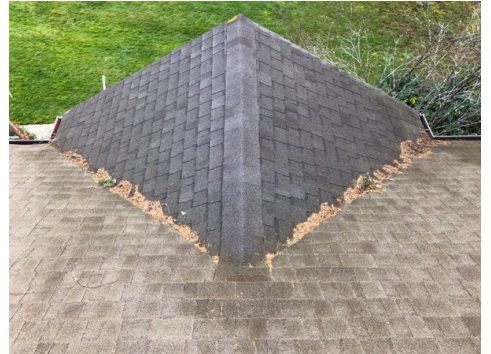
6.3.2 Roofing Material Defects

There is moss or debris present on roof. As part of normal maintenance, moss and debris should be cleaned off of the roof as it can lead to damage and leaking.

Contact a qualified professional.

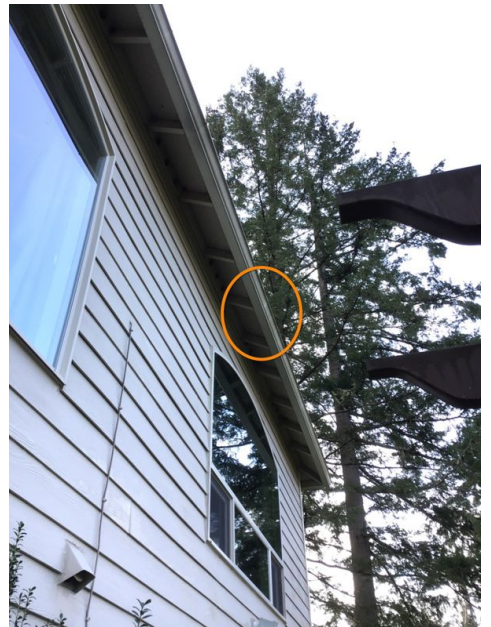
6.6.1 Gutters

DAMAGED

Gutter is damaged. Recommend repair to prevent leaks.

Contact a qualified professional.

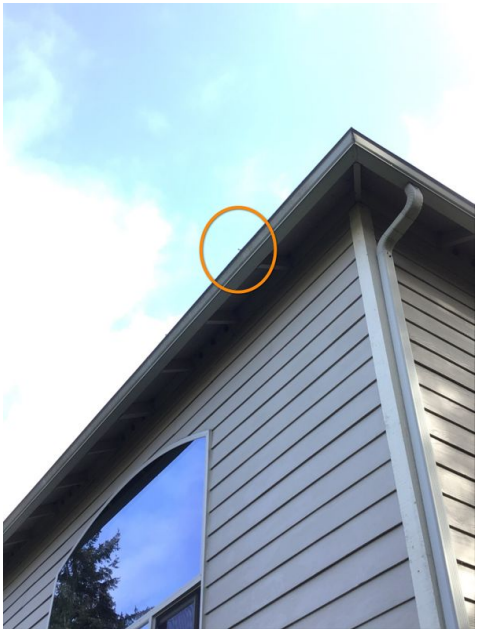
6.6.3 Gutters

FASTENER - LOOSE

The gutter nail is becoming dislodged. Recommend repair to prevent the gutter from pulling away from the structure.

Contact a qualified professional.

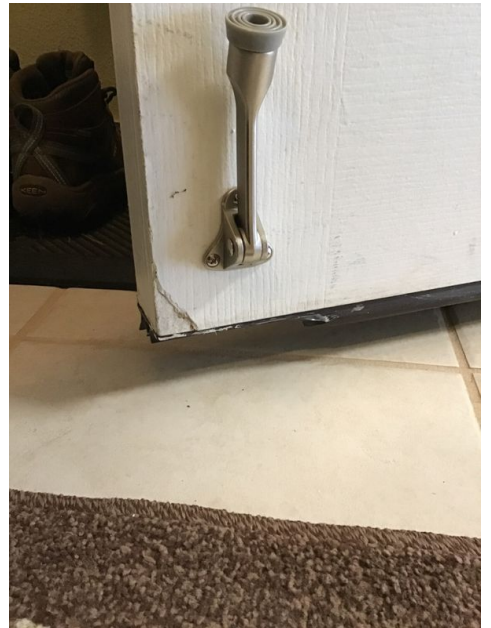
7.5.1 House Entry Door

**DOOR - WEATHERSTRIP
MISSING/DAMAGED**

The weatherstrip to the house is missing or damaged. Because the door from the garage to the house is part of the firewall, it is important it seals properly. Recommend repair.

Contact a handyman or DIY project

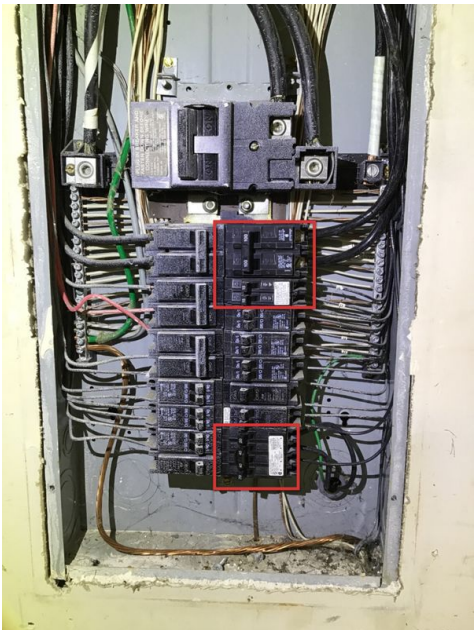
Circuit breakers are mismatched. Breakers do not appear to be compatible with panel brand and model. Recommend an electrician evaluate panel.

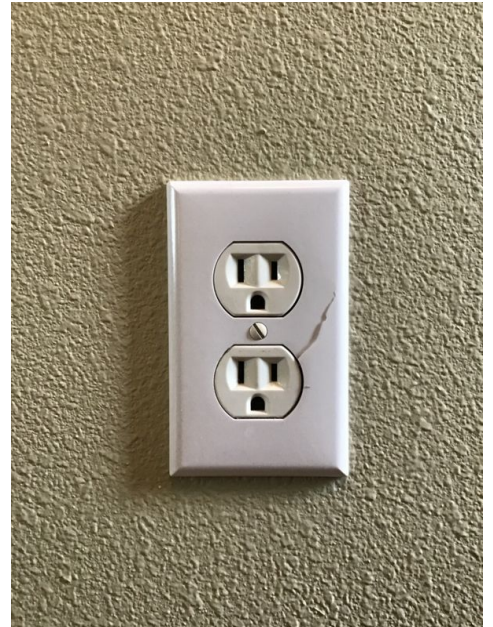
8.8.1 Receptacles

COVER - DAMAGED

Some electric outlet cover plates are damaged. If on the exterior, further damaged may occur from the weather. Recommend replacement.

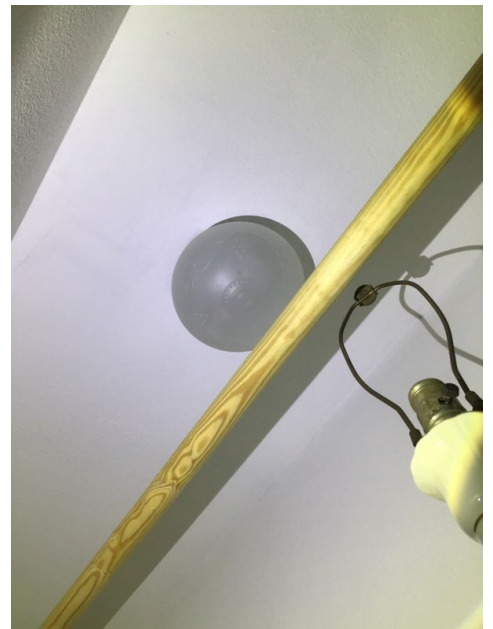
8.9.1 Lights

INOP

Light(s) are not operational in some areas. This may occur simply due to a bad bulb. Exterior lights may be on a sensor and won't turn on unless it's dusk. Recommend having the seller check and install a new bulb for any light which does not work. If this does not correct the condition, an electrician should be consulted.

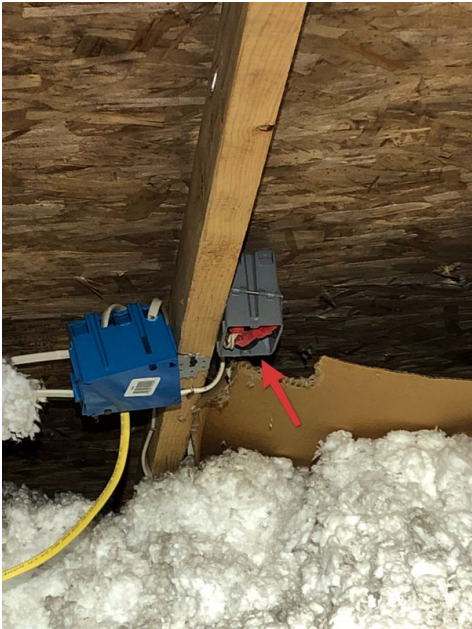
8.10.1 Branch Wiring

Missing electric junction box covers are noted. Junction boxes should always have covers in place. Repair/replacement is recommended.

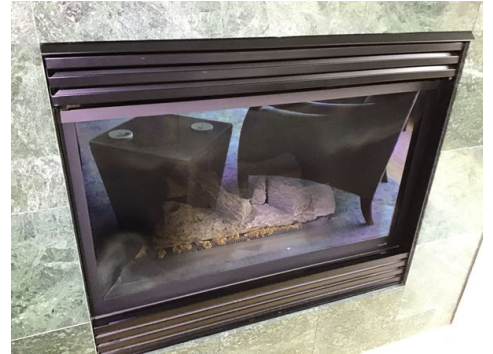
The fireplace/stove door has soot on it. The presence of soot could indicate a condition with improper combustion of the appliance whether it be a gas stove or fireplace. Further professional evaluation is recommended.

Contact a qualified professional.

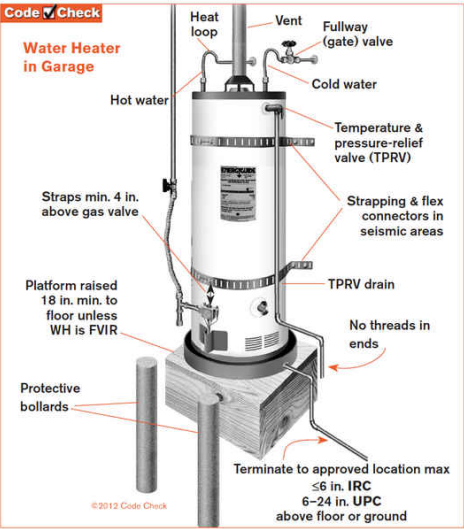
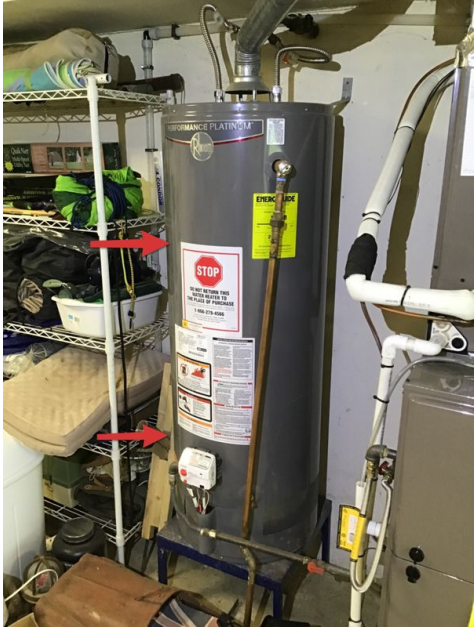
12.7.1 Earthquake Straps

The water heater's seismic straps or struts are substandard. For example, they may allow significant movement or use improper fasteners. This is a potential safety hazard since movement can cause leaks in the gas supply lines or damage wiring. Leaks may also occur in water supply pipes. Generally-accepted modern safety standards mandate one strap be installed in the lower third of the tank and one in the upper third. A qualified contractor should evaluate and either repair existing straps or install new straps or struts as necessary and as per standard building practices.

Recommendation
Contact a qualified plumbing contractor.

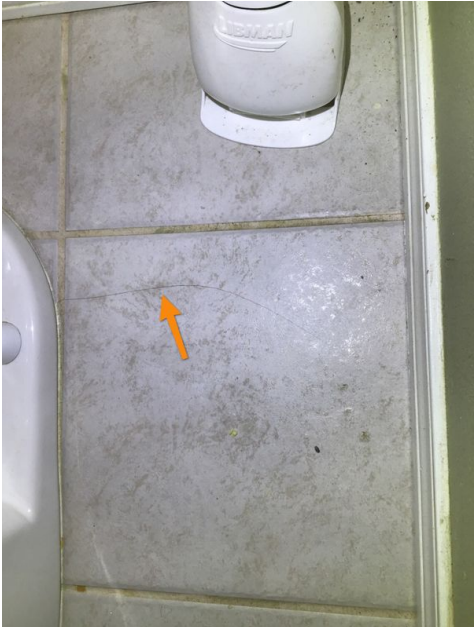
16.3.1 Flooring Defects

TILE - DAMAGE

Contact a qualified flooring contractor

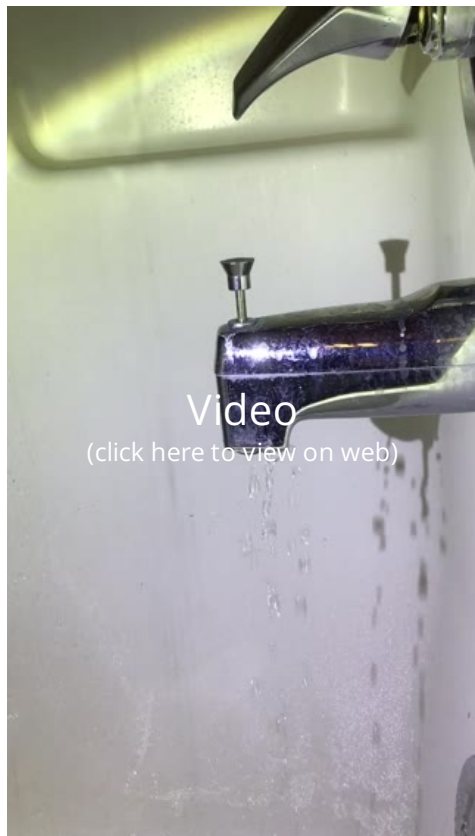
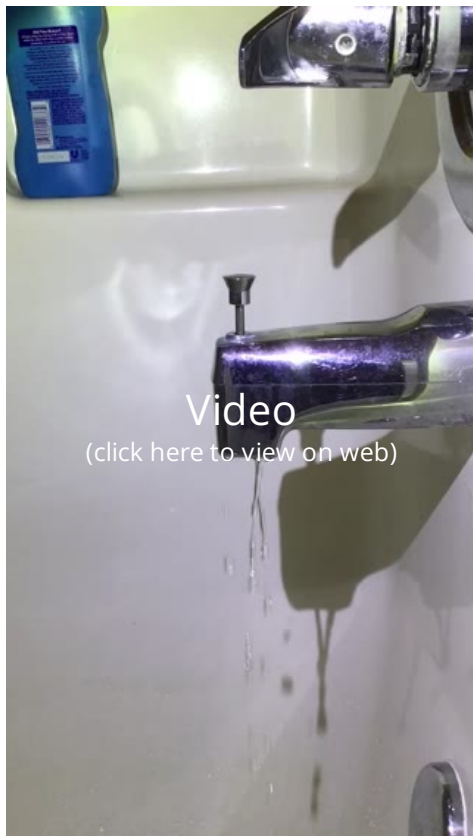
19.9.1 Tub/Shower Fixtures

DIVERTER - LEAK

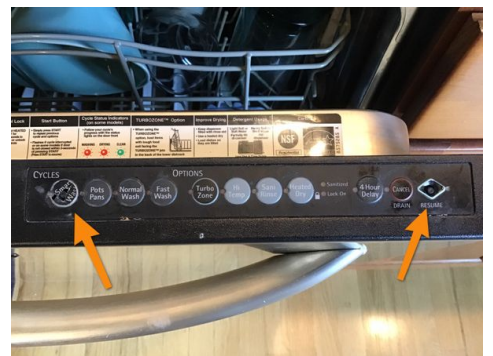
20.7.2 Dishwasher

CONTROLS - DAMAGED

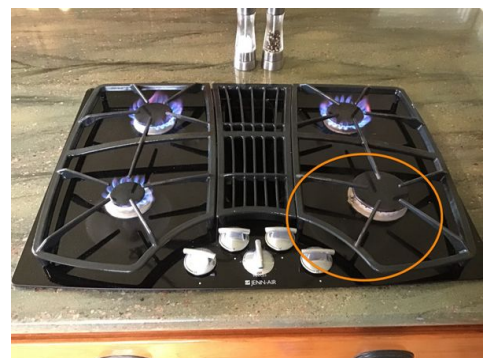
20.9.1 Cooktop and Oven

BURNERS - INOP/DAMAGED

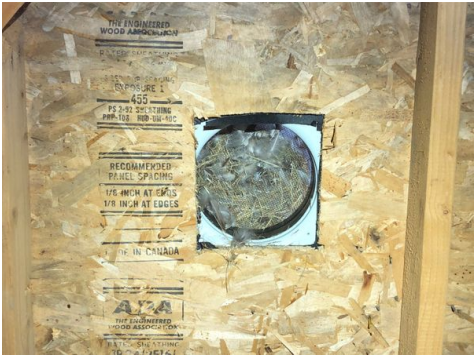
21.2.2 General Defects

VENTING - BLOCKED

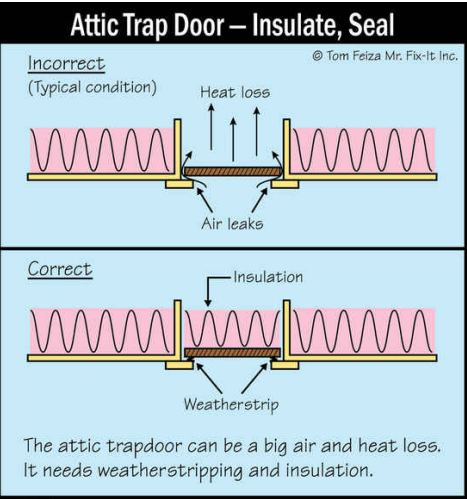
21.5.1 Insulation

INSULATION - MISSING ON ACCESS LID
