HOME INSPECTION REPORT

29819 45th Ave S Auburn WA 98001

> Kurt Keselburg JANUARY 30, 2020

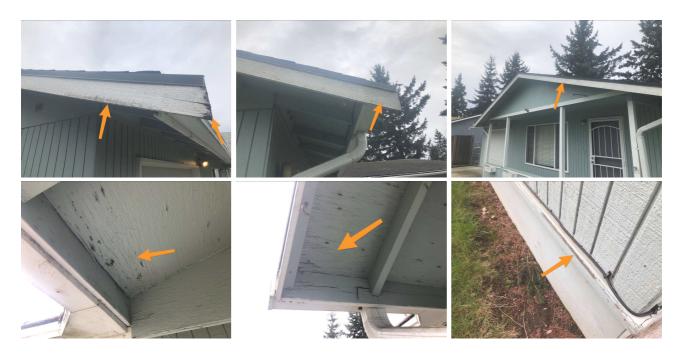
Sections of the fascia board or wood trim around the residence are slightly weathered, and should be serviced as necessary to prevent further deterioration. Service such as scraping, repainting and sealing.

Contact a qualified handyman.

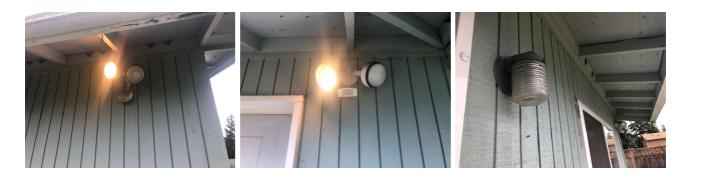
3.13.2 Lights LIGHT FIXTURE DAMAGED/MISSING COVER

A lights fixture was damaged or missing a cover and repair is recommended.

Recommendation Contact a qualified handyman.

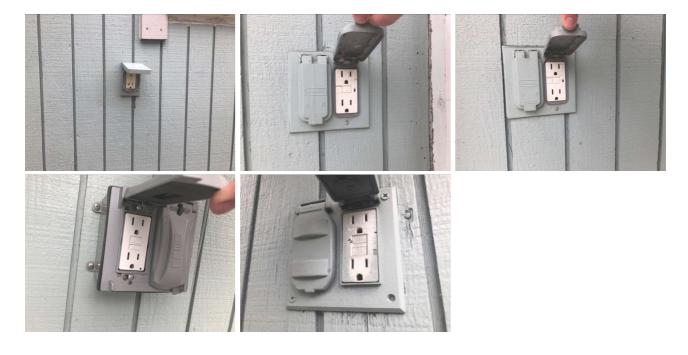
LEFT SIDE, FRONT The GFCI outlet does not test on demand and needs service or replacement from a qualified technician. Recommendation

Contact a qualified electrical contractor.

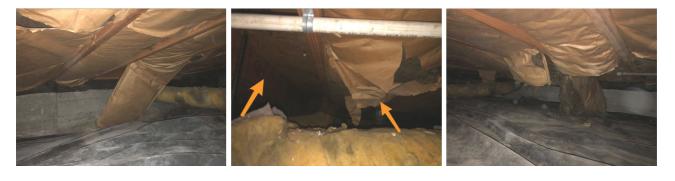
The insulation in the crawlspace was falling down in one or more locations at the time of the inspection. Recommend re-installing.

Recommendation Contact a qualified handyman.
