PROPERTY INSPECTION REPORT

Concerning: 1234 Main Street, The Colony TX 75056
(Address or Other Identification of Inspected Property)

By: Tristan Eager - TREC #22148 07/19/2018 8:00 am
(Name and License Number of Inspector) (Date)

Type of Building: Single Family (2-story)

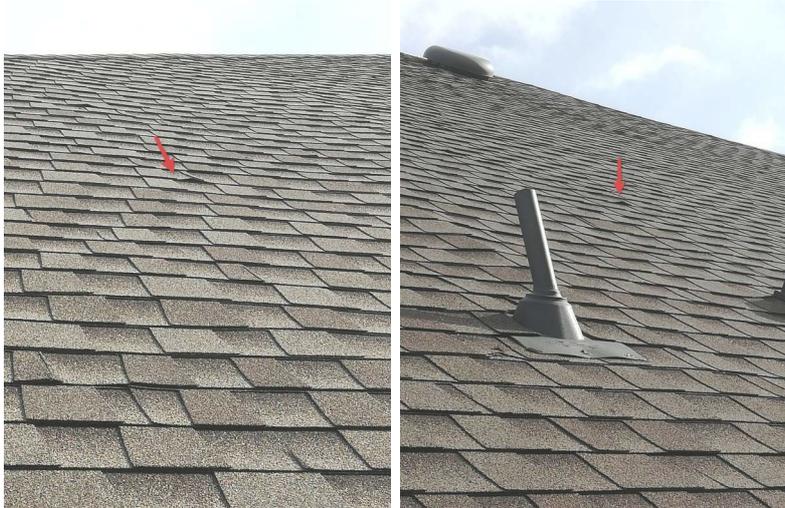
1: Lifted Shingles

Lifted shingles were observed in multiple locations. This may be caused by nail heads sticking up. This will make the roof more prone to wind damage.

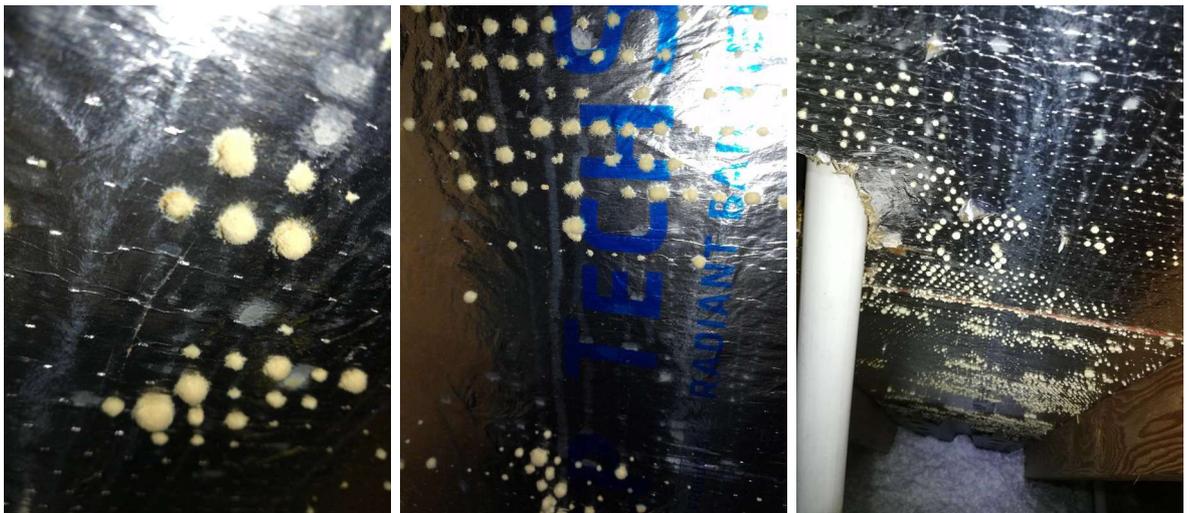
2: Mold Like substance observed on sheathing

Mold like substance was observed in multiple locations on roof sheathing. Inspector did not test and can not determine if this is actually mold. Sheathing was probed with a moisture meter and was dry. This substance was covering much of the sheathing in the attic. Professional evaluation is recommended.

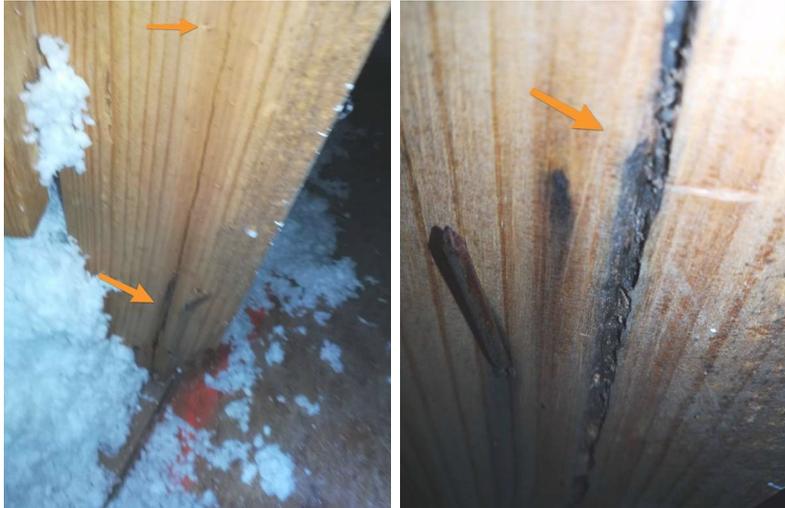
3: Split strut

Strut has cracked along its length in attic. There is a defect in the lumber where the crack occurred. Inspector can not determine if this will affect the performance of the roof structure.

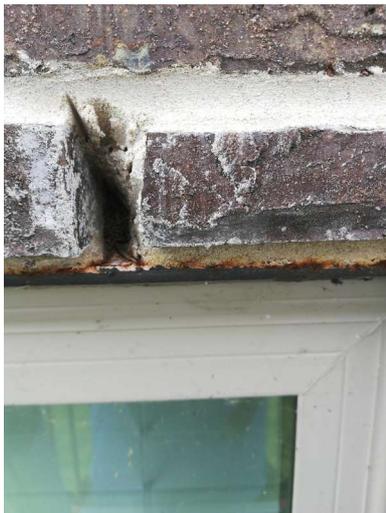
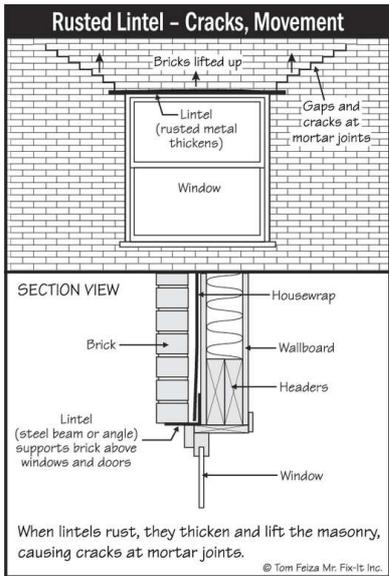
1: Rusting Lintels

Rusting observed on lintel. It should be cleaned and painted to prevent further deterioration. Lintels support brick above wall openings. Lintels that rust can expand and cause brick cracking. Rusting lintels will eventually loose strength and can cause damage to the wall.

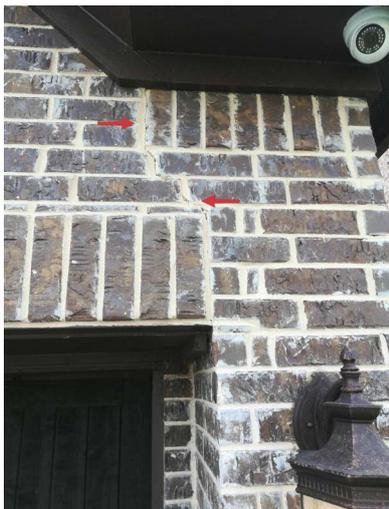
2: Brick cracking above garage door

Brick cracking observed above garage door. This is a high stress area that is prone to cracking. Recommend monitoring cracking and if it worsens, consider professional evaluation.

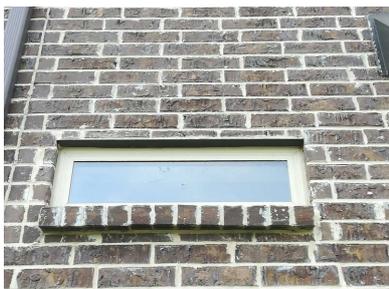
3: Weep holes not installed above winow

Weep holes help reduce moisture inside the walls and are needed to allow walls to breathe.

No weep holes installed

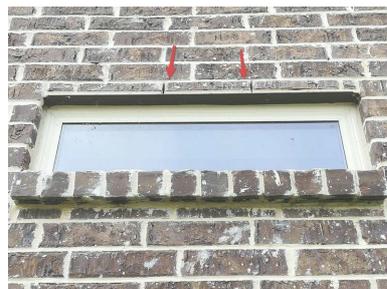
Weep holes installed

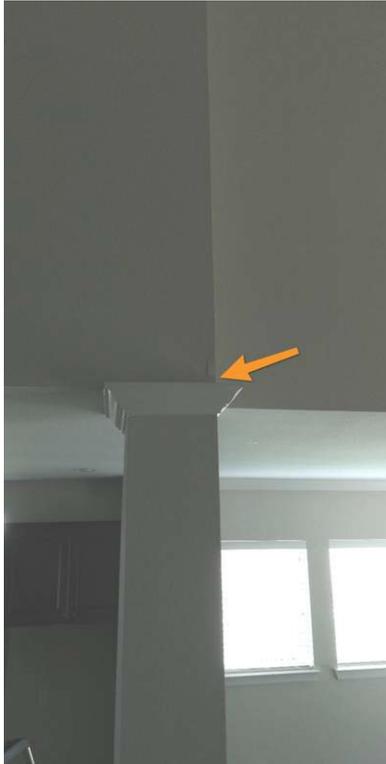
4: Drywall tape separation (minor)

above column near kitchen

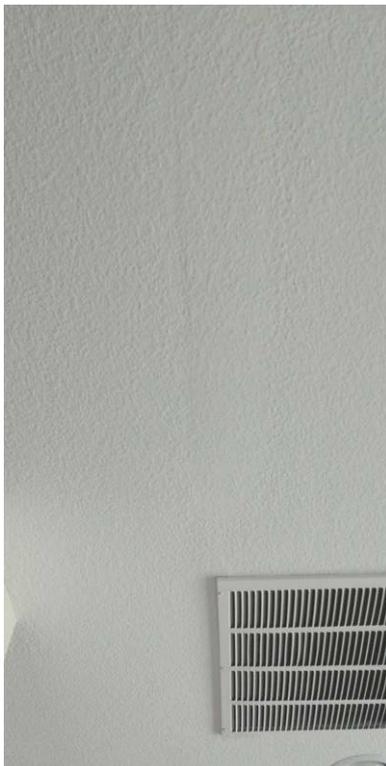
1: Minor Ceiling cracking

No other indicators of foundation movement were observed. Recommend monitoring and if it worsens consider professional evaluation.

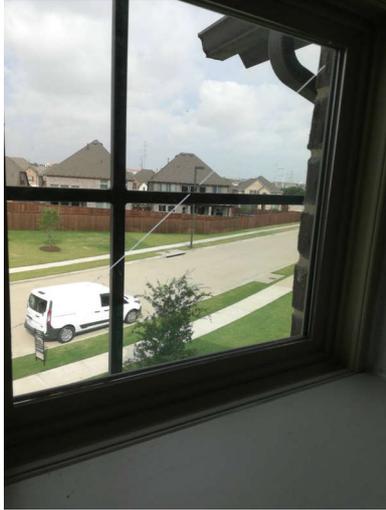
1: Cracked window

2nd Floor West Bedroom closet

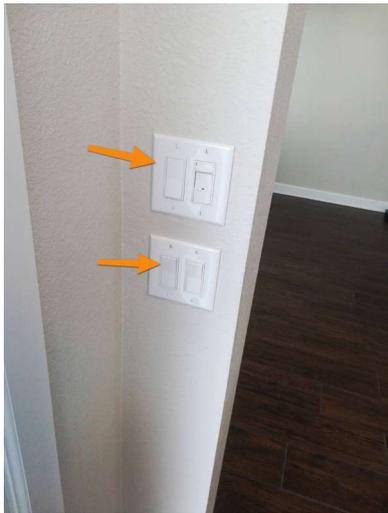
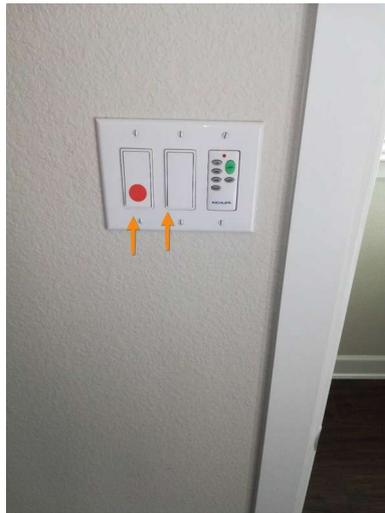
2: Unknown Function of Switch

Pictured switches by back door

Pictured switches in master bedroom

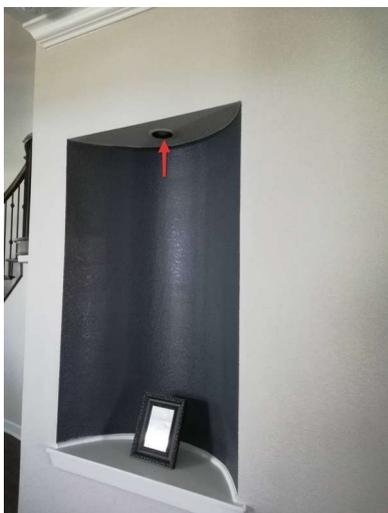
3: Pictured Light - Did not turn on when all switches were tested.

The bulb may be burned out or there may be an issue with the circuit.

Additionally, the trim ring for this light fell out when the garage door was opened. The trim ring is now broken.

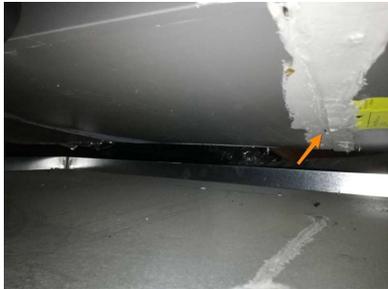
3: Water and Rusting Observed in Condensate overflow pan and water leaking from evaporator housing

Water was leaking out of the evaporator housing. Evaporator condensate drains may be plugged or there could be in problem with the drain system inside the evaporator. Professional evaluation is recommended.

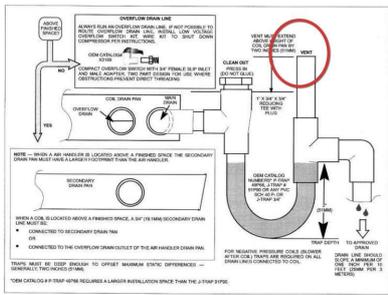
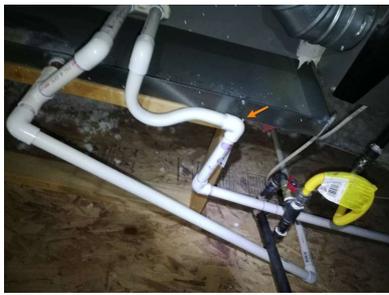
4: Condensate Drain does not have a vent installed

A vent is needed to prevent water from siphoning out of the trap.

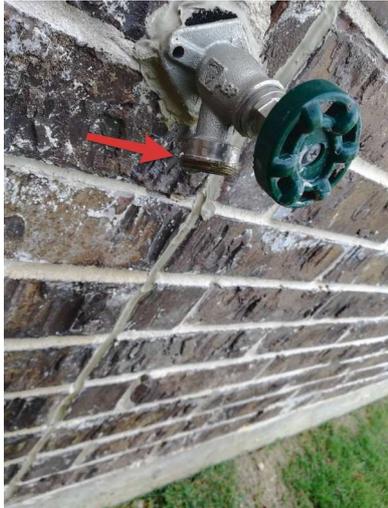
1: Backflow Preventer has been removed

Half of the backflow preventer has been removed. A hose can not be fitted to the backflow preventer body threads. A backflow preventer is needed to prevent hose water from entering the water distribution system.

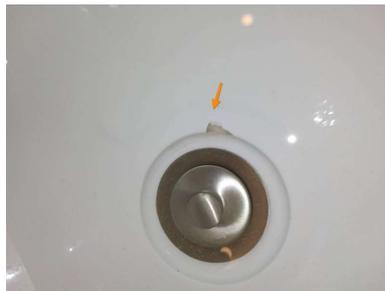
3: Chipping observed in bath tub finish

Master Bathroom

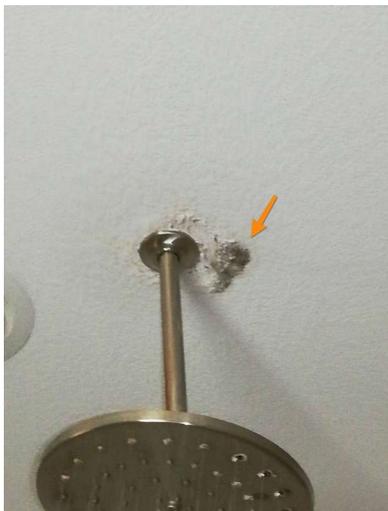
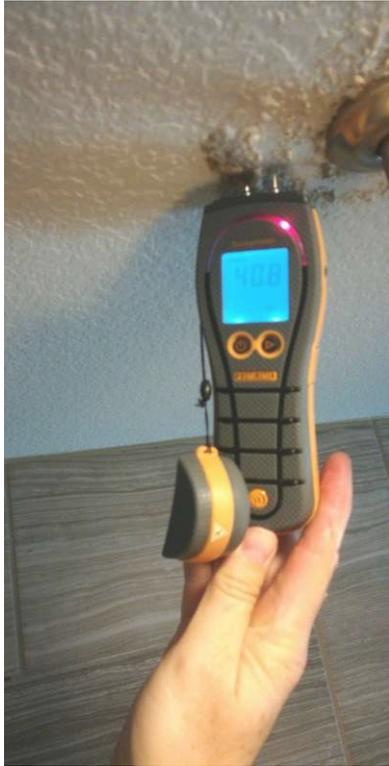
4: Active water leak inside wall at shower head connection.

Staining observed on ceiling and was damp when probed with a moisture meter.

40% moisture, 15% would be normal.
Mold grows above 20%

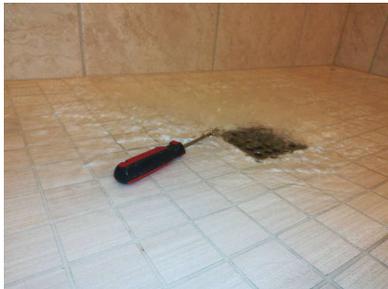
1: Slow shower drain
2nd Floor West Bathroom

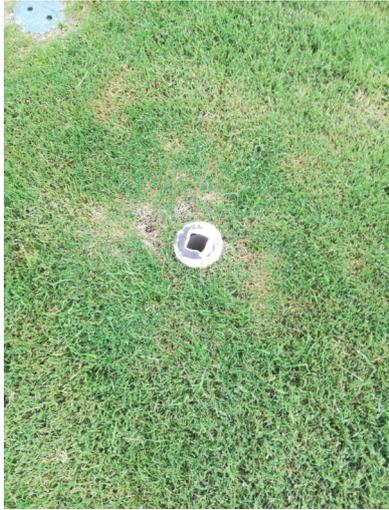
2: Sanitary sewer cleanout covers missing/damaged
Front yard
Sewer cleanout needs to be covered to prevent debris from entering the sewer line.

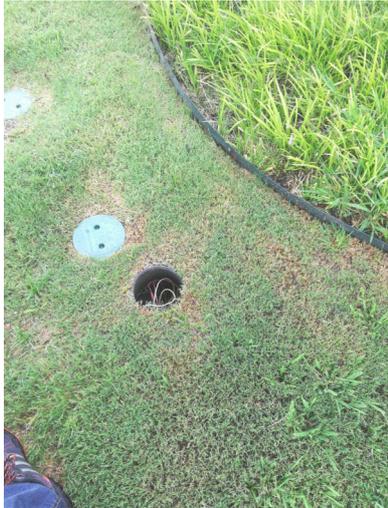
- A. Sprinkler Operation**
- B. Controllers**
- 1: Valve vault cover missing**
Northwest
