# MOUNTAINS TO SOUND HOME INSPECTION LLC

## HOME INSPECTION REPORT

702 N Mason Ave  
Tacoma WA 98406

MAY 21, 2019

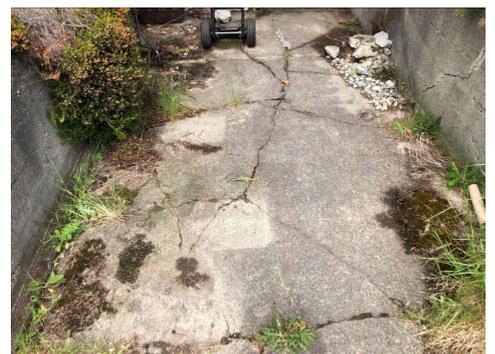
**SMALL CRACKS IN DRIVEWAY**

There are common cracks in the driveway that would not necessarily need to be serviced.

Recommend monitoring.

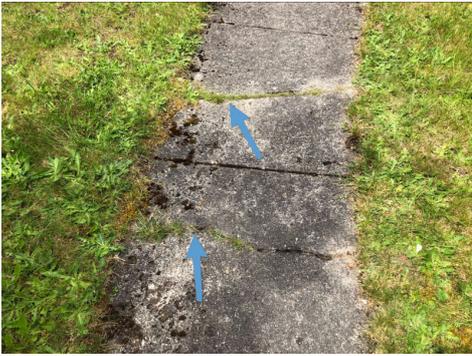
## 3.2.2 Driveway, Walkways &amp; Patio

**CRACKS IN WALKWAYS**

There are a few cracks in the walkways around the residence that are mostly cosmetic. We suggest you view these yourself and repair as necessary.

Contact a qualified professional.

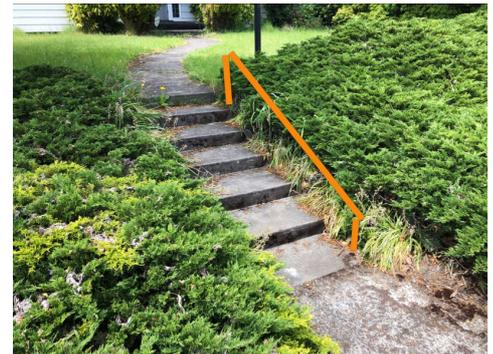
3.2.3 Driveway, Walkways & Patio

**MISSING RAIL**

The stairs are missing graspable rails. These are recommended on stairs where three or more risers are present. We recommend rail be installed.

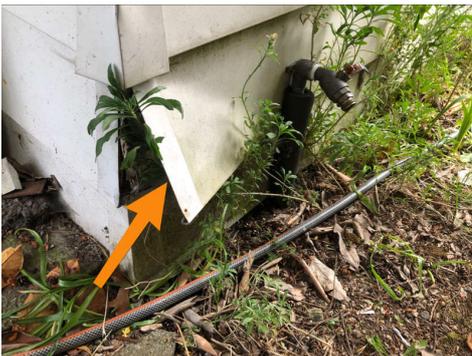
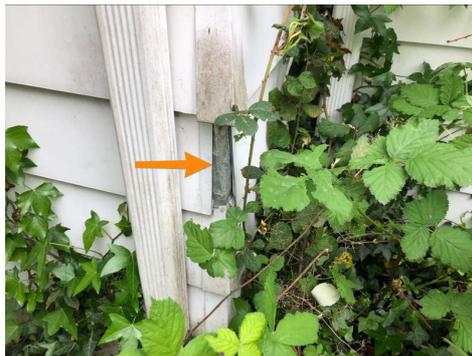
3.5.2 Exterior Siding Notes

**DAMAGED SIDING**

Observed areas of damaged siding around the residence that should be repaired to help prevent moisture intrusion issues. These damaged areas can allow moisture to penetrate the walls if not properly repaired.

Contact a qualified handyman.

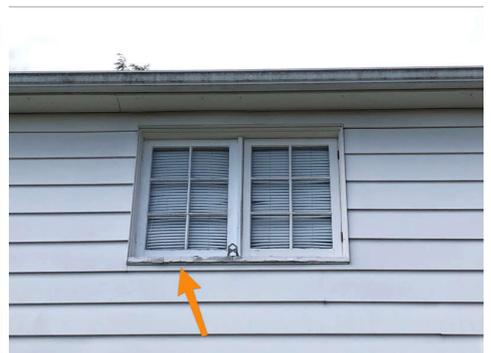
3.7.1 Fascia, Trim & Eaves

**SECTIONS OF FASCIA OR WOOD TRIM ARE WEATHERED**

Sections of the fascia board or wood trim around the residence are slightly weathered, and should be serviced as necessary to prevent further deterioration. Service such as scraping, repainting and sealing.

Contact a qualified handyman.

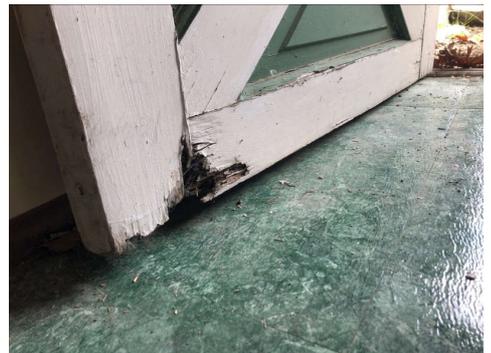
3.10.3 Exterior Doors

**STORM DOOR OFF**

The back door storm door was off/missing. Recommend installing.

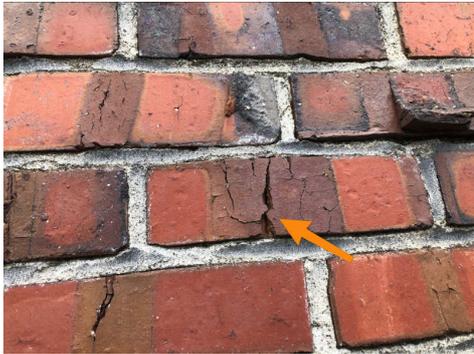
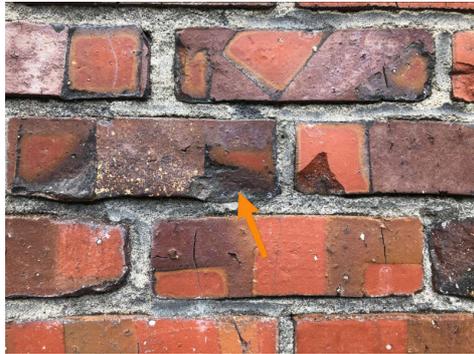
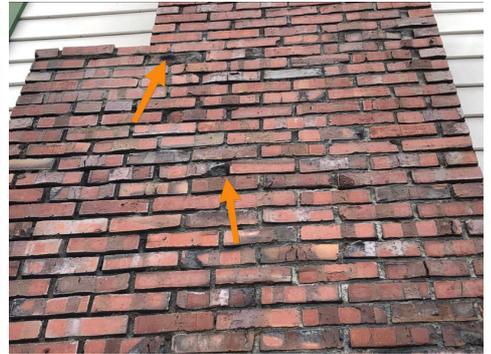
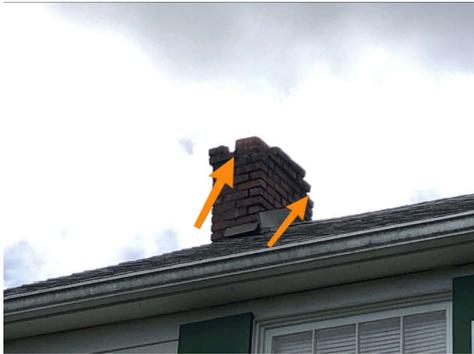
**SPALLING BRICKS**

The chimney material is spalling (loose section falling off). We recommend patching these sections.

Contact a qualified chimney contractor.

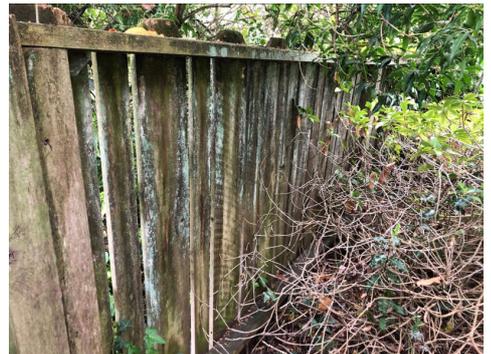
3.13.1 Fences & Gates

**FENCES WEATHERED**

The fences are weathered. Recommend maintenance and repairs.

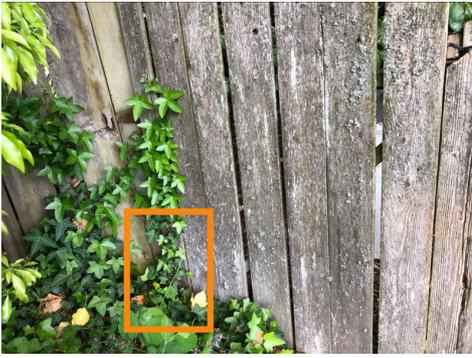
3.13.2 Fences & Gates

**A GATE SUPPORT LOOSE**

A gate support is loose and should be secured.

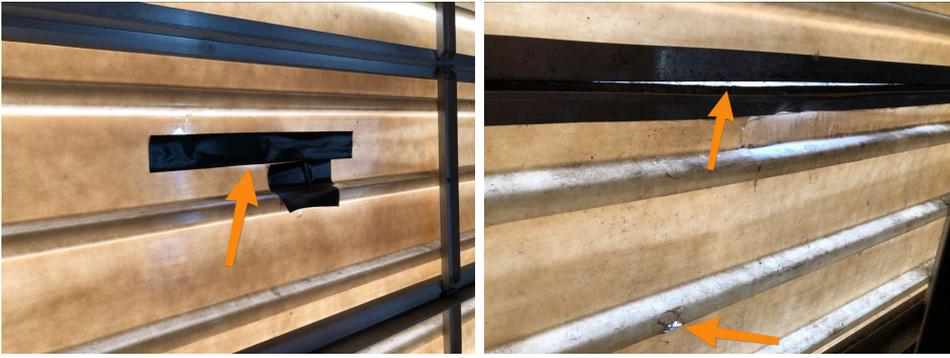
### 5.3.1 Garage Door & Hardware

#### **DAMAGE TO GARAGE DOOR**

The garage door is damaged and further evaluation and repair from a garage specialist is recommended

Contact a qualified garage door contractor.

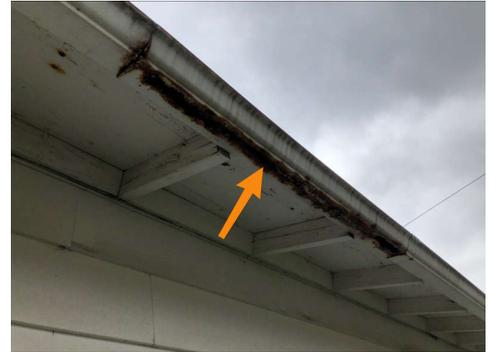
Medium Priority**GUTTERS IN POOR CONDITION**

The gutters are in poor condition, and should be repaired or replaced.

Contact a qualified roofing professional.

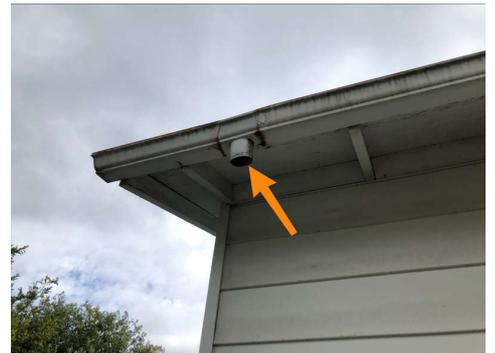
## 5.8.3 Gutters &amp; Drainage

Medium Priority**MISSING DOWNSPOUT**

There was a missing downspout on the garage. Recommend installing.

Contact a qualified professional.

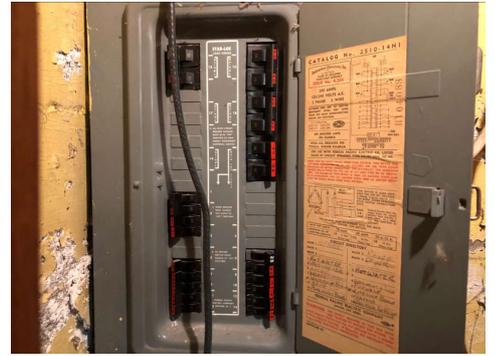
The panel was manufactured by Federal Pacific Electric Company and employs Stablok breakers and other components that have been alleged to be defective. However, the panel is old and the company is now out of business, and although field reports of defects and dangers were never apparently substantiated by laboratory tests they have been numerous and serious enough for us to recommend either upgrading the panel or seeking a second opinion. Also, you can learn more about this issue from Dan Friedman at [CLICK HERE](#).

Contact a qualified professional.

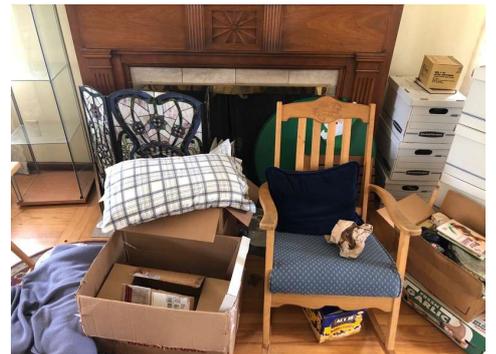
#### **FIREPLACES NOT INSPECTED**

The fireplaces were covered by the sellers stored items. They are unable to inspect the fireplaces. Recommend getting access and inspecting.

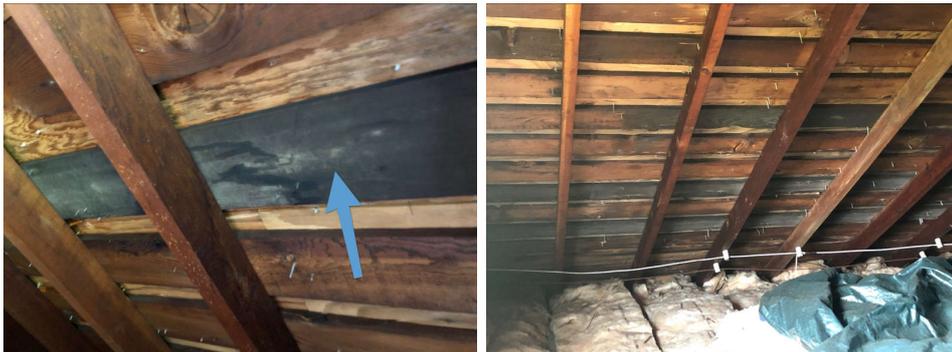
#### DECK STAINING

Discoloration and dark staining was observed on the roof sheathing. This is often caused by poor ventilation and is commonly considered a microbial growth. Recommend improving ventilation and cleaning.

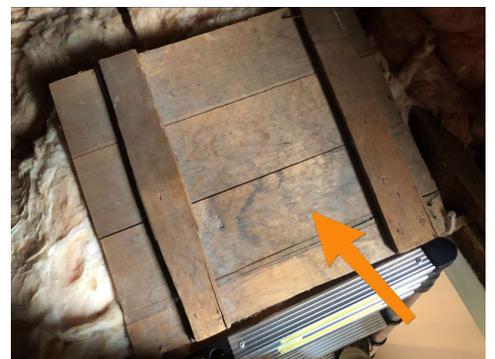
### 14.5.1 Insulation Notes

#### HATCH MISSING INSULATION

The attic access hatch was missing insulation. We recommend installing.
