IDAHO SKY
208.267.0540
netmail@idahosky.com
<https://www.idahosky.com>

ROOM-BY-ROOM RESIDENTIAL DEMO

1234 Demonstration Report 1
Bonners Ferry ID 83805

Mr Anderson
NOVEMBER 17, 2021

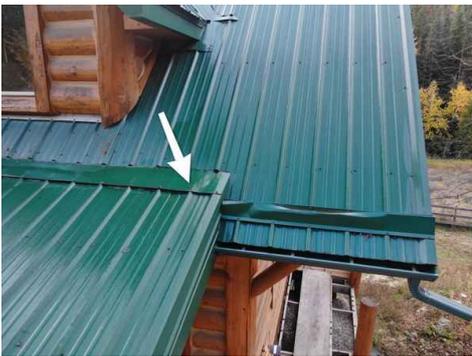
2.1.1 Coverings

LOOSE AND MISSING SCREWS/NAILS

Observed one or more under-driven nails/fasteners. Recommend a qualified roofing contractor evaluate and repair.

There are small holes in the roof where screws are missing.

Missing / Popped Screw

Contact a qualified roofing professional.

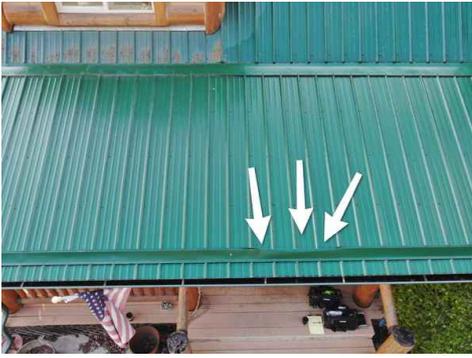
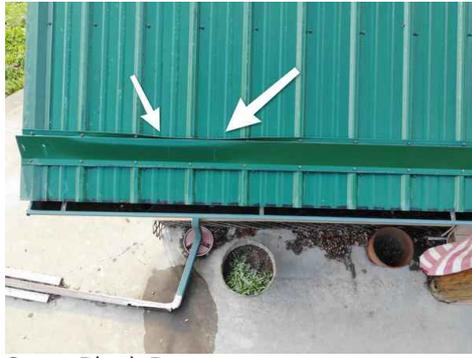
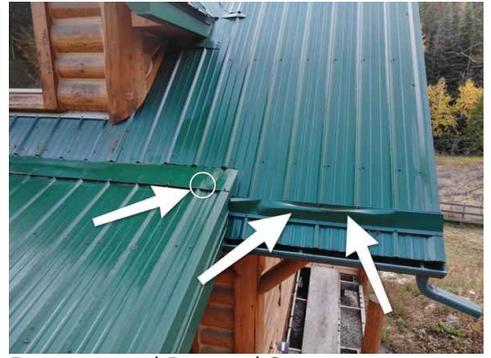
SNOW BREAKS - DAMAGED

There are several places where the snow blocks are damaged. Some even have screws missing and/or popped.

Snow Block Damage

Damage and Popped Screw

Recommend a qualified roofing professional evaluate and repair.

Contact a qualified roofing professional.

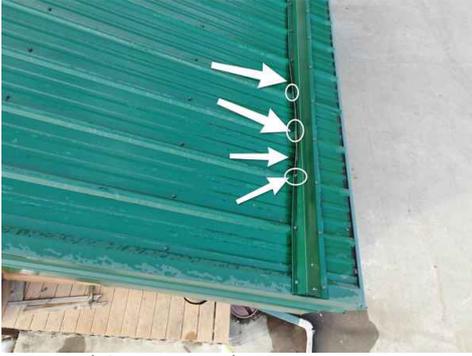
Popped Screws and Damage

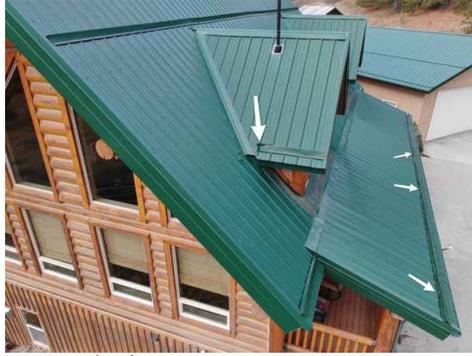
Snow Block Damage

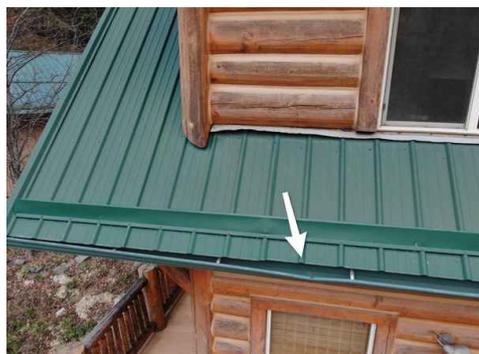
South West Gutter

GUTTER DAMAGED

The runoff gutters were damaged in several places. This can result in excessive moisture in the soil at the foundation, which can lead to foundation/structural movement. Recommend a qualified contractor evaluate and repair.

Contact a qualified gutter contractor

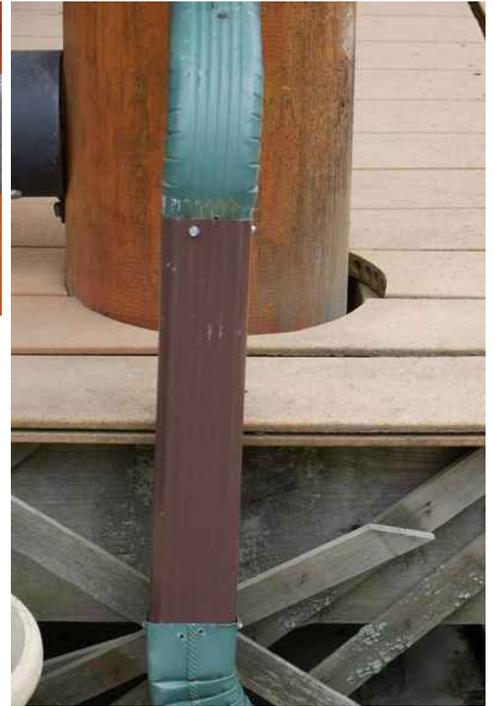
GUTTER LEAKAGE

Gutters were observed to be leaking in one or more areas. This can result in excessive moisture in the soil at the foundation, which can lead to foundation/structural movement. Recommend a qualified contractor evaluate and repair gutters to proper functionality.

Contact a qualified roofing professional.

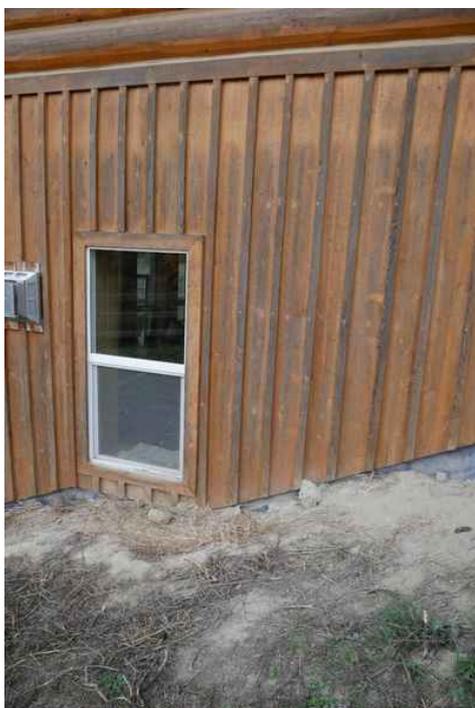
Eastside

Inadequate clearance between siding and ground. Recommend a minimum ground clearance between bottom of siding and ground of 4". Siding in contact with the ground or soil is a serious concern because that condition can provide direct access for wood destroying insects.

Contact a qualified siding specialist.

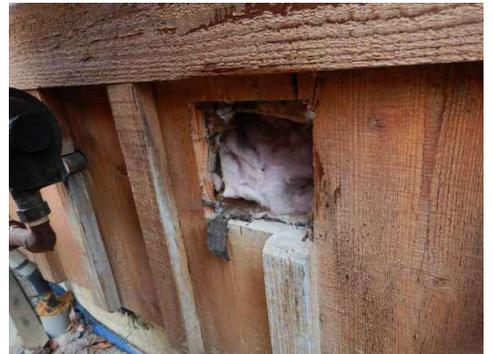
There is a hole on the southwest side of the house. Moisture and animal entrance to the house. Repair recommended.

Hole by Gas Regulator

Contact a qualified professional.

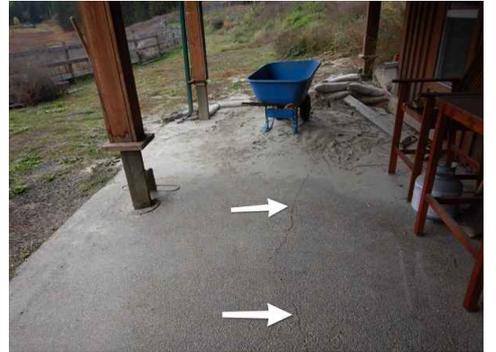
Basement concrete has signs of minor cracking.
The concrete has a noticeable hump. This hump could be caused by frost heave, or water.
Evaluation and repair by a qualified contractor recommended.

Concrete Cracks

Recommendation
Contact a qualified professional.

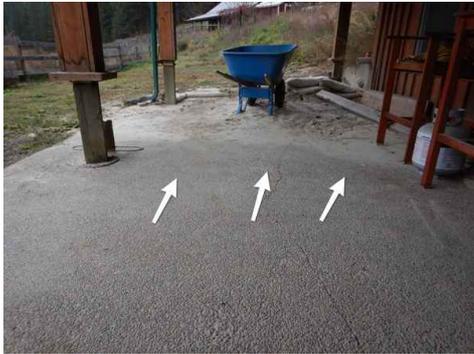
Concrete Hump

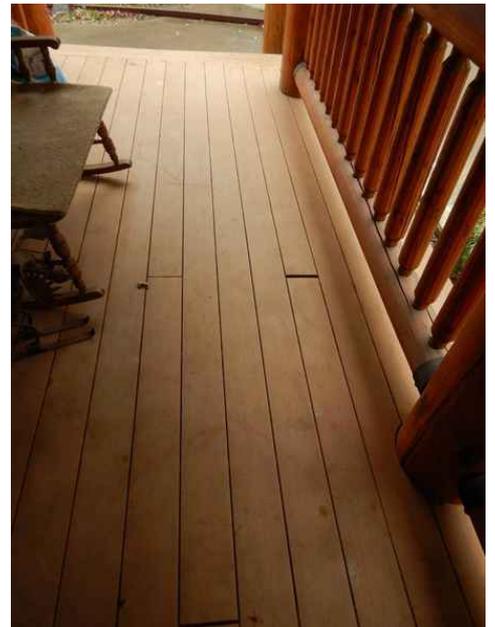
The boards on the covered porch are made from 1st generation Trex material that is unsafe to use.

Porch Boards

Replacement strongly recommended.

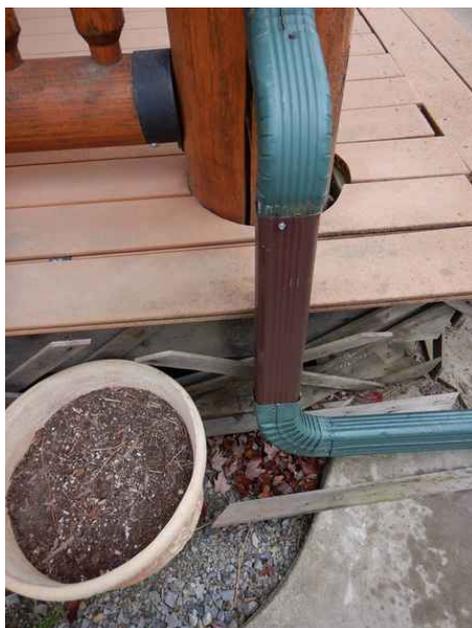
The front porch lattice is broken in some spots, and is detaching from the porch framing.

Broken Lattice

Repair recommended.

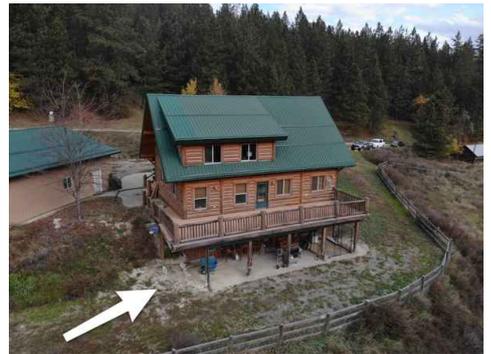
1: The South West Post that is supposed to be holding up the entire corner of the deck, is missing. It appears to be built as a possible cantilever. However, it is insufficient.

Missing Corner Support Post

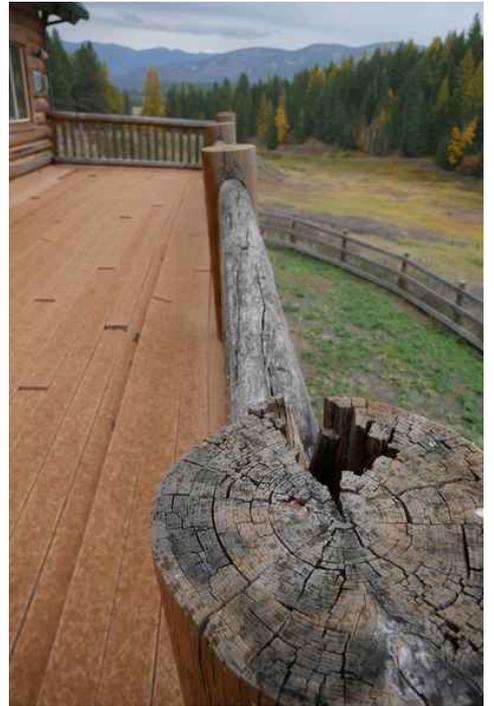
3: The railing is not connected properly at the corners. If someone leans against the railing, it can easily break away due to rot, and/or being disconnected.

Railings and Posts Rotting and Unsafe

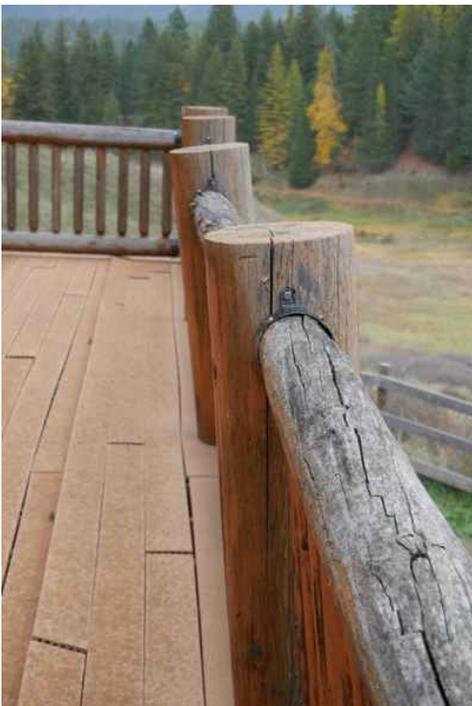
Railings Delapitated

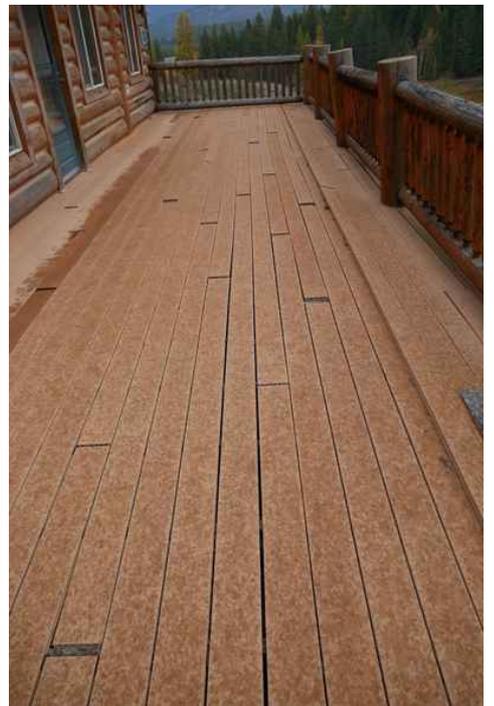
4: The flooring on the deck is made with 1st generation Trex. This material is unsafe, and should be replaced throughout with a different material. The current deck floor boards are not properly fastened. There are many loose and unfastened boards. A person could easily fall through the deck floor.

Trex Flooring Unsafe to Walk on

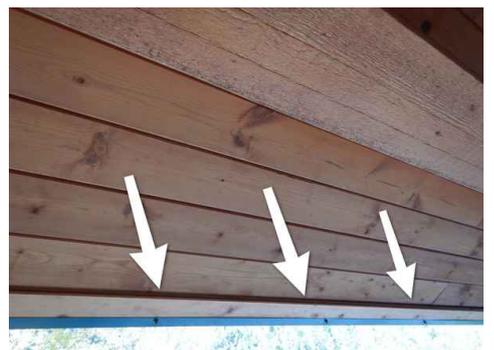
The front porch soffits board is loose and creating gap between the boards. Possibility for moisture and insect intrusion.

Gap Between Boards

Repair recommended.

Contact a qualified professional.

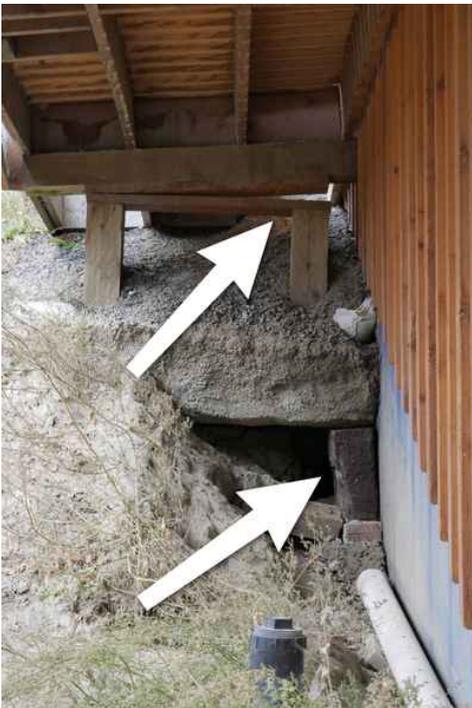
Additionally, the deck entrance ramp has structural failures underneath. There is a single brick holding it up. (see photo)

Ramp Structural Failures

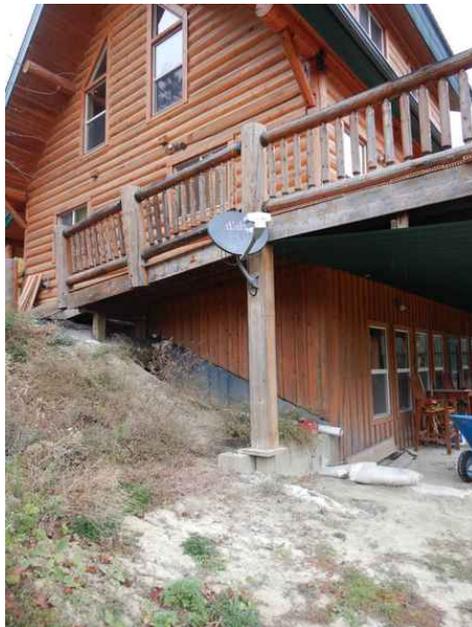
Water and earth erosion was discovered under the deck ramp close to the house foundation. It creates a mud slide that can enter the house which can also create mold problems.

West Side Erosion

It is recommended to remediate the erosion issues.

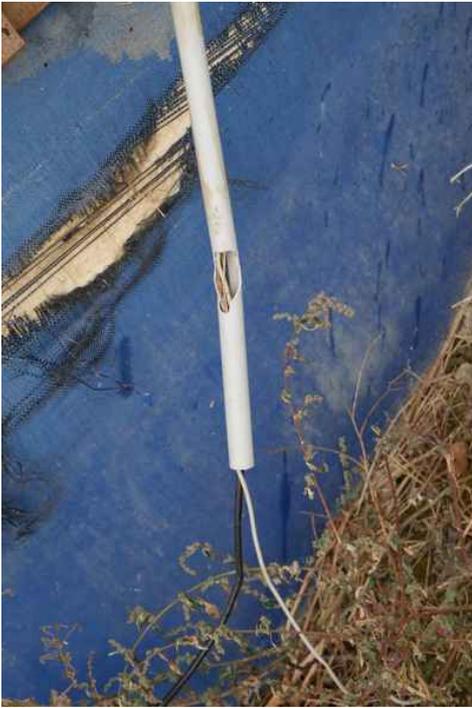
We observed a wire bundle protruding from the telco box.

Sheathing Split

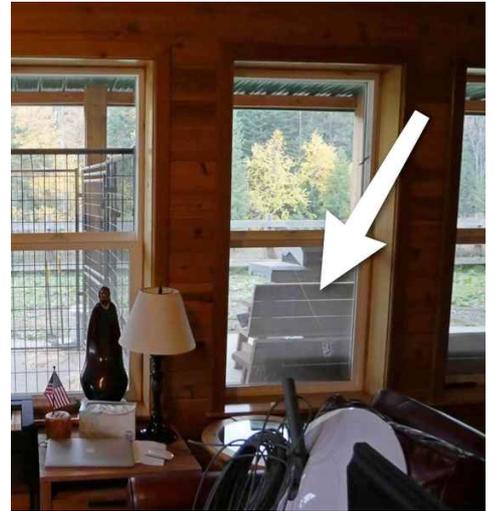
BASEMENT WINDOW DAMAGE

One window in the basement has broken glass, and damaged screen.

Broken Window

Repair recommended.

Contact a qualified window repair/installation contractor.

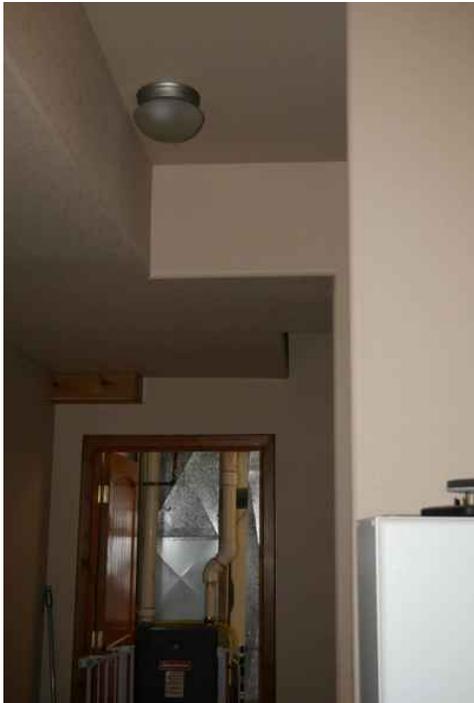
Non-working Light Location

Repair recommended.

Contact a qualified electrical contractor.

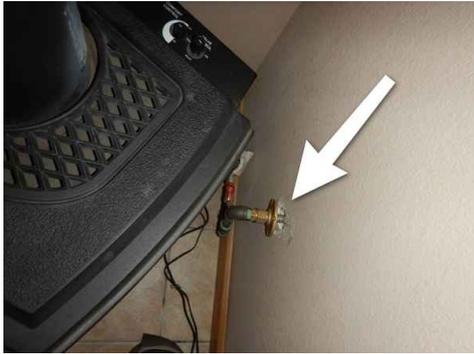
Propane supply pipe is detached from the wall.
Repair recommended by a qualify professional.

Propane Supply Pipe

Contact a qualified professional.

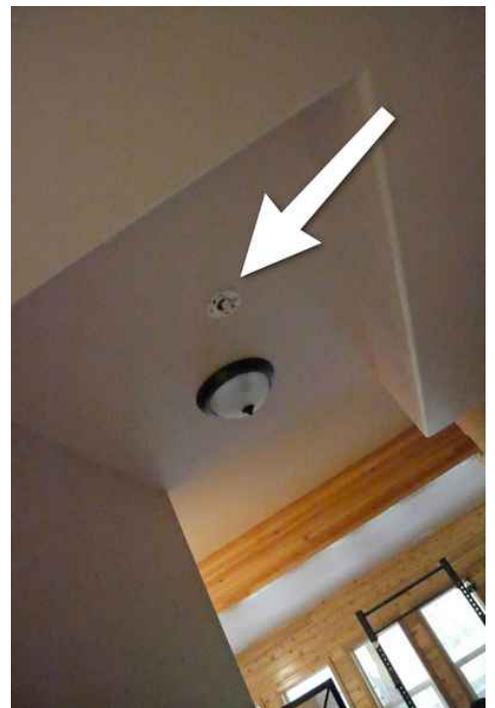
SMOKE DETECTORS ARE MISSING

Smoke detector is missing.

Missing Smoke Detector

Contact a qualified electrical contractor.

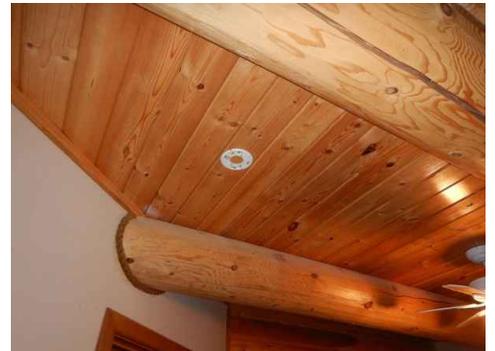
Missing Smoke Detector

Contact a qualified electrical contractor.

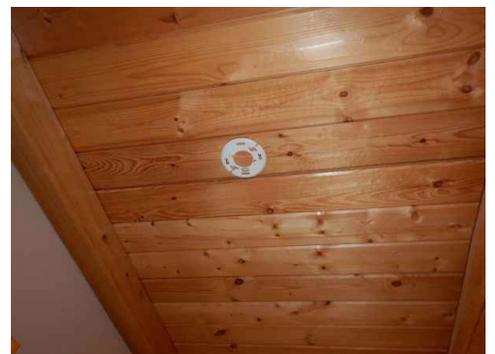
Missing Smoke Detector

Contact a qualified electrical contractor.

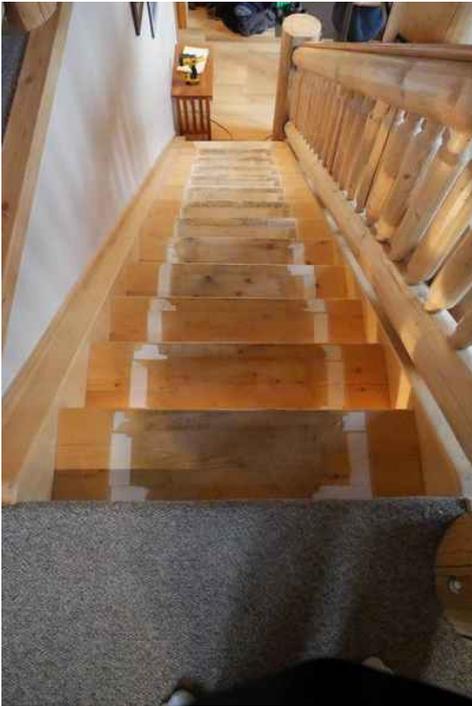
Non Slip Treat is Missing

Contact a qualified professional.

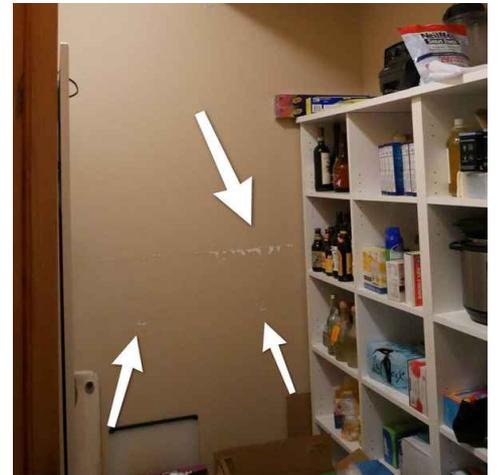
Wall Damage

Contact a qualified professional.

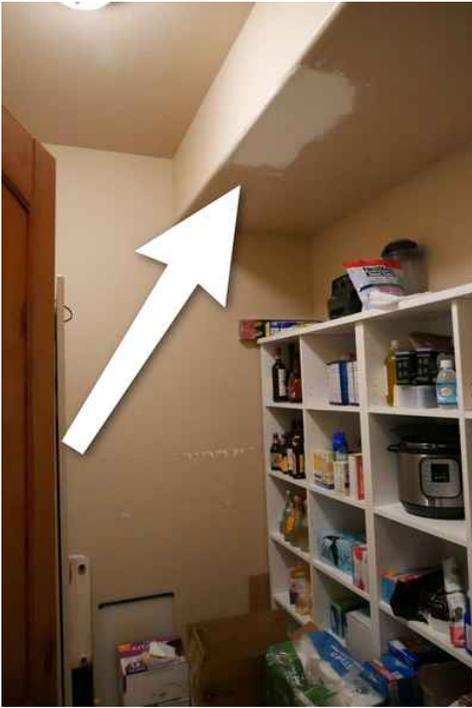
Ceiling Patchwork

Contact a qualified professional.

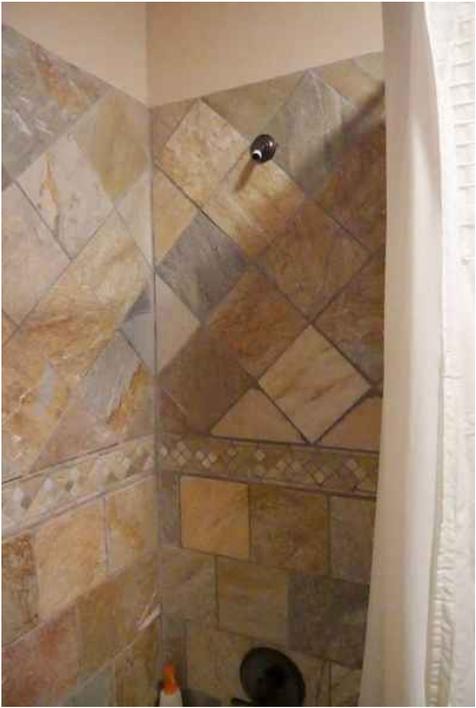
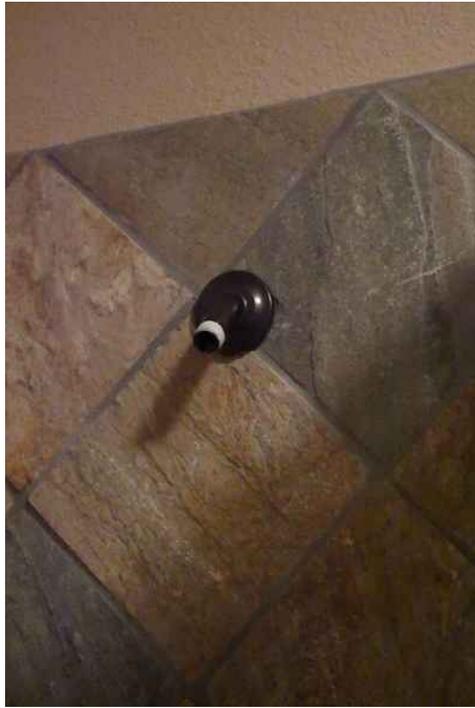
Missing Showerhead

Contact a handyman or DIY project

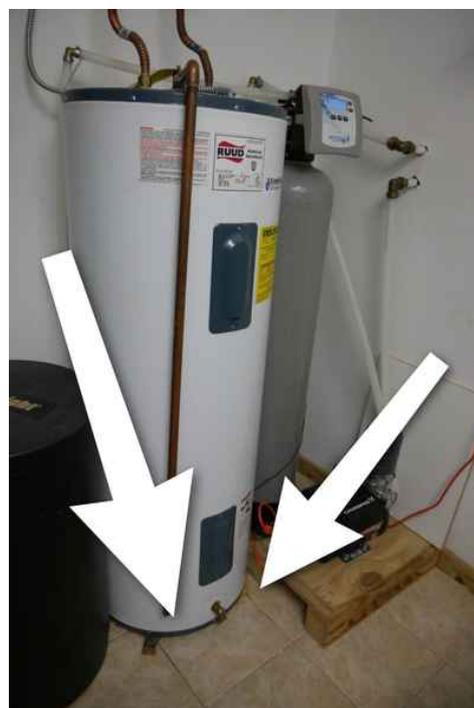
Missing Drip Pan

Contact a qualified plumbing contractor.

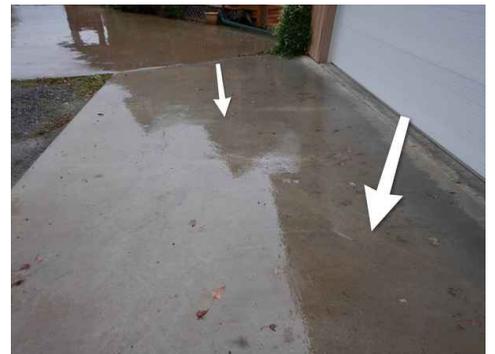
Minor Cracks

Contact a qualified professional.

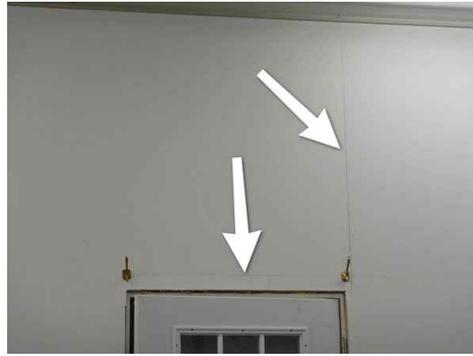
MINOR CRACKS PRESENT

Drywall Cracks
