TREC-7-6

PROPERTY INSPECTION REPORT FORM

5940 Fairbrook Dr, San Antonio, TX 78242

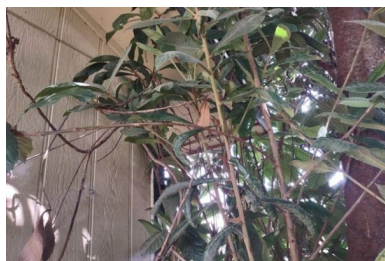
Perimeter

Vegetation is contacting the exterior of the home. This can lead to increased pest activity, moisture intrusion as well as paint/siding damage. Recommend trimming vegetation away from the home or removal as needed by a qualified landscaping professional.

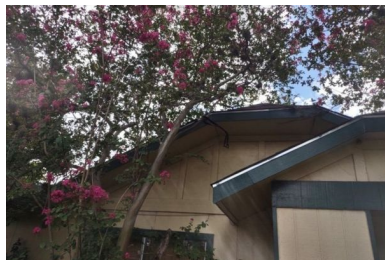
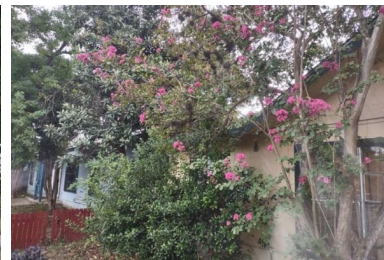
Tree(s) are contacting and/or overhanging the roof. This can lead to roof covering damage as well as excessive debris build-up resulting in a lack of drainage. Recommend having the trees trimmed in these locations by a qualified arborist.

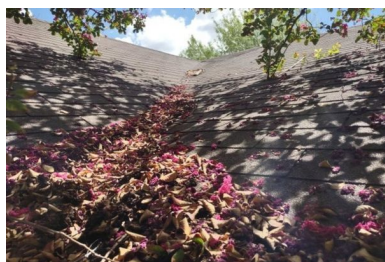
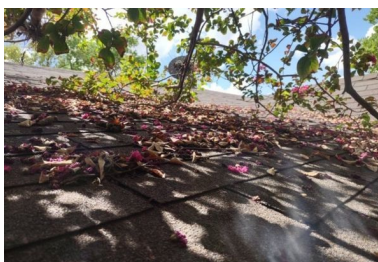
**2: Minor vegetation debris resting on roof**[Service/Repair or Replace](#)

Vegetation debris observed on the roof may gather and eventually lead to a lack of drainage. Recommend having all debris cleared/removed.

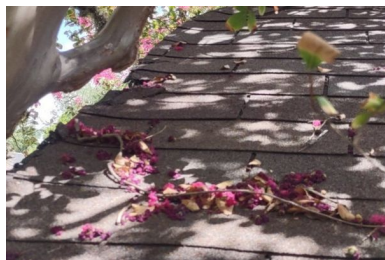
**3: Damaged/Missing Asphalt Shingles**

Various asphalt shingles have lifted and tabs are damaged and/or missing. Recommend having damaged shingles replaced where necessary by a qualified roofer.

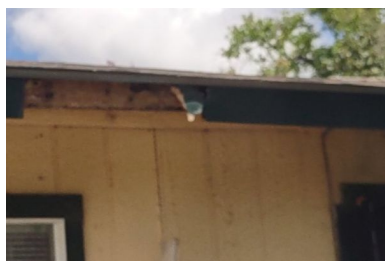
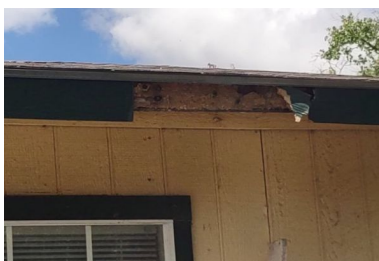
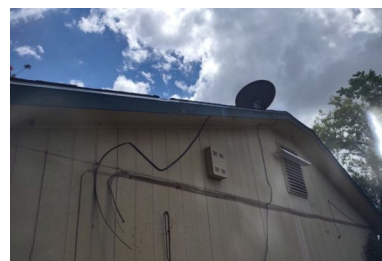
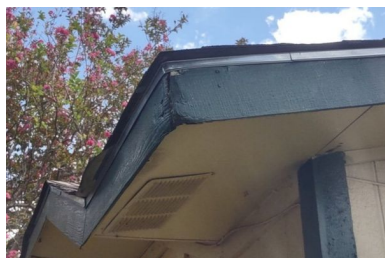
4: Deteriorated fascia board

Deteriorated fascia board observed and various places around the perimeter of the house. Recommend replacing fascia board as needed

Recommendation: Contact a qualified professional.

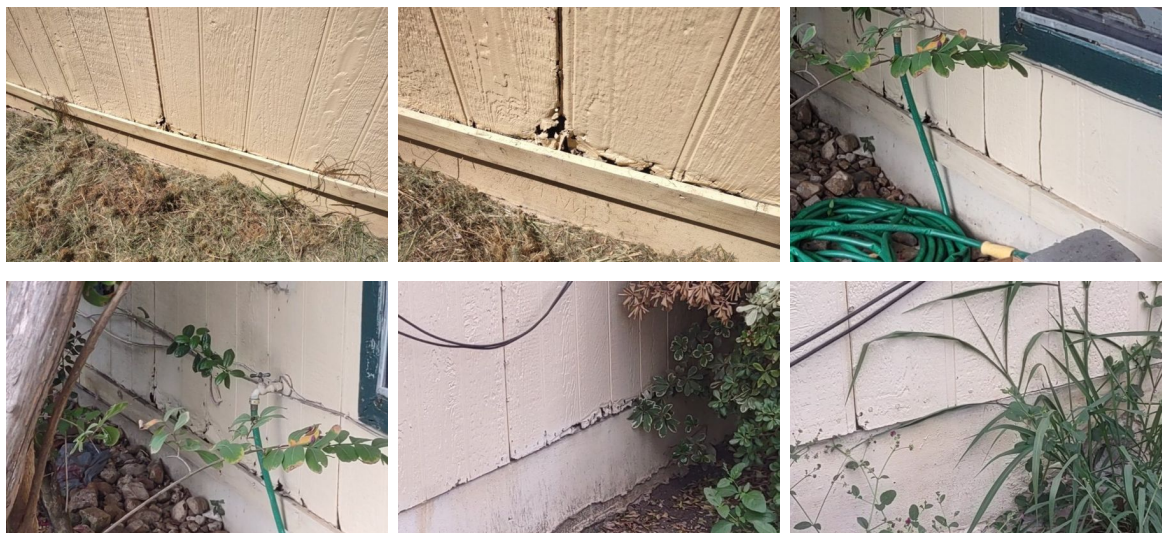
1: Water damaged and deteriorating material

Water damaged and deteriorating composite board siding material. Recommend evaluation by a qualified professional to repair and replace siding as necessary

Recommendation: Contact a qualified professional.

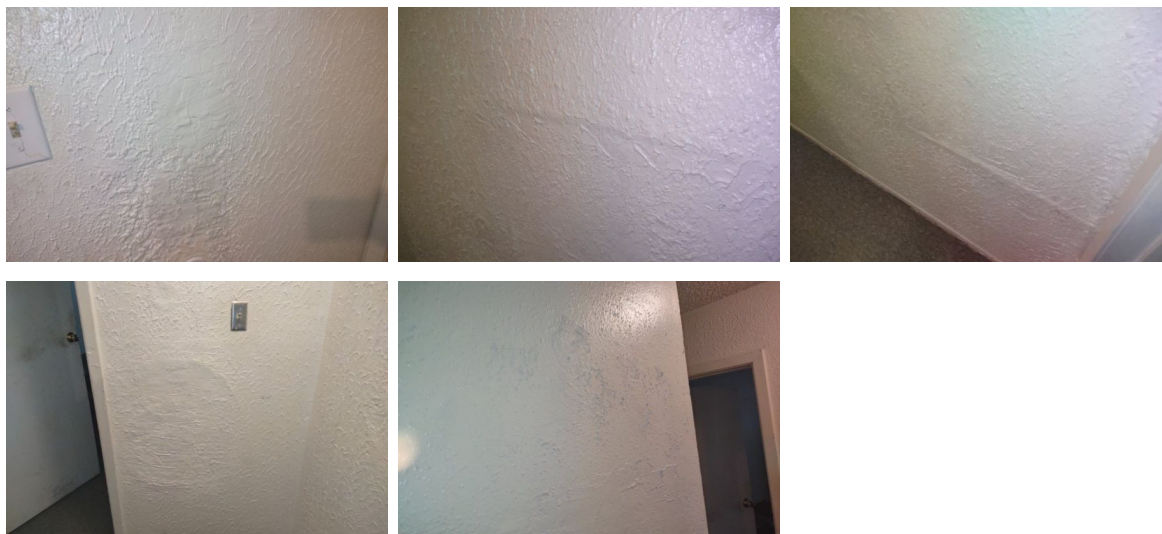
2: Drywall patchwork

Very visible drywall patchwork throughout unit 5902. Recommend repairs as needed

Recommendation: Contact a qualified professional.

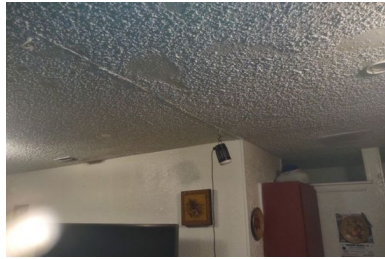
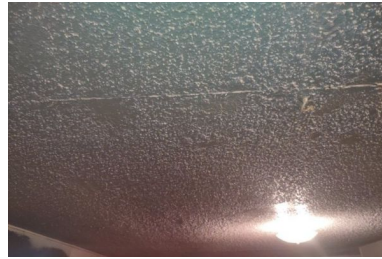
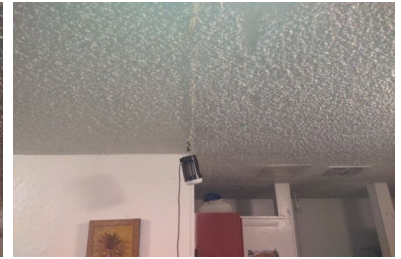
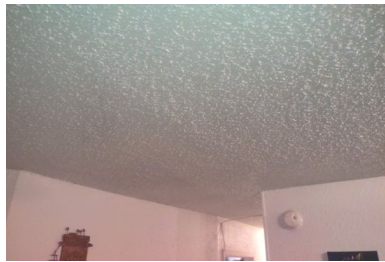
1: Long/wide Drywall cracks (evaluation recommended)

Long and/or wide drywall cracks observed. This degree of cracking may indicate excessive or abnormal movement/shifting. Recommend further evaluation by a qualified structural contractor.

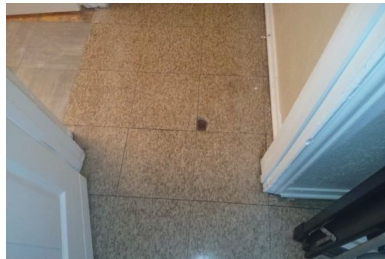
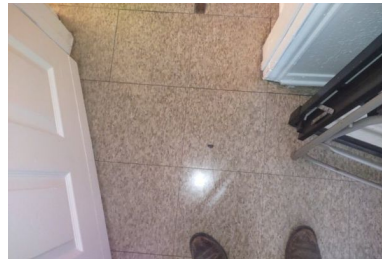
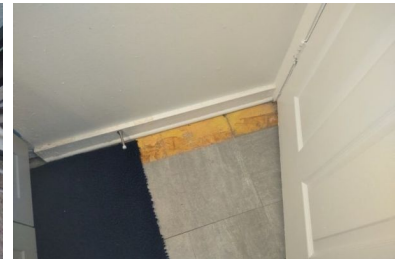
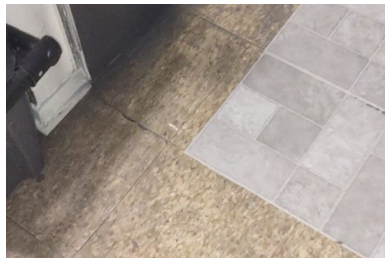
Hallway and bedroom unit 5942

Damaged and/or missing vinyl/linoleum flooring observed. Recommend service/replacement as needed by a qualified flooring professional.

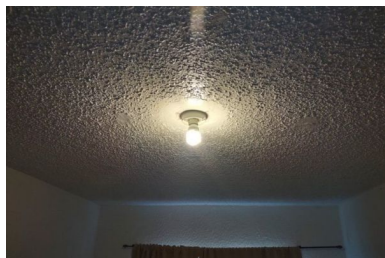
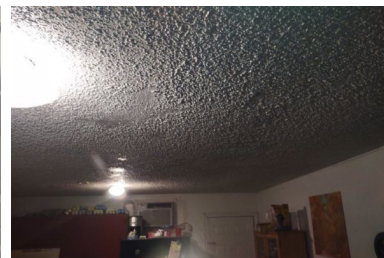
3: Peeling popcorn style texture

Peeling and missing popcorn style texture throughout unit 5942. Recommend application of texture as needed by a qualified professional.

Recommendation: Contact a qualified professional.

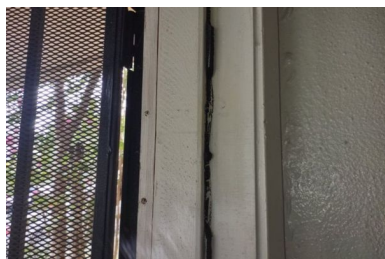
Unit 5940

Damaged weather stripping observed at the exterior entry door appears to be compromising moisture/weather seal. Recommend replacement. Recommend consulting a qualified door technician if needed.

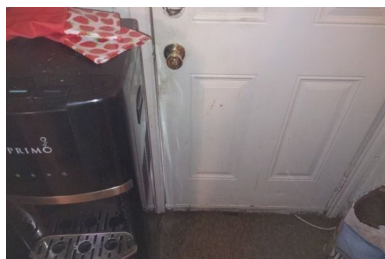
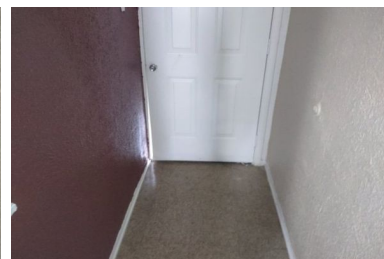
All Exterior entry doors at both units

The entry door does not appear to be adequately/fully sealed when closed. Recommend service/adjustment of the door (or replacement of the weather sealing components if needed) by a qualified door technician.

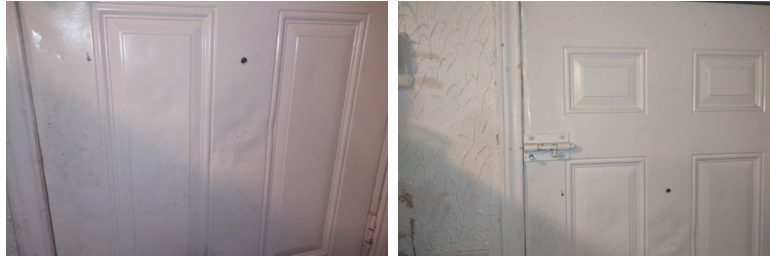
3: Damaged door

Damaged rear and front entry doors. The rear entry door is hard to open. Recommend repairs or replacements by a qualified professional

Recommendation: Contact a qualified professional.

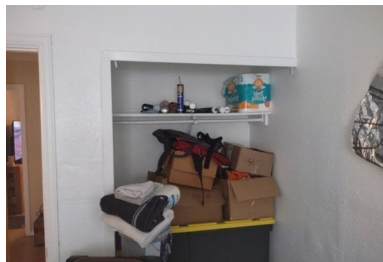
4: Missing closet doors

Missing closet doors. One bedroom in both units (2 total). Recommend installation of closet doors as needed

Recommendation: Contact a qualified professional.

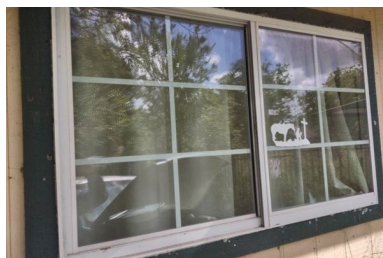
Perimeter

Missing window screens noted. Recommend replacement as needed by a qualified window professional.

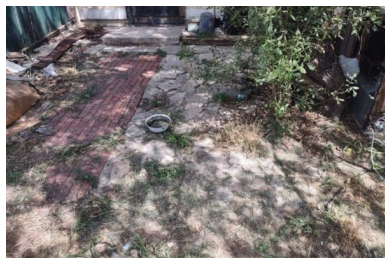
1: Cracked and uneven concrete

Cracked and uneven concrete to back driveway at unit 5940. Recommend repairs as needed by qualified professional

Recommendation: Contact a qualified professional.

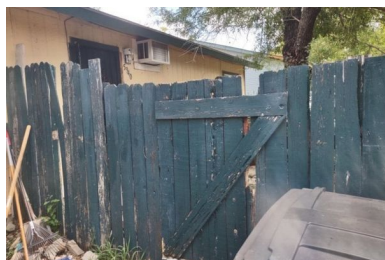
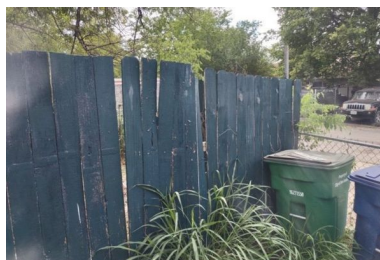
Loose, weathered and/or damaged wood planks observed at the wood fence. Recommend replacement as/where needed by a qualified professional.

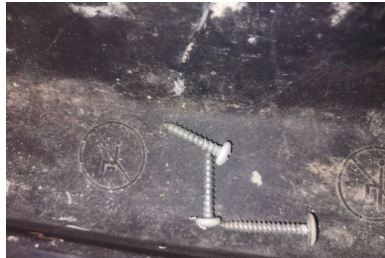
Main service panel unit 5940

Pointed fastener(s) installed to secure the dead front cover could damage wiring within. Recommend replacement with appropriate non-pointed fastener(s). Recommend consulting a qualified electrician if needed.

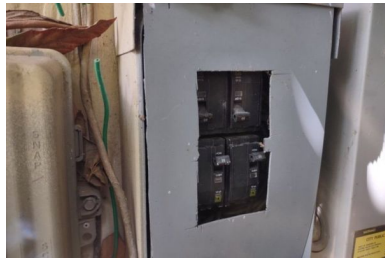
**4: Exposed exterior circuits**

Homemade dead front cover was installed. Recommend installation of manufacturer's dead front cover that will cover exposed exterior circuits.

Recommendation: Contact a qualified professional.

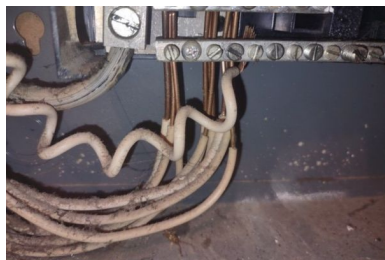
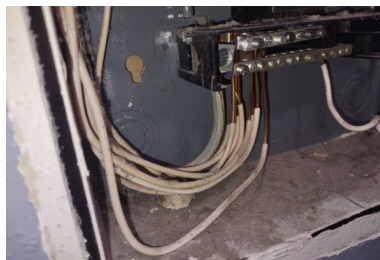
Both sub panels

Some of the neutral conductor terminals are double-tapped. These conductors should often terminate individually. Recommend assessment/correction if necessary by a qualified electrician.

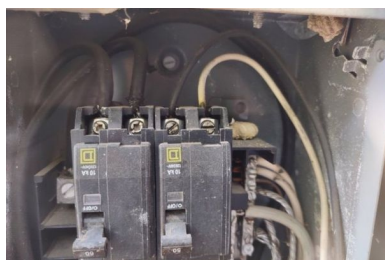
Both main service panels

Electrical conductors with white insulation are installed as line/hot. These conductors are to be installed as grounded/neutral conductors or should be correctly color coded if installed as a line/hot or equipment grounding conductor. Recommend application of appropriate color coding tape by a qualified electrician.

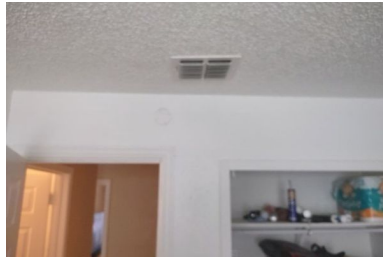
Smoke detector(s) are missing or have been removed. Recommend replacement by a qualified electrician.

Recommendation: Contact a qualified professional.

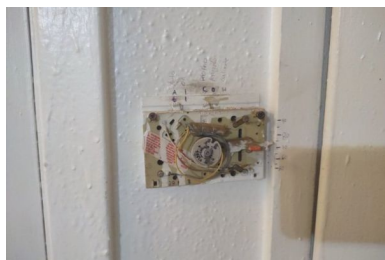
4: Missing thermostat cover

Missing cover to thermostat. Recommend installation as needed

Recommendation: Contact a qualified professional.

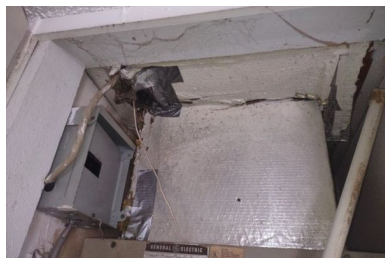
1: Damageductwork

Damaged duct at the supply air plenum. Recommend repairs

Recommendation: Contact a qualified professional.

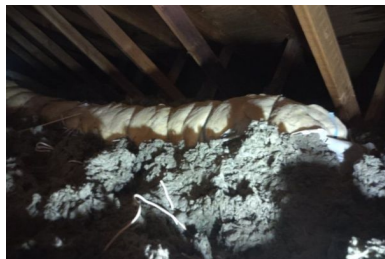
2: Deteriorated insulation

Insulation on the ductwork is deteriorating. Recommend replacement of ductwork as needed by qualified professional

Recommendation: Contact a qualified professional.

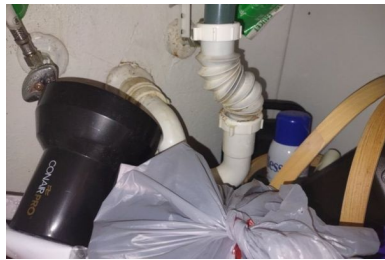
Unit 5940

Flexible drain piping is installed. These drain pipes can be prone to clogging as they do not have a smooth interior. They also may be easily deformed or punctured. Recommend replacement with a solid/rigid piping by a qualified plumber.

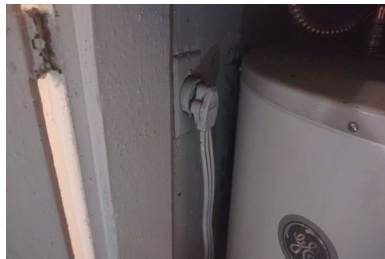
2: Missing quick disconnect

Missing quick disconnect to hot water heaters. Recommend installation

Recommendation: Contact a qualified professional.
