## STUCCO REPORT

123 Main Street, Philadelphia pa  
Philadelphia, PA 19125

FEBRUARY 28, 2023

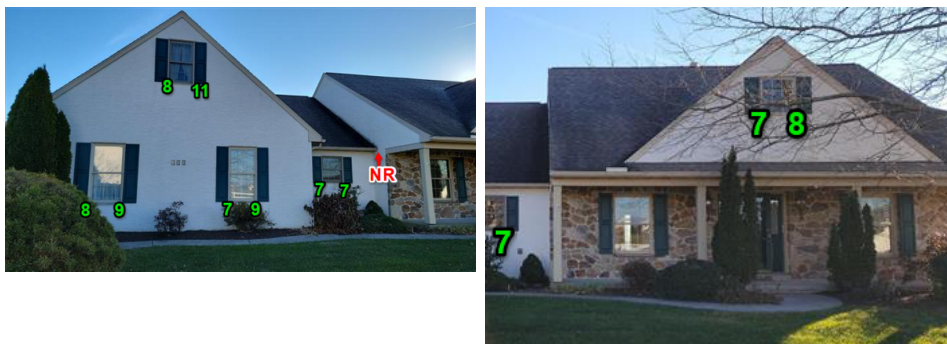
#### 3.1.1 Front Elevation Moisture Readings:

##### **SOFT**

Although there were no HIGH moisture readings on this elevation, the substrate was noted to be soft and/or non-existent, indicating the likelihood of structural damage at the areas that are noted in red. This deterioration has been caused by continuous moisture intrusion due to lack of proper flashing details and/or a lack of proper system sealants at penetrations in the system. The system should be opened up and the stucco removed until clean, dry substrate is found. Structural repairs should be made as needed and the system should be re-installed as per ASTM standards.

Action should be taken immediately to correct these conditions before further moisture intrusion and/or damage occurs. Specific prescriptions for remediation are outlined in the Repair & Remediation Recommendations to follow.

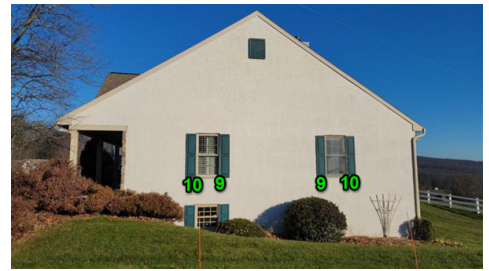
#### 3.2.1 Right Elevation Moisture Readings:

##### **LOW MOISTURE**

Noted moisture probing in critical areas on this elevation did NOT reveal any elevated or high moisture levels at the time of this inspection. There may be other moisture maps in this report that show specific areas on this elevation that do reveal elevated or high moisture readings. If so, they will be specifically called out.

Although no elevated moisture readings were recorded at the time of this inspection, conditions may be present that may cause moisture problems in the future. Action should be taken now to correct these conditions before moisture intrusion and/or damage occurs. Specific prescriptions for remediation are outlined in the Repair & Remediation Recommendations to follow.

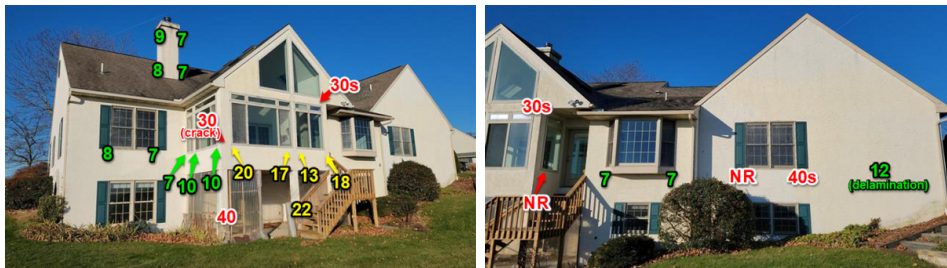
### 3.3.1 Rear Elevation Moisture Readings:

#### **ELEVATED AND HIGH**

There were ELEVATED & HIGH moisture readings on this elevation. The substrate was noted to be soft and/or non-existent, indicating the likelihood of structural damage at the areas that are noted in red. This deterioration has been caused by continuous moisture intrusion due to lack of proper flashing details and/or a lack of proper system sealants at penetrations in the system. The system should be opened up and the stucco removed until clean, dry substrate is found. Structural repairs should be made as needed and the system should be re-installed as per ASTM standards.

Action should be taken immediately to correct these conditions before further moisture intrusion and/or damage occurs. Specific recommendations for remediation are outlined in the Evaluation Summary and narratives on the photos to follow.

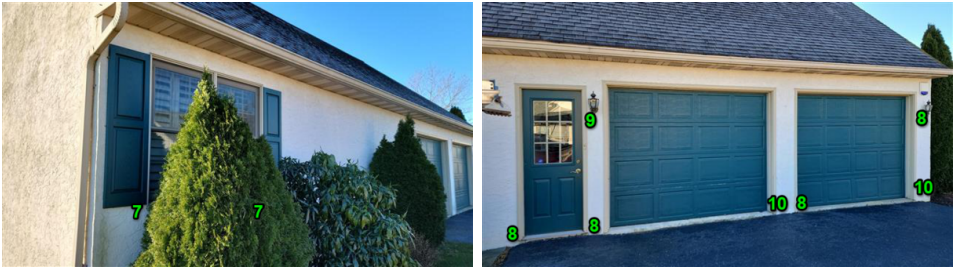
### 3.4.1 Left Elevation Moisture Readings:

#### **LOW MOISTURE**

Noted moisture probing in critical areas on this elevation did NOT reveal any elevated or high moisture levels at the time of this inspection. There may be other moisture maps in this report that show specific areas on this elevation that do reveal elevated or high moisture readings. If so, they will be specifically called out.

Although no elevated moisture readings were recorded at the time of this inspection, conditions may be present that may cause moisture problems in the future. Action should be taken now to correct these conditions before moisture intrusion and/or damage occurs. Specific prescriptions for remediation are outlined in the Repair & Remediation Recommendations to follow.

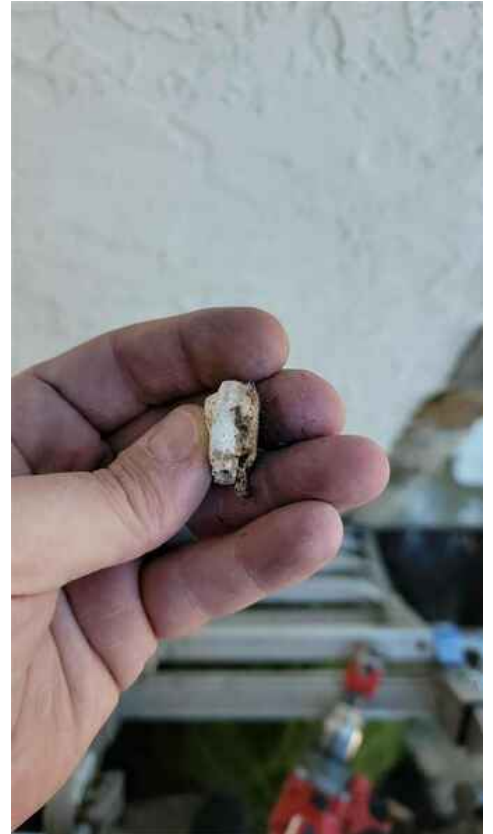
#### 5.1.1 System Thickness

##### **LESS THAN 1/2**

The thickness of the system was measured either by core sampling or the removal of an attachment or by moisture probing. The system thickness was found to be Less than 1/2" - This is considerably less than the ASTM minimum standard. This system thickness is an approximation based on the limited sampling taken. The system thickness can vary greatly. The ASTM minimum standard for traditional hardcoat stucco is 7/8". The ASTM minimum standard for the base of an adhered stone veneer system is 3/4". EIFS and other synthetic system each have a minimum standard based on the type of system and substrate utilized.

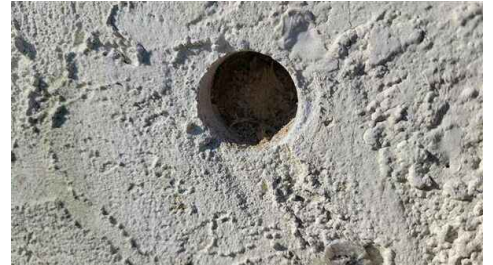
Core Sample

##### **OSB**

Oriented Strand Board - Oriented strand board (OSB), also known as sterling board, sterling OSB, and aspenite, is an engineered wood particle board formed by adding adhesives and then compressing layers of wood strands (flakes) in specific orientations.

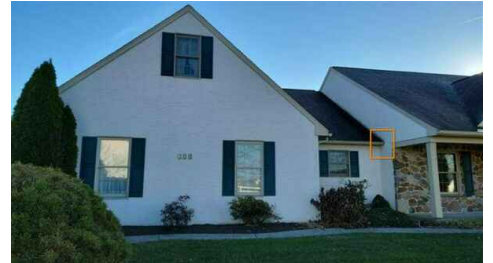
### 10.1.1 Kickout Flashing

#### **KICKOUT MISSING**

Kickout flashing is missing at location noted in the pictures below. Kickout flashing is a diverter flashing that is installed as the first piece of flashing at the end of the roof where it intersects the wall. Intended to prevent channeling of moisture behind system at roof/wall or roof/chimney intersections. Kickout flashing should be installed at ALL primary and secondary kickout locations.

**KICKOUT FLASHING MISSING****Install Kickout Flashing**

Kickout flashing should be installed into the system according to the specifications noted herein. Kickout flashing should be installed at all primary and secondary kickout locations (secondary locations include chimneys stacks and washes, bay windows, etc). When installing kickout flashing/diverters use DryFlekt® type or equivalent. Kickout flashing should at least 6" x 6" x 12" in size. Kickout flashing should penetrate the stucco cladding and be set against the substrate with the system applied over it. The base of the kickout should be set on the roof deck with the roof coverings and tar paper set over the top of the base of the kickout. On completion both the front and back of the kickout bucket should be caulked.

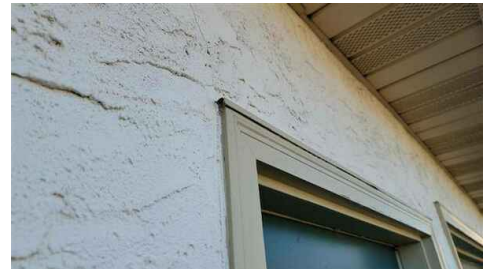
### 11.2.1 Windows

#### **POOR CAULKING**

The window frames are sealed with caulking, but the application of sealant was not in accordance with the prescribed remedial recommendation. There is no bond-breaking joint around the window frames. The caulking is too thin and was not applied in accordance with ASTM standards for sealing window perimeters. The sealant is susceptible to premature adhesion failure which can lead to future moisture intrusion.

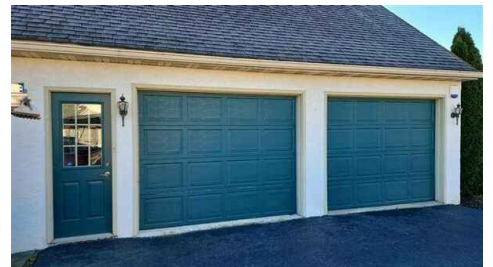
### 12.2.1 Garage Door Frames

#### **NOT SEALED**

The door frames are not sealed properly. There is no bond-breaking joint or sealant around the door frames. The door frames are susceptible to moisture intrusion. All wall assemblies must be able to prevent moisture intrusion from wind-driven rain through testing of the exterior wall envelope, including joints, penetrations and intersections with dissimilar materials.

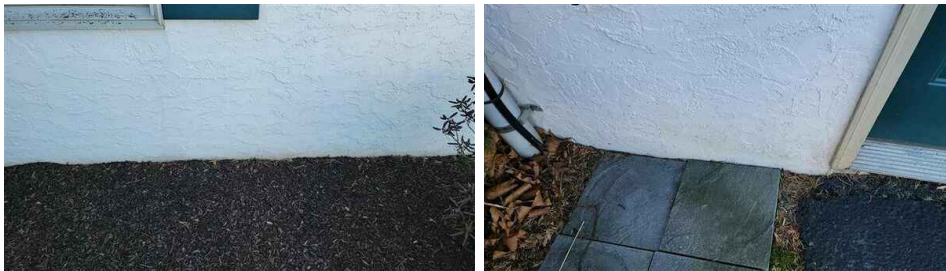
### 13.1.1 Stucco Grade

#### **IMPROPER**

At the locations where the stucco system is applied over wood framing, the stucco is in close proximity to or terminates below grade. Improper ground clearance at soft grade/landscaping provides means of conveyance for moisture and wood-destroying insect egress to the structure.

A clearance of 4" above soft grade and 2" above hard grade is standard.

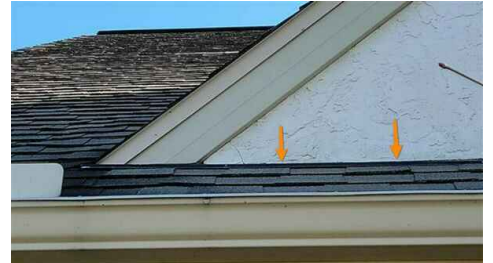
#### 14.1.1 Improper Roof Termination

##### **NO WEEP SCREED- IMPROPER CLEARANCE**

Industry standards require a 2" separation between the roof covering and the stucco/stone cladding. There should also be an integral weep system at the base of the adhered stucco/stone system. There is not a 2" separation between the roof & stucco/stone system. The stucco system should not be in contact w/ roof covering. There is NOT an integral weep system installed.

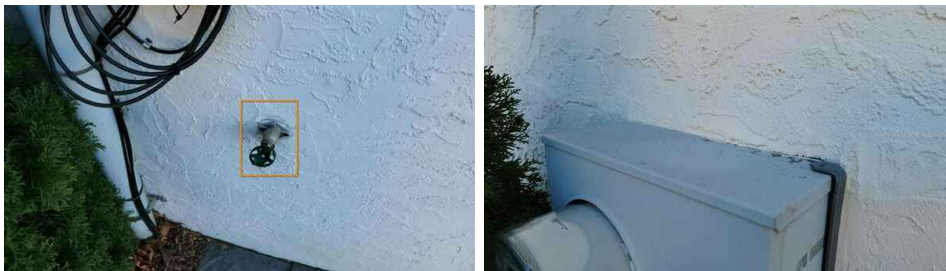
### 15.1.1 Attachments/Penetrations

#### **SOME**

Some of the attachments and/or penetrations are not properly sealed with approved sealant and in a manner that is in accordance with industry standards. All system penetrations such as light fixtures, electrical outlets, and utility conduit or utility boxes should be properly attached and/or sealed with a manufacturer-approved sealant to prevent moisture intrusion. A proper fillet bead of sealant should be applied at ALL penetrations and attachments. The sealant should exhibit a minimum surface contact area of 1/4" onto each surface and have a depth of at least 1/2".

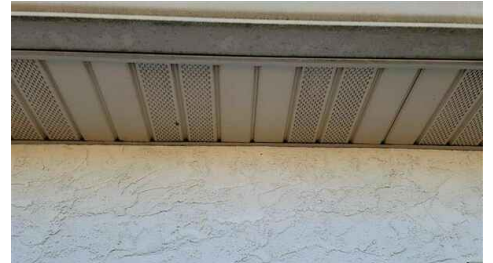
### 16.1.1 Soffit/Fascia/Frieze/Rake Intersections

#### **IMPROPER**

The stucco/stone intersection with soffit, fascia, rake or frieze board is NOT adequately sealed. Stucco industry details require soffit and/or frieze boards to lap over stucco a minimum 1" or alternatively, if stucco is abutted to soffit or frieze board, it should be sealed to prevent moisture intrusion due to wind-driven rain.

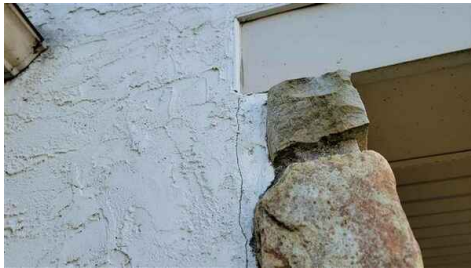
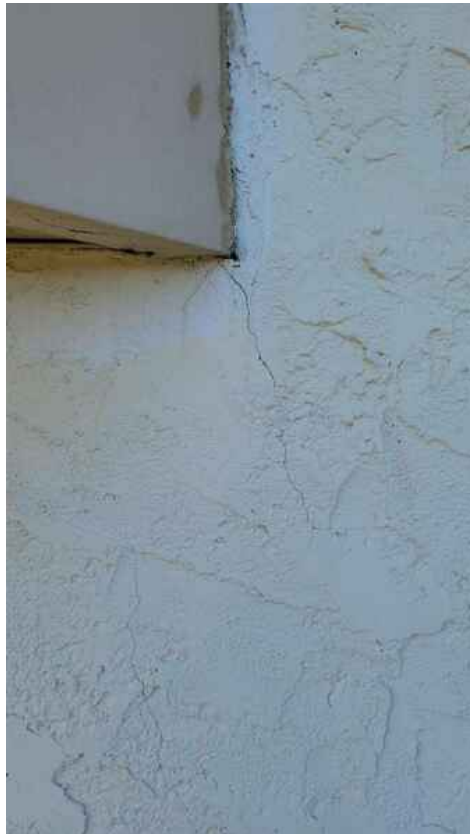
### 17.1.1 Cracking Stucco

#### **CRACKING**

Cracking was noted at numerous locations throughout the system. Compression cracking in stucco systems is usually related to the absence of proper control joints. The stucco system should be inspected regularly and any cracks that are found should be sealed to prevent further moisture intrusion.

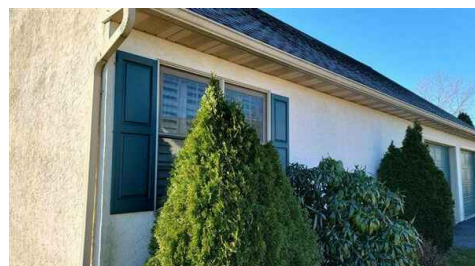
#### 18.1.1 Physical Damage

##### **VEGETATION**

Vegetation is in close contact with/growing on the stucco surface. Dense vegetation can prevent stucco from drying properly, or cause impact damage. Vines can take root behind the stucco surface and allow water to penetrate. All vegetation should be a minimum 18 inches from the stucco surface.

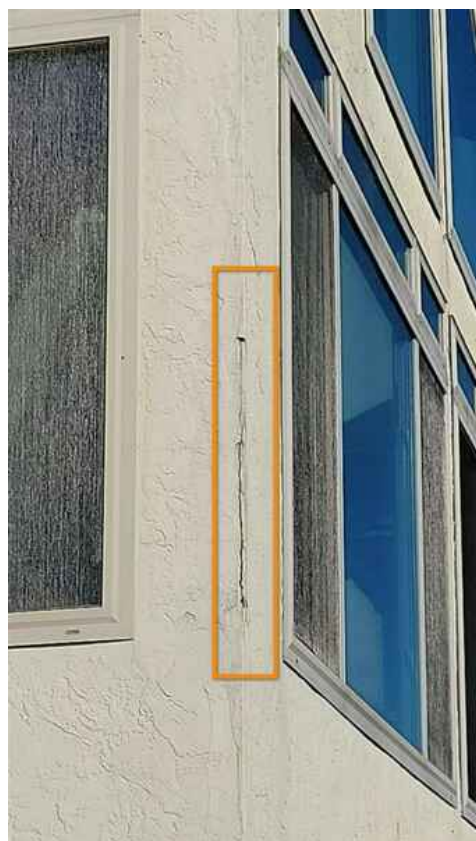
Rear elevation

##### **PHYSICAL DAMAGE**

The inspector observed some type of physical damage to the system that was the result of impact, blunt force, or physical stress. These area(s) of damage may be prone to moisture intrusion and must be repaired in accordance with product specifications. See the photos below depicting the damage observed.

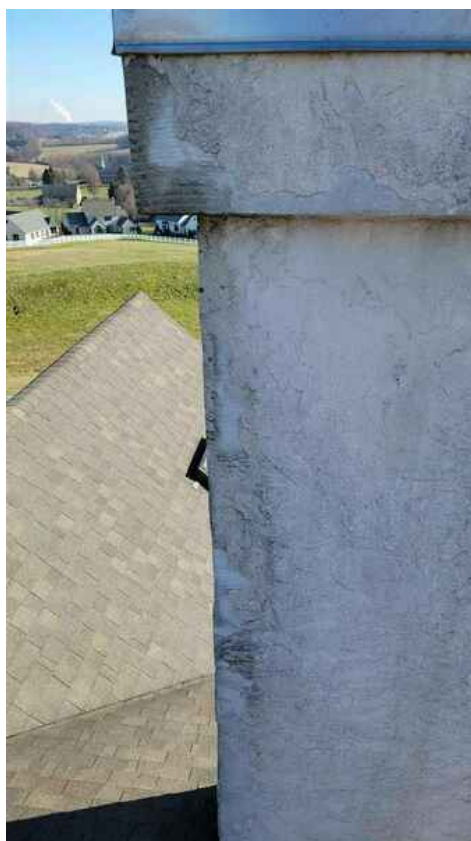
Chimney damage
