RENTAL INSPECTION REPORT

345 Rental Ave
Denver CO 80123

ABC Property
OCTOBER 31, 2018

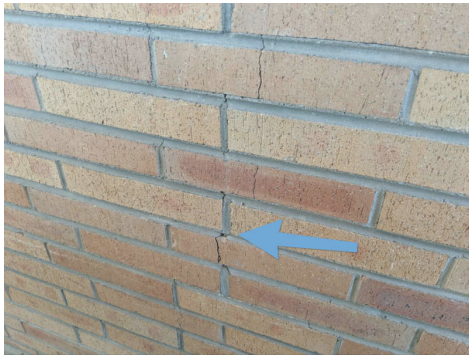
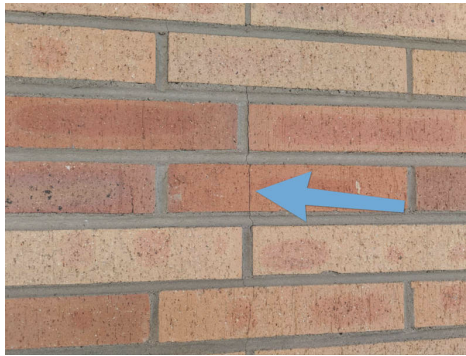
LEFT

MINOR CRACKING OF THE BRICK VENEER

There is minor cracking in the brick veneer present around the chimney.

Recommend monitoring.

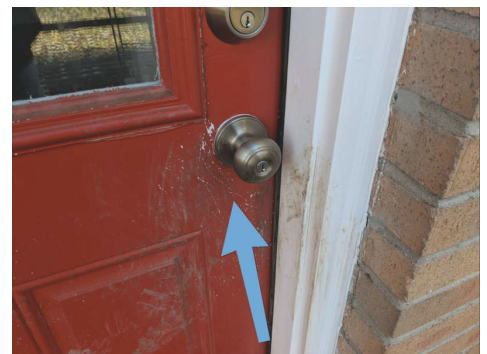
BACK

SCRATCHES ON DOOR

There are scratches on the paint of the rear door. The paint should be redone at this time by a qualified person.

Contact a handyman or DIY project

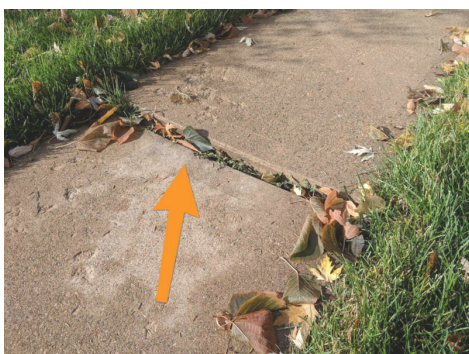
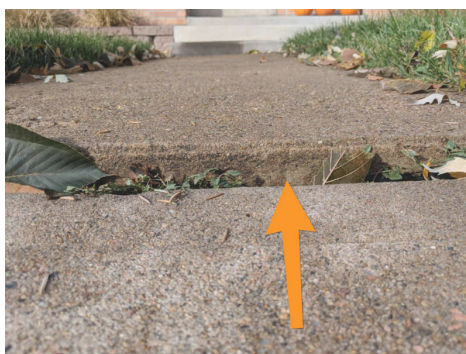
SIDEWALK TRIP HAZARD - MUDJACK OR REPLACE

The concrete walkway at the front of the home has settled or heaved in areas. This appears to have created possible tripping hazards, where the concrete is raised in areas. Consider replacement or mud-jacking at this time, to repair. Consult with a concrete professional for repair options and costs.

Contact a qualified concrete contractor.

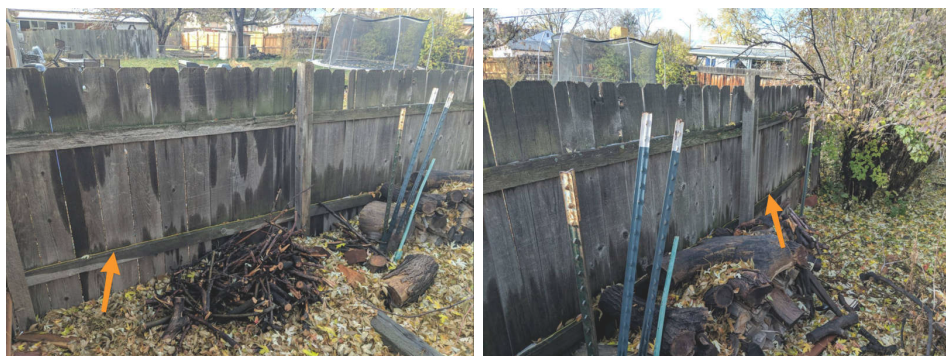
SOUTH FENCE ONLY

FENCE POOR CONDITION

The fence is in poor overall condition, and significant repairs or replacement will likely be needed. Consult with a fence professional for repair/replacement options and costs.

Contact a qualified fencing contractor

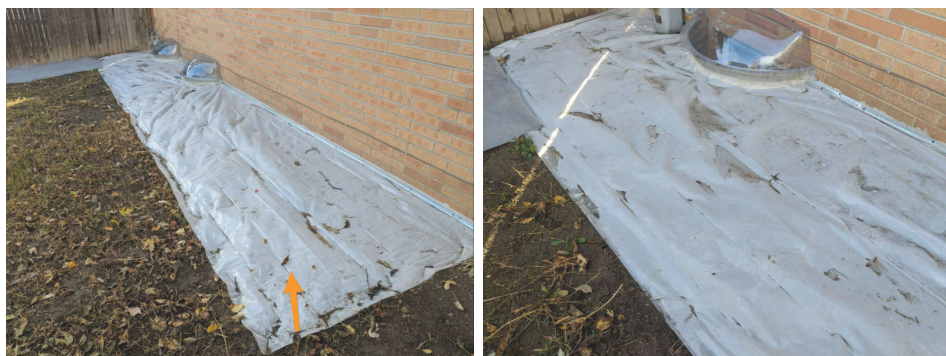
NORTH

PLASTIC SHEETING EXPOSED

There's plastic sheeting around the edge of the north side of the home. This is likely to keep water from sitting near the foundation. I recommend covering the plastic to protect it with landscaping material.

Contact a qualified landscaping contractor

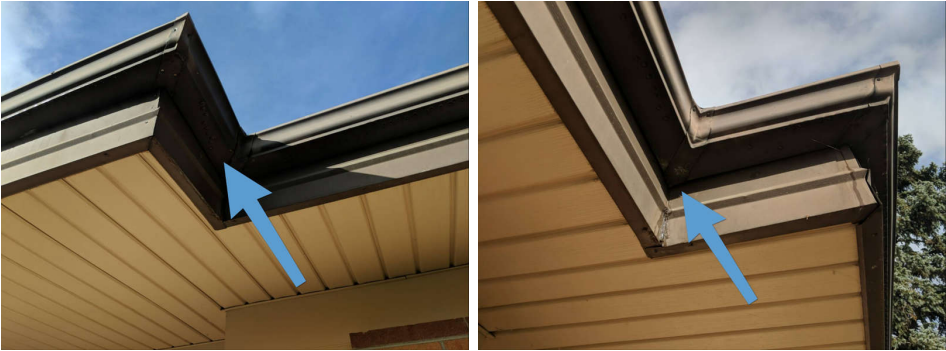
FRONT

SEAM LEAK ON GUTTER

The gutter appears to leak at the seam. I recommend cleaning and apply gutter sealant or epoxy.

Contact a qualified handyman.

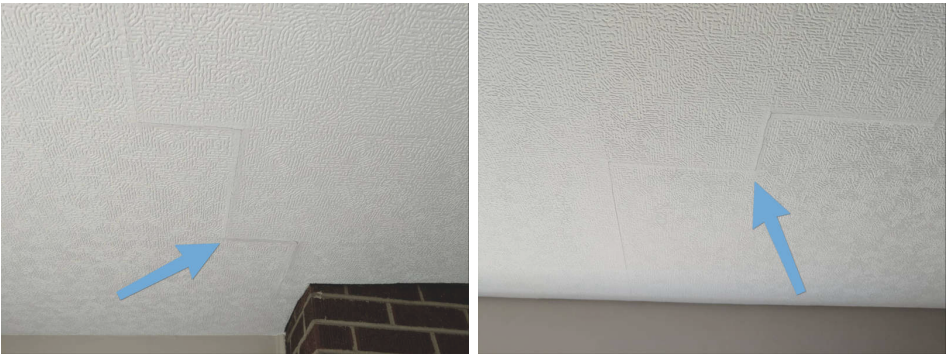
LIVING ROOM FRONT

MOISTURE STAIN

Moisture staining was present at the ceiling. No moisture was currently present or evident in this area, and it may be that whatever leak had occurred has since been repaired. Inquire with occupant for more information on this item. Otherwise, monitor these areas for further moisture concerns, and repair as desired.

Recommendation
Recommend monitoring.

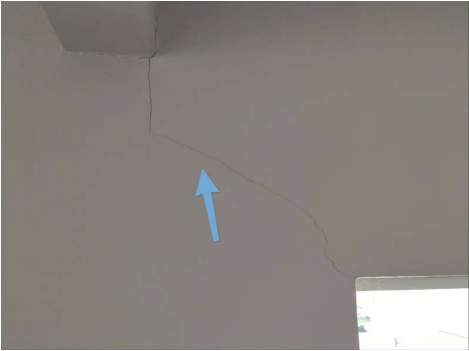
SOUTH WALL

MINOR CRACK

Minor cracking was noted at the wall. These types of cracks are somewhat typical of minor settling, and should be monitored for further movement, and patched and repaired as desired.

Recommend monitoring.

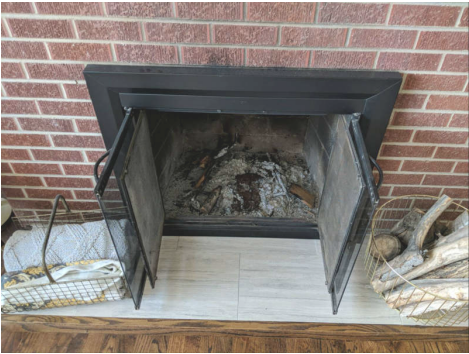
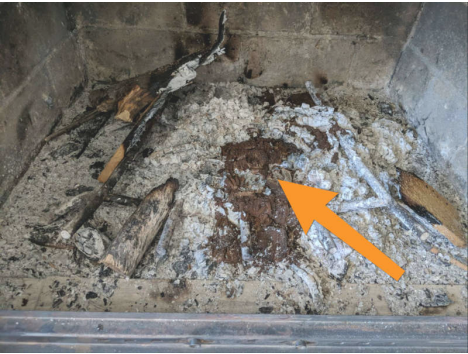
LIVING ROOM

FIREPLACE CLEANING

The fireplace was inspected and appears to be in good working condition at this time. The damper was functioning and the visible portion of the flue appears to be free of obstructions. However, the fire box and flue are dirty with soot and ash. Cleaning by a professional chimney sweep is recommended before using.

Contact a qualified chimney sweep.

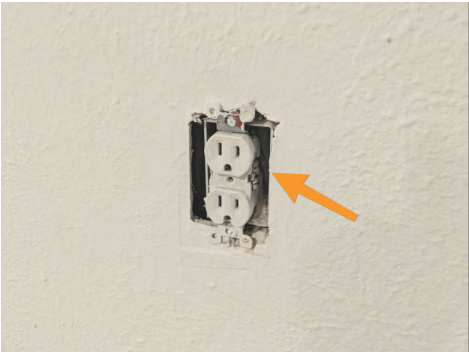
BASEMENT LIVING ROOM WEST

COVER PLATE MISSING

One outlet is missing a cover plate. A cover plate should be installed for safety. This is a minor repair item.

Contact a qualified electrical contractor.

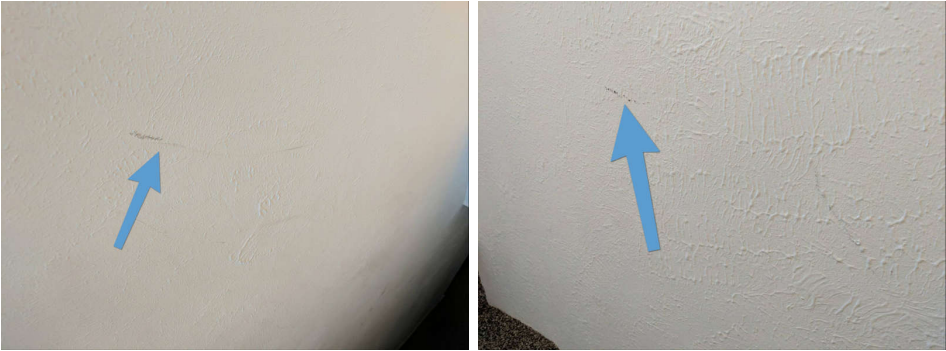
BASEMENT STAIR WELL

WALL SCRATCHES

There are multiple minor scratches and scuffs on the drywall. These areas should be painted over as needed by a qualified person.

Contact a handyman or DIY project

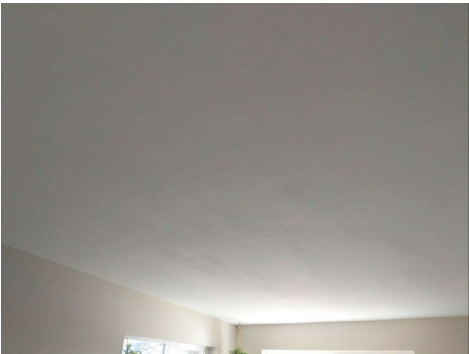
ADD SMOKE ALARM IN BEDROOM

Some smoke alarms are present at the hallways, but additional units are recommended at the bedrooms at this time. By today's standards, units should be present on each floor of the home and within each sleeping room/area. Additional units should be installed where needed. Annual battery replacement is recommended. Units older than 10 years should be replaced at this time, according to the National Fire Protection Association.

Contact a qualified handyman.

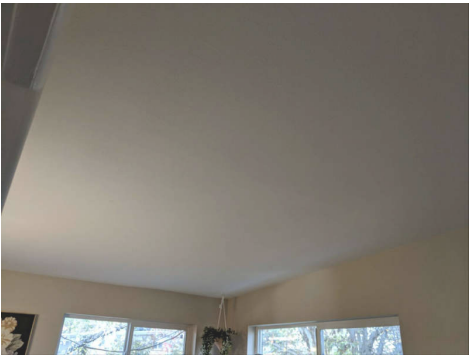
ADD SMOKE ALARM IN BEDROOM

Some smoke alarms are present in the home, but additional units are recommended at this time. Units should be present on each floor of the home and within each sleeping room/area. Add more units as needed. Annual battery replacement is recommended. Units older than 10 years should be replaced at this time, according to the National Fire Protection Association.

Contact a qualified handyman.

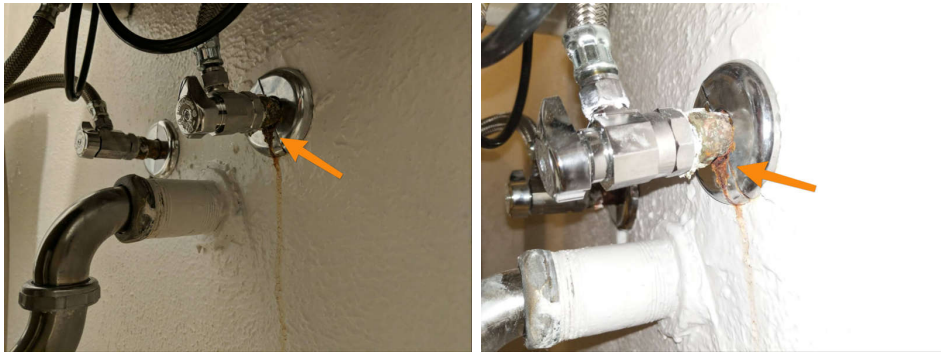
BASEMENT BATHROOM

SUPPLY PIPE LEAK UNDER SINK

There appears to be a leak and/or water staining around the supply piping below the sink. A plumber should evaluate and repair the supply piping at this time.

Contact a qualified plumbing contractor.

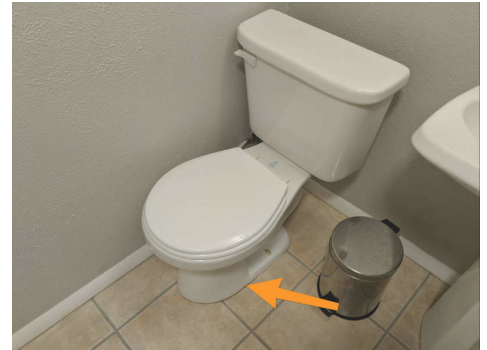
TOILET LOOSE, INVESTIGATE

The toilet is loose at floor. Repair is needed to secure the toilet to the floor properly, and may also involve re-setting the toilet on a new wax seal. It is unknown if any moisture damage or leaking is occurring around the toilet, and if any damage is present to the sub-flooring, framing, or surrounding materials, or whether any mold is present from this leaking. When the toilet is removed to replace the wax seal, the surrounding area should be evaluated and investigated for any moisture damage or potential mold.

Contact a qualified plumbing contractor.

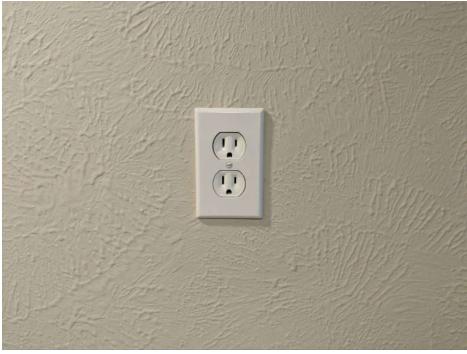
LAUNDRY ROOM

NO GCFI IN KITCHEN/BATH/LAUNDRY

The electrical outlets are not protected by a GFCI outlet. While this may not have been required when the home was built, GFCI outlets provide protection from electric shock and are now required to be installed near sources of water, such as at kitchens, bathrooms, laundry rooms, and outdoors. I recommend that an electrician install GFCI outlets where needed for safety protection.

Not GFCI protected

Contact a qualified electrical contractor.
