MICHAEL TOFANO PROPERTY AND HOME INSPECTIONS

INTERNACHI RESIDENTIAL

34 Madoc Drive
Brampton Ontario L6V 1Z9

Domenic Castiello
JULY 30, 2018

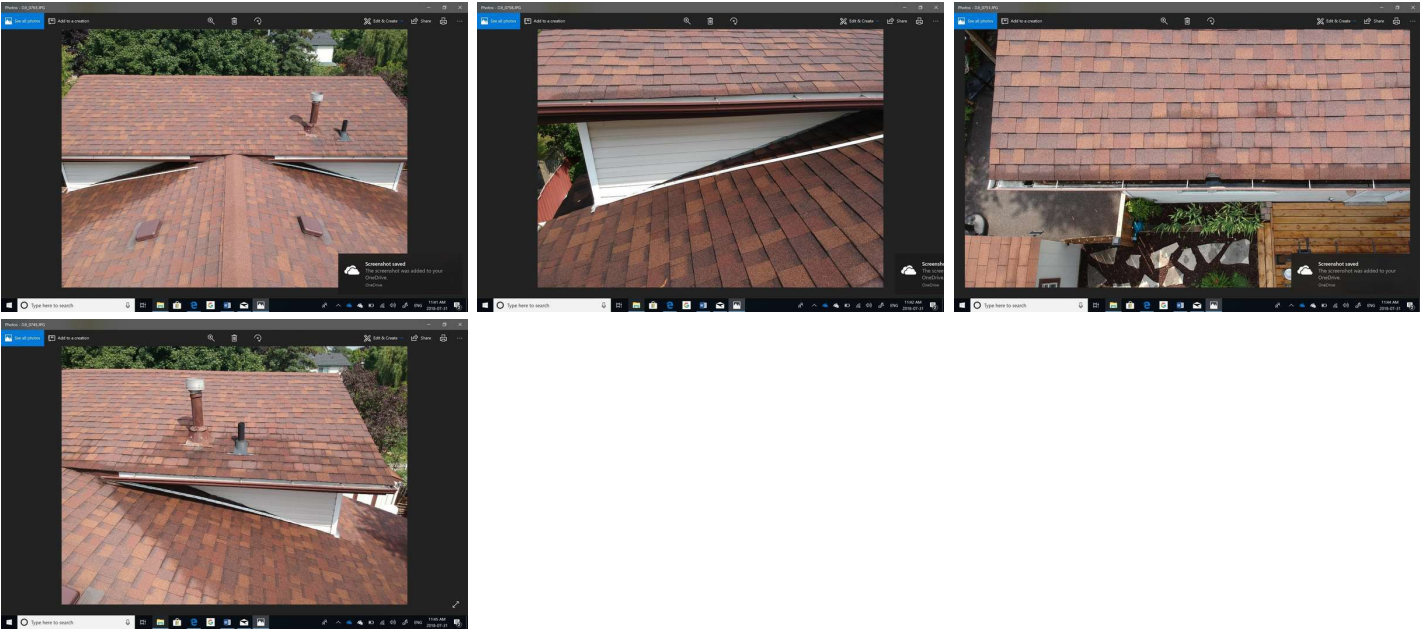
2.1.2 Coverings

DISCOLORATION

Roof shingles were discolored, which can be caused by moisture, rust or soot. Recommend a qualified roofing contractor evaluate and remedy with a roof cleaning or repair.

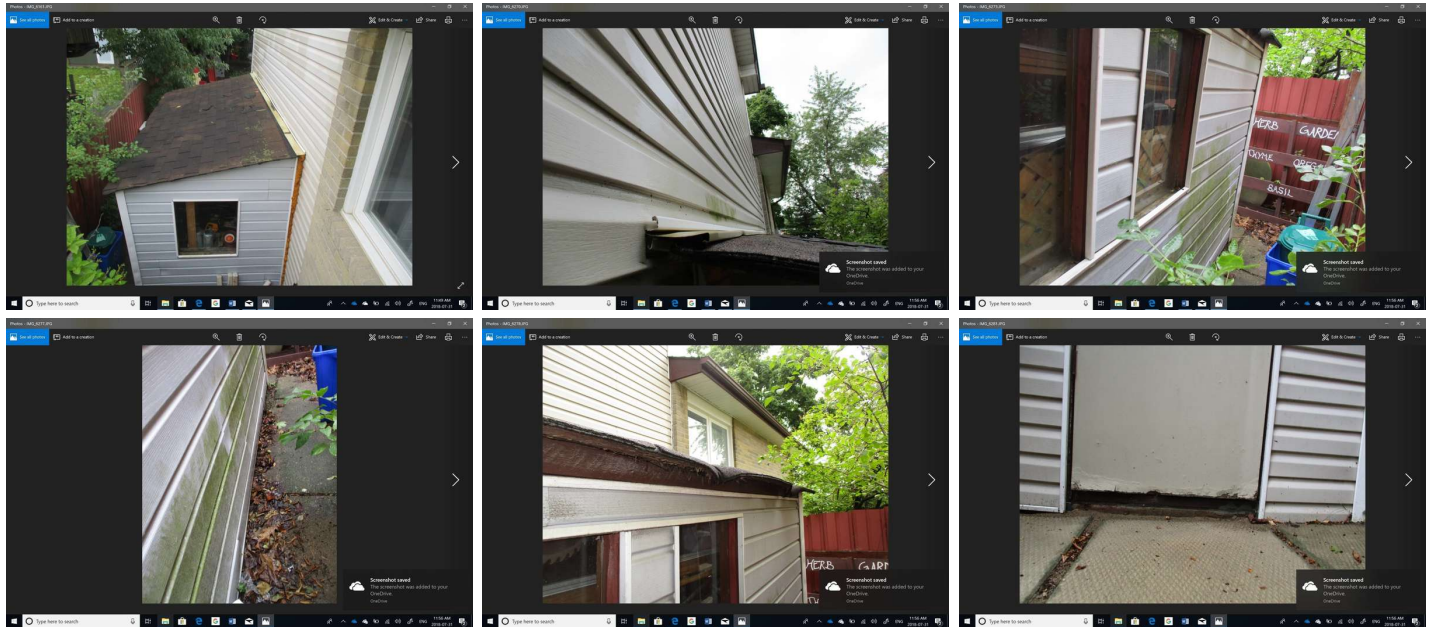
2.1.4 Coverings

REPLACE ATTACHED SHED ROOF

Recommend licenced roofing contractor to replace or remove of attached shed roofing system. Present roof is failing and in poor condition, causing moisture damage.

Recommendation
Contact a qualified professional.

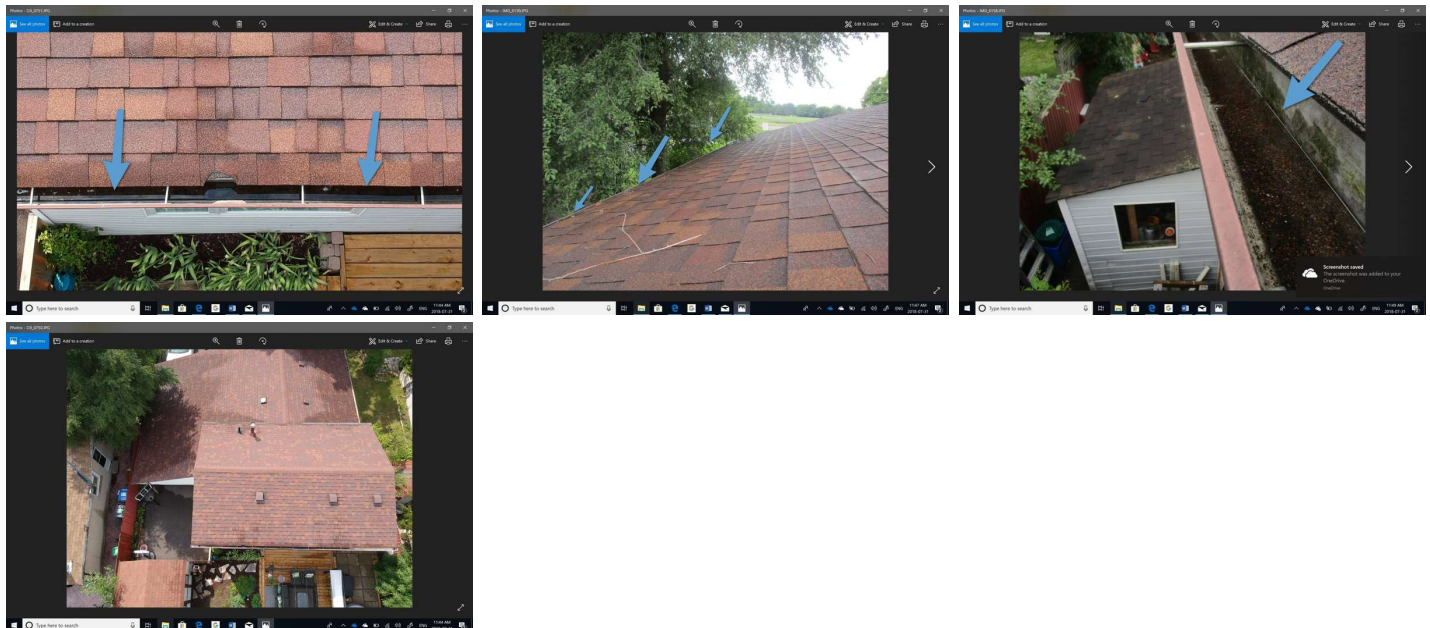
2.2.1 Roof Drainage Systems

DEBRIS

Debris has accumulated in the gutters. Recommend cleaning to facilitate water flow.

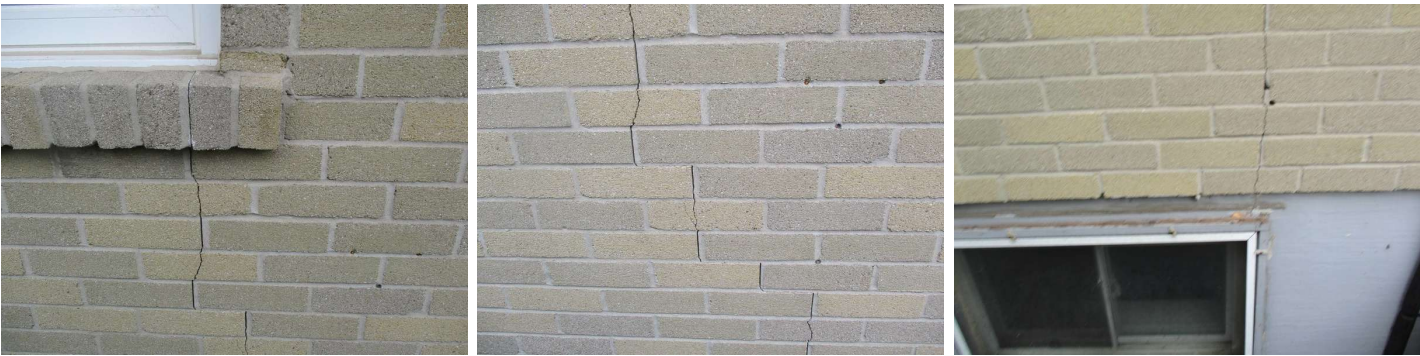
3.1.1 Siding, Flashing & Trim

CRACKING - MINOR
Brick Siding showed cracking in one or more places. This is a result of temperature changes and previous water damage. This is typical as homes age. Recommend monitoring.

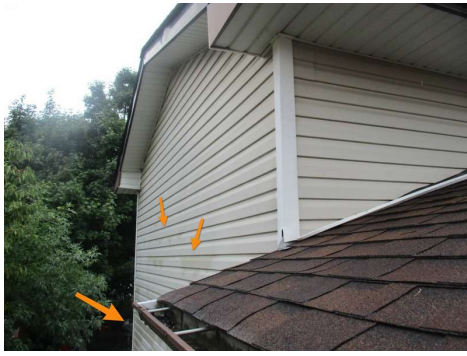
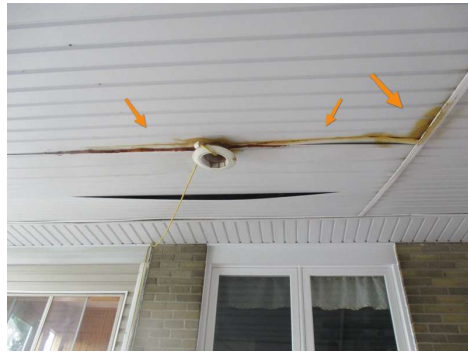
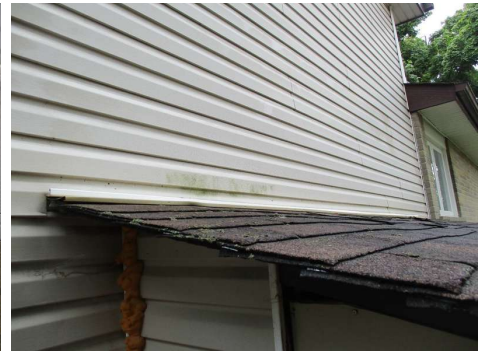
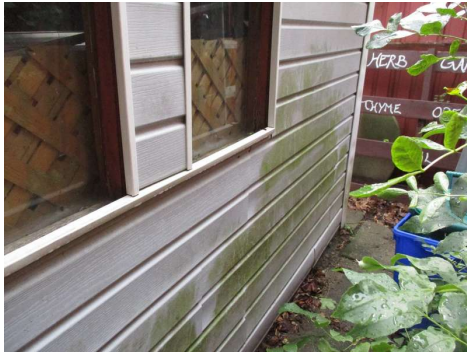
3.1.2 Siding, Flashing & Trim

EVIDENCE OF WATER INTRUSION
Siding showed signs of water intrusion. This could lead to further siding deterioration and/or mold. Recommend a qualified siding contractor evaluate and repair.

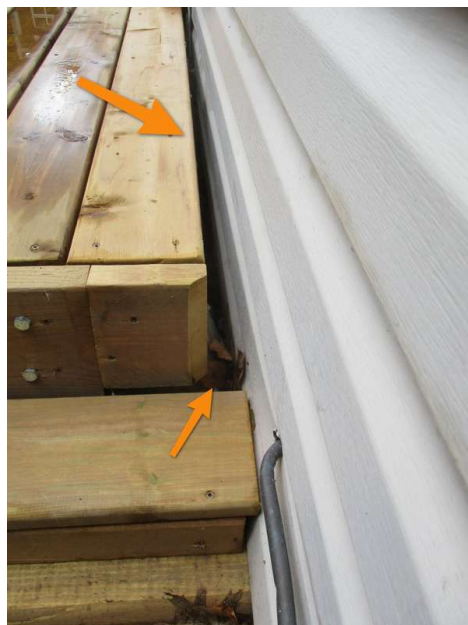
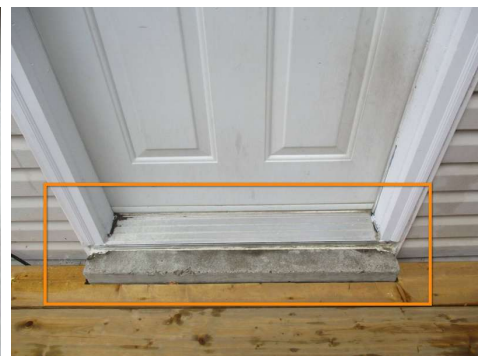
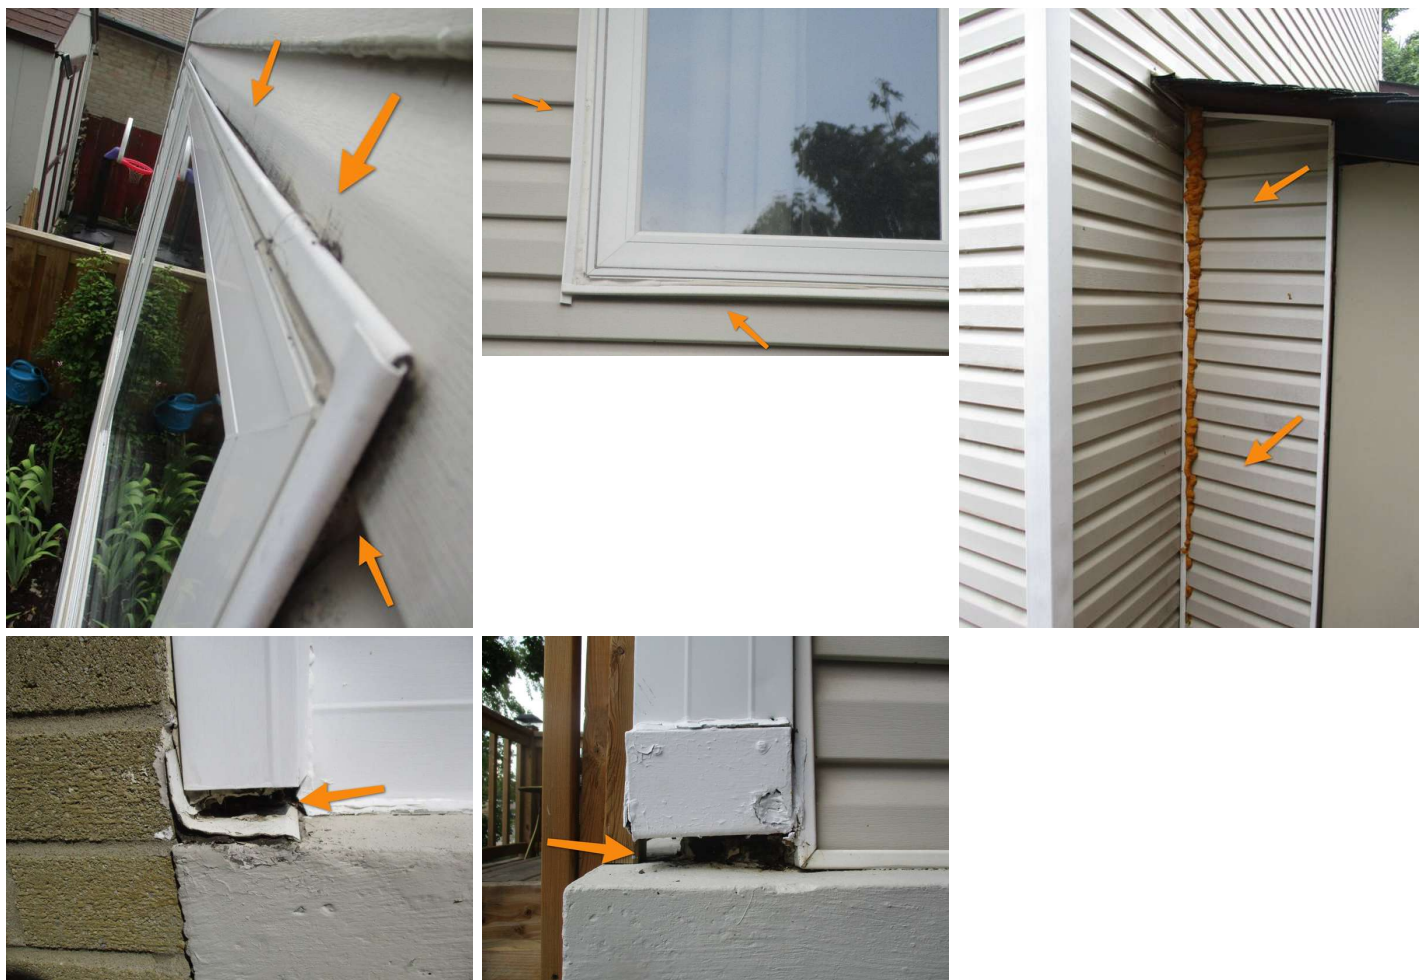
3.1.3 Siding, Flashing & Trim

FLASHING/TRIM IMPROPERLY INSTALLED

Flashing & trim pieces were improperly installed, which could result in moisture intrusion and damaging leaks. Recommend a qualified siding contractor evaluate and repair.

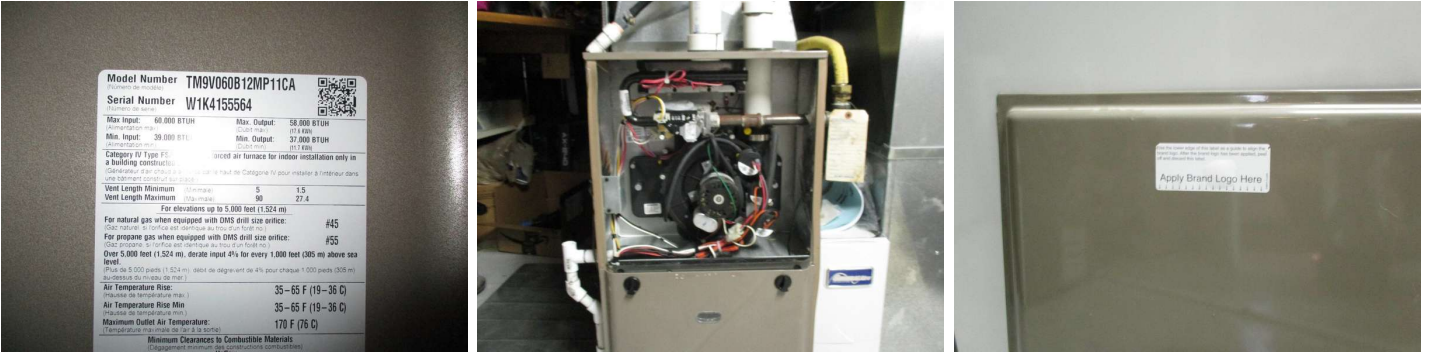
5.1.1 Equipment

NEEDS SERVICING/CLEANING

Furnace should be cleaned and serviced annually. Recommend a qualified HVAC contractor clean, service and certify furnace.

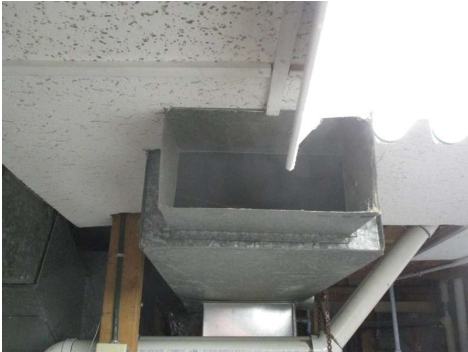
5.3.1 Distribution Systems

DUCT LEAKING

Air supply duct was leaking air. Recommend a qualified HVAC technician or vents & ducts contractor repair.

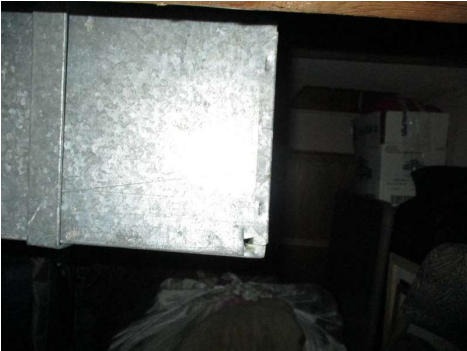
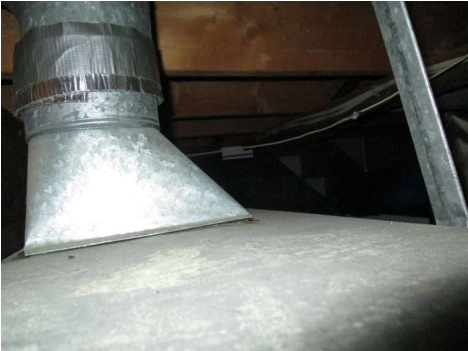
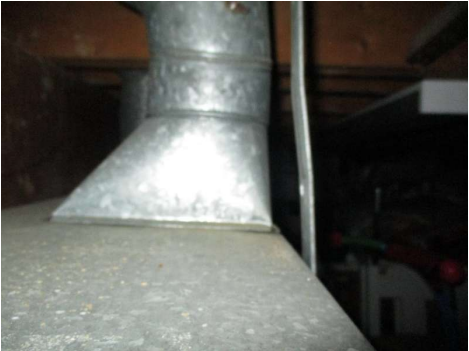
5.3.2 Distribution Systems

DUCTS NOT SEALED

Air supply ducts were not properly sealed. Recommend a qualified HVAC contractor seal supply and return ducts for maximum efficiency.

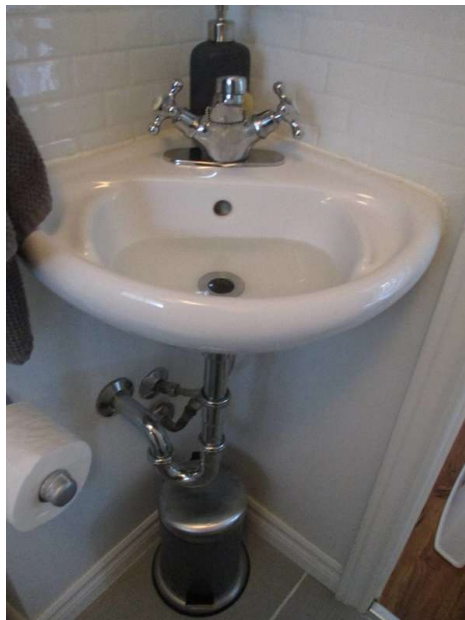
7.2.3 Drain, Waste, & Vent Systems

SINK - POOR DRAINAGE

Sink had slow/poor drainage. Recommend a qualified plumber repair.

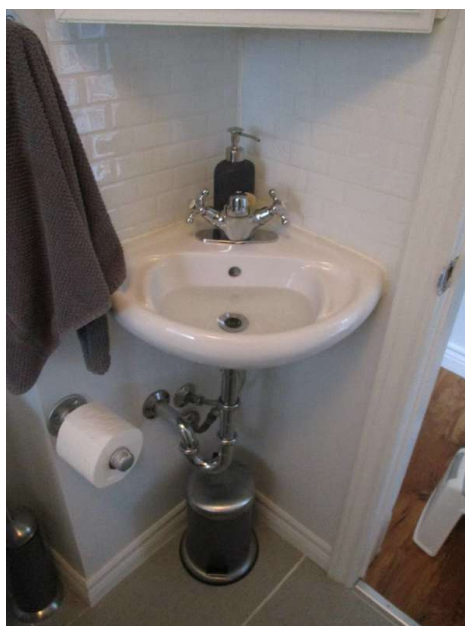
7.3.1 Water Supply, Distribution Systems & Fixtures

IMPROPER INSTALLATION

Distribution pipes were installed in a sub-standard way (Missing Shut-off Valves). Recommend a qualified plumber evaluate and properly fit and install pipes.

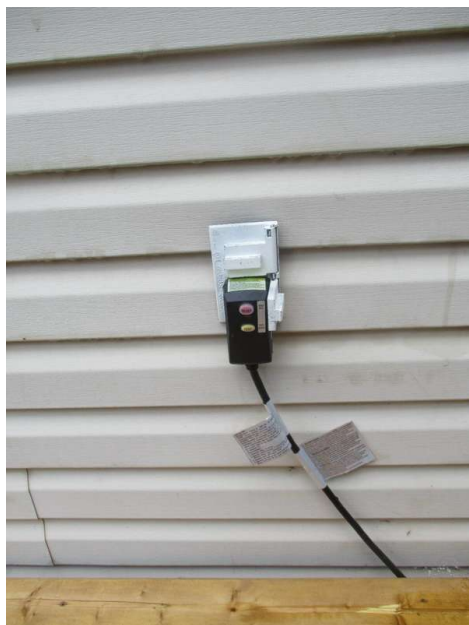
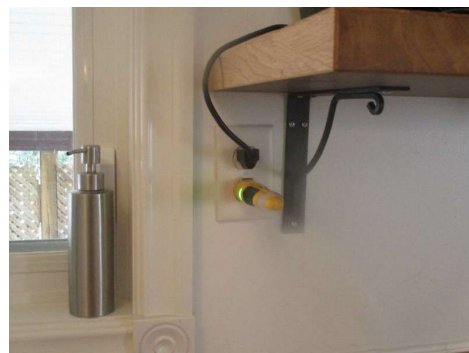
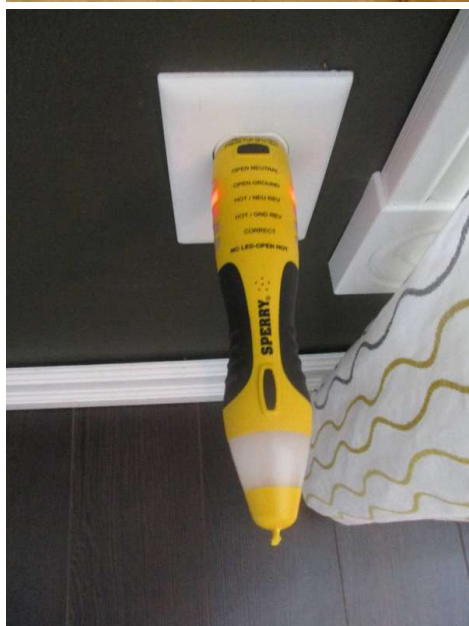
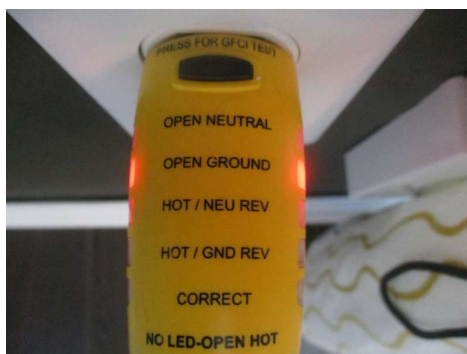
No GFCI protection present in all locations. One or more receptacles are ungrounded. To eliminate safety hazards, all receptacles in kitchen, bathrooms, garage & exterior should be grounded. Recommend licensed electrician upgrade by installing ground fault receptacles in all locations.

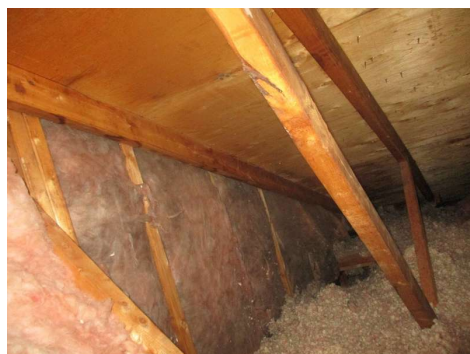
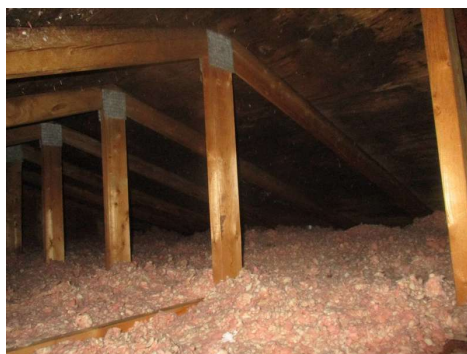
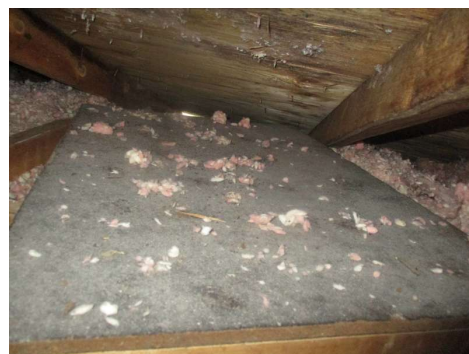
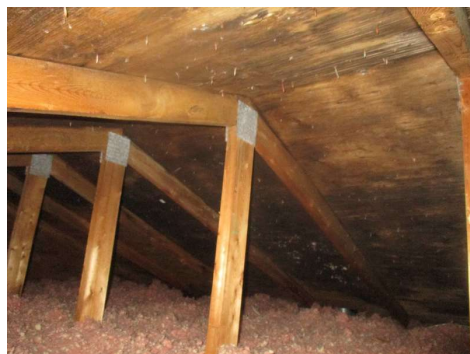
DAMAGED/INSUFFICIENT INSULATION

Insulation appears to have been pulled out and/or damaged by pests. Insulation depth was inadequate. Recommend a qualified attic insulation contractor install additional insulation and evaluate and repair.

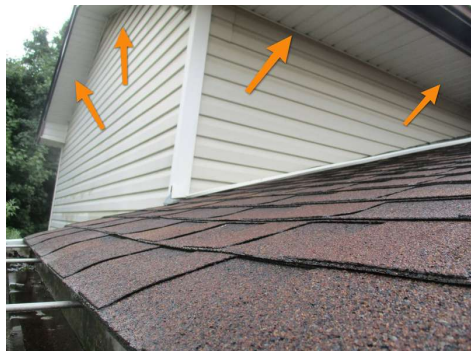
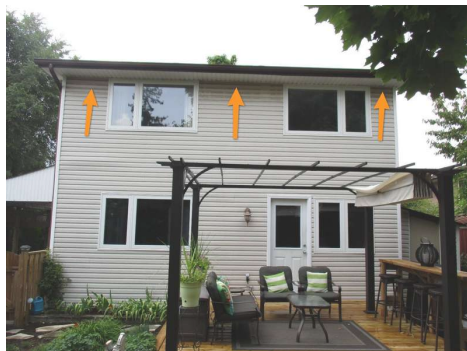
9.3.1 Ventilation

ATTIC VENTILATION INSUFFICIENT

Attic venting was insufficient at time of inspection. Modern standards recommend 1.5 square feet of venting area for every 300 square feet of attic floor space. Recommend an attic contractor evaluate and remedy.

Recommend Soffit Venting

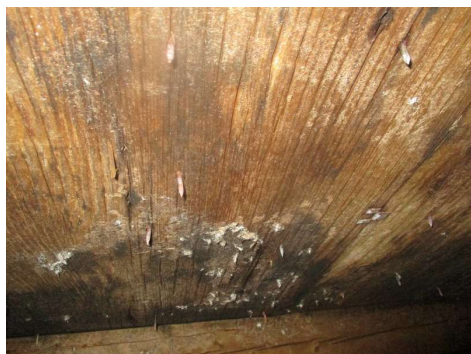
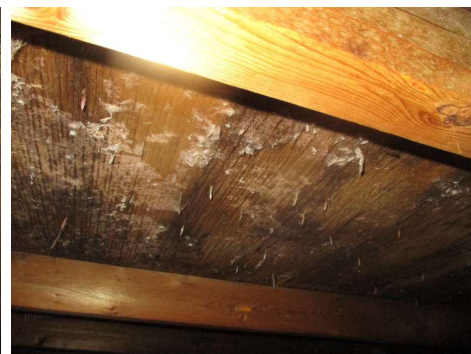
9.3.2 Ventilation

DISCOLORATION - POSSIBLE MOLD

Attic showed areas of discoloration and possible mold growth. Recommend a mold lab analysis to prevent spread of potential mold and damage to home or health risk. I also recommend finding source of moisture or lack of ventilation in attic space.
