REPAIR REQUEST LIST

1234 Main Street
02/02/2020 12:51 pm

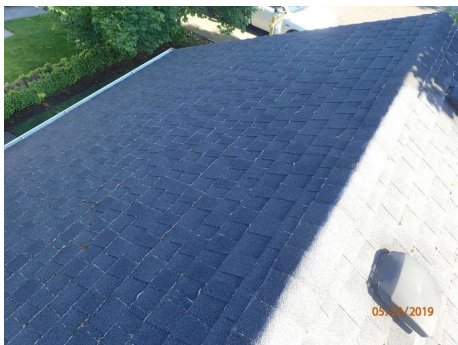
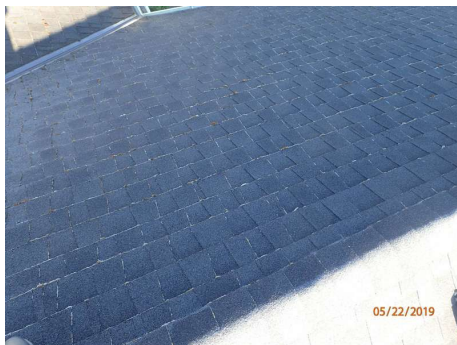
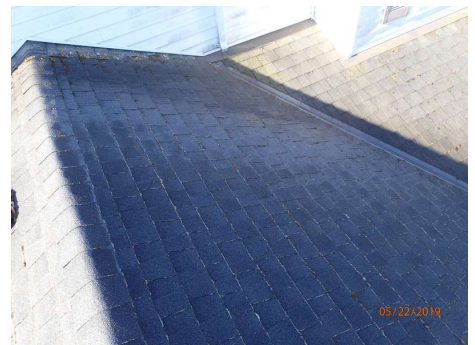
2.1.2 - Roof: Coverings MOSS

Recommend cleaning and removing any moss from the roof, after which a moss treatment plan can be established to limit future growth. Avoid power washing the moss off because that can drive moisture under the shingles, damaging the underlying roof components. If the roof is to high or steep, recommend contacting a licensed roofing contractor or moss removal specialist.

Moss growth is usually greatest on north-facing roofs, roof areas shaded by trees and other places that are not exposed to enough sun to dry out.

Once established, it acts like a sponge, soaking up and storing rainwater. Some of that water then wicks up under the shingles through capillary action and soaks into and through the roof underlayment, which is typically 15- or 30-pound felt. Eventually, it saturates the roof sheathing below.

Moss can shorten the life span of a shingled roof and result in costly repairs both structural and cosmetic that would not be necessary if the roof were maintained properly and kept clear of moss.

Recommendation
Contact a handyman or DIY project

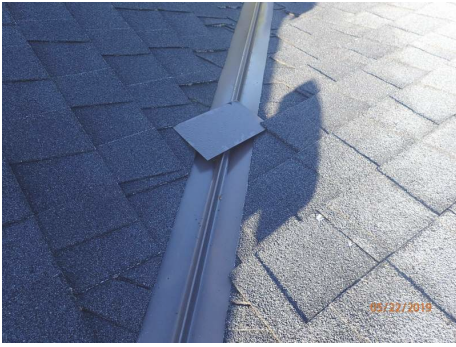
2.1.4 - Roof: Coverings DEBRIS - CONSTRUCTION

A piece of flashing was found lodged into the valley. This flashing was not able to be identified from anything necessary in the area and no leaks were noted in the attic. Recommend removing this and monitoring the roof closely as it ages.

Recommendation
Contact a qualified professional.

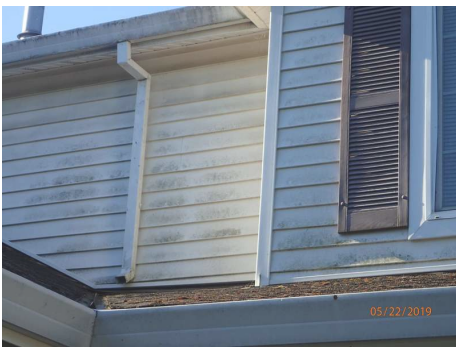
3.1.1 - Exterior: Siding

VINYL SIDING - DIRTY

Moss and dirt are heavy on several locations of the vinyl siding. Recommend cleaning to help Maximize life span.

Contact a qualified professional.

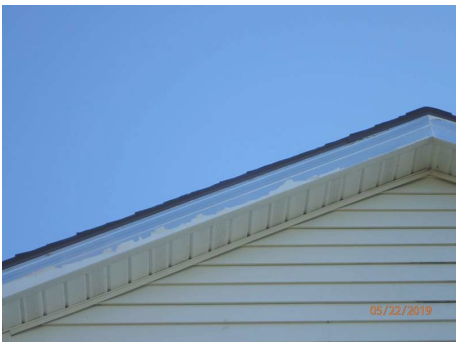
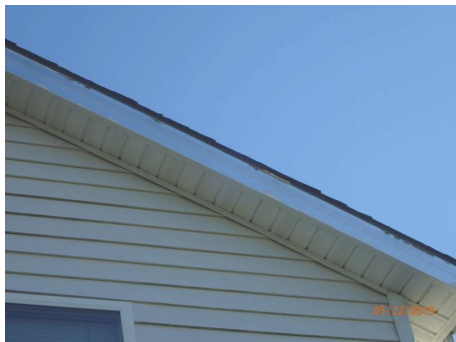
3.5.1 - Exterior: Eaves, Soffits & Fascia

PAINT/FINISH FAILING

Paint is peeling from the south fascia.

Contact a qualified painting contractor.
