REPAIR REQUEST LIST

1234 Main Street
04/02/2022 4:10 pm

Repair Request Ms. XXXXXX

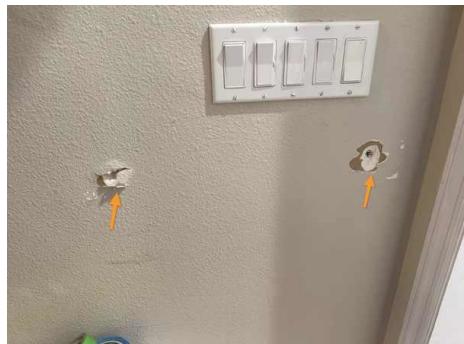
2.1.1 - Floors, Walls & Ceilings: Floors, Walls & Ceilings
DAMAGED DRYWALL

Drywall damage visible in the entryway likely due to wall anchors failing.

Location
Entryway

Recommendation
Contact a qualified drywall contractor.

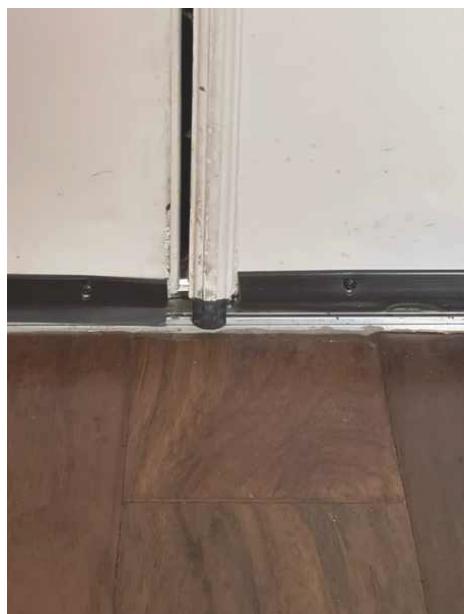
3.1.1 - Doors, Windows & Interior: Doors
NOTICEABLE GAP

Air gap exists at the base of the French door which could lead to energy loss and pest infestation. Recommend handyman or door contractor evaluate.

Location
Main Entrance

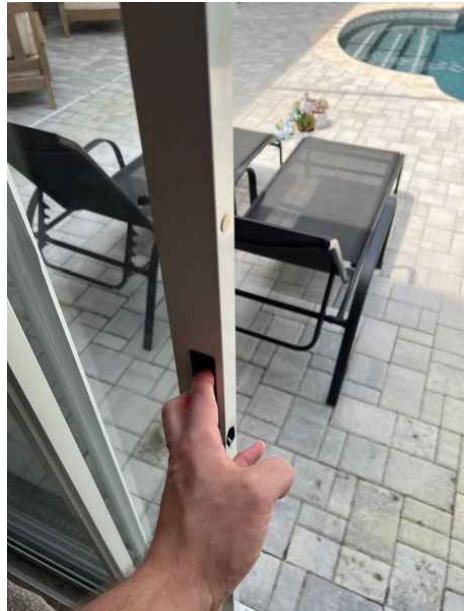
3.1.2 - Doors, Windows & Interior: Doors
PATIO DOOR DOESN'T SLIDE SMOOTHLY

The patio door from the living room to the pool area was difficult to slide open and shut.

Contact a qualified door repair/installation contractor.

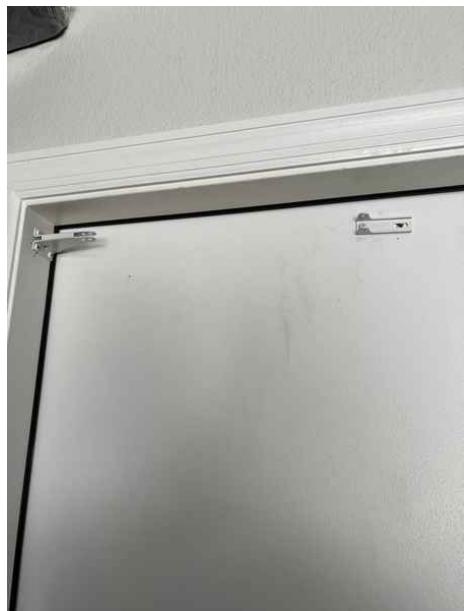
3.1.3 - Doors, Windows & Interior: Doors
FIRE DOOR SELF-CLOSE MECHANISM MISSING

The fire door from the living quarters to the garage lacks a self-closing mechanism. No fire rating sticker present so unable to verify it meets minimum requirements.

Contact a qualified door repair/installation contractor.

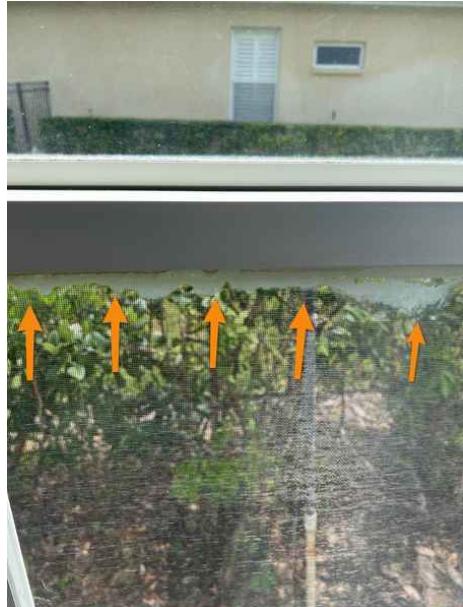
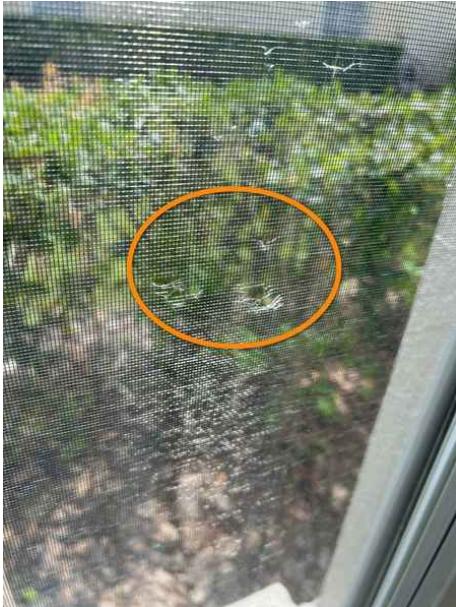
3.2.1 - Doors, Windows & Interior: Windows
DAMAGED WINDOW

One or more windows appears to have general damage, but are operational in the East middle bedroom. There is staining on the glazing and the screen is damaged. Recommend a window professional clean, lubricate & adjust as necessary.

Contact a qualified window repair/installation contractor.

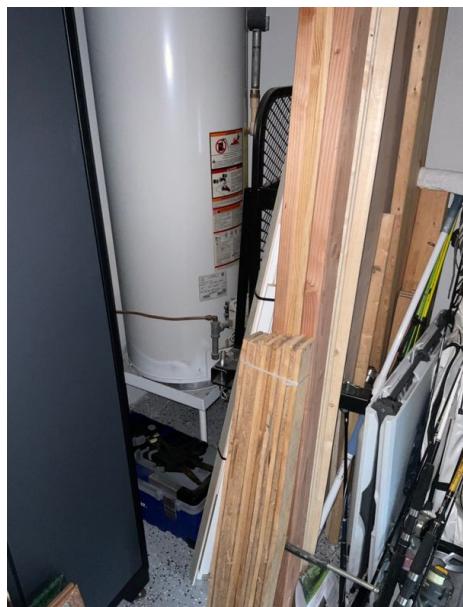
4.4.1 - Plumbing: Hot Water Systems, Controls, Flues & Vents
IMPROPER INSTALLATION

A Safety Hazard

Water heater is improperly installed or in a dangerous location. Recommend qualified plumber evaluate & repair/relocate.

Combustible contents in close proximity to gas and ignition sources

Rectified by removal of contents

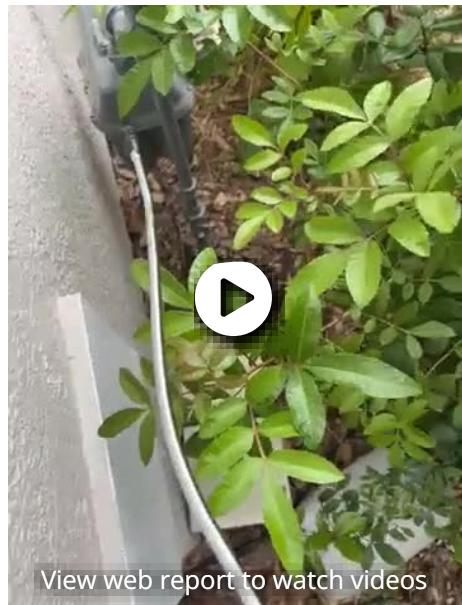
4.5.1 - Plumbing: Fuel Storage & Distribution Systems
GAS LEAK

Gas leak detected at the gas meter with hydrocarbon detection device. Have evaluated by the utility company or a qualified plumbing contractor inspect immediately.

Location
Gas Meter

Recommendation
Contact your local utility company

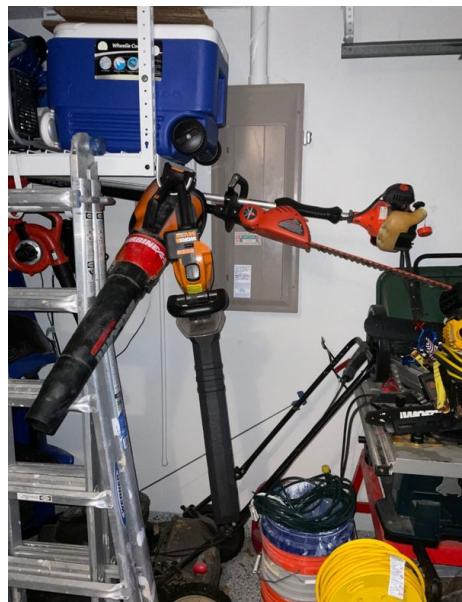
5.4.1 - Electrical: Breakers & Fuses
INADEQUATE WORKSPACE AT PANEL

I observed inadequate workspace at the electrical panel. Inspection restriction. This makes accessing the electrical panel disconnects and components difficult.

A clear working space must be provided and maintained for safe access. At least 3 feet deep clear space should be in front of the equipment, 30 inches wide, and 6 feet 6 inches of headroom.

Recommendation
Contact a qualified professional.

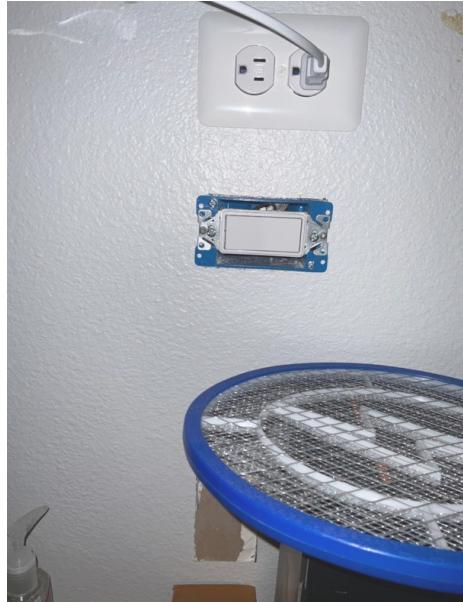
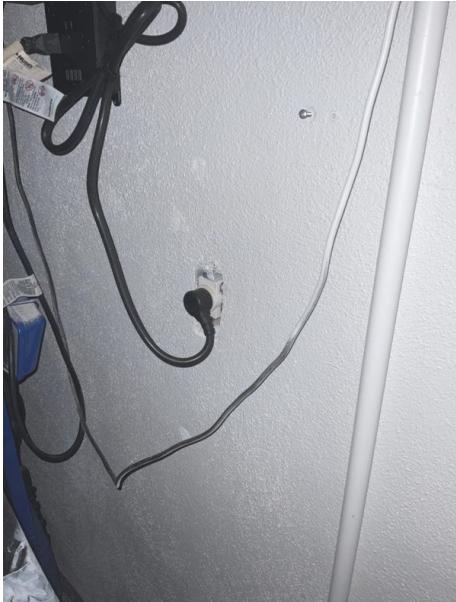
5.5.1 - Electrical: Lighting Fixtures, Switches & Receptacles
COVER PLATES MISSING

One or more receptacles are missing a cover plate. This causes short and shock risk. Recommend installation of plates.

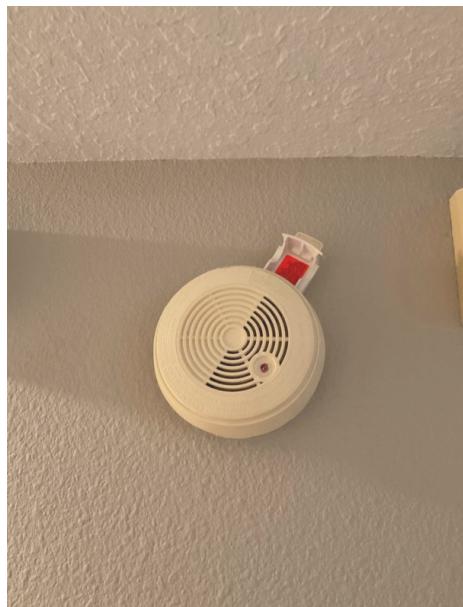
5.7.1 - Electrical: Smoke Detectors
SMOKE DETECTORS ARE TOO OLD

The Smoke Detectors were over 10 years old and should be replaced.

Recommended DIY Project

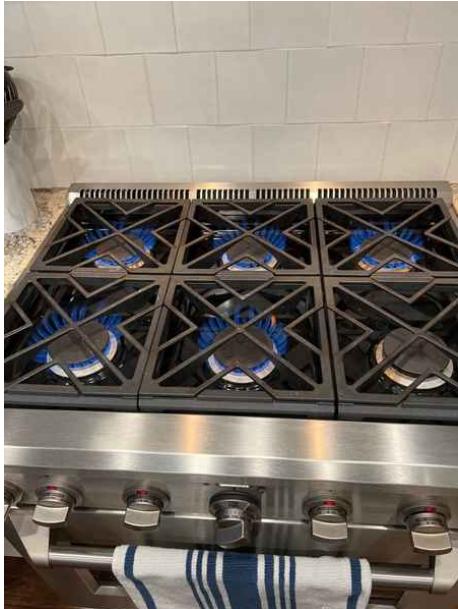
6.3.1 - Built-in Appliances: Range/Oven/Cooktop
BURNER NOT LIGHTING

One or more heating elements did not heat up when turned on. Recommend qualified professional evaluate & repair.

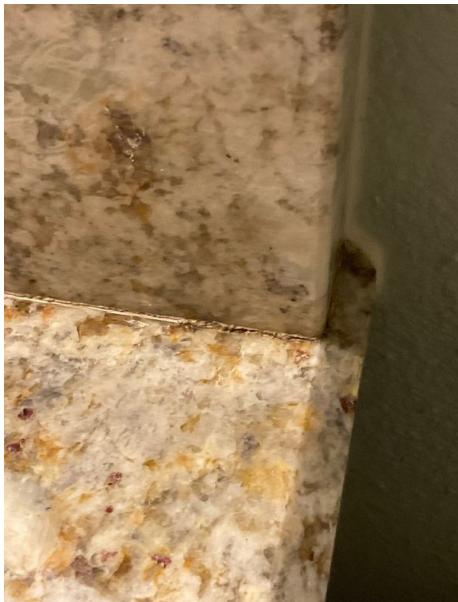
7.5.1 - Bathrooms & Kitchen: Countertops & Surfaces
POOR/MISSING CAULK

Bathroom countertop was missing sufficient caulk/sealant at the wall. This can lead to water damage. Recommend adding sealant at sides and corners where counters touch walls.

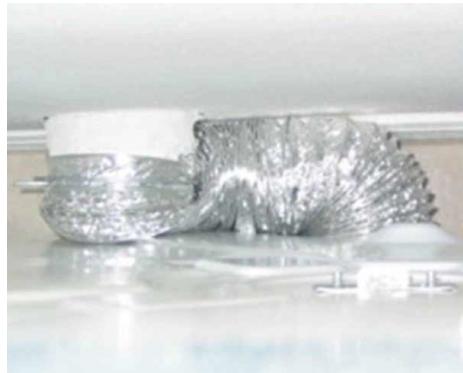
8.1.1 - Laundry Room: Laundry Room
DAMAGED DRYER EXHAUST PIPE

I observed indications of a damaged exhaust pipe of the clothes dryer.

Recommendation
Recommended DIY Project

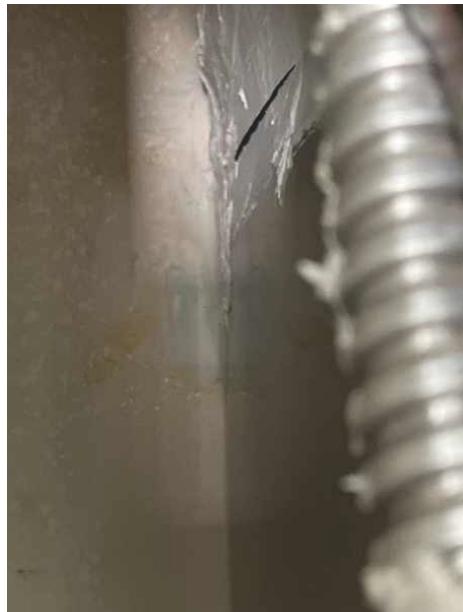
9.1.1 - Heating: Equipment
DUCT SEAL SEPARATION

The seal from the duct to the air handler is separating. Recommend evaluation by a qualified HVAC technician.

Location
Garage

Recommendation
Contact a qualified HVAC professional.

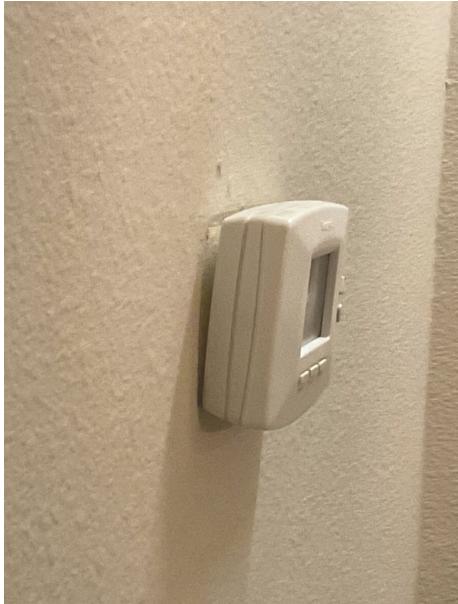
9.2.1 - Heating: Normal Operating Controls
LOOSE THERMOSTAT

Thermostat was loose on the wall. Recommend repair or replacement.

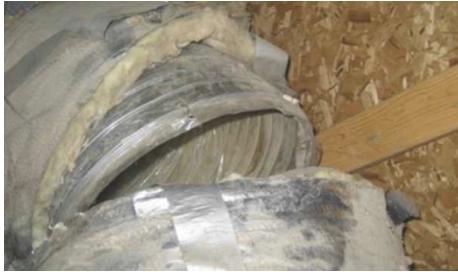
11.4.1 - Attic, Insulation & Ventilation: Distribution System
JOINT DISCONNECTED

There are disconnected joints in the ductwork, resulting in significant energy loss and localized condensation/mold. Recommend licensed HVAC contractor repair or replace.

above northeast bedroom

Recheck and seal ducts as needed in attic

Contact a qualified HVAC professional.

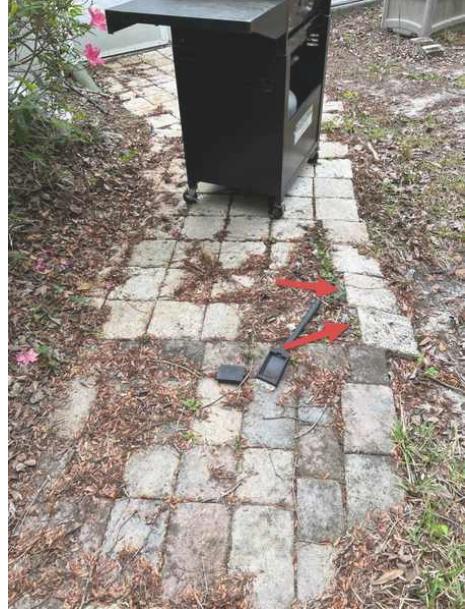
13.3.1 - Exterior: Walkways, Patios & Driveways

TRIP HAZARD

I observed a trip hazard at the walkway to the swimming pool. This condition is a safety concern.

Correction and further evaluation are recommended. The correction may require removal/replacement of the displaced sections.

Contact a qualified professional.

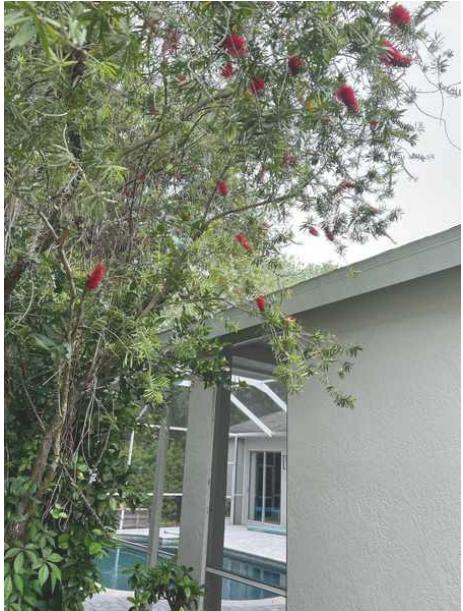
13.7.2 - Exterior: Vegetation, Grading, Drainage & Retaining Walls

TREE OVERHANG

Trees observed overhanging the roof. This can cause damage to the roof and prevent proper drainage. Recommend a qualified tree service trim to allow for proper drainage.

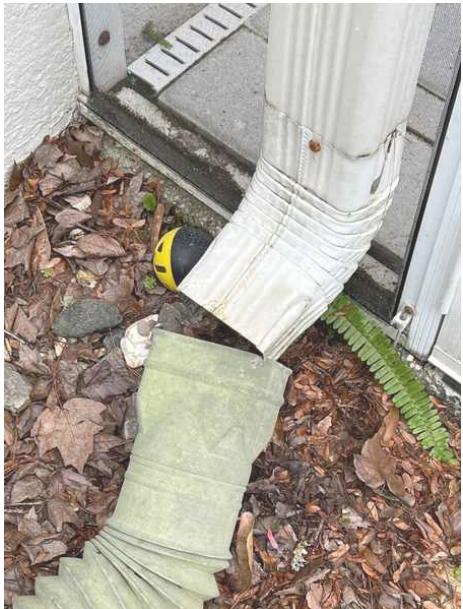
13.7.3 - Exterior: Vegetation, Grading, Drainage & Retaining Walls
DOWNSPOUT NOT CONNECTED

Gutter downspout not connected to drainage line. This will allow rainwater to pool in the area of the pool enclosure entrance.

Contact a qualified professional.

Clean out and re-connect

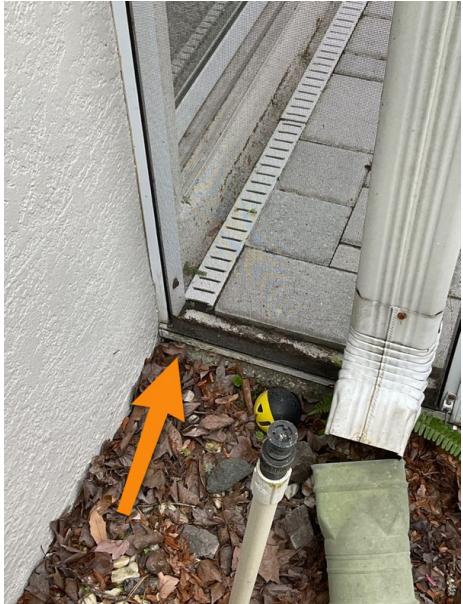
13.11.1 - Exterior: Exterior pool deck
CHANNEL DRAIN IS OBSTRUCTED

Channel drain terminates into the pool cage framing, which constitutes a construction defect.

Contact a qualified professional.

Concrete needs to be cut away to allow drainage
