REPAIR REQUEST LIST

1234 Main Street
04/02/2022 4:10 pm

Repair Request Ms. XXXXXX

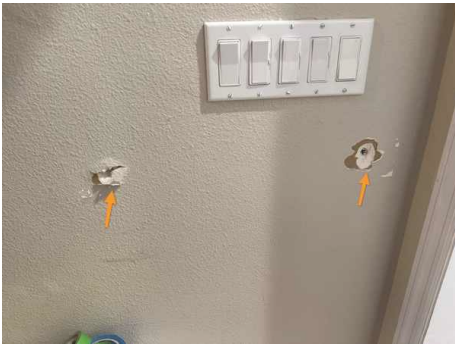
2.1.1 - Floors, Walls & Ceilings: Floors, Walls & Ceilings
DAMAGED DRYWALL

Drywall damage visible in the entryway likely due to wall anchors failing.

Location
Entryway

Recommendation
Contact a qualified drywall contractor.

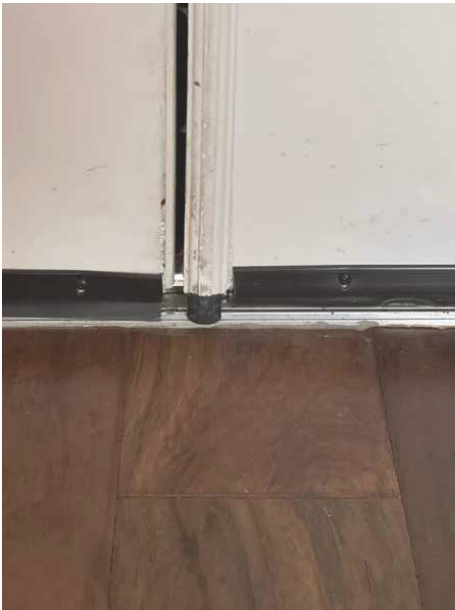
3.1.1 - Doors, Windows & Interior: Doors
NOTICEABLE GAP

Air gap exists at the base of the French door which could lead to energy loss and pest infestation. Recommend handyman or door contractor evaluate.

Location
Main Entrance

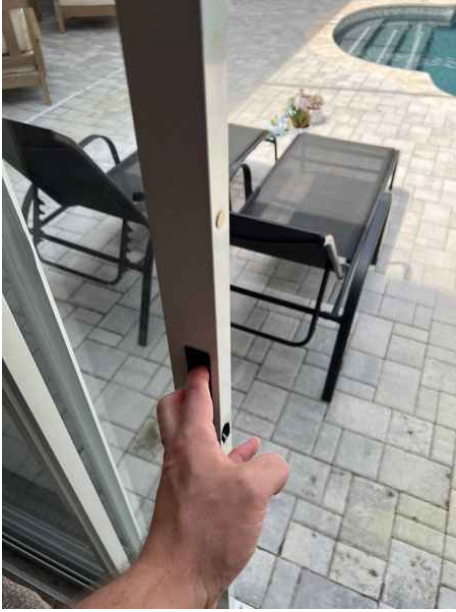
PATIO DOOR DOESN'T SLIDE SMOOTHLY

The patio door from the living room to the pool area was difficult to slide open and shut.

Contact a qualified door repair/installation contractor.

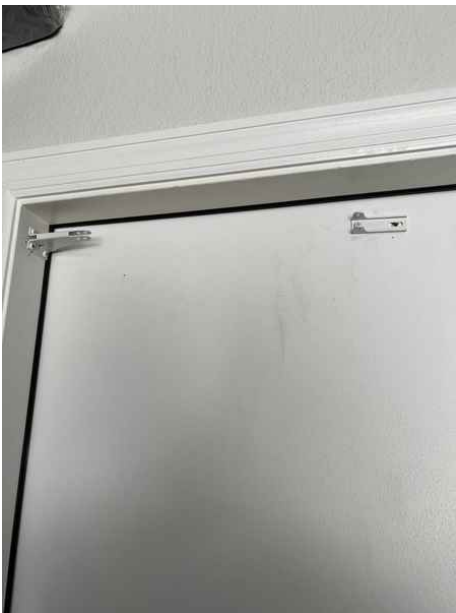
FIRE DOOR SELF-CLOSE MECHANISM MISSING

The fire door from the living quarters to the garage lacks a self-closing mechanism. No fire rating sticker present so unable to verify it meets minimum requirements.

Contact a qualified door repair/installation contractor.

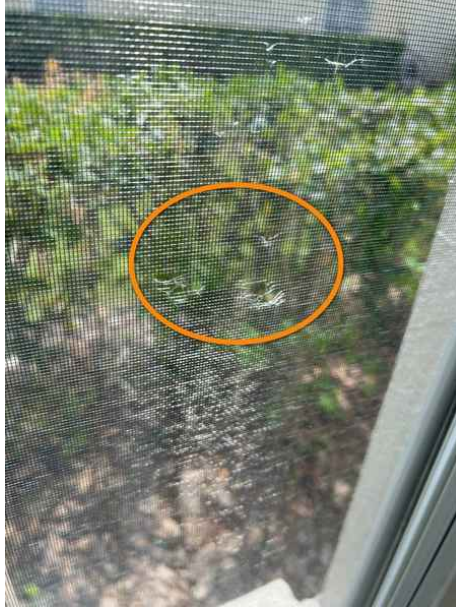
3.2.1 - Doors, Windows & Interior: Windows
DAMAGED WINDOW

One or more windows appears to have general damage, but are operational in the East middle bedroom. There is staining on the glazing and the screen is damaged. Recommend a window professional clean, lubricate & adjust as necessary.

Contact a qualified window repair/installation contractor.

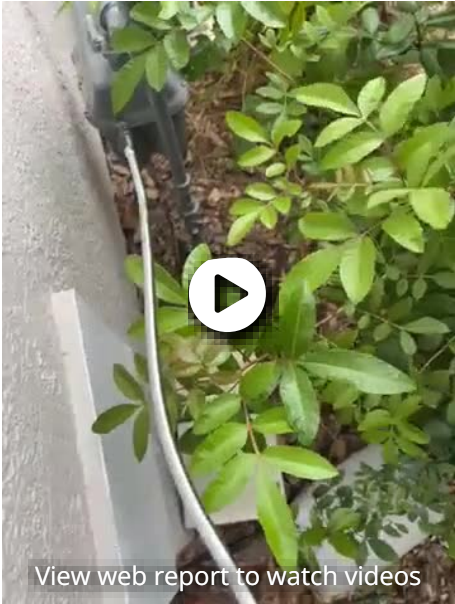
GAS LEAK

Gas leak detected at the gas meter with hydrocarbon detection device. Have evaluated by the utility company or a qualified plumbing contractor inspect immediately.

Location
Gas Meter

Recommendation
Contact your local utility company

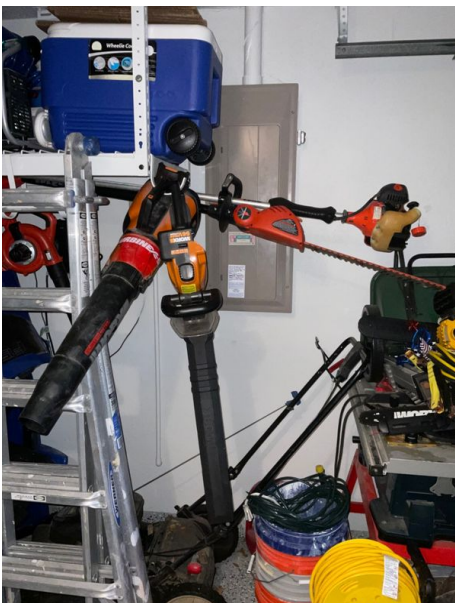
INADEQUATE WORKSPACE AT PANEL

I observed inadequate workspace at the electrical panel. Inspection restriction. This makes accessing the electrical panel disconnects and components difficult.

A clear working space must be provided and maintained for safe access. At least 3 feet deep clear space should be in front of the equipment, 30 inches wide, and 6 feet 6 inches of headroom.

Recommendation
Contact a qualified professional.

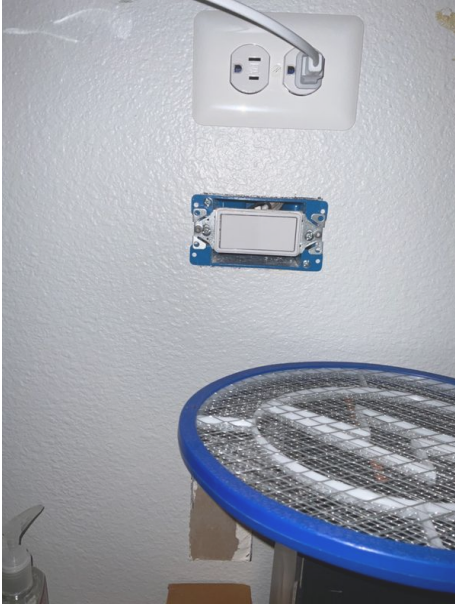
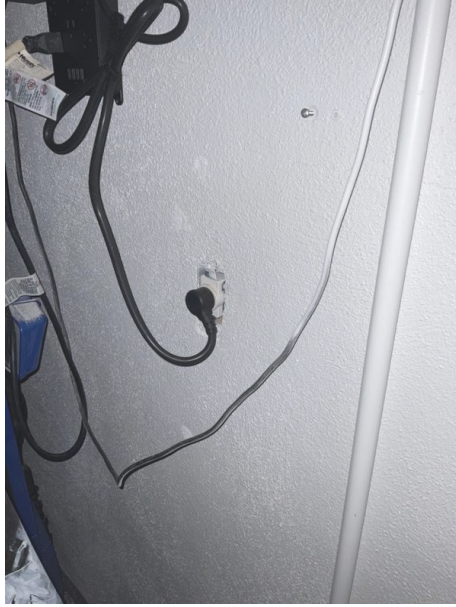
5.5.1 - Electrical: Lighting Fixtures, Switches & Receptacles
COVER PLATES MISSING

One or more receptacles are missing a cover plate. This causes short and shock risk. Recommend installation of plates.

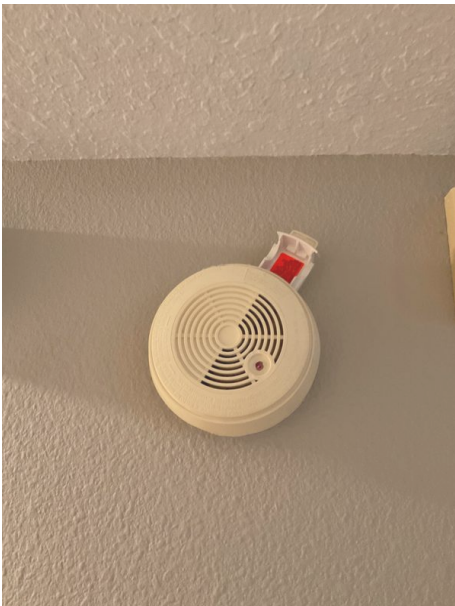
5.7.1 - Electrical: Smoke Detectors
SMOKE DETECTORS ARE TOO OLD

The Smoke Detectors were over 10 years old and should be replaced.

Recommended DIY Project

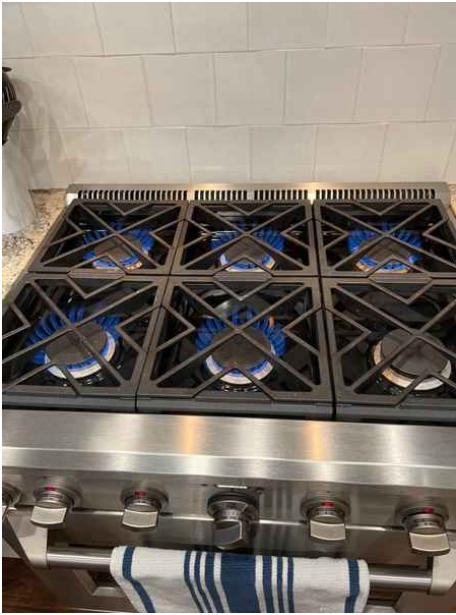
6.3.1 - Built-in Appliances: Range/Oven/Cooktop
BURNER NOT LIGHTING

One or more heating elements did not heat up when turned on. Recommend qualified professional evaluate & repair.

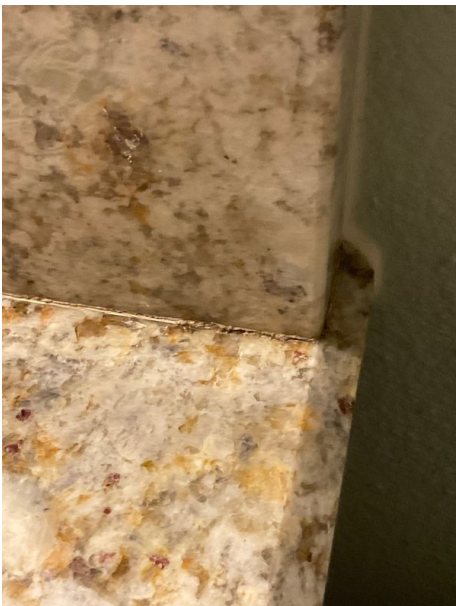
7.5.1 - Bathrooms & Kitchen: Countertops & Surfaces
POOR/MISSING CAULK

Bathroom countertop was missing sufficient caulk/sealant at the wall. This can lead to water damage. Recommend adding sealant at sides and corners where counters touch walls.

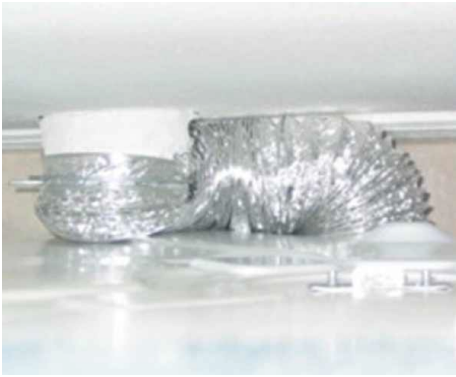
8.1.1 - Laundry Room: Laundry Room
DAMAGED DRYER EXHAUST PIPE

I observed indications of a damaged exhaust pipe of the clothes dryer.

Recommended DIY Project

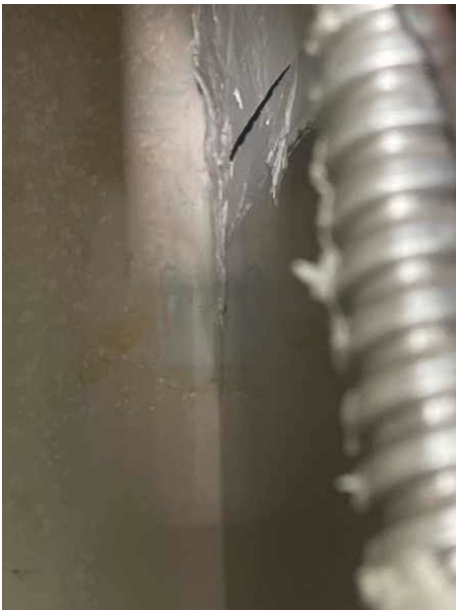
9.1.1 - Heating: Equipment
DUCT SEAL SEPARATION

The seal from the duct to the air handler is separating. Recommend evaluation by a qualified HVAC technician.

Location
Garage

Contact a qualified HVAC professional.

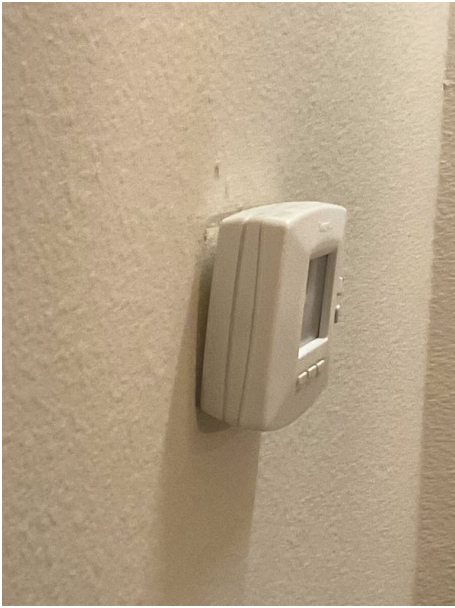
9.2.1 - Heating: Normal Operating Controls
LOOSE THERMOSTAT

Thermostat was loose on the wall. Recommend repair or replacement.

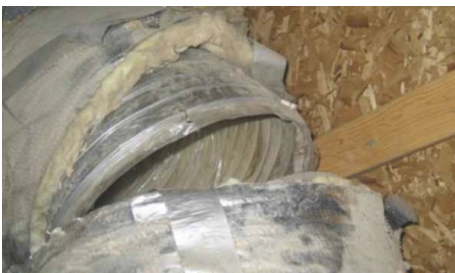
JOINT DISCONNECTED

There are disconnected joints in the ductwork, resulting in significant energy loss and localized condensation/mold. Recommend licensed HVAC contractor repair or replace.

above northeast bedroom

Recheck and seal ducts as needed in attic

Contact a qualified HVAC professional.

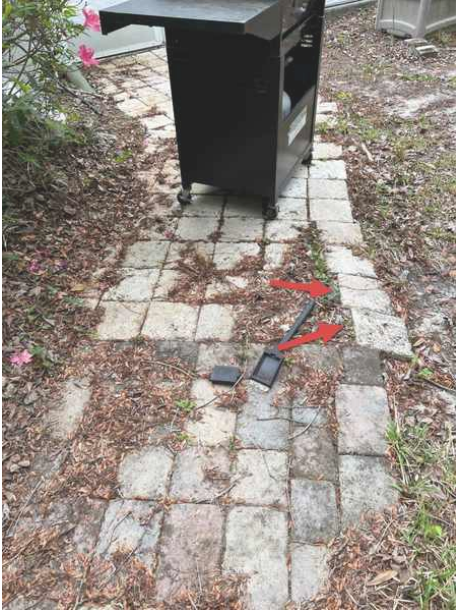
TRIP HAZARD

I observed a trip hazard at the walkway to the swimming pool. This condition is a safety concern.

Correction and further evaluation are recommended. The correction may require removal/replacement of the displaced sections.

Contact a qualified professional.

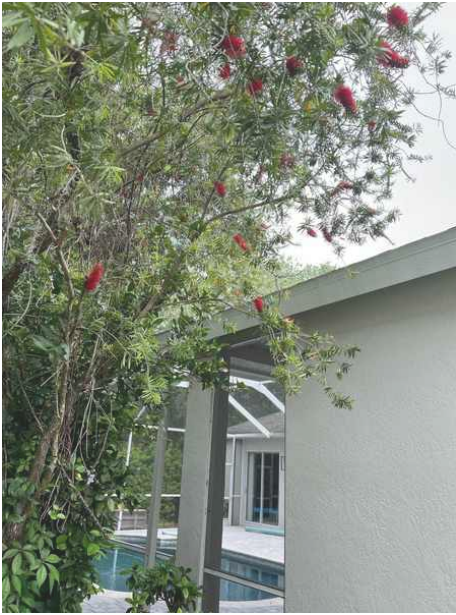
TREE OVERHANG

Trees observed overhanging the roof. This can cause damage to the roof and prevent proper drainage. Recommend a qualified tree service trim to allow for proper drainage.

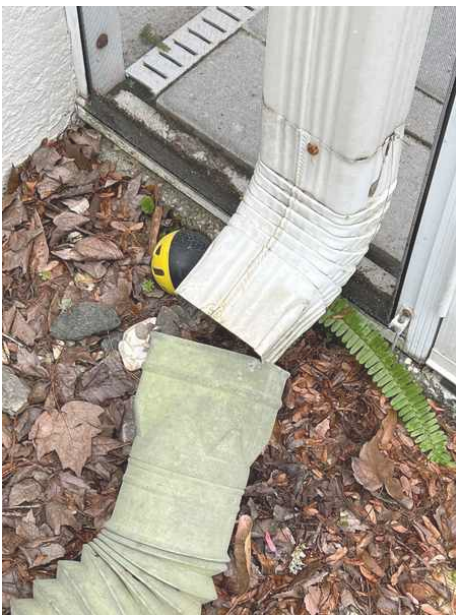
13.7.3 - Exterior: Vegetation, Grading, Drainage & Retaining Walls
DOWNSPOUT NOT CONNECTED

Gutter downspout not connected to drainage line. This will allow rainwater to pool in the area of the pool enclosure entrance.

Recommendation
Contact a qualified professional.

Clean out and re-connect

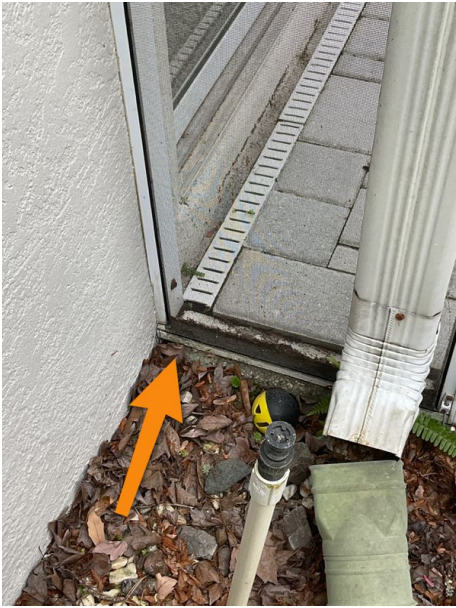
13.11.1 - Exterior: Exterior pool deck
CHANNEL DRAIN IS OBSTRUCTED

Channel drain terminates into the pool cage framing, which constitutes a construction defect.

Recommendation
Contact a qualified professional.

Concrete needs to be cut away to allow drainage
