# REPAIR REQUEST LIST

1234 Main Street  
05/18/2024 9:26 pm

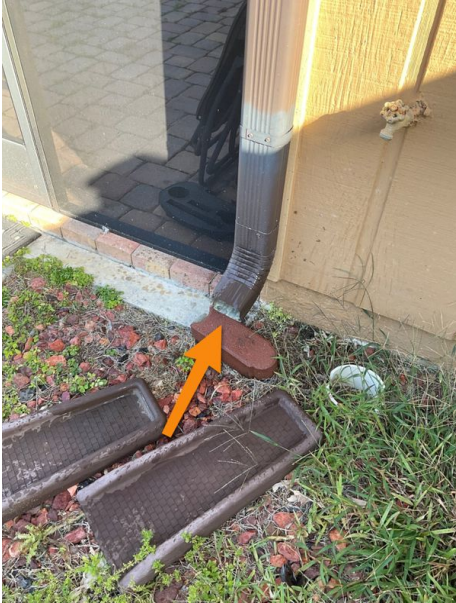
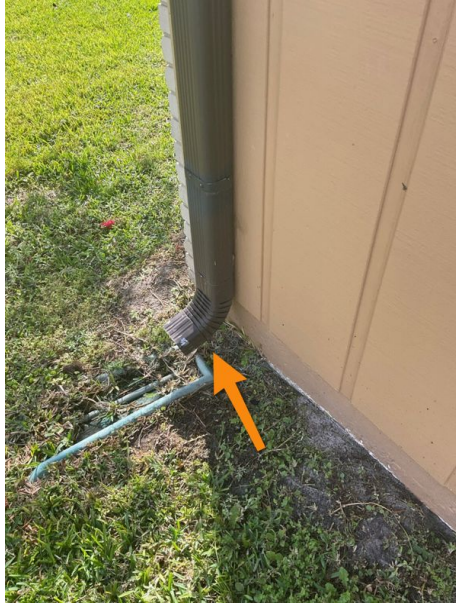
2.2.1 - Roof: Roof Drainage Systems

## DOWNSPOUTS DRAIN NEAR HOUSE

One or more downspouts drain too close to the home's foundation. This can result in excessive moisture in the soil at the foundation, which can lead to foundation/structural movement. Recommend a qualified contractor adjust downspout extensions to drain at least 6 feet from the foundation.

Contact a qualified gutter contractor

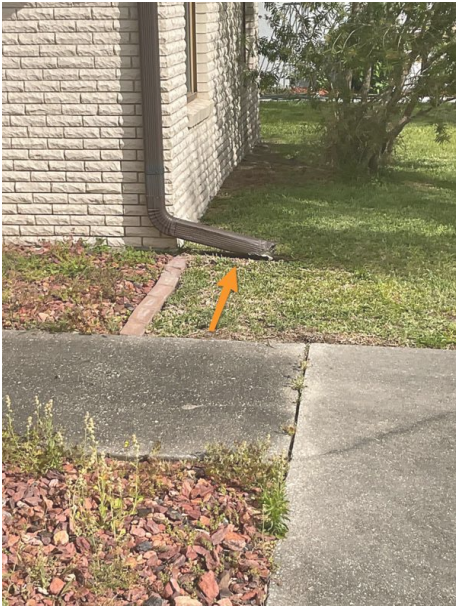
Front Elevation

## GUTTER DAMAGED

Gutters were damaged. This can result in excessive moisture in the soil at the foundation, which can lead to foundation/structural movement. Recommend a qualified contractor evaluate and repair.

Contact a qualified gutter contractor

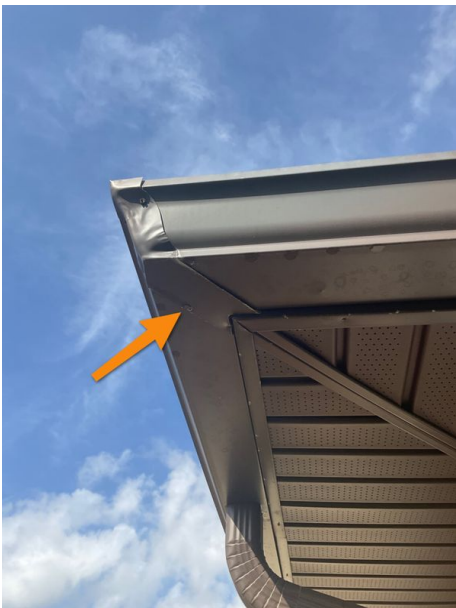
Front Elevation

#### GUTTER LEAKAGE

Gutters were observed to be leaking in one or more areas. This can result in excessive moisture in the soil at the foundation, which can lead to foundation/structural movement. Recommend a qualified contractor evaluate and repair gutters to proper functionality.

Contact a qualified gutter contractor

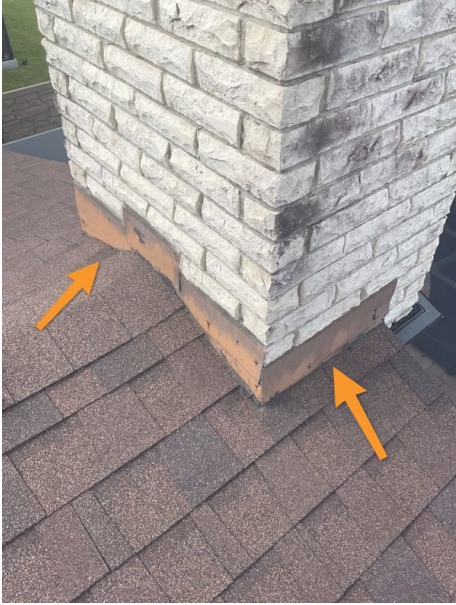
#### CORROSION

Roof flashing showed signs of corrosion. Recommend a qualified roofing contractor evaluate and repair.

Contact a qualified roofing professional.

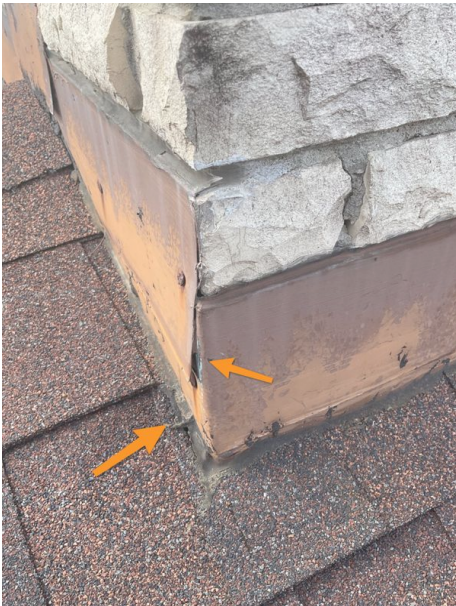
Chimney

2.3.2 - Roof: Flashings  
**LOOSE/SEPARATED**

Flashings observed to be loose or separated. Recommend a qualified roofing contractor repair.

Recommendation  
Contact a qualified roofing professional.

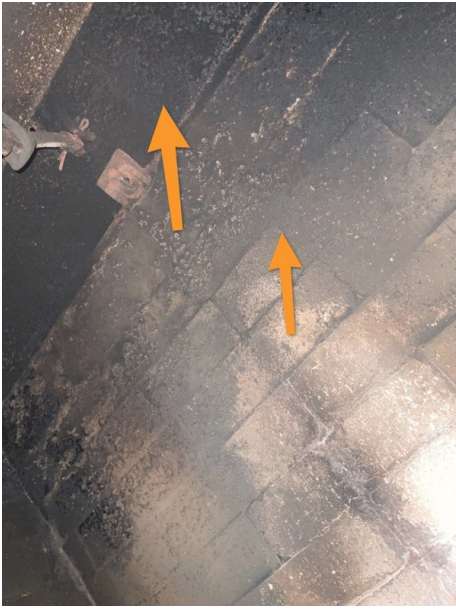
2.4.1 - Roof: Skylights, Chimneys & Other Roof Penetrations  
**CHIMNEY FLUE DIRTY**

Chimney flue was excessively dirty. Recommend a qualified chimney contractor clean the build up in the flue.

Contact a qualified chimney sweep.

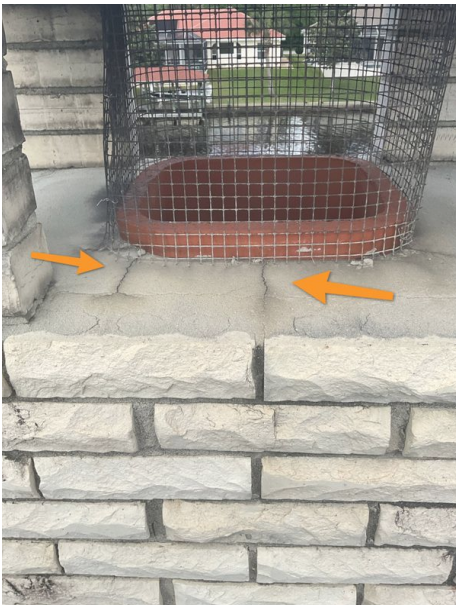
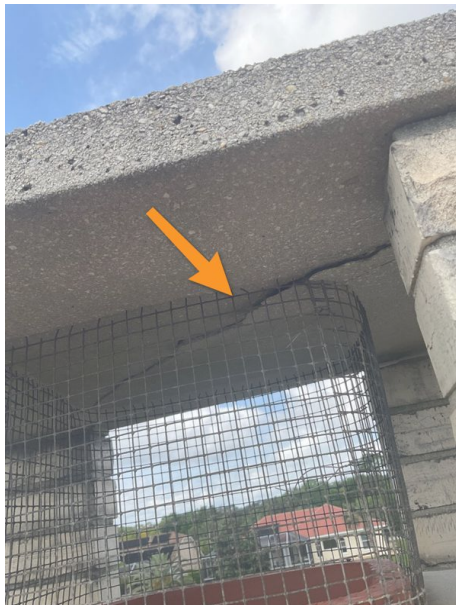
2.4.2 - Roof: Skylights, Chimneys & Other Roof Penetrations  
**CHIMNEY CAP DAMAGED**

Chimney Cap/Crown Was observed damaged and/or cracked. Repairs are recommended.

Contact a qualified professional.

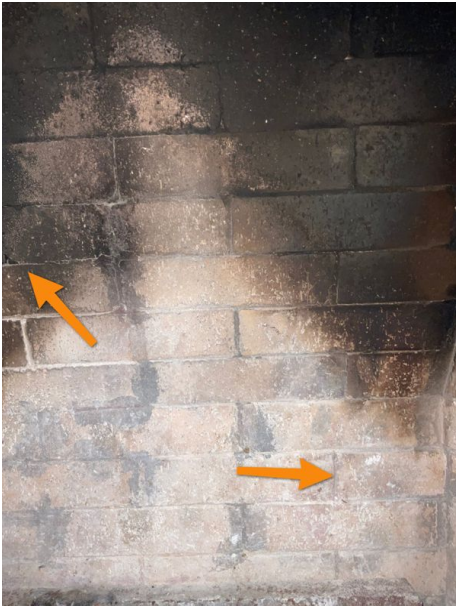
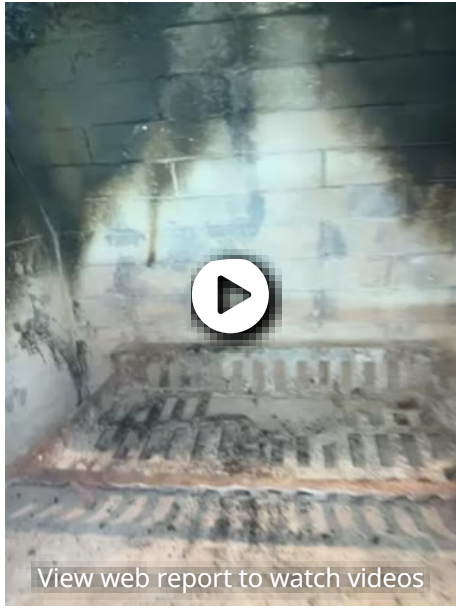
2.4.3 - Roof: Skylights, Chimneys & Other Roof Penetrations  
**DAMAGED FIRE BOX**

Damage was observed at fireplace fire box at time of inspection. Repairs are recommended.

Contact a qualified fireplace contractor.

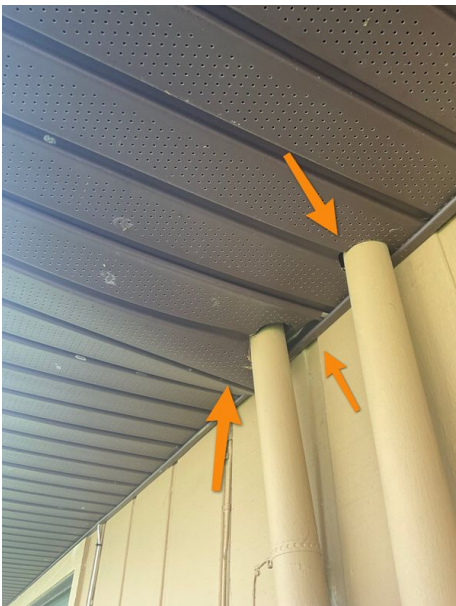
Right Elevation

2.5.1 - Roof: Soffit and Fasciae  
**DAMAGE (SOFFIT/EAVES)**

One or more sections of soffit/eave was observed damaged. It is possible this damage was caused by wood destroying organisms. It is recommended a licensed pest control company further evaluate the damage and determine corrective action needed.

Contact a qualified roofing professional.

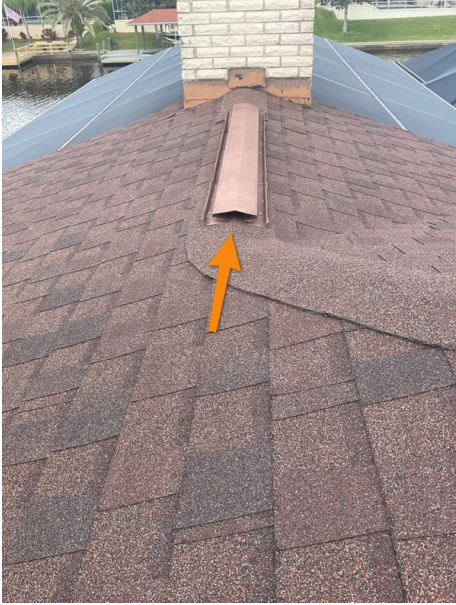
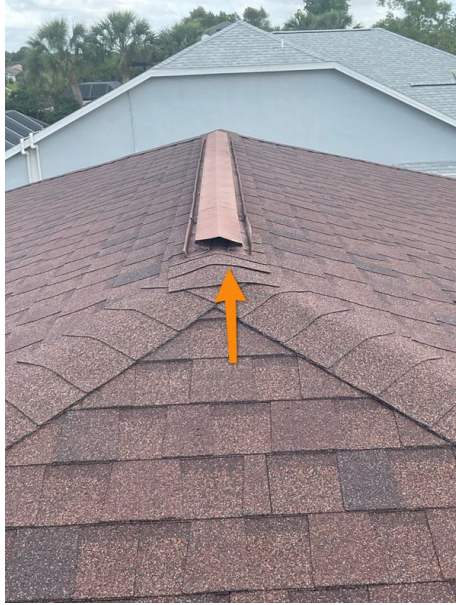
**END CAPS**

One or more ridge vents were missing end caps at the time of inspection. Replacement is recommended.

Contact a qualified roofing professional.

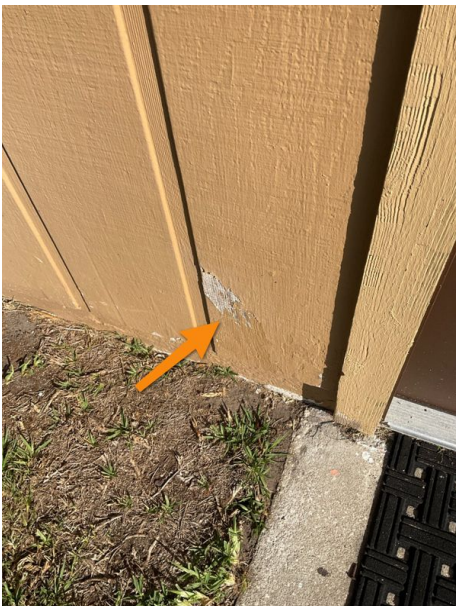
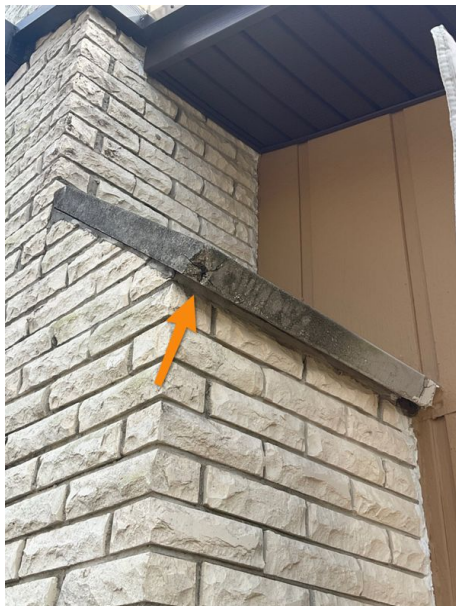
**DAMAGE**

One or more areas of siding/stucco were observed damaged at time of inspection. Recommend a licensed contractor address as needed.

Contact a qualified siding specialist.

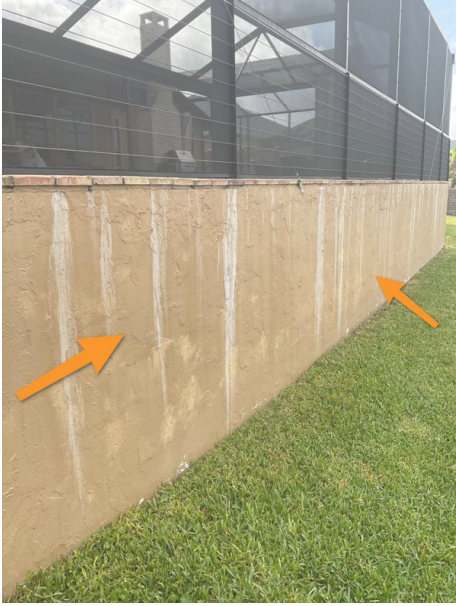
Rear Elevation

3.1.2 - Exterior: Siding, Flashing & Trim  
**MILDEW/ALGAE**

There are signs of staining, algae and/or mildew on the siding. This is a cosmetic issue and is not uncommon especially on shaded portions of the home. Recommend that said areas be washed or cleaned on a regular basis.

Contact a qualified professional.

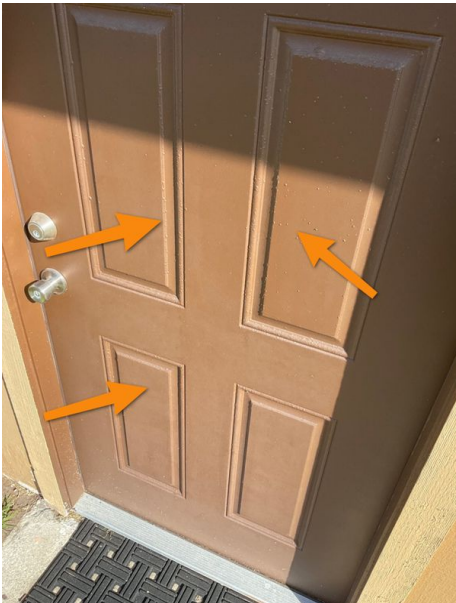
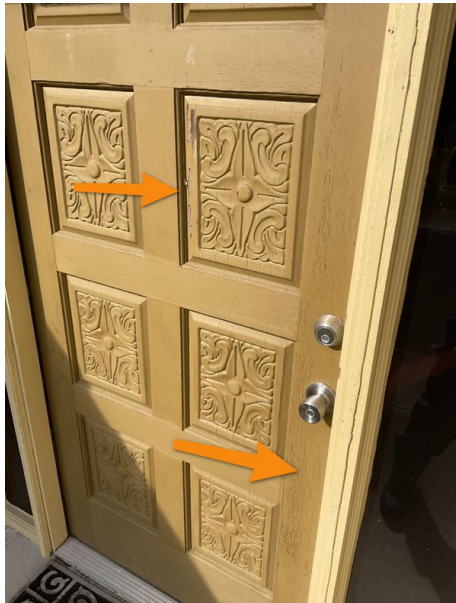
3.2.1 - Exterior: Exterior Doors  
**DAMAGE**

One or more exterior doors was observed damaged at time of inspection. Repair/replacement is recommended.

Contact a qualified door repair/installation contractor.

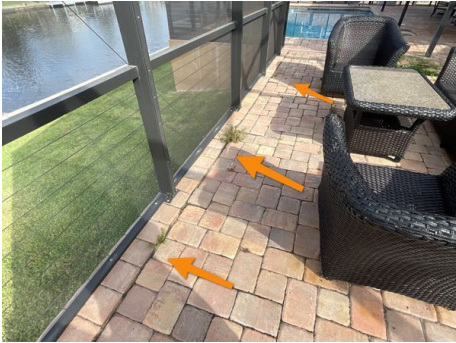
Rear Elevation

**SINKING**

Rear patio was observed to be sinking at the time of inspection. Recommend a licensed landscape contractor evaluate and address as needed.

Contact a qualified landscaping contractor

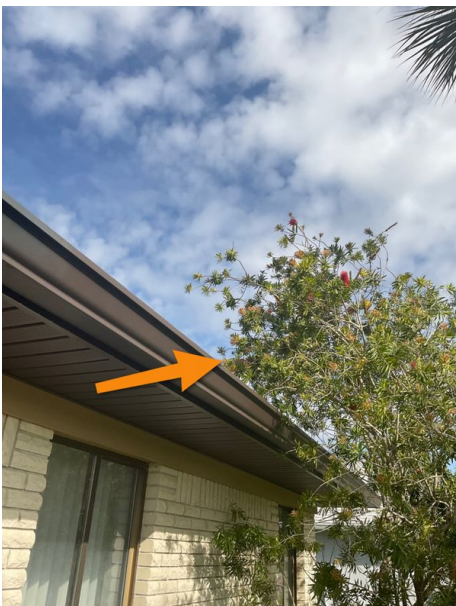
Front Elevation

**TREE OVERHANG**

Trees observed overhanging the roof. This can cause damage to the roof and prevent proper drainage. Recommend a qualified tree service trim to allow for proper drainage.

Contact a qualified tree service company.

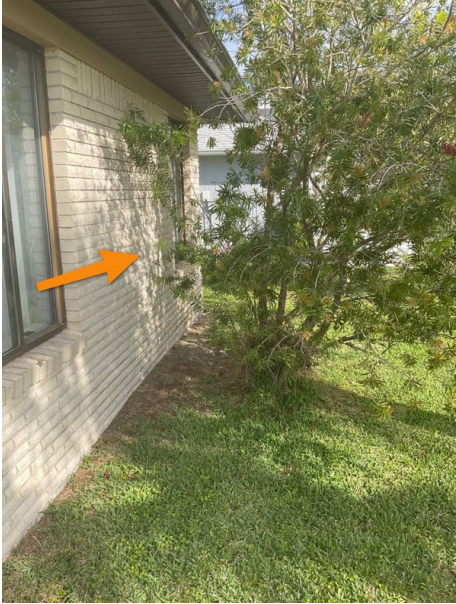
Trees/bushes were observed in direct contact with the subject property exterior walls. It is recommended all vegetation in contact with exterior walls be trimmed back.

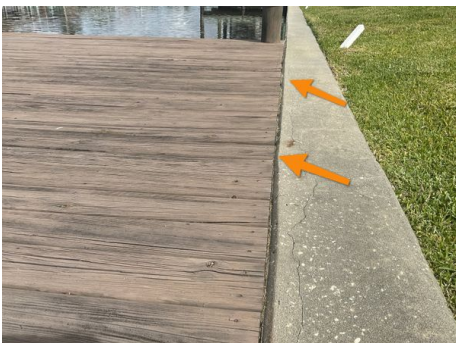
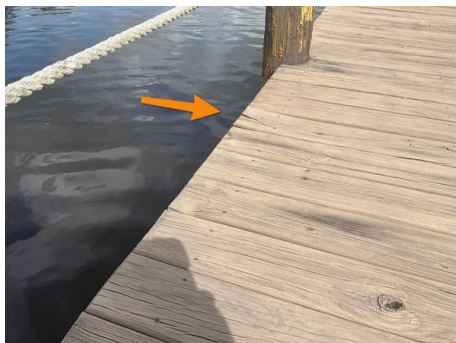
**LOOSE BOARDS**

One or more boards were observed to be loose. Recommend they be refastened.

Contact a qualified deck contractor.

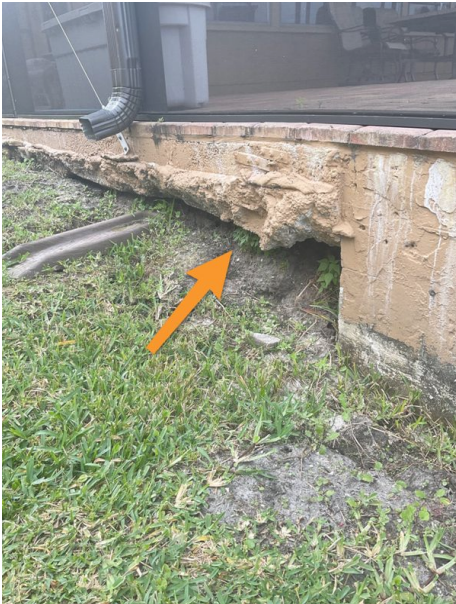
4.1.2 - Basement, Foundation, Crawspace & Structure: Foundation

There appears to be moderate to significant erosion beneath the rear patio slab. Recommend a licensed professional evaluate and make necessary repairs.

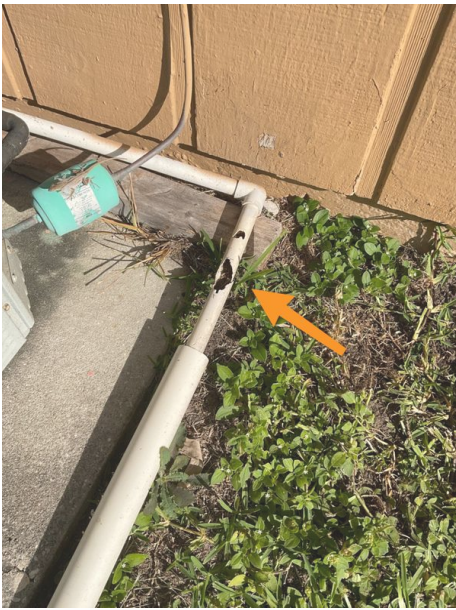
Left Elevation

5.1.1 - Heating/Cooling: Heating/Cooling Equipment  
**CONDENSATE TUBE DAMAGED/LEAKING**

Condensate tube was damaged and/or leaking, which compromises safe discharge of condensation produced by evaporator coils. Recommend a qualified HVAC technician repair.

Contact a qualified heating and cooling contractor

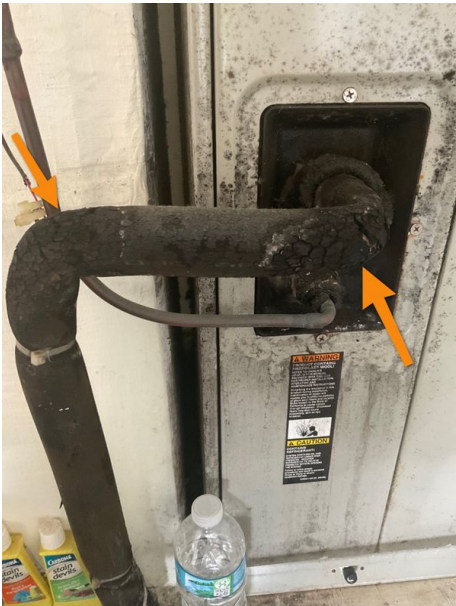
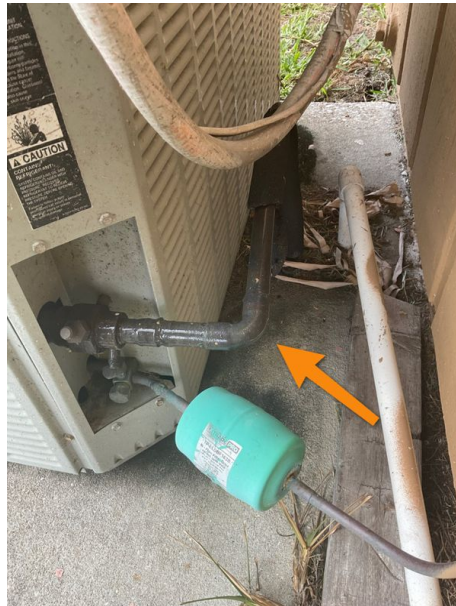
5.1.2 - Heating/Cooling: Heating/Cooling Equipment  
**INSULATION MISSING OR DAMAGED**

Missing or damaged insulation on refrigerant line can cause energy loss and condensation.

Contact a qualified heating and cooling contractor

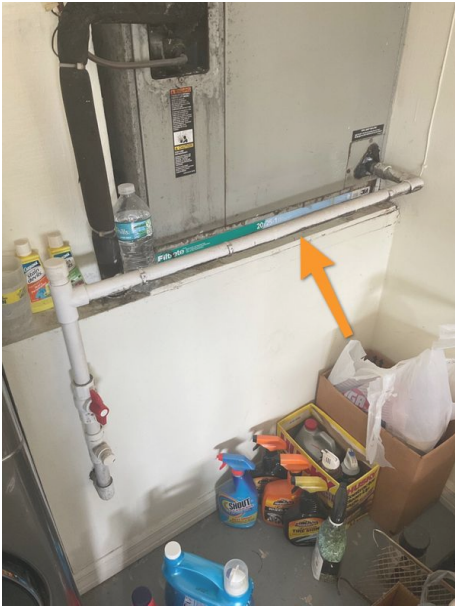
5.1.3 - Heating/Cooling: Heating/Cooling Equipment  
**FLOAT SWITCH**

It is recommended that a float switch be installed at the air handler condensate drain line. In the event there is a condensate line blockage, this will turn the system off to prevent possible water damage

Contact a qualified heating and cooling contractor

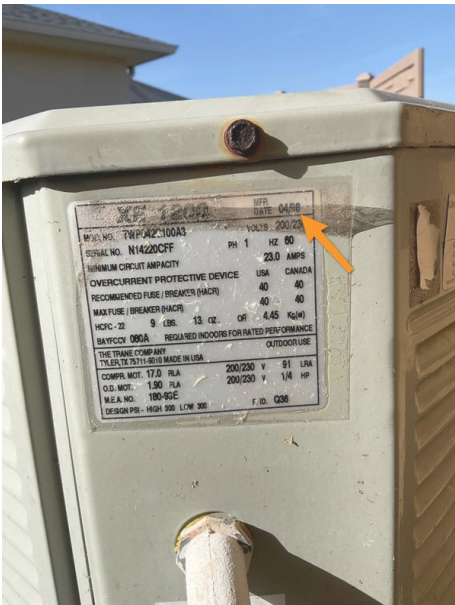
Condenser

#### 5.1.4 - Heating/Cooling: Heating/Cooling Equipment UNIT NEAR LIFE EXPECTANCY

HVAC systems in the state of Florida have an average life expectancy of 12-15 years. Although well maintained systems may potentially last longer, it is recommended that, once in this age range, the system's replacement be anticipated.

Recommendation  
Contact a qualified heating and cooling contractor

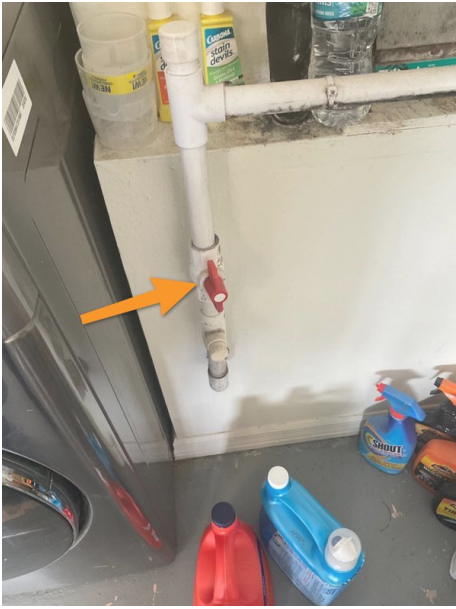
#### 5.1.5 - Heating/Cooling: Heating/Cooling Equipment VALVE

Valve was observed installed on condensate drain line. Condensate drain line should not have shut off valves. Removal is recommended.

Contact a qualified heating and cooling contractor

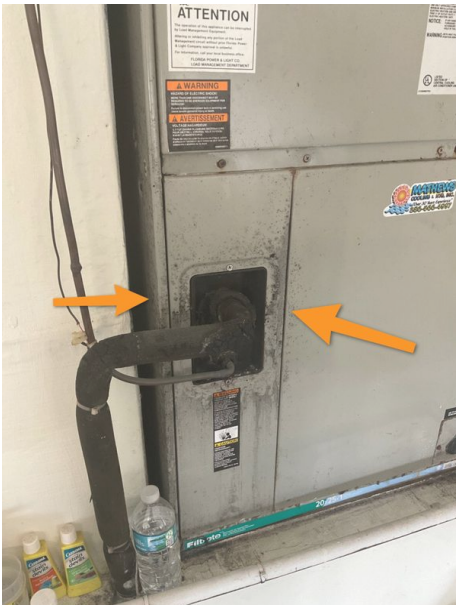
**POSSIBLE MOLD AIR HANDLER COMPONENTS**

Suspect fungal growth was observed at air handler components. The only way to identify type/amount of fungal growth is by performing testing. Whenever suspect fungal growth is present, testing is strongly recommended at your discretion.

Contact a qualified mold inspection professional.

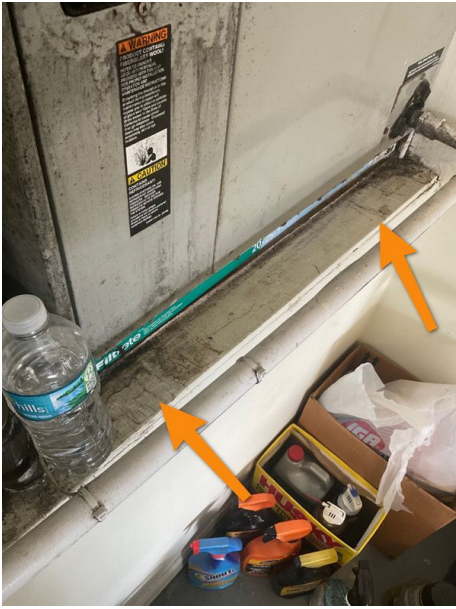
**DAMAGED AIR HANDLER PLATFORM**

Air handler platform was observed damaged at time of inspection. Recommend a qualified professional repair as needed.

Recommendation  
Contact a qualified professional.

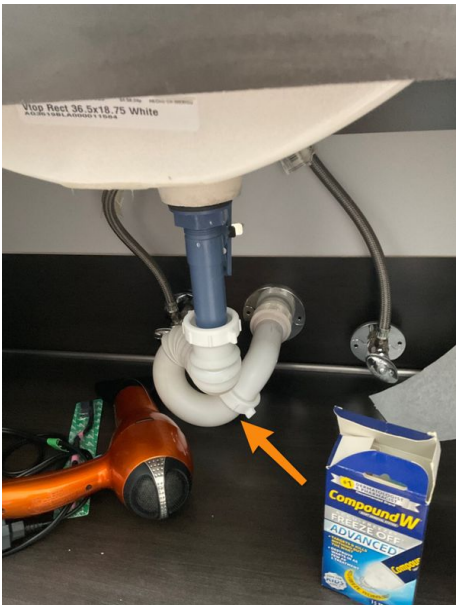
Bathroom 2

6.2.1 - Plumbing: Drain, Waste, & Vent Systems  
**IMPROPER INSTALLATION**

Drain pipe was observed improperly installed at one or more locations. Repairs are recommended.

Recommendation  
Contact a qualified plumbing contractor.

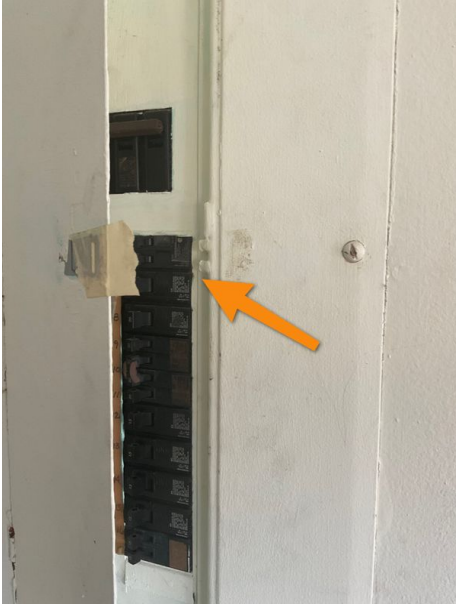
7.2.3 - Electrical: Main & Subpanels, Service & Grounding, Main Overcurrent Device  
**PANEL COVER DAMAGE**

Electrical panel is damaged. Repair/replacement is recommended.

Contact a qualified electrical contractor.

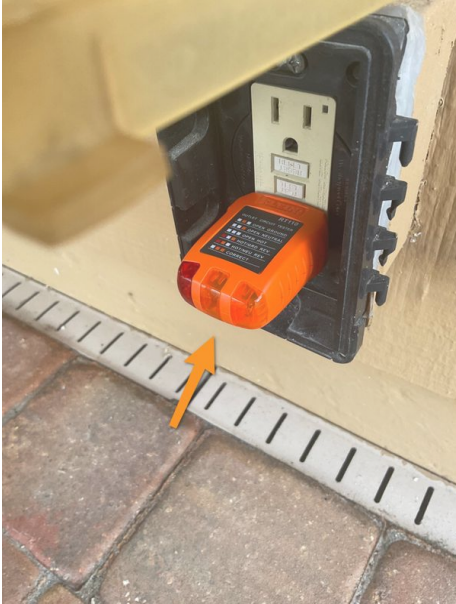
7.4.2 - Electrical: Lighting Fixtures, Switches & Receptacles  
**NO POWER**

One or more electrical receptacles did not have power at time of inspection. Recommend a licensed electrical contractor evaluate and address as needed.

Recommendation  
Contact a qualified electrical contractor.

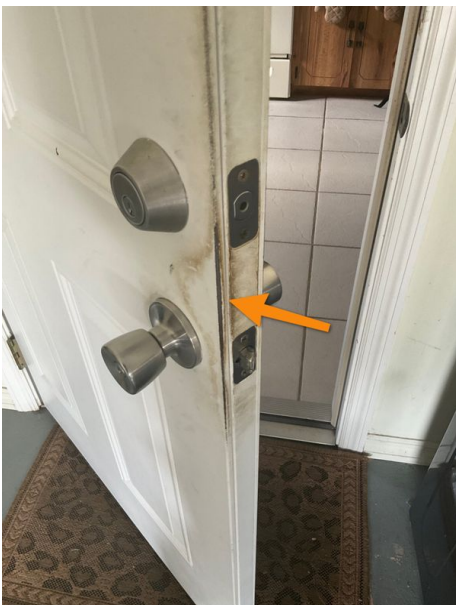
Garage

9.1.1 - Doors, Windows & Interior: Doors  
**DAMAGED**

One or more interior doors is damaged. Repair/replacement recommended.

Recommendation  
Contact a qualified door repair/installation contractor.

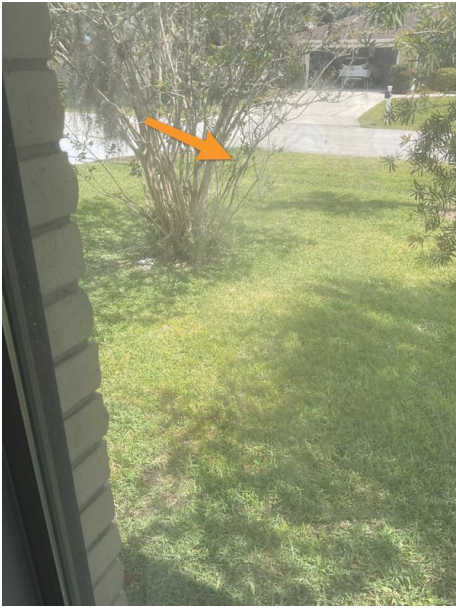
Bedroom 2

9.2.1 - Doors, Windows & Interior: Windows  
**FAILED/MIGRATING SEAL**

Observed condensation between the window panes and/or a seal that has moved, which indicates a failed seal. Recommend qualified window contractor evaluate & replace.

Contact a qualified window repair/installation contractor.

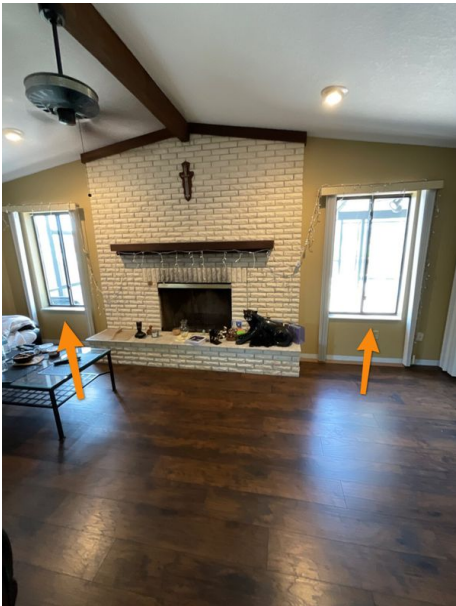
9.2.4 - Doors, Windows & Interior: Windows  
**NOT OPERATING PROPERLY**

One or more windows was observed not opening/closing properly. Repair/replacement is recommended.

Contact a qualified window repair/installation contractor.

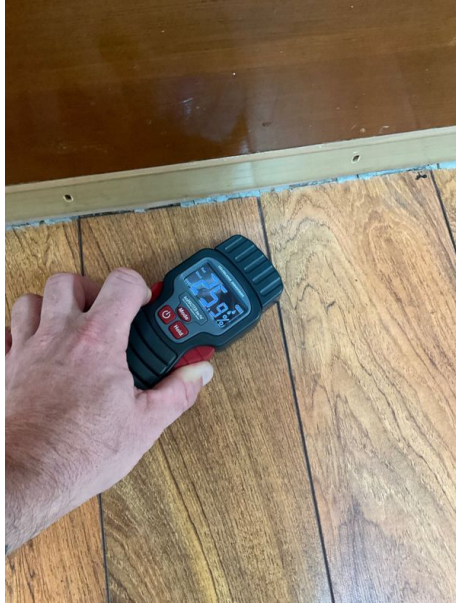
Foyer

9.3.1 - Doors, Windows & Interior: Floors  
**MOISTURE DAMAGE**

Floors had areas of visible moisture damage. Infrared imaging and/or moisture meter readings will be used to determine whether the damage appears to be active, but it is recommended a qualified professional perform further evaluation to verify whether necessary corrective action has been taken.

Contact a qualified flooring contractor

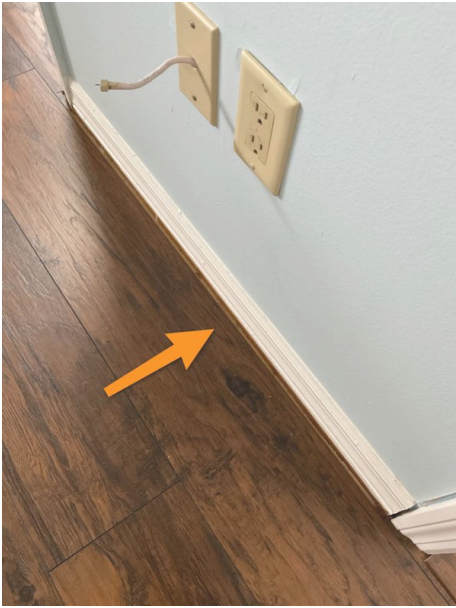
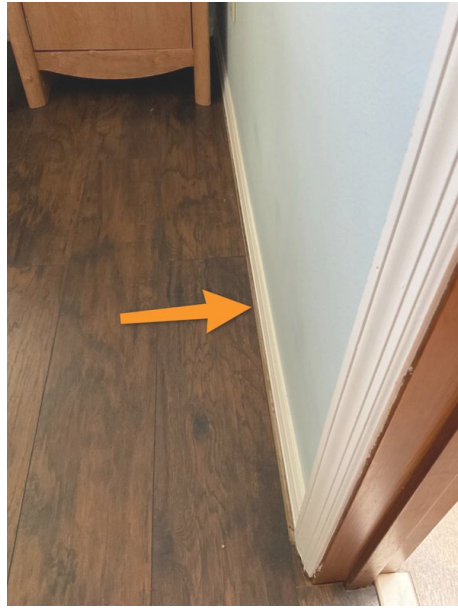
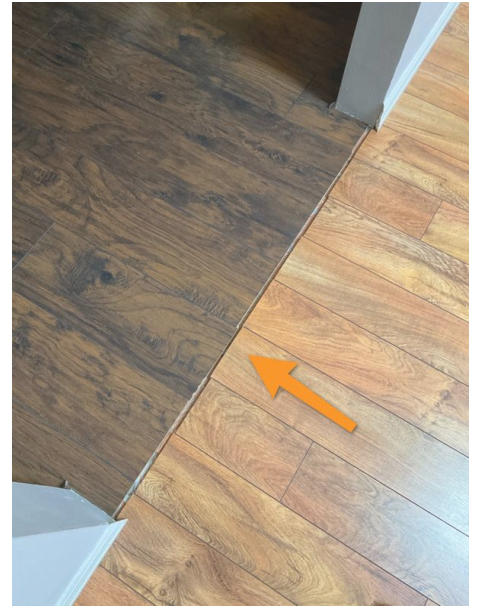
9.3.2 - Doors, Windows & Interior: Floors  
**FLOORING MISSING**

Flooring in one or more areas of the subject property was observed missing at time of inspection. Recommend a licensed contractor evaluate and address as needed.

Recommendation  
Contact a qualified flooring contractor

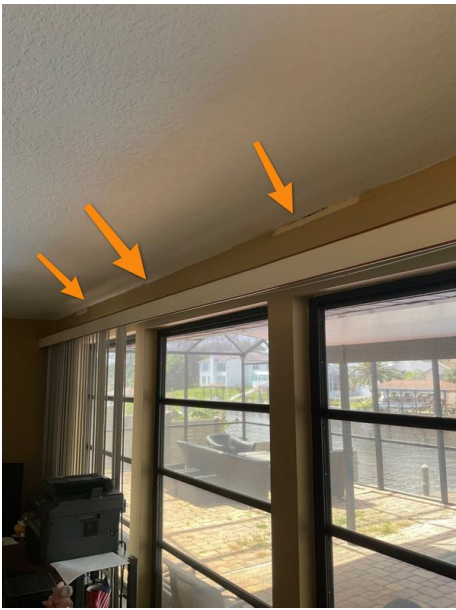
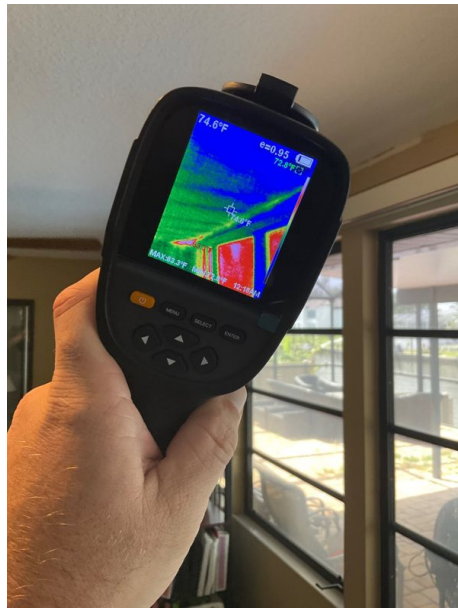
9.4.1 - Doors, Windows & Interior: Walls  
**DAMAGE**

Damage was observed on interior walls. Recommend a licensed contractor make necessary repairs.

Recommendation  
Contact a qualified drywall contractor.

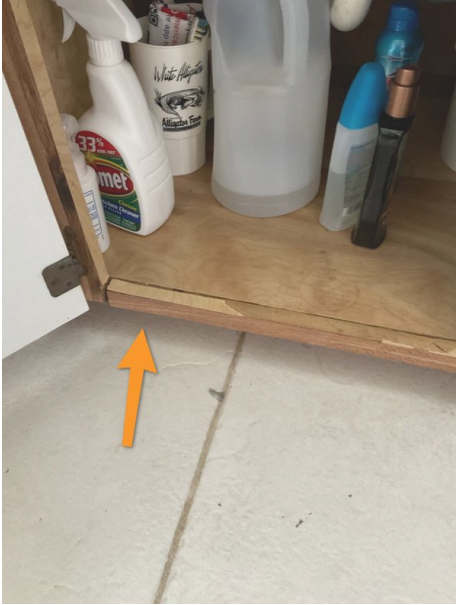
10.1.1 - Kitchen: Cabinets and Countertops  
**CABINETS DAMAGED**

Cabinets were observed with visible damage. Recommend a licensed cabinet contractor evaluate and make necessary repairs.

Recommendation  
Contact a qualified cabinet contractor.

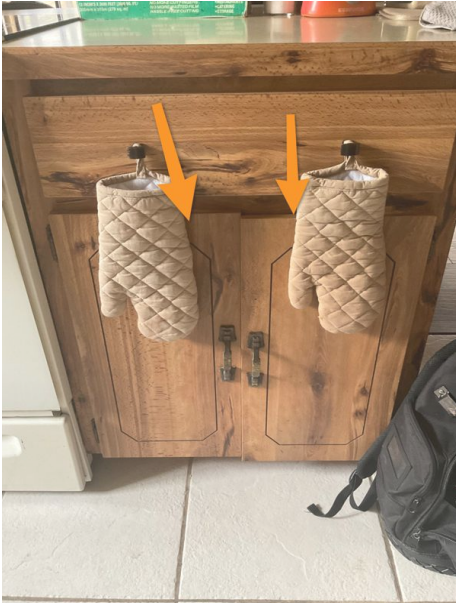
10.1.2 - Kitchen: Cabinets and Countertops  
**IMPROPER INSTALLATION**

Cabinet door/drawer is improperly installed. Recommend a licensed contractor make necessary repairs.

Recommendation  
Contact a qualified cabinet contractor.

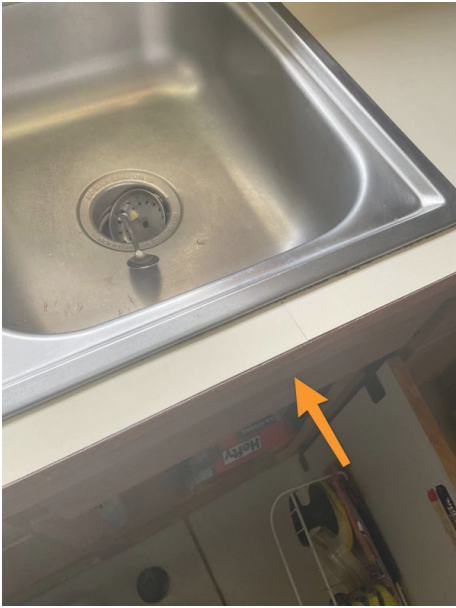
10.1.3 - Kitchen: Cabinets and Countertops  
**COUNTERTOP DAMAGED**

Countertop was observed with visible damage at time of inspection. Recommend a qualified professional make necessary repairs.

Recommendation  
Contact a qualified countertop contractor.

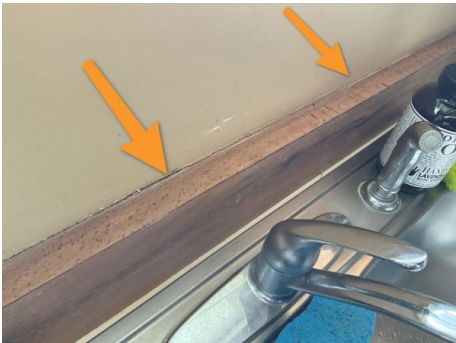
10.1.4 - Kitchen: Cabinets and Countertops  
**POOR/MISSING CAULK**

Missing and/or deteriorated caulk was observed at kitchen countertops. Recommend a qualified professional make necessary repairs.

Recommendation  
Contact a handyman or DIY project

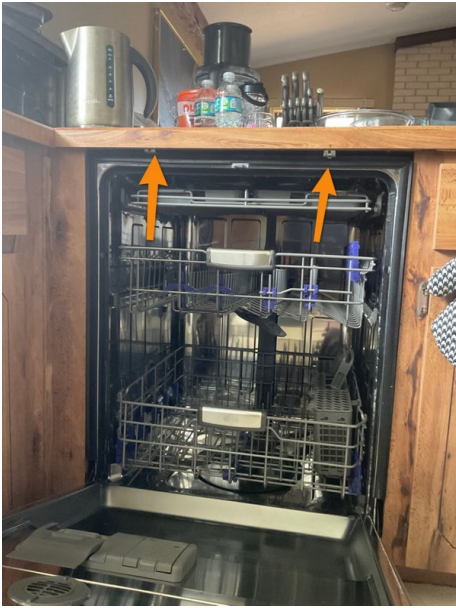
11.1.1 - Built-in Appliances: Dishwasher  
**IMPROPER INSTALLATION**

Dishwasher is not properly installed/secured. Recommend a qualified professional address as needed.

Recommendation  
Contact a qualified appliance repair professional.

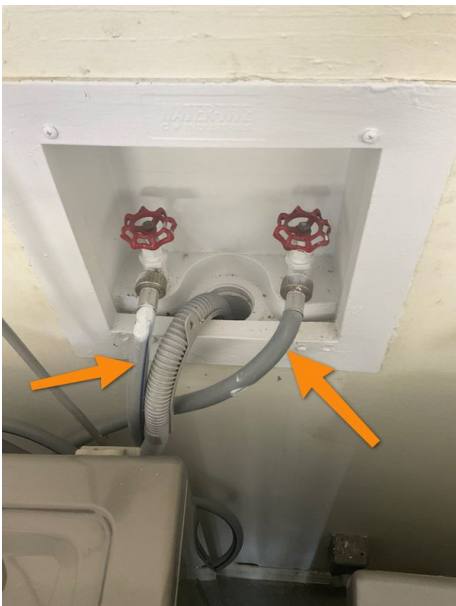
HOSES

Recommend replacing rubber laundry hoses with stainless steel braided.

Contact a handyman or DIY project

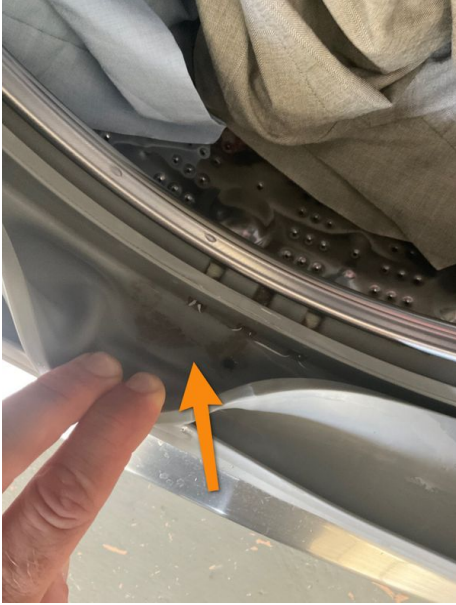
GASKET DAMAGE

Dryer gasket is damaged. Cleaning/Replacement is recommended.

Contact a qualified appliance repair professional.

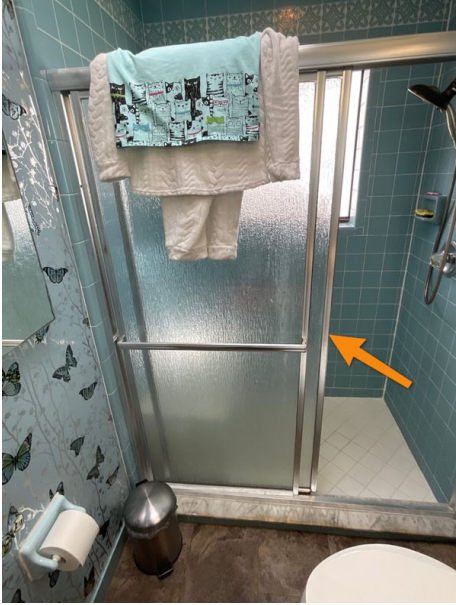
12.3.3 - Bathroom 1: Shower

### SHOWER DOORS

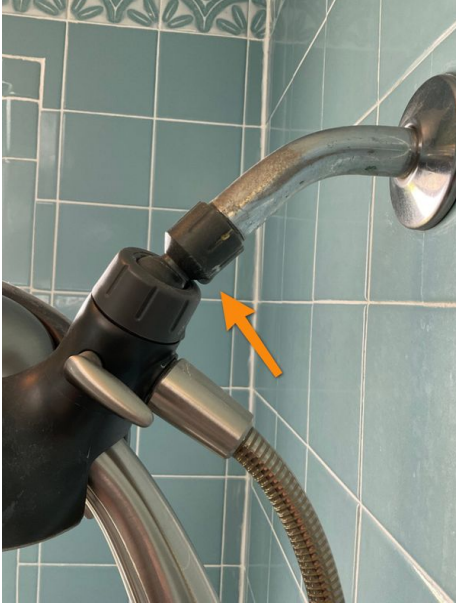
#### 12.3.5 - Bathroom 1: Shower SHOWER HEAD LEAKING

Shower head is leaking. Repairs are recommended.

Contact a qualified plumbing contractor.

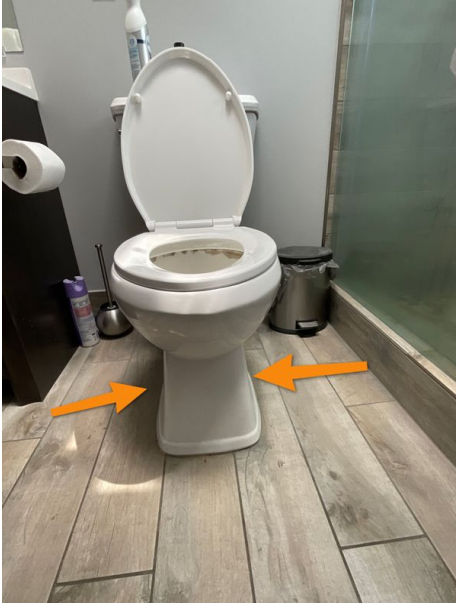
**LOOSE TOILET**

Toilet is loose at the base and/or tank. Repairs are recommended.

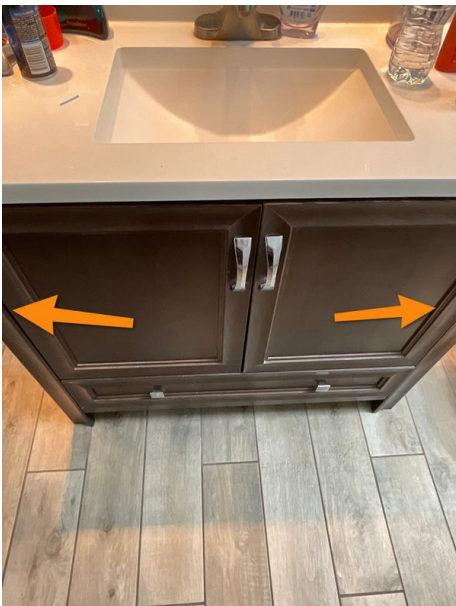
13.6.1 - Bathroom 2: Sink  
**CABINET HINGE LOOSE**

One or more cabinet hinges were observed loose at time of inspection. Repairs are recommended.

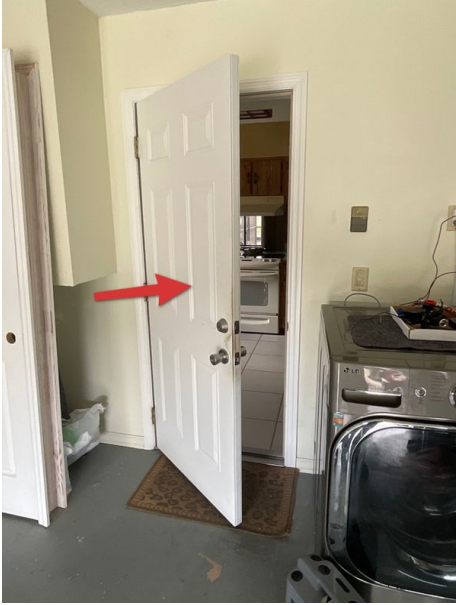
14.6.1 - Garage: Occupant Door (From garage to inside of home)

**NOT SELF-CLOSING**

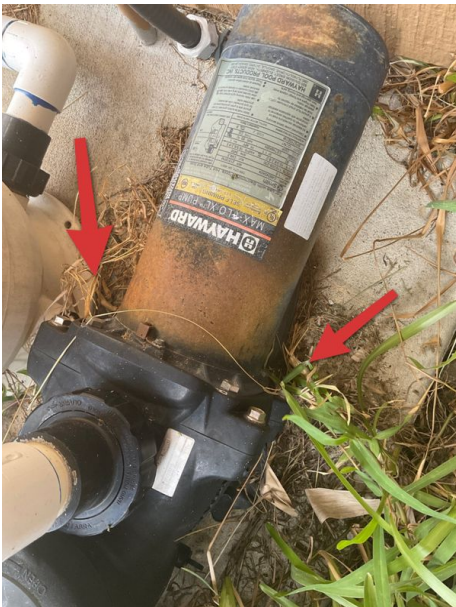
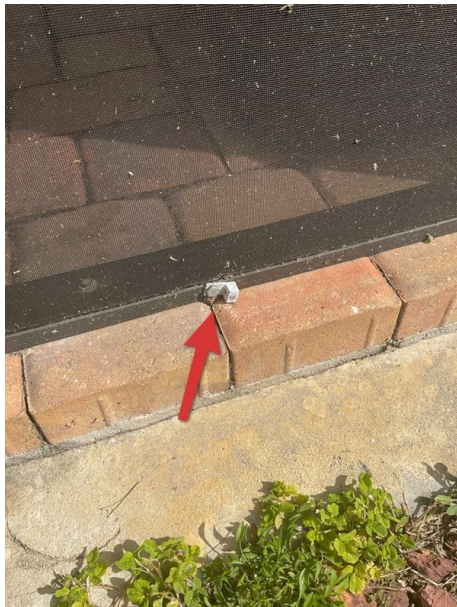
Rear Elevation

Swimming pool/pump does not appear to be properly bonded. Recommend a licensed pool contractor evaluate and address as needed.
