REPAIR REQUEST LIST

1234 Main Street
10/02/2022 11:09 am

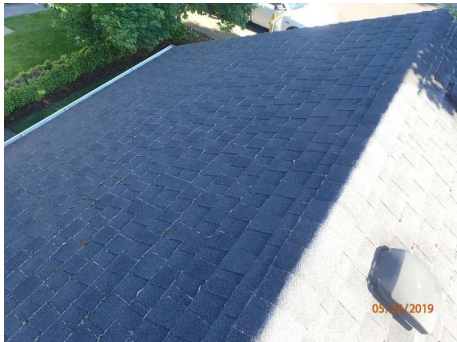
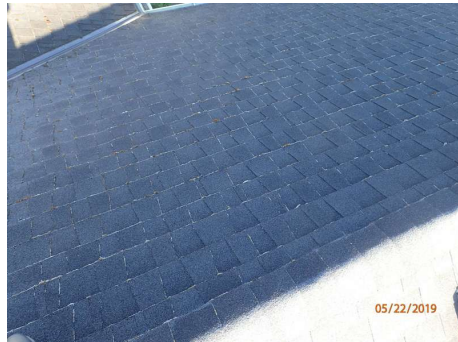
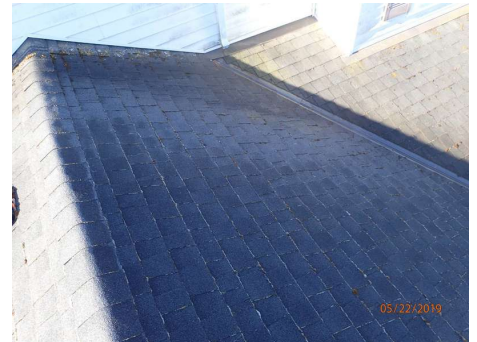
MOSS

Moss growth is usually greatest on north-facing roofs, roof areas shaded by trees and other places that are not exposed to enough sun to dry out.

Once established, it acts like a sponge, soaking up and storing rainwater. Some of that water then wicks up under the shingles through capillary action and soaks into and through the roof underlayment, which is typically 15- or 30-pound felt. Eventually, it saturates the roof sheathing below.

Moss can shorten the life span of a shingled roof and result in costly repairs both structural and cosmetic that would not be necessary if the roof were maintained properly and kept clear of moss.

Recommend cleaning and removing any moss from the roof, after which a moss treatment plan can be established to limit future growth. Avoid power washing the moss off because that can drive moisture under the shingles, damaging the underlying roof components. If the roof is to high or steep, recommend contacting a licensed roofing contractor or moss removal specialist.

Contact a handyman or DIY project

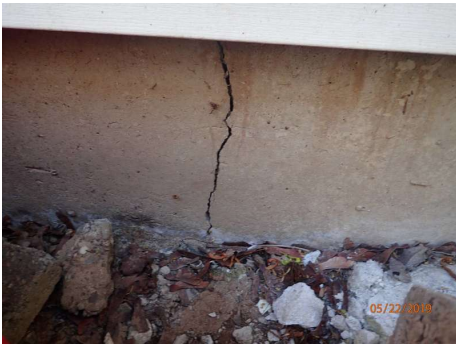
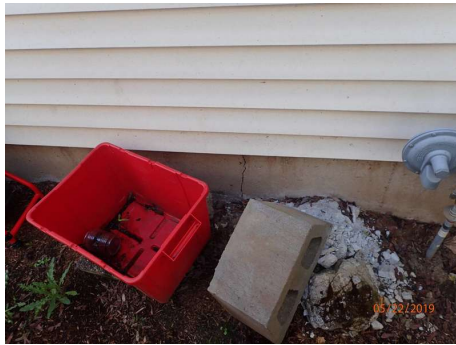
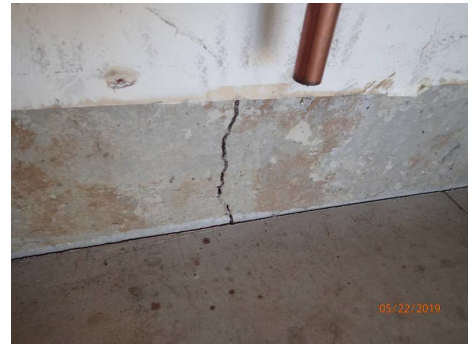
4.1.2 - Basement, Foundation, Crawlspace & Structure: Foundation
FOUNDATION CRACKS-

Moderate cracking was noted at the foundation in one or more locations. This is common as concrete ages and shrinkage but cracks of this size are generally influenced by additional settling. Recommend monitoring for more serious shifting/displacement.

East Side, Garage

A foundation contractor should be consulted if the crack ever grows.

Recommend monitoring.

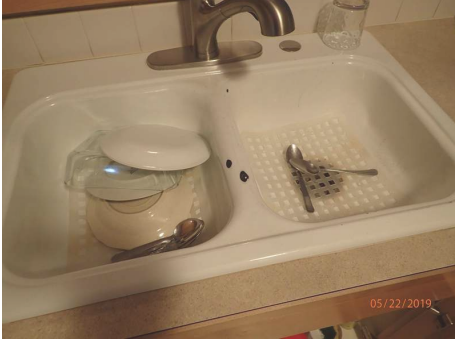
SINK - SURFACE DAMAGE

The sink has surface damage that is cosmetic but could also lead to a potential leak in the future. Recommend replacing the fixture at your own convenience.

Contact a qualified plumbing contractor.

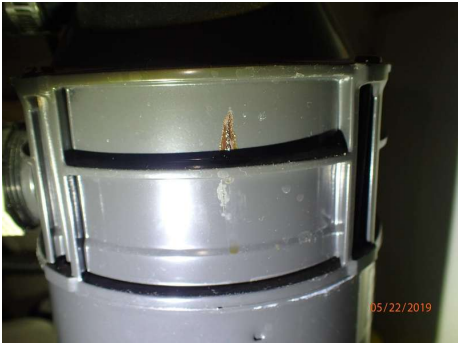
DAMAGED - HOLE/CRACK

A hole/crack was found in the garbage disposal causing a leak. Often times parts can be found to repair this but it tends to be more economical to just replace the unit.
