Uniform Mitigation Verification Inspection Form

Inspection Date: 05/13/2024		
Owner Information		
Owner Name: Leyan Muniz	Contact Person: Leyan Muniz	
Address: 11153 NW 7TH ST	Home Phone:	
City: CORAL SPRINGS	Zip: 33071	Work Phone:
County: Broward County	Cell Phone: 786-227-1744	
Insurance Company:	Policy #:	
Year of Home: 1983	# of Stories: 1	Email: munizleyan@gmail.com

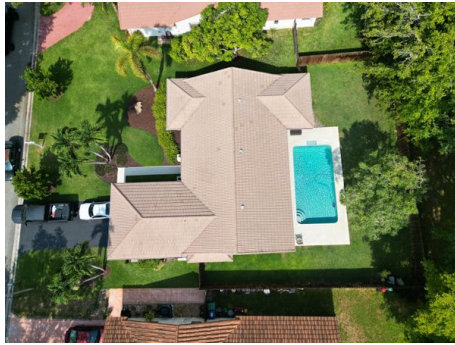
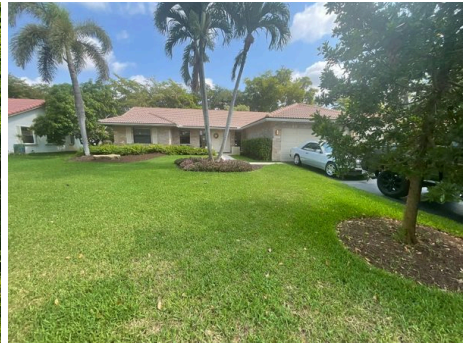
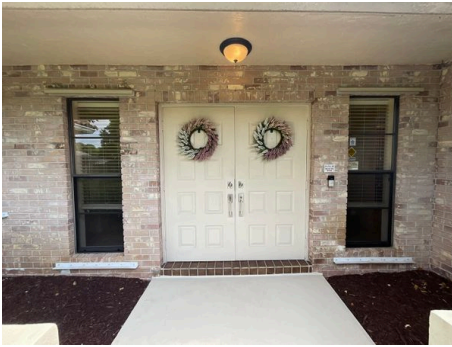
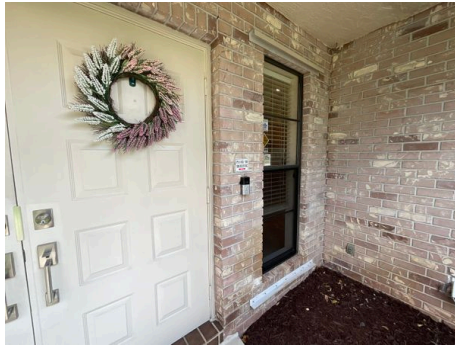
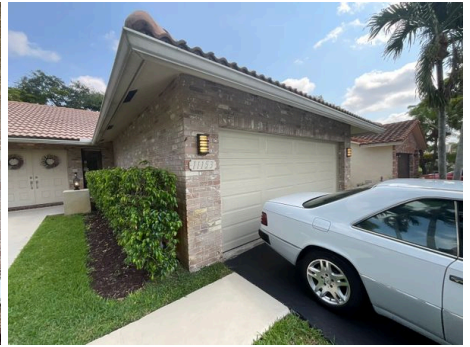
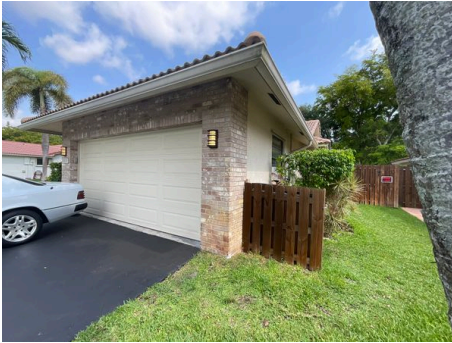
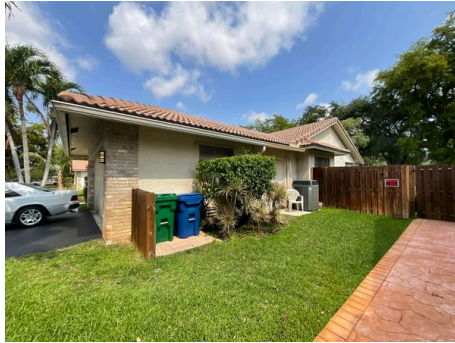
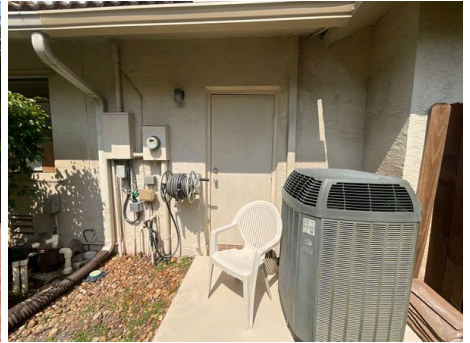
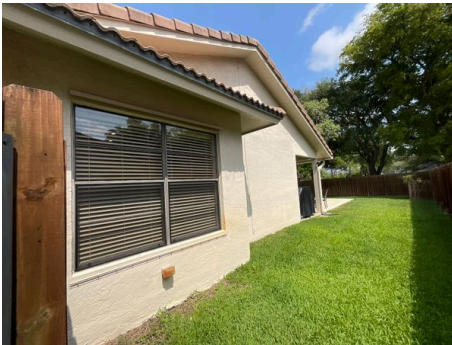
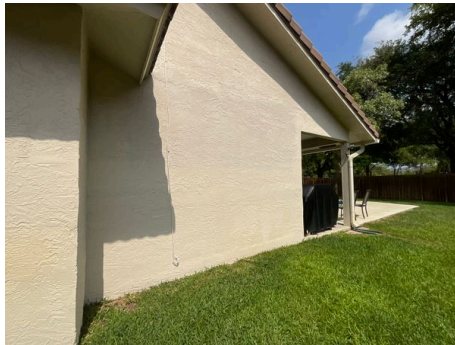
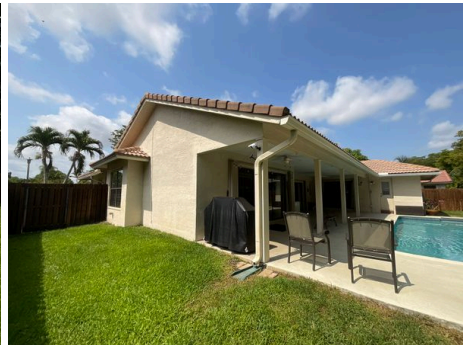
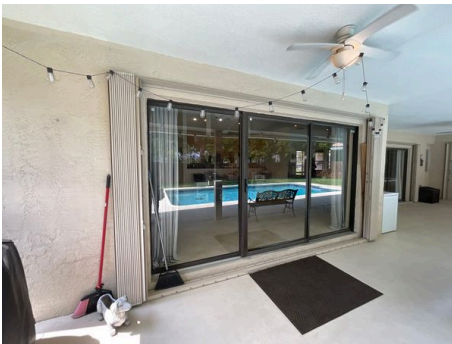
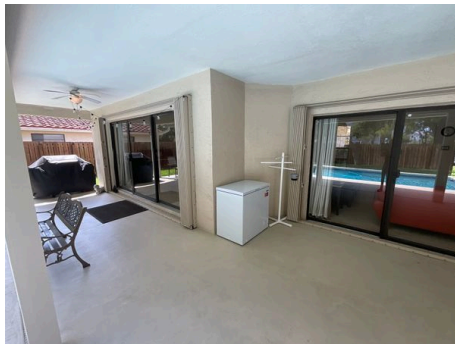
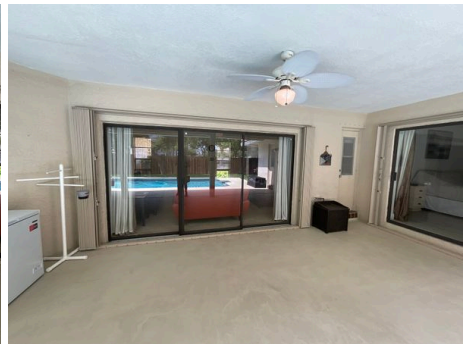
Photos

Oct 03, 2000	STR: HURRICANE SHUTTERS	APPROVED	
1998			
Permit #:	98-00006942		
Permit Type:	STR: RE-ROOF SLOPE	Applied date: Nov 17, 1998	
Work class:	STR: RE-ROOF	Issued date: Nov 18, 1998	
Permit status:	CLOSED	Status date: Apr 05, 1999	
Job Cost:	\$ 0.00		
Inspections			
Date	Type	Result	Description
Nov 18, 1998	OF: NOTICE OF COMMENCEMENT	APPROVED	
Dec 07, 1998	STR: ROOF SHEATHING/IN PROGRESS	CANCELLED	
Dec 08, 1998	STR: ROOF SHEATHING/IN PROGRESS	APPROVED	
Dec 11, 1998	STR: TIN TAG TILE	APPROVED	
Jan 07, 1999	STR: ROOF TILE/IN PROGRESS	APPROVED	
Jan 08, 1999	STR: FINAL ROOF	APPROVED
