Uniform Mitigation Verification Inspection Form

Inspection Date: 06/28/2018			
Owner Information			
Owner Name: Phil Beers		Contact Person: Phil Beers	
Address: 6094 Sabal Creek Blvd		Home Phone:	
City: Port Orange	Zip: 32128	Work Phone:	
County: Volusia		Cell Phone: 203.317.7070	
Insurance Company:		Policy #:	
Year of Home: 1997	# of Stories: 1	Email: talon1320@yahoo.com

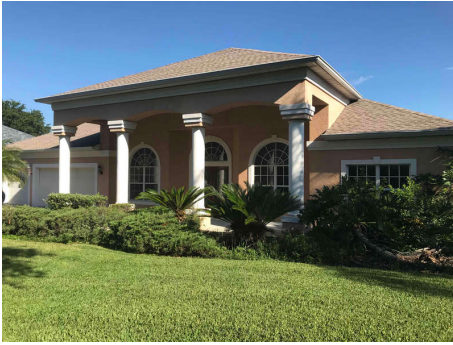
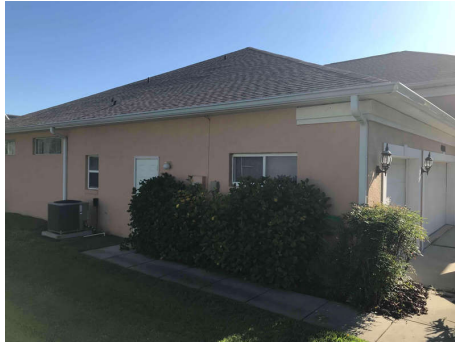
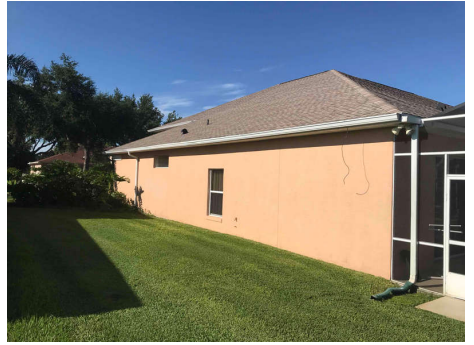
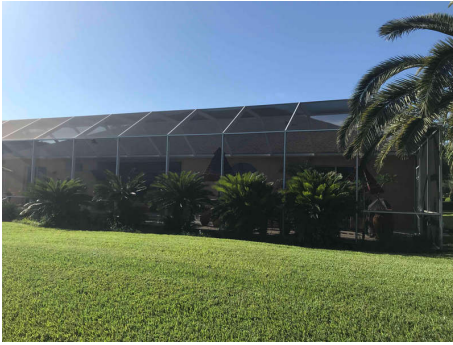
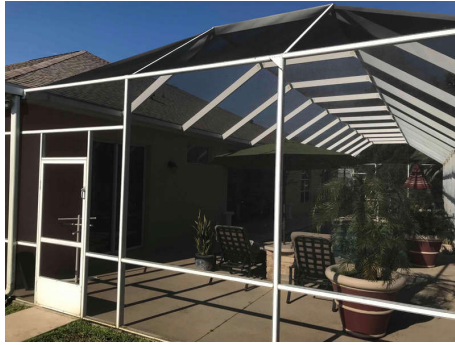
Elevation Photos

- ☒ A. Hip Roof Hip roof with no other roof shapes greater than 10% of the total roof system perimeter. Total length of non-hip features: _____ feet; Total roof system perimeter: _____ feet
- ☐ B. Flat Roof Roof on a building with 5 or more units where at least 90% of the main roof area has a roof slope of less than 2:12. Roof area with slope less than 2:12 _____ sq ft; Total roof area _____ sq ft
- ☐ C. Other Roof Any roof that does not qualify as either (A) or (B) above.

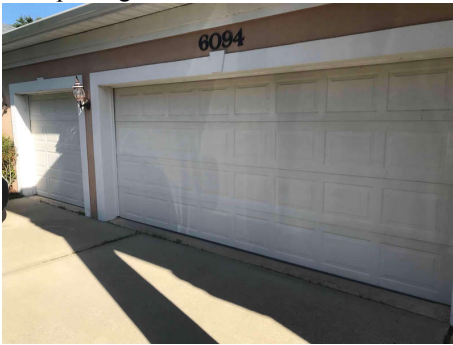
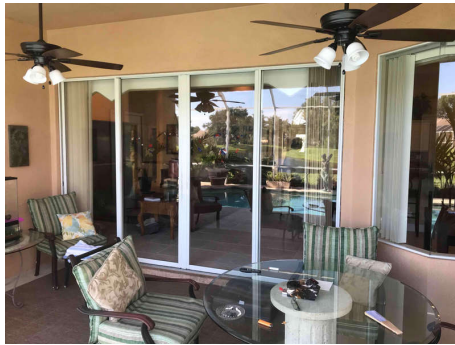
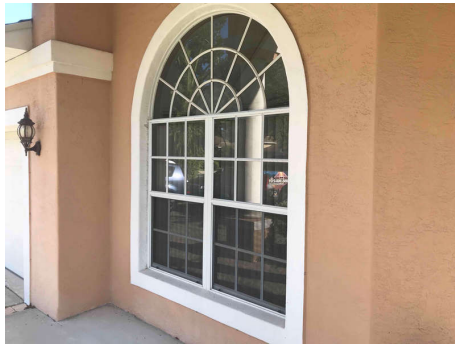
All Openings Photos

N	Opening Protection products that appear to be A or B but are not verified						
	Other protective coverings that cannot be identified as A, B, or C						
X	No Windborne Debris Protection	X				X	X

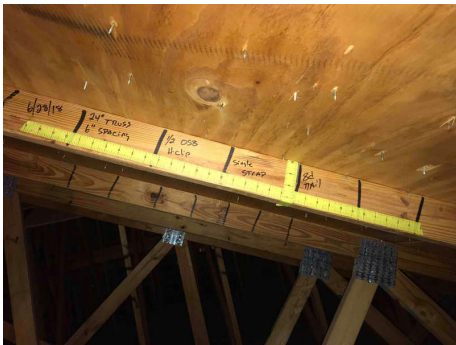
Roof/ Deck Attachment Photos

- ☒ C. Plywood/OSB roof sheathing with a minimum thickness of 7/16" inch attached to the roof truss/rafter (spaced a maximum of 24" inches o.c.) by 8d common nails spaced a maximum of 6" inches in the field. -OR- Dimensional lumber/Tongue & Groove decking with a minimum of 2 nails per board (or 1 nail per board if each board is equal to or less than 6 inches in width). -OR- Any system of screws, nails, adhesives, other deck fastening system or truss/rafter

spacing that is shown to have an equivalent or greater resistance than 8d common nails spaced a maximum of 6 inches in the field or has a mean uplift resistance of at least 182 psf.

- ☒ C. Single Wraps
 - Metal connectors consisting of a single strap that wraps over the top of the truss/rafter and is secured with a minimum of 2 nails on the front side and a minimum of 1 nail on the opposing side.
