# Uniform Mitigation Verification Inspection Form

| Address: <b>2753 Vista parkway</b> | | Home Phone: | |
| Year of Home: <b>1986</b> | # of Stories: <b>1</b> | Email: <b>contact@billingshomein...</b> | |

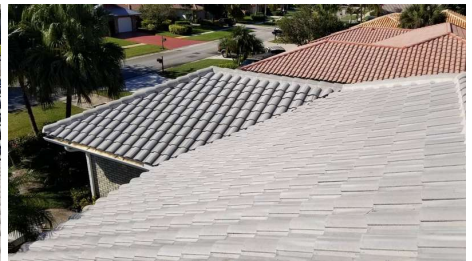
| 2.1 Roof Covering Type | Permit Application Date | FBC or MDC Product Approval # | Year of Original Installation or Replacement | No Information Provided for Compliance |
|---|---|---|---|---|
| <input checked="" type="checkbox"/> 2. Concrete/Clay Tile | <u>11/21/2016</u> | <u>B-2016-028633-0000</u> | <u>2016</u> | <input type="checkbox"/> |

- ☒ A. Hip Roof Hip roof with no other roof shapes greater than 10% of the total roof system perimeter. Total length of non-hip features: 21 feet; Total roof system perimeter: 286 feet
- ☐ B. Flat Roof Roof on a building with 5 or more units where at least 90% of the main roof area has a roof slope of less than 2:12. Roof area with slope less than 2:12 \_\_\_\_\_ sq ft; Total roof area \_\_\_\_\_ sq ft
- ☐ C. Other Roof Any roof that does not qualify as either (A) or (B) above.

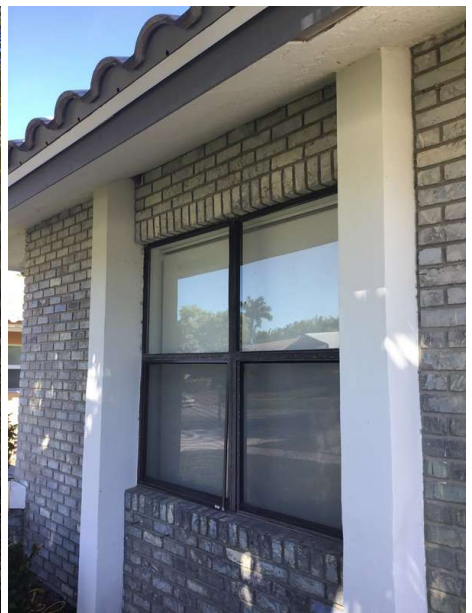
Unprotected openings

| Opening Protection Level Chart<br>Place an "X" in each row to identify all forms of protection in use for each opening type. Check only one answer below (A thru X), based on the weakest form of protection (lowest row) for any of the Glazed openings and indicate the weakest form of protection (lowest row) for Non-Glazed openings. | | Glazed Openings | | | | Non-Glazed Openings | |
|---|---|---|---|---|---|---|---|
| X | No Windborne Debris Protection | X | | | | X | X |

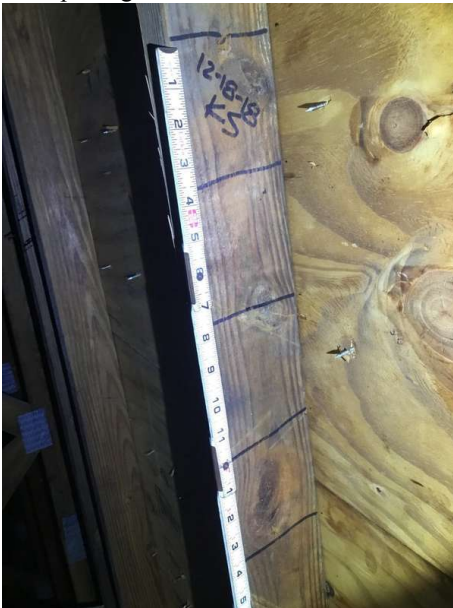
Roof to wall attachments

- ☒ Secured to truss/rafter with a minimum of three (3) nails, **and**
- ☒ Attached to the wall top plate of the wall framing, or embedded in the bond beam, with less than a 1/2" gap from the blocking or truss/rafter **and** blocked no more than 1.5" of the truss/rafter, **and** free of visible severe corrosion.

- ☒ C. Single Wraps
  - Metal connectors consisting of a single strap that wraps over the top of the truss/rafter and is secured with a minimum of 2 nails on the front side and a minimum of 1 nail on the opposing side.
