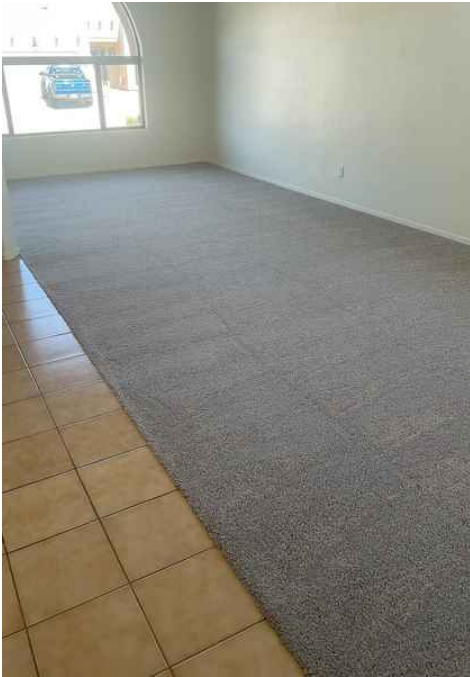
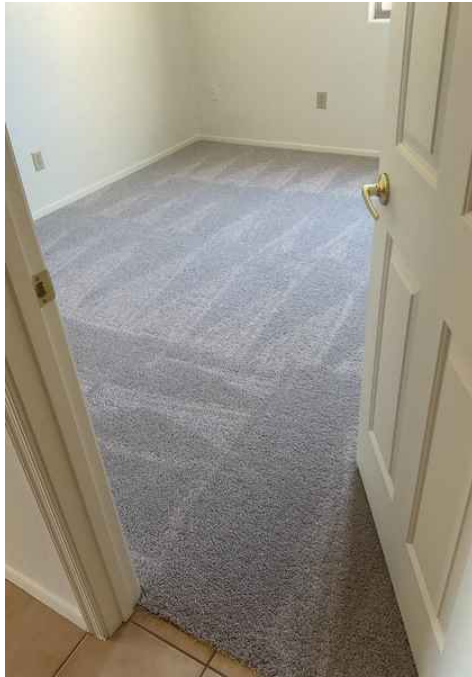
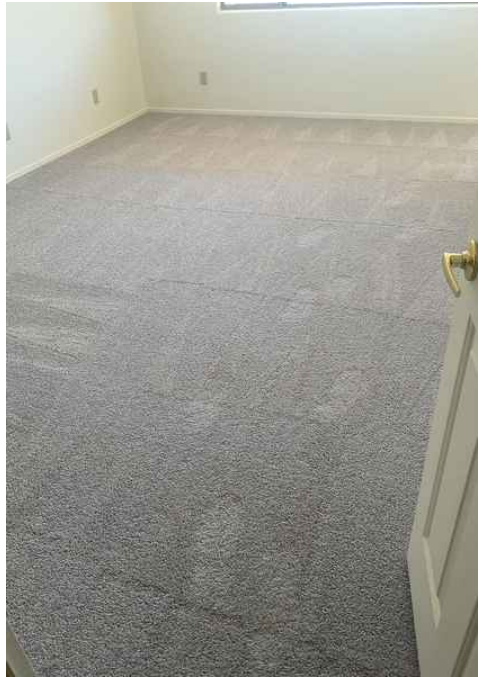
New Carpet

**NEW CARPET INSTALLED**

The construction team installed new carpet throughout the home so it's clean and fresh for its new owner.

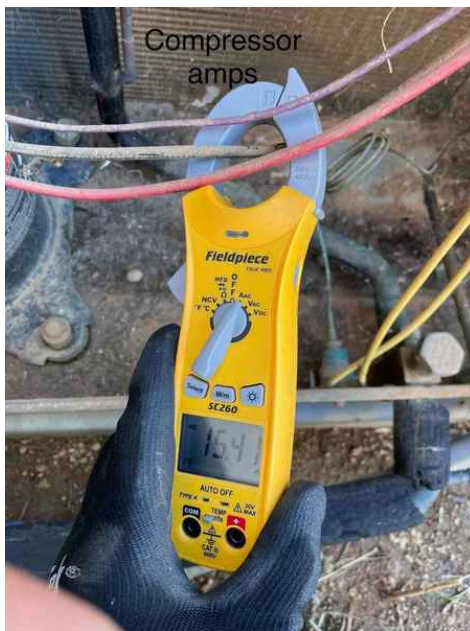
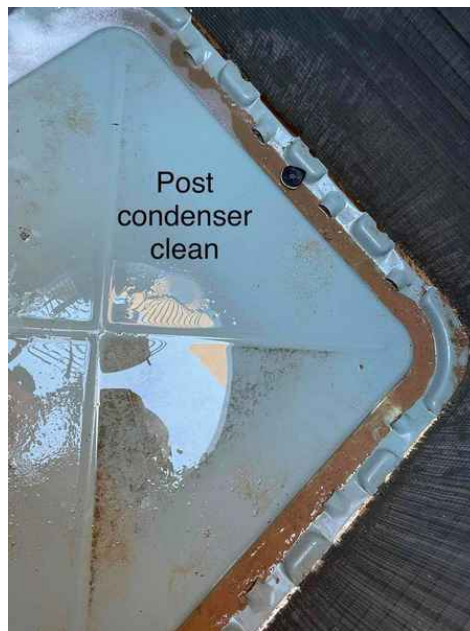
#### 9.2.1 HVAC Inspection

### NO VISIBLE SERVICE DATE - SERVICE RECOMMENDED

The last service date is over one year ago or is unable to be determined. The unit may be operating properly from controls but there are areas which cannot be seen without specialized equipment, removing covered areas, and/or invasive examination. Recommend consulting the owner for recent service or repair records and/or have an HVAC specialist service the unit.

A professional HVAC contractor performed a full service call on the system, including condenser cleaning, new filters, and standard operational diagnostics. The system is now in good working order.

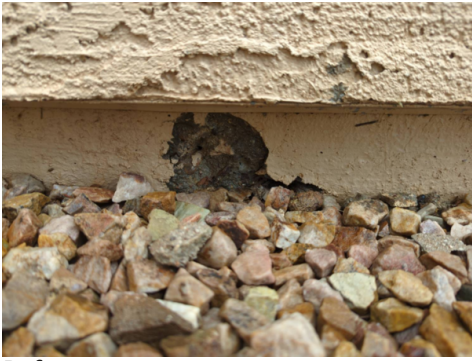
Before

### COMMON SPALLING/DETERIORATION AT STEMWALL

There is concrete spalling and/or deterioration of the stemwall observed. Recommend having the area sealed to prevent further wear. The area should also be monitored for ponding water and addressed as needed.

Several small spots of foundation spalling were fixed with appropriate patching compound to limit future moisture infiltration. This type of spalling is common and should be monitored by the owner for possible future patching and repair.
