SCOTT HOME INSPECTION, LLC

ENERGY AUDIT REPORT

1234 Homeplace Dr
Boulder, CO 80503

NOVEMBER 19, 2018

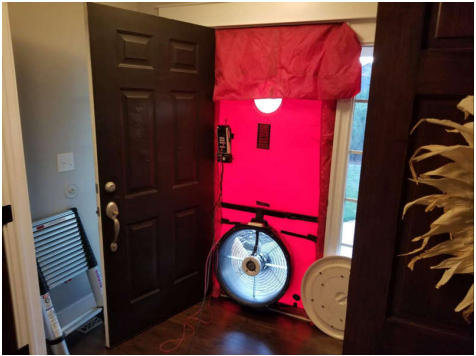
2.1.1 Blower Door
Testing Air Leakage Rate

ENERGY AUDIT BLOWER DOOR RESULTS - IMPROVEMENT NEEDED

The air sealing in the home can be improved. The blower door test measured 2983 CFM at 50 PA, which calculates to 5.4 Air Changes per Hour at 50 PA, or .36 NACH (Natural Air Changes per Hour). A NACH over 0.30 indicates leakage rates where air sealing efforts would be beneficial. The following areas noted in the Air Sealing section were discovered and need to be improved.

Contact a qualified professional.

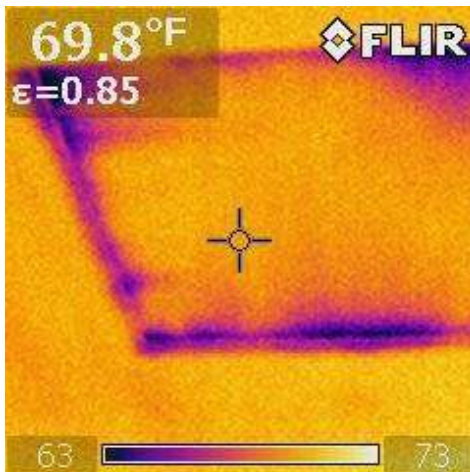
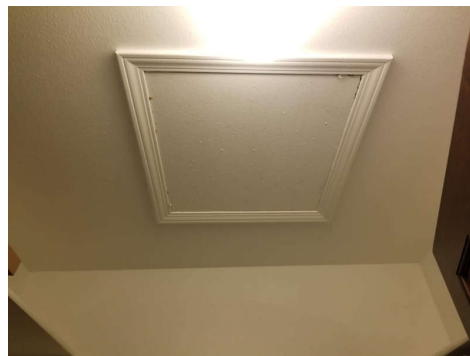
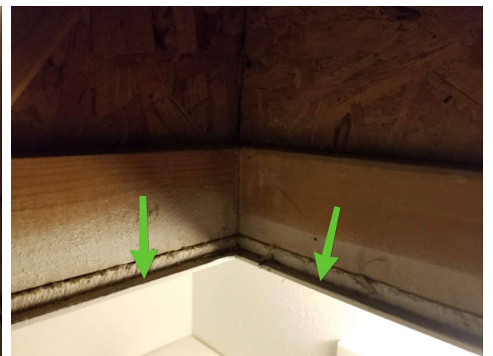
3.1.1 Attic Air Sealing

SEAL ATTIC HATCH

Attic Hatch - Weather-strip the attic hatch edges, so that when the hatch drops, it rests on the weather stripping. Also, ensure the upper part of the hatch cover is insulated to at least R-30. If possible, have tightening cam latches installed to keep hatch securely closed.

Contact a qualified handyman.

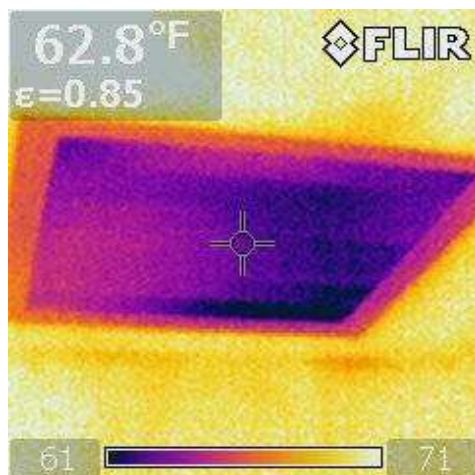
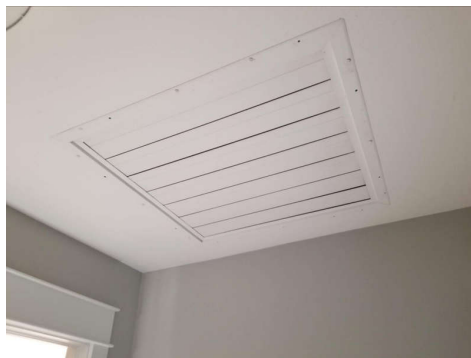
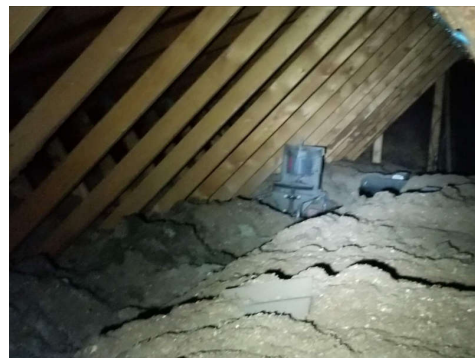
3.1.2 Attic Air Sealing

WHOLE HOUSE FAN COVER

An insulating cover is needed for the attic side of the fan unit, to be installed over this fan during cold months. This will prevent heat losses into the attic from the fan area.

Contact a qualified handyman.

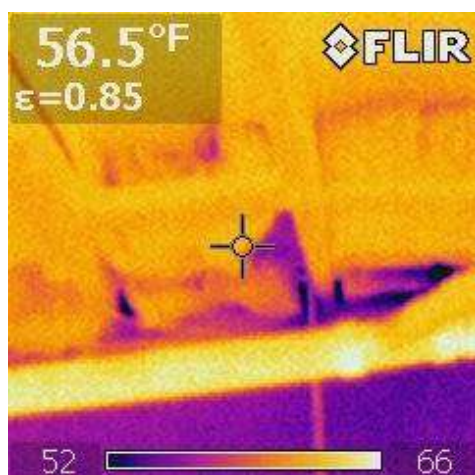
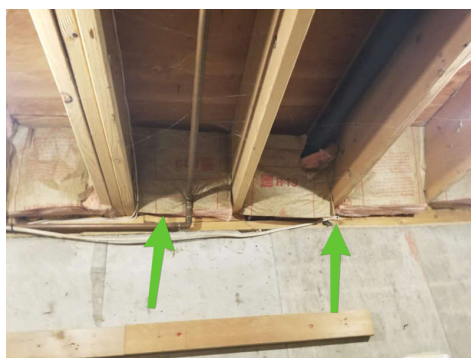
3.2.1 Basement-Crawlspace Air Sealing

RIM JOIST SEALING

Seal all the rim joist areas in the basement, where cold air leakage is occurring. This will involve removing the insulation in these areas, if present, sealing all edges, and replacing the insulation.

Contact a qualified handyman.

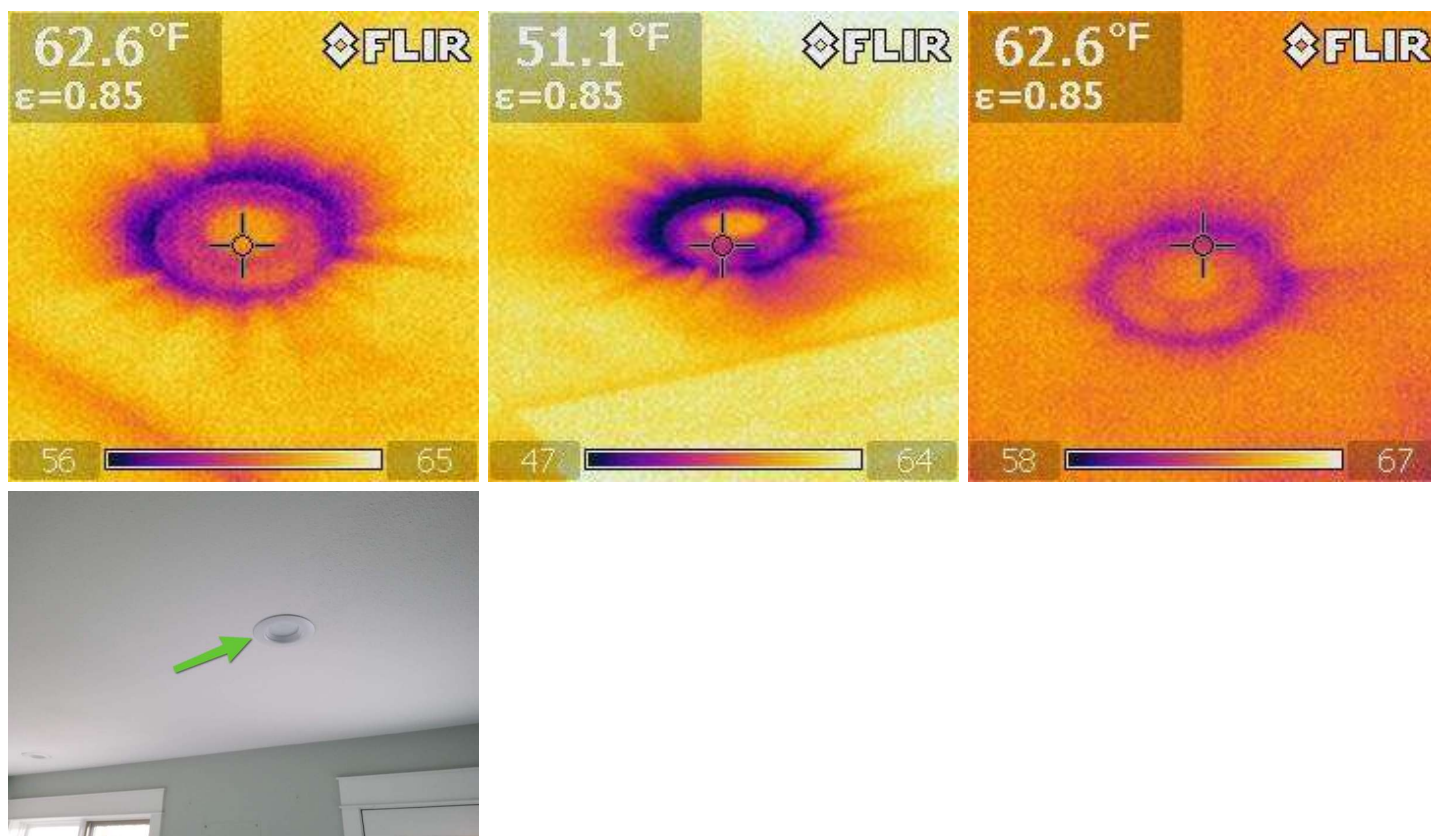
3.3.1 Interior-Exterior Air Sealing

CAN LIGHTS SEAL

Seal the recessed light fixtures in the home. The majority of the leakage present is occurring around the edge of the light, in the space between the drywall and the edge of the light can. This gap needs to be sealed. Seal around the edges with the trim and bulb are removed from inside the home, with an appropriate fire rated caulking. The better alternative is to seal all these light fixtures in the attic, around the edges of the cans, adjacent to the drywall, where access is available in the attic.

Contact a qualified handyman.

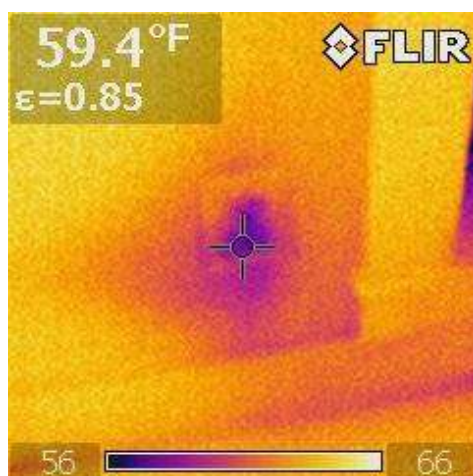
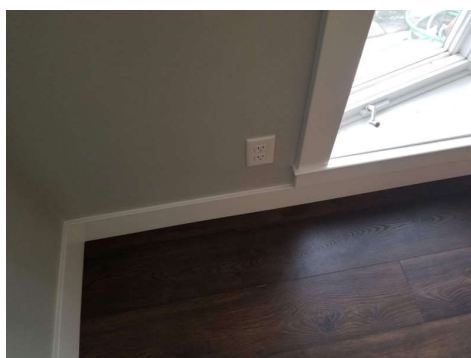
3.3.2 Interior-Exterior Air Sealing

OUTLET/SWITCH GASKETS

Install foam sealing gaskets behind exterior wall electric outlet and switch covers. Plug unused electrical outlets on exterior walls with child-safety plugs. These items can be purchased at any hardware store. It is recommended that power be removed to the outlets and switches when installing gaskets for safety.

Contact a qualified handyman.

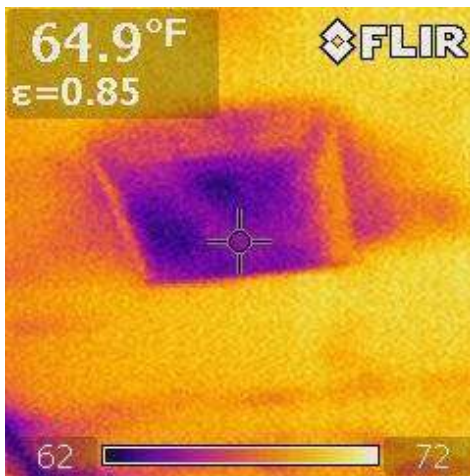
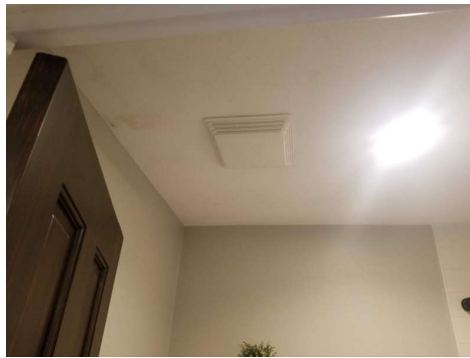
3.3.3 Interior-Exterior Air Sealing

SEAL AT BATH FAN

The bathroom vent fan has air leakage around the edges of the fan assembly. From within the attic, if possible, or around the edges with the trim/cover removed, seal around the edges adjacent to the drywall, to stop the air leakage from occurring.

Contact a qualified handyman.

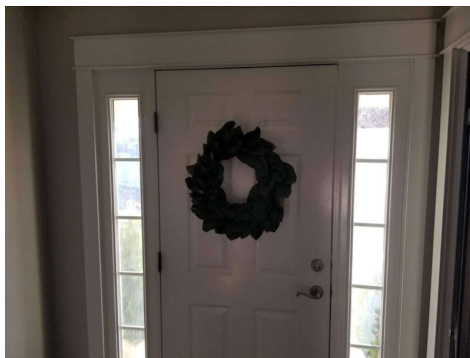
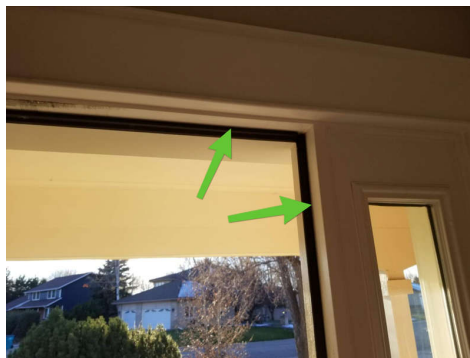
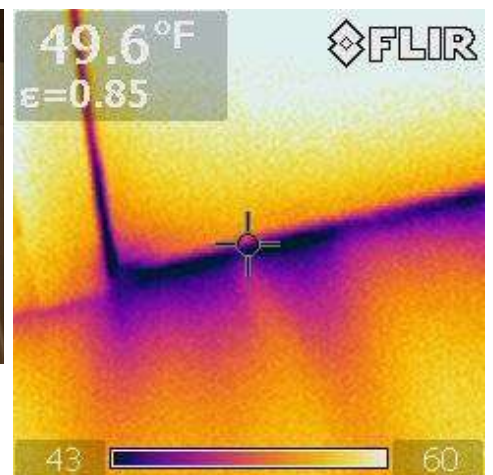
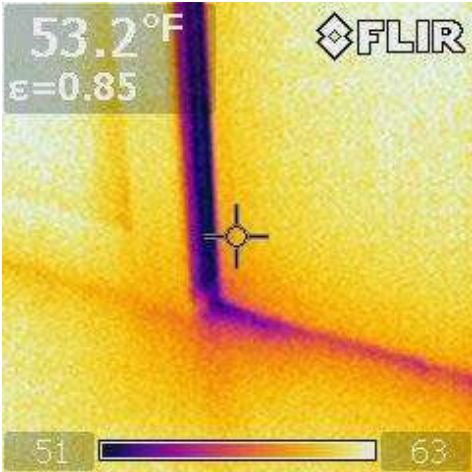
3.4.1 Window and Door Air Sealing

DOOR WEATHER STRIPPING

ENTRY

The door needs to have the weather-stripping replaced around the edges, to prevent air leakage and heat loss from occurring. Replacement pieces of weather-stripping can usually be purchased at most hardware stores and installed where needed to seal off gaps. Follow [this link](#) for more information on weather-stripping doors.

Contact a qualified handyman.

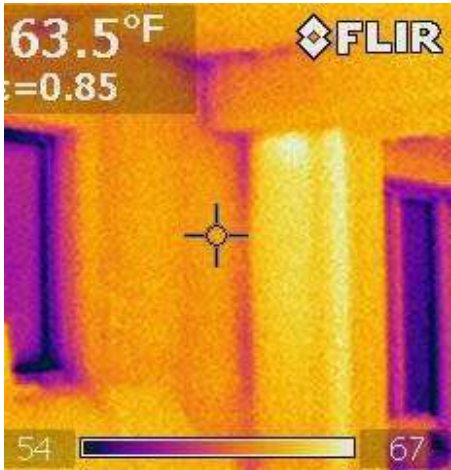
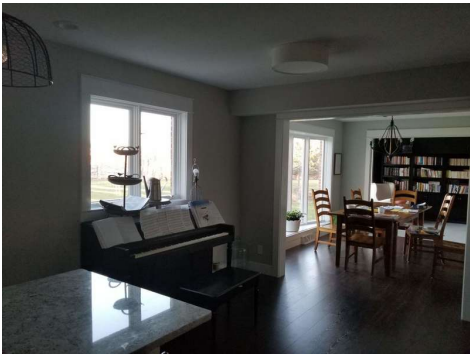
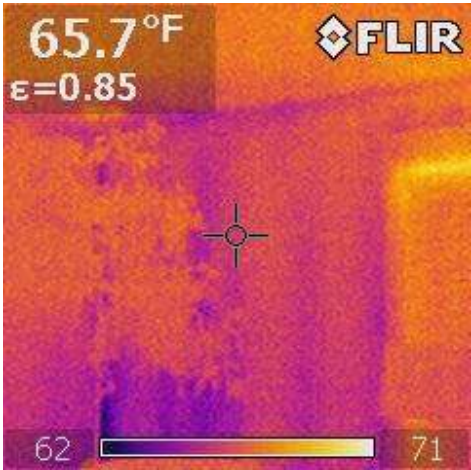
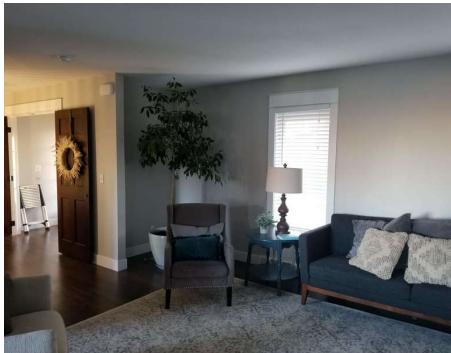
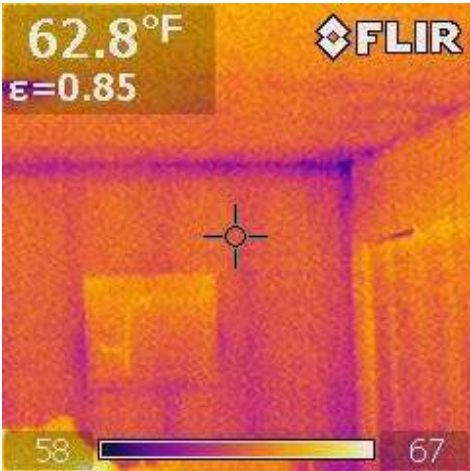
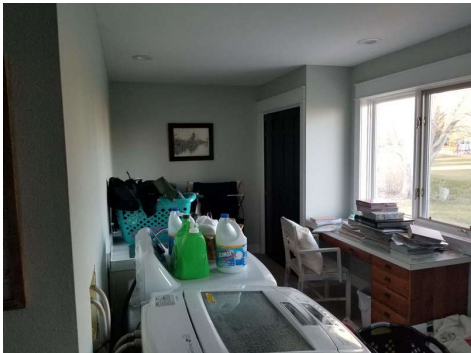
Wall Insulation: No Concerns Noted

A basic inspection of the wall insulation was done using infra-red scans, and observing insulation levels behind outlet plates, where possible. This limited inspection showed that the walls appear to be insulated well at this time. No gaps, voids or missing areas were noted.

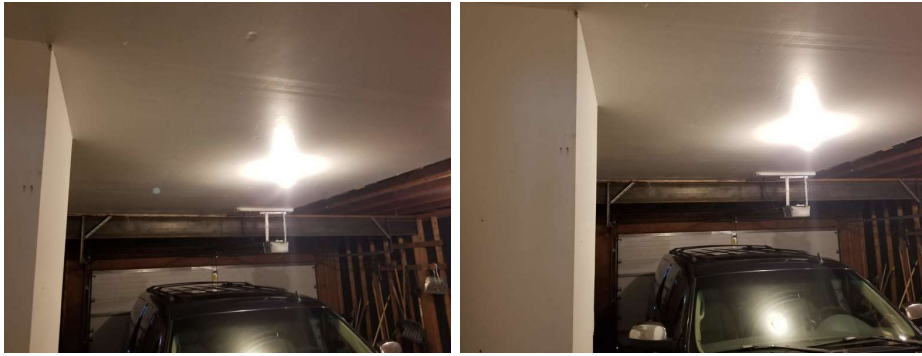
Garage Ceiling Insulation: No Concerns

The floors over the garage were viewed with Infrared and appear to be adequately insulated, with no significant voids or gaps noted.

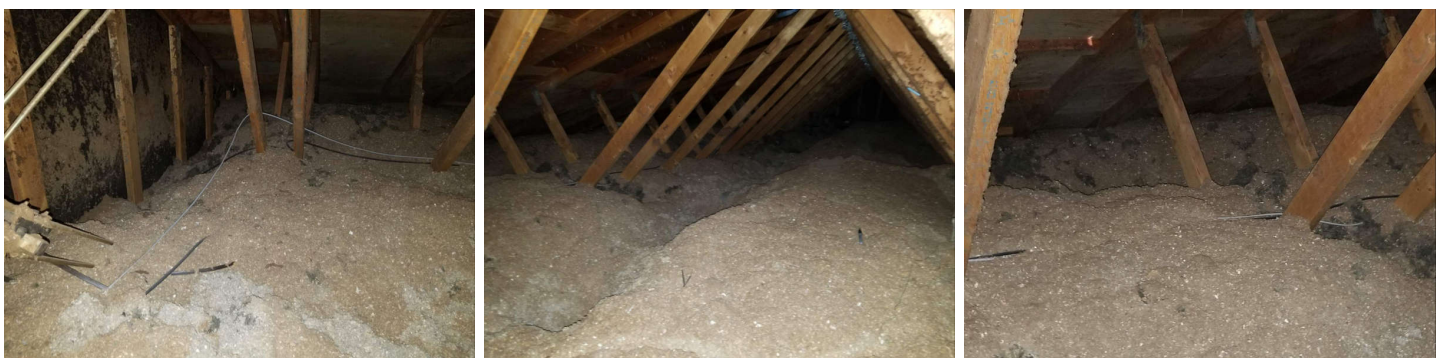
4.1.2 Attic Insulation

INSULATION TRAMPLED

The insulation has been trampled, spread thin, or pulled away in areas of the attic space. Increased heat loss can occur in these areas. An insulation professional should repair, or add more insulation as needed.

Contact a qualified insulation contractor.

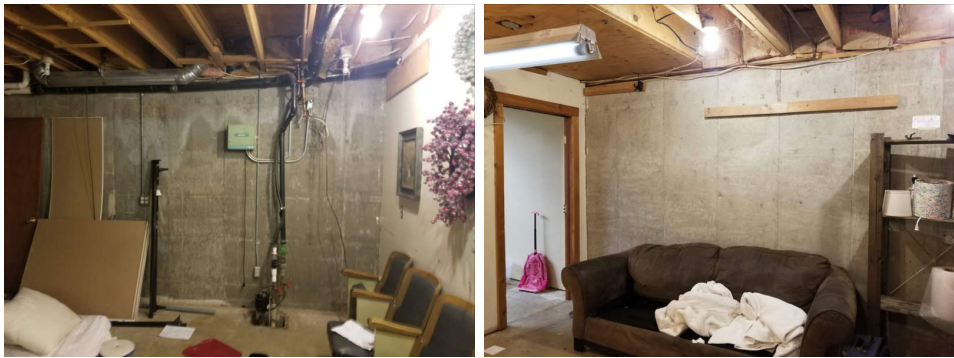
4.3.1 Basement Insulation

BASEMENT WALLS UNINSULATED

The concrete foundation walls are not insulated where visible. This is causing the basement to be colder than the rest of the home. I recommend adding fiberglass batt insulation, or vinyl faced fiberglass sheet insulation to the concrete walls where accessible.

Recommendation
Contact a qualified insulation contractor.

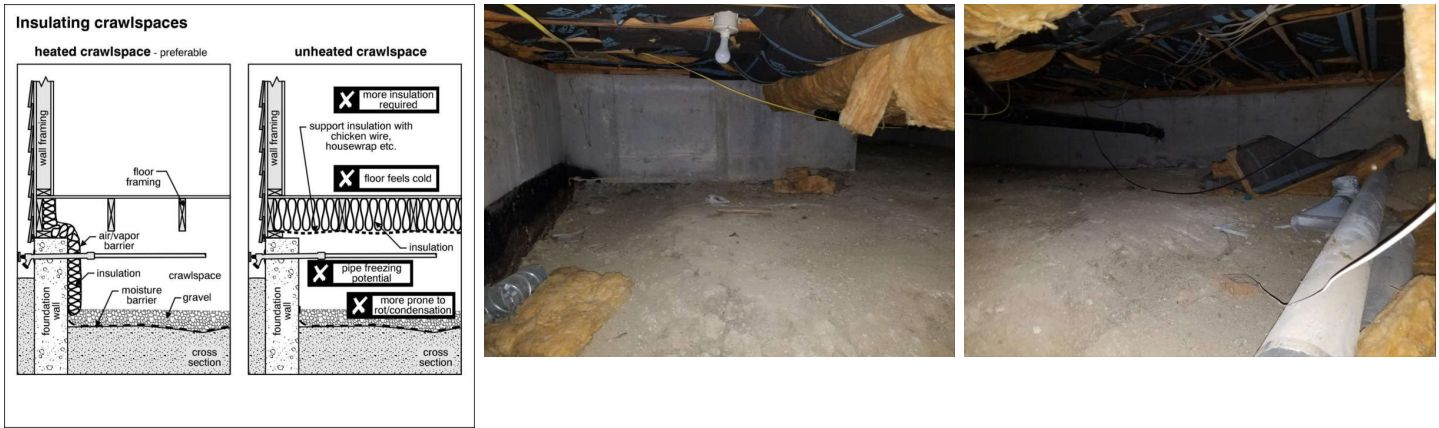
4.4.1 Crawlspace Insulation

CONDITION THE CRAWLSPACE

Considerable air leakage is occurring at the crawlspace, and the floors above are noted to be colder than the floors in the rest of the home. It is recommended that you consider converting this to become a conditioned crawlspace, which will improve energy efficiency and prevent moisture concerns. To accomplish this, typically the following steps are taken: The vapor barrier should be installed to cover all of the soil, and the vapor barrier should be attached and sealed to the foundation walls along the perimeter, as well as sealed at all seams throughout the crawlspace. Insulation should be installed at the rim joists and on the foundation walls to drape over the sealed edges of the vapor barrier. Seal off the crawlspace vents to the exterior, and consider sealing at the exterior sill plates on the foundation where accessible to minimize air leakage. An HVAC professional should also investigate installing a heat supply into the crawlspace, which will provide drying and air exchange. This will result in a somewhat conditioned crawlspace that will be less prone to air leakage and condensation occurring on the underside of the floor system from cold air entering in the wintertime. Consult with an insulation or HVAC specialist to verify these recommendations and to determine other repair options.

Recommendation
Contact a qualified insulation contractor.

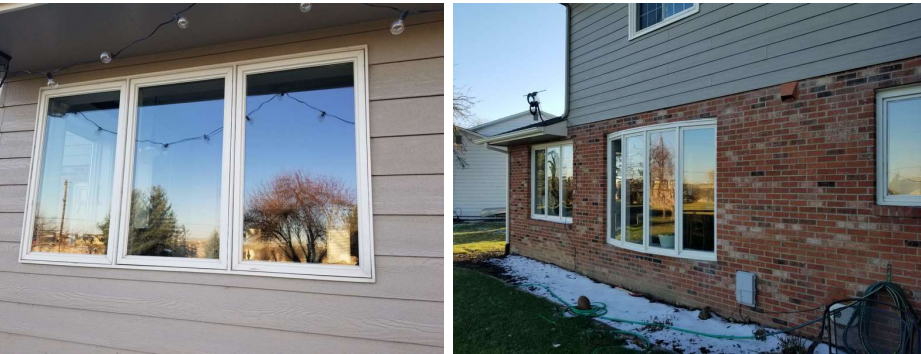
Windows: No Immediate Concerns Noted

The windows in the home are currently double-pane type windows, with no performance or air-sealing concerns noted. No action is recommended from an energy efficiency standpoint at this time.

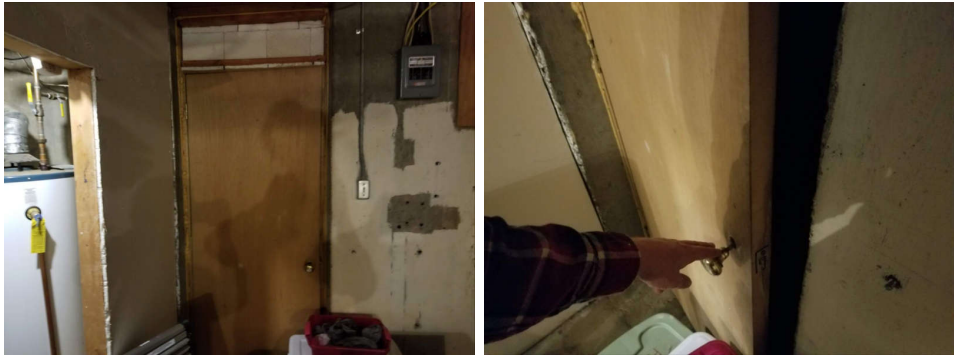
5.2.1 Doors

DOOR REPLACEMENT FOR EFFICIENCY

BASEMENT

Consider replacing the door from the basement to the garage stairwell with a steel, insulated core door. The door is of poor insulating quality, and is likely allowing cold air to conduct into the home.

Contact a qualified door repair/installation contractor.

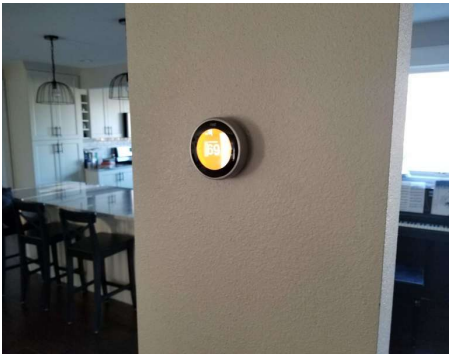
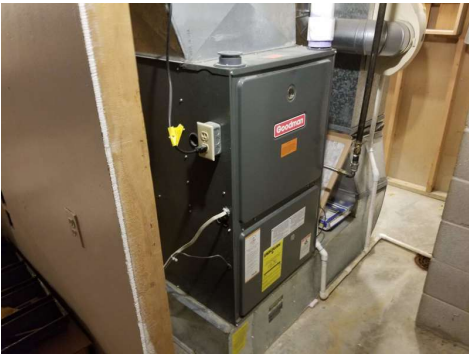
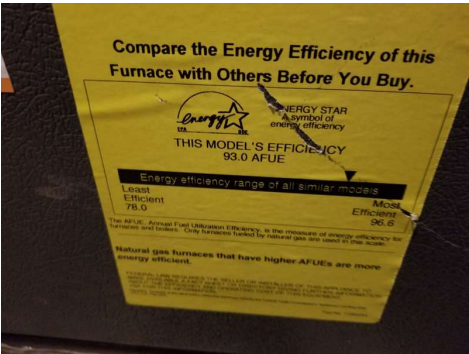
Heating Equipment: Furnace - No Immediate Concerns Noted

The existing furnace is a high-efficiency, condensing unit and is in good operating condition at this time. No actions are recommended from an energy efficiency standpoint.

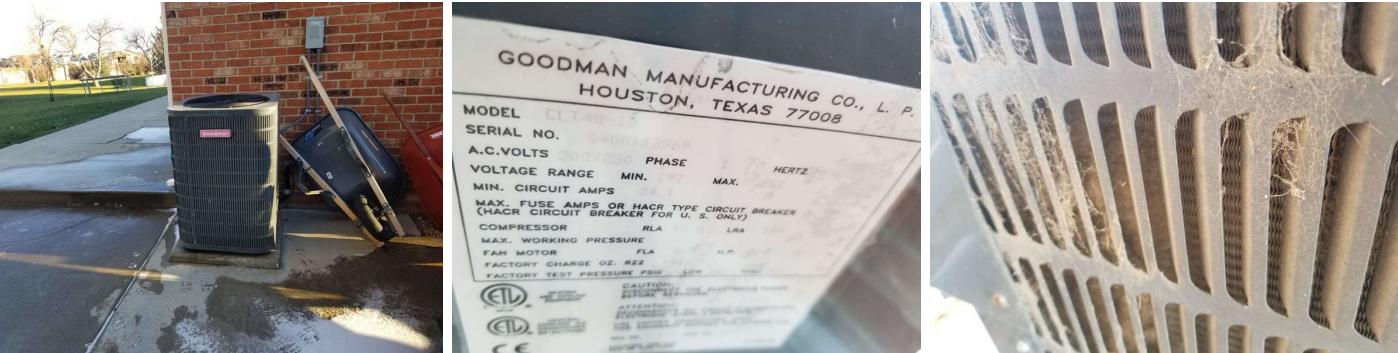
Cooling and Air Handler Equipment: AC - No Immediate Concerns Noted

The existing AC unit is a high-efficiency model and is in good operating condition at this time. No actions are recommended from an energy efficiency standpoint.

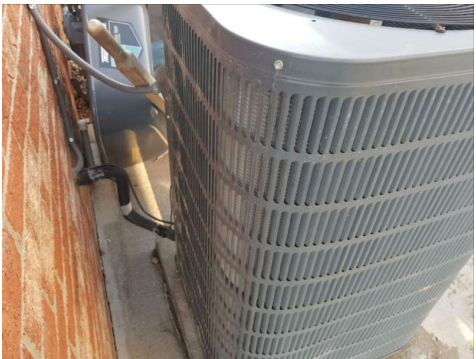
7.1.1 Cooling and Air Handler Equipment

CLEAN AND SERVICE OUTDOOR UNIT

The condensing unit outside has a buildup of debris. This can reduce the efficiency of the unit considerably. Cleaning is needed at this time. An HVAC professional should clean and service as needed.

Contact a qualified HVAC professional.

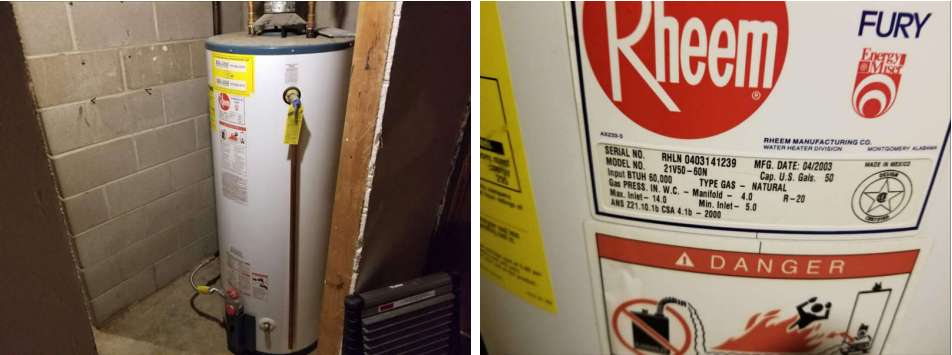
8.1.1 Hot Water Systems

REPLACEMENT OPTIONS

Your water heater is older and is approaching the end of its useful life. I would recommend that you consider a high efficiency or tank-less system when replacing. These systems are much more efficient. The other option is to consider solar-hot-water systems. For more information, refer to [this link](#).

Contact a qualified plumbing contractor.

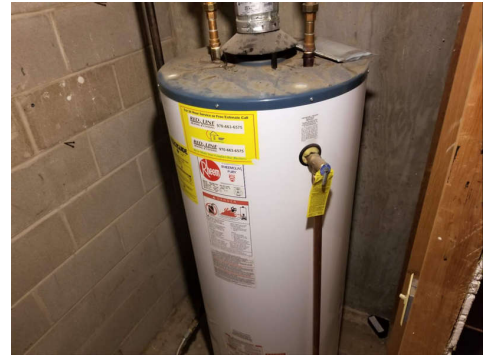
8.1.2 Hot Water Systems

ADD INSULATING BLANKET

Consider installing an insulating blanket on the hot water heater, which will help reduce energy use and ambient losses.

Contact a handyman or DIY project

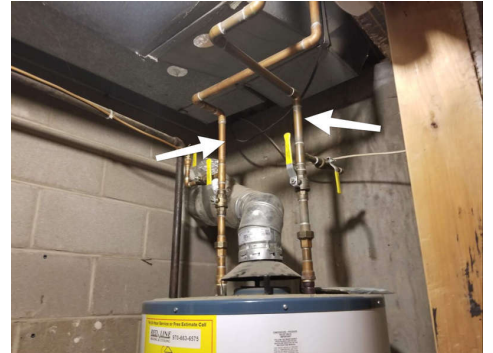
8.2.1 Water Supply and Distribution Systems

INSULATING PIPES

BASEMENT

Insulate accessible hot water piping coming from the water heater with low cost foam wrap insulating material. This should be done for the first 6 feet of both hot and cold piping off the water heater, and wherever possible on the hot line.

Contact a handyman or DIY project

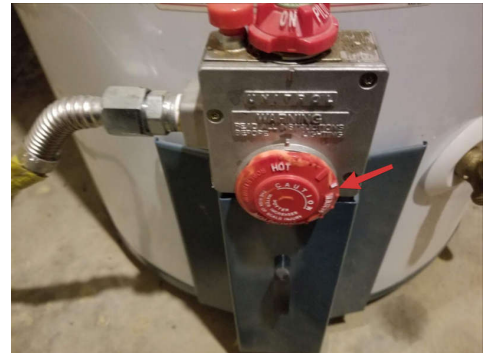
8.3.1 Temperature of Hot Water

TEMPERATURE SETTING

The water heater temperature setting is too high, and the water temperature was measured at >135F. This will cause excessive energy use from the water heater. I recommend reducing the set-point to help reduce costs and save energy. The Department of Energy recommends 120F as the optimum setting for efficiency. See [here](#) for more details.

Recommended DIY Project

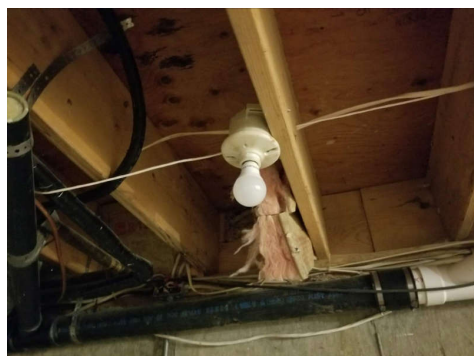
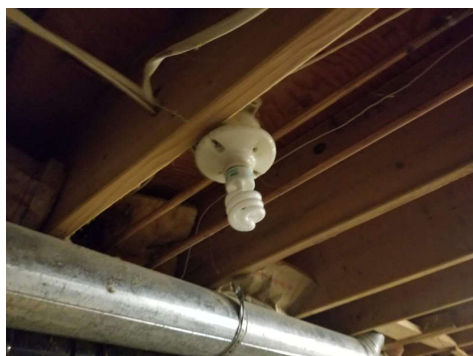
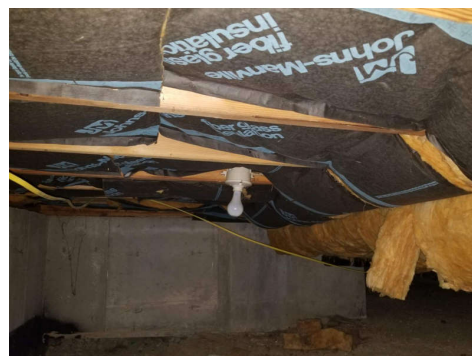
9.1.1 Energy Efficient Lighting

CONTINUE ADDING LED/CFL BULBS

Currently, there are many LED or CFL bulbs in use in the home. Continue to install LED's or CFL's in as many non-dimmed light fixtures as possible. LED and CFL bulbs consume 1/4 the power of incandescent lights, and often last up to 10 times longer. This will help to reduce your overall electric energy consumption. For more information visit [here](#).

Contact a handyman or DIY project

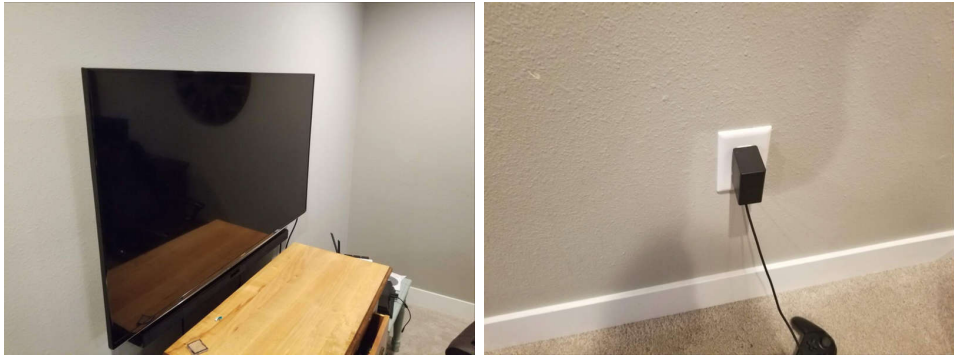
9.2.1 Fixtures, Switches, and Connected Devices

SMART STRIP

For entertainment center areas and computer system areas, I recommend that you consider using "smart-strip" power strips. These devices use one device as the primary device, and completely remove power to all the secondary devices plugged into the power strip, when the primary or control device is turned off.

Recommended DIY Project

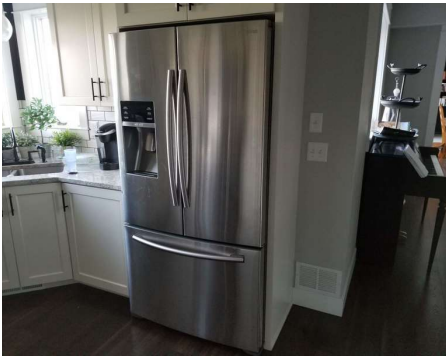
Refrigerator/Freezer: No Immediate Concerns

The refrigerator installed in the home is a newer style unit, and likely has acceptable power consumption. No energy efficiency action is recommended at this time.

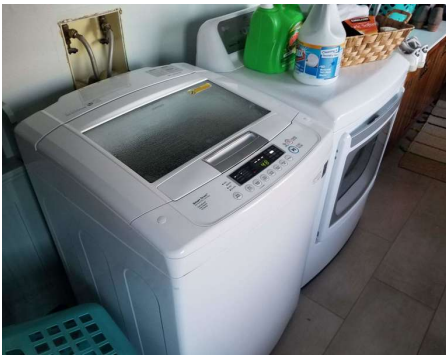
Clothes Washer/Dryer: No Immediate Concerns

The washer and dryer installed in the home are newer, front-load units and are in good condition. No improvement action is recommended.

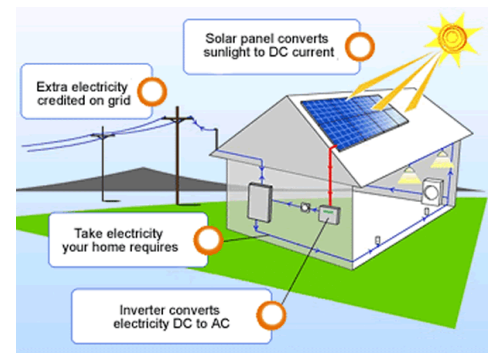
11.1.1 Photo-Voltaic Solar Information

PV SOLAR OPTIONS

Once the high priority energy efficiency improvements noted in this report are implemented, you should consider the installation of Photo-Voltaic Solar Panels. There are rebates and tax credits available to help reduce the up-front costs. PV systems represent the best opportunity to offset your electric use and consumption, and are an excellent means of reducing your net energy use. For additional information on this technology visit [this useful resource](#).

Contact a qualified professional.
