HOME INSPECTION REPORT BY SNEAK PEAK HOME INSPECTION LLC

6290 Joaquin Murieta Ave Unit D
Newark, CA 94560

OCTOBER 19, 2022

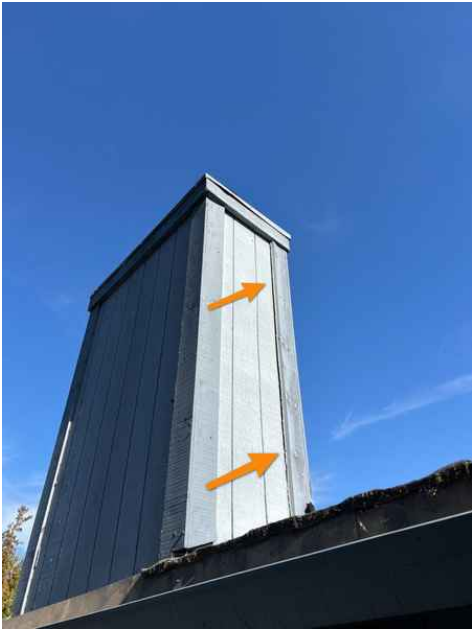
CHIMNEY TRIM LOOSE

I observed a portion of the chimney wood trim that is detaching and has a gap which may allow water penetration. Recommend contacting the HOA to inquire about repairs.

Contact your local homeowners association

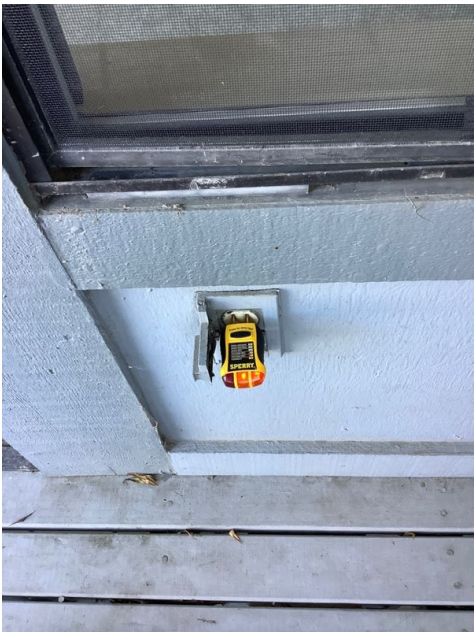
MISSING GFCI

I observed that a GFCI is missing in an area that is required to keep people safe. All exterior outlets are required to be GFCI protected to prevent electrocution. Further evaluation and correction is recommended.

Contact a qualified electrical contractor.

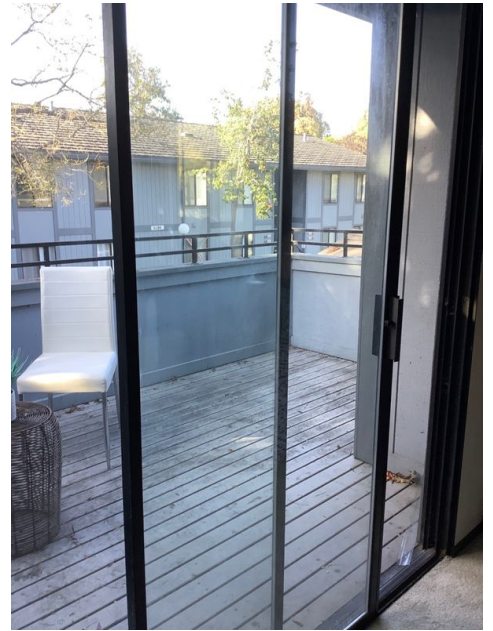
SCREEN DOOR MISSING

I observed a missing screen door at the rear patio. Further evaluation and correction is recommended.

Contact a qualified door repair/installation contractor.

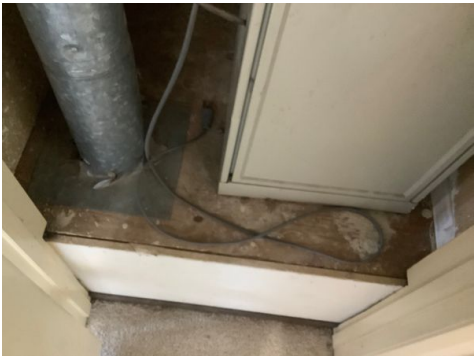
Thermostat and Normal Operating Controls

DID NOT OPERATE THERMOSTAT

I did not operate the thermostat because the heater was unplugged. Recommend further evaluation when the furnace is tested and operational.

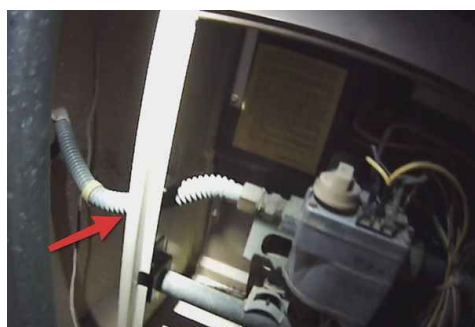
I did not observe a sediment trap at the furnace. A sediment trap is recommended to be installed as close as possible to the gas valve to prevent sediment from entering the furnace's components and causing damage. I also observed a flex gas pipe running through the furnace cabinet which is not allowed. Recommend further evaluation and correction.

Contact a qualified HVAC professional.

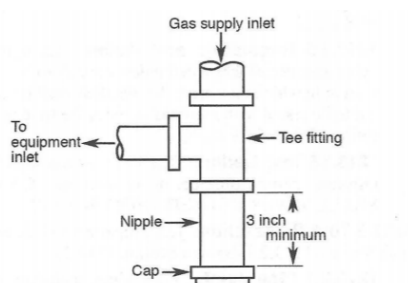
Flex gas pipe is not allowed to be ran through the side of the furnace cabinet. There should be rigid pipe extended from the furnace valve assembly to the outside of the cabinet. A sediment trap is also recommended.

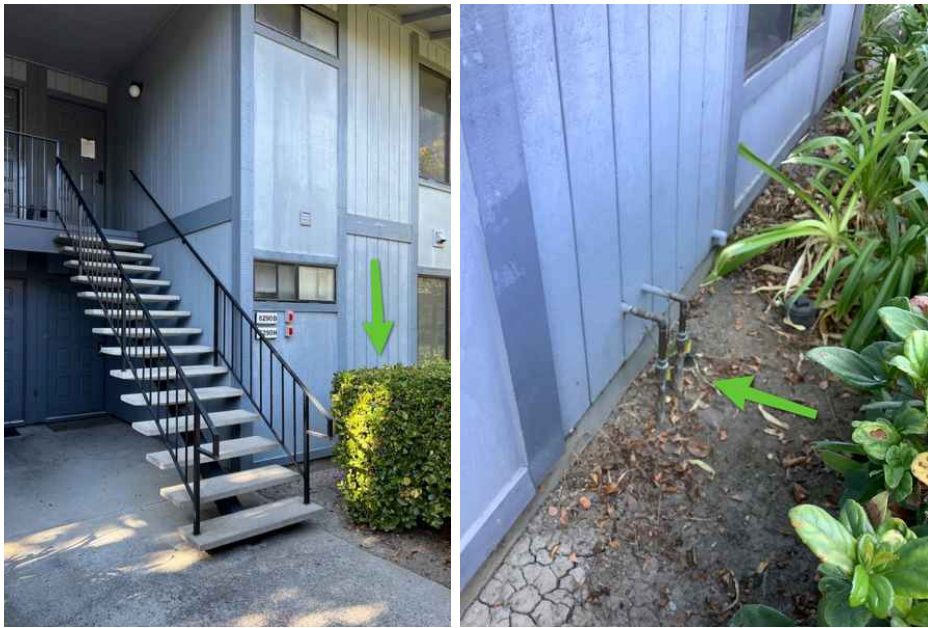
Main Water Shut-Off Valve: Location of Main Shut-Off Valve

Outside of House
The water shut off to this unit was located in front of the home, to the right of the base of the stairway.

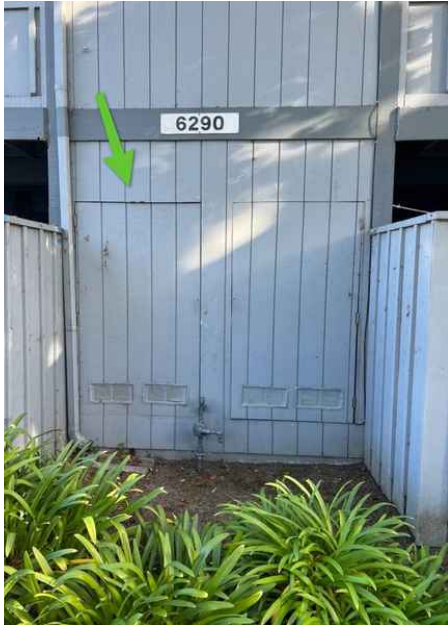
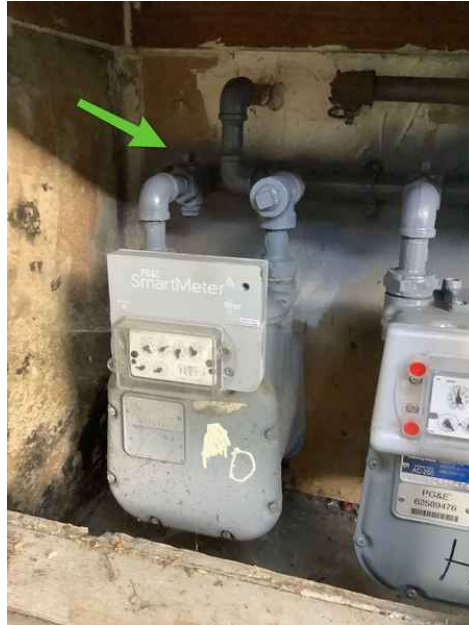
Main Fuel Supply Shut-Off Valve: Location of Main Shut-Off Valve

Near Electric Meter, Back of house

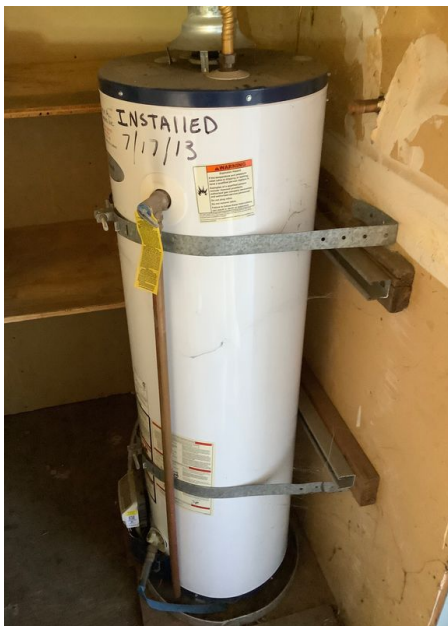
**Hot Water Source: Inspected Hot Water Source**

I inspected the hot water source and equipment according to the [Home Inspection Standards of Practice](#).

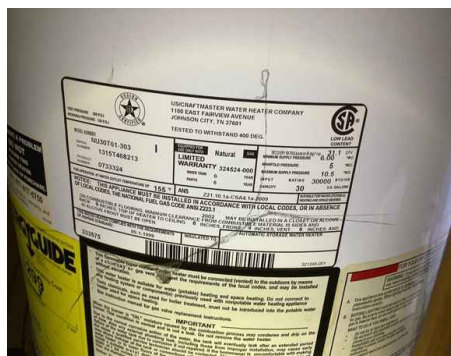
Hot Water Source: Data plate: photo

The photo shows the data plate of this hot water heater. It appears to have a manufacture date of April 2013.

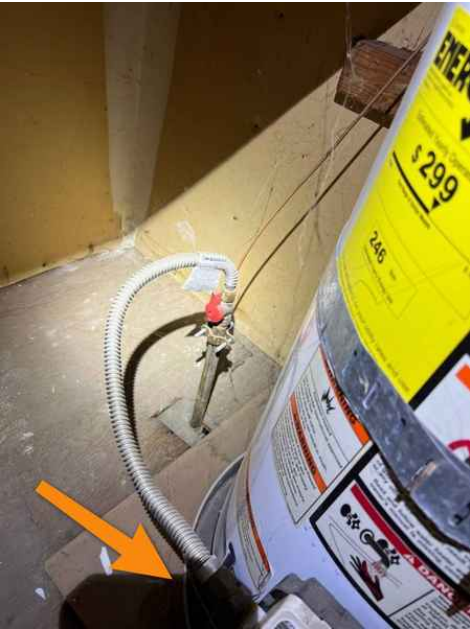
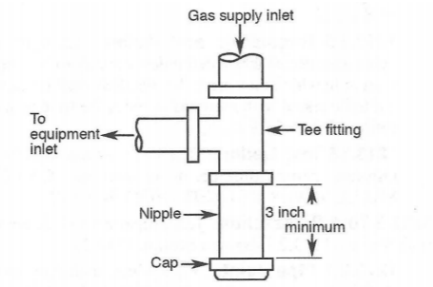
I did not observe a sediment trap at the hot water heater. A sediment trap is recommended to be installed as close as possible to the gas valve to prevent sediment from entering the water heater components and causing damage. Recommend further evaluation and correction.

Contact a qualified plumbing contractor.

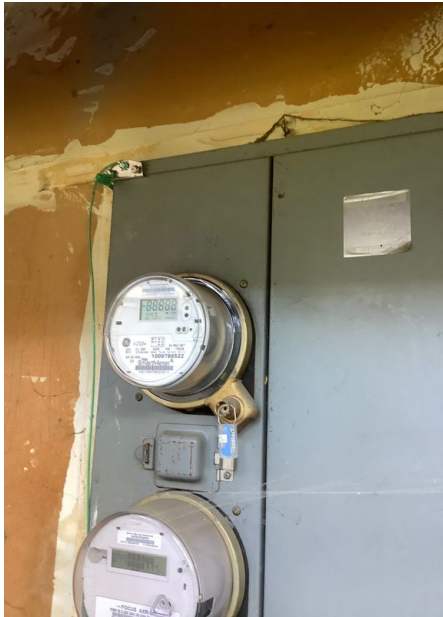
Panelboards & Breakers: Service Panel Brand

Zinsco

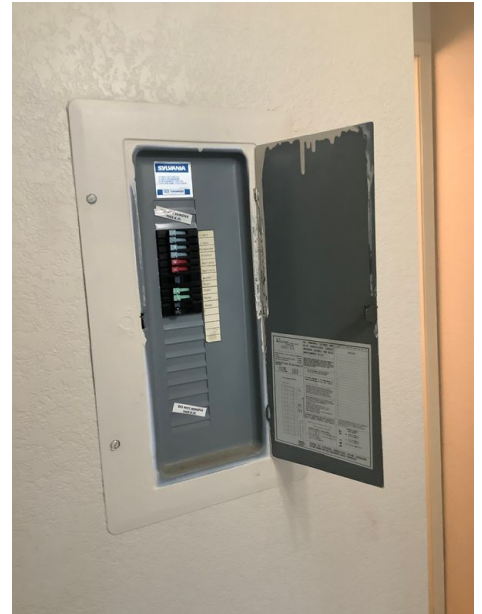
I observed that the panelboard was manufactured by Zinsco. Zinsco panels are reputed to have a high rate of circuit breaker failure that can result in a fire or shock/electrocution. Recommend further evaluation by a licensed electrical contractor.

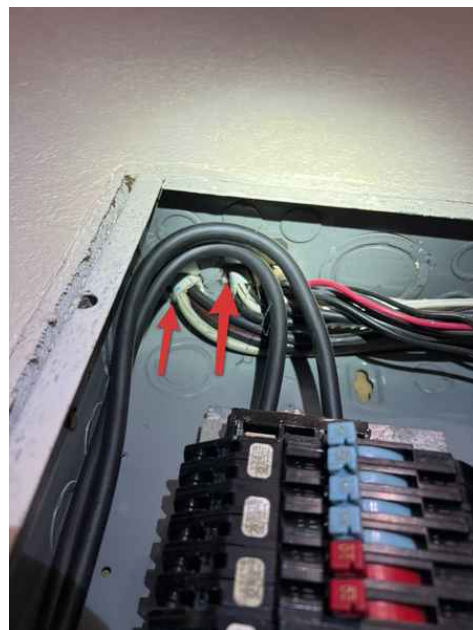
CABLE CLAMPS MISSING

Non-metallic conductors had no clamps installed where they passed through knock-outs in the electrical service panel. This condition can result in damage to the conductor from contact with the sharp edges of the metal cabinet or can result in conductors being pulled loose from connections inside the panel; a potential a shock/electrocution or fire hazard. The Inspector recommends that appropriate devices approved for this purpose be installed by a qualified electrical contractor.

Contact a qualified electrical contractor.

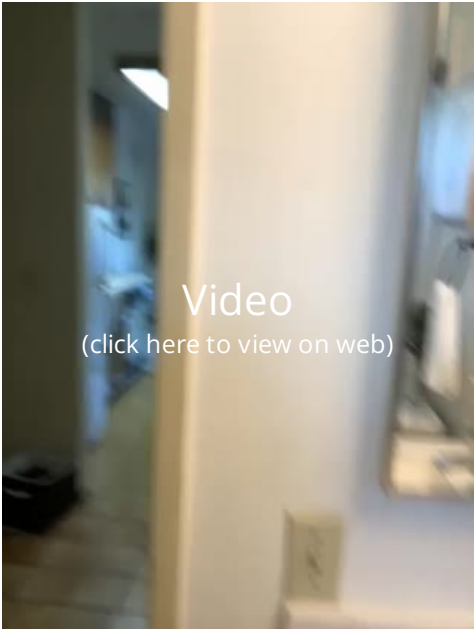
I observed that the bathroom door was not closing or opening properly due to contact with the top right corner to the door jamb. Recommend further evaluation and correction.

Contact a qualified door repair/installation contractor.

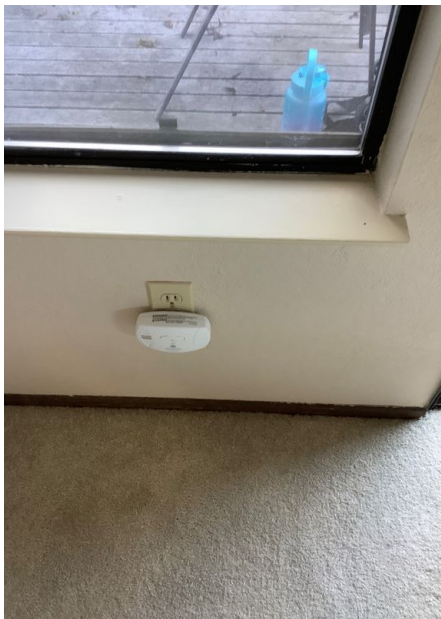
Presence of Smoke and CO Detectors: Inspected for Presence of CO Detectors

I inspected for the presence of carbon-monoxide detectors.

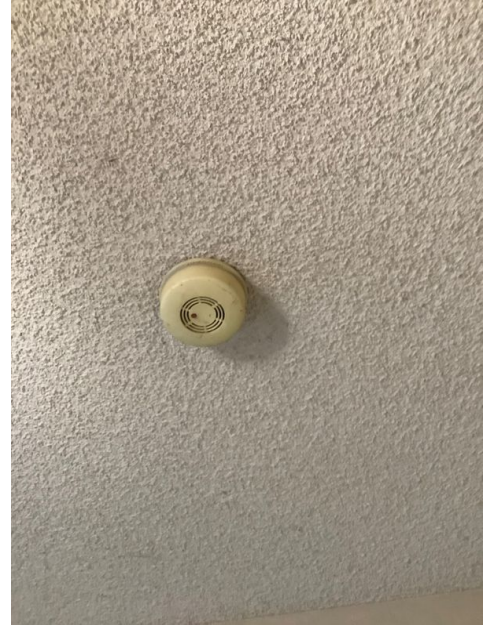
OLD DETECTORS, NEW DETECTORS RECOMMENDED

I observed at least one old smoke detector in the home. Smoke detectors should be replaced every 5-10 years. Replacement of old smoke detectors is recommended.

Contact a qualified professional.

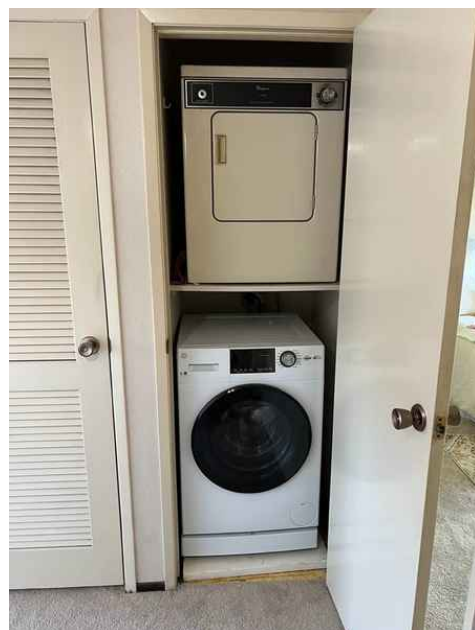
WAS NOT ABLE TO CLOSE INSPECT EVERYTHING IN LAUNDRY AREA DUE TO OBSTRUCTIONS.

I was not able to closely inspect every component behind the washer and dryer due to limited clearance on the sides.

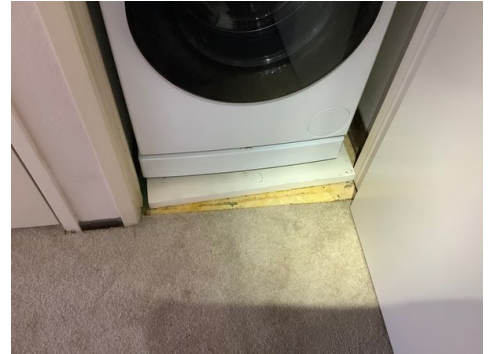
MISSING CATCH PAN UNDER WASHER

I observed that the clothes washer did not have a water leak catch pan. It is recommended in case of overflow or a leak. Further evaluation and correction is recommended.

Contact a qualified professional.

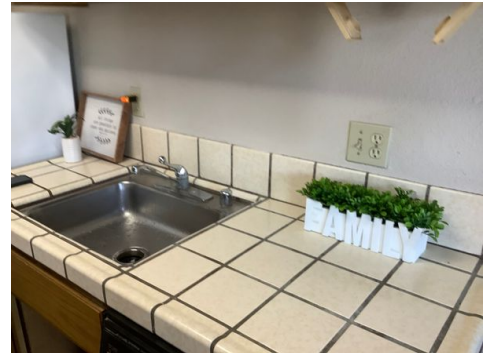
MISSING GFCI PROTECTION

I observed missing GFCI protection in the kitchen. All kitchen counter receptacles are required to be GFCI protected. Recommend further evaluation and correction.

Contact a qualified electrical contractor.
