THE SALLADE'S INSPECTION SERVICES

COMMERCIAL INSPECTION

1830 Lakeway Dr Lewisville, TX 75057

Construction Company OCTOBER 28, 2022

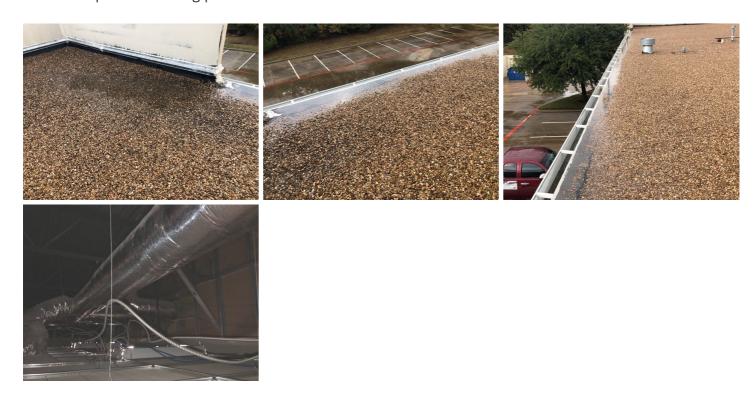
2.1.1 Coverings

Standing water was observed at a couple places on the roof covering. However no leaks were found when walking inside the building.

Contact a qualified roofing professional.

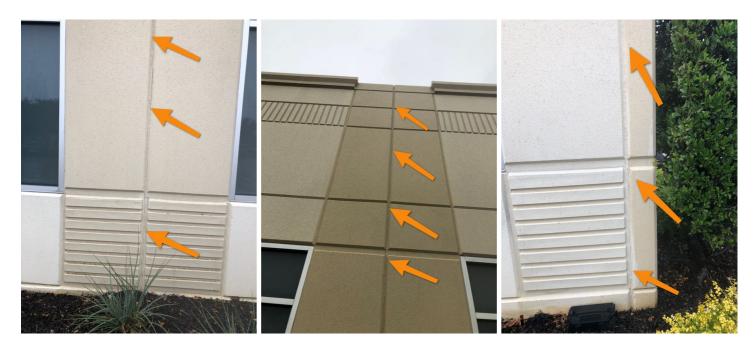
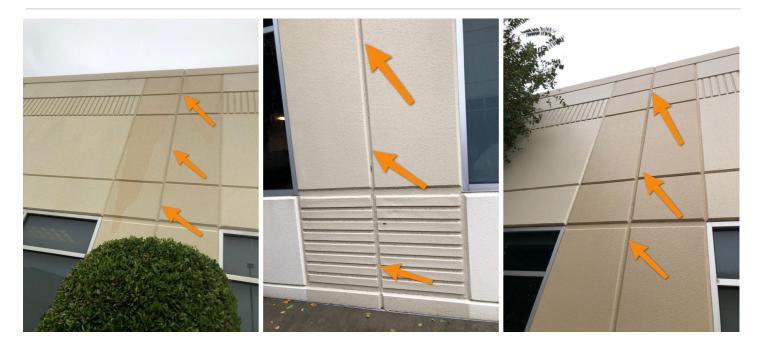
The sealant in the expansion joints has cracked and show some signs of age it is recommended that the old sealant be removed and expansion joint resealed to help prevent water intrusion.

Contact a qualified professional.

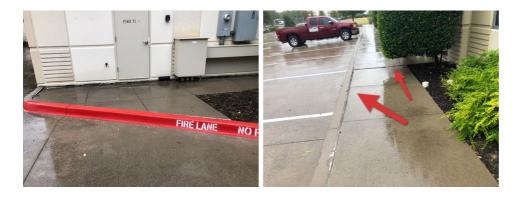
3.3.1 Walkways, Patios & Driveways

SIDEWALKS SETTLING

Contact a qualified professional.

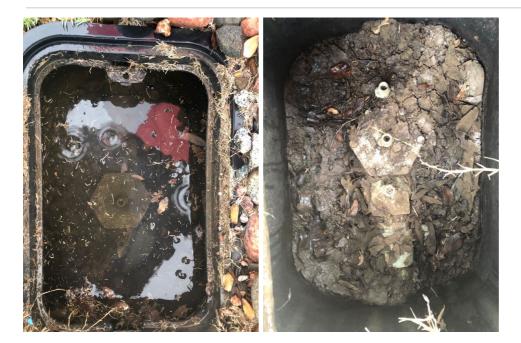
The double checks are full of dirt and the handles could not be found. It is recommended that the dirt be removed so the handles can be viewed for service. If the handles are damaged they should be replaced.

Contact a qualified landscaping contractor

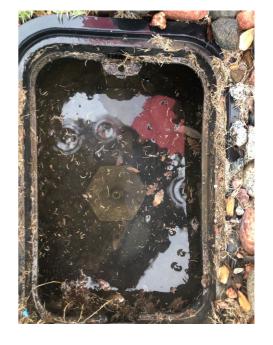
3.4.3 Vegetation, Grading, Drainage & Retaining Walls

DOUBLE CHECK FULL OF WATER

The double check was full of water at the time of inspection. The shut off handles for double checks can rust and become damaged went underwater. It is recommended that the water or drainage to double check box be corrected

Contact a qualified landscaping contractor

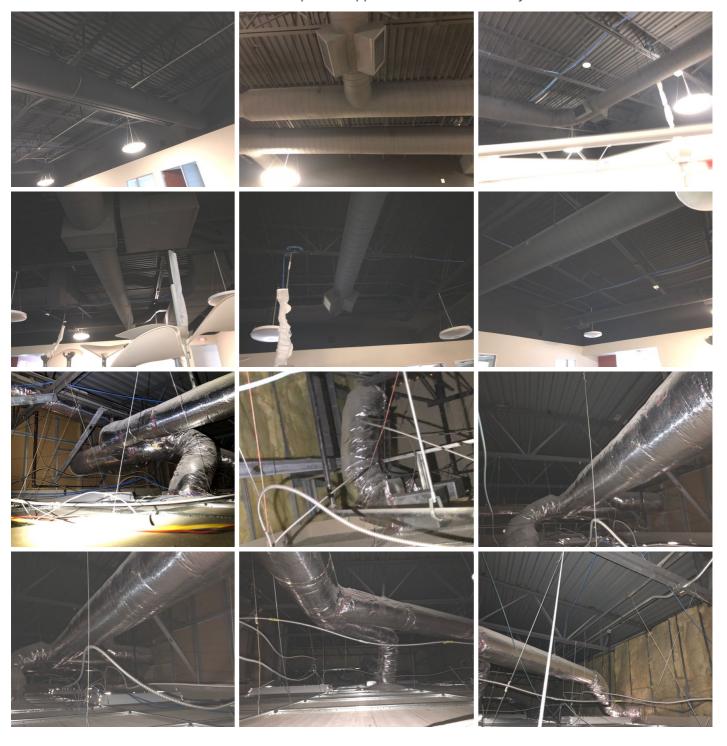
Ductwork: Visible ductwork OK

• Pictures of the ductwork for reference. The ductwork appeared to be in satisfactory condition at the time of inspection.

The ductwork that was visible at the time of inspection appeared to be in satisfactory condition.

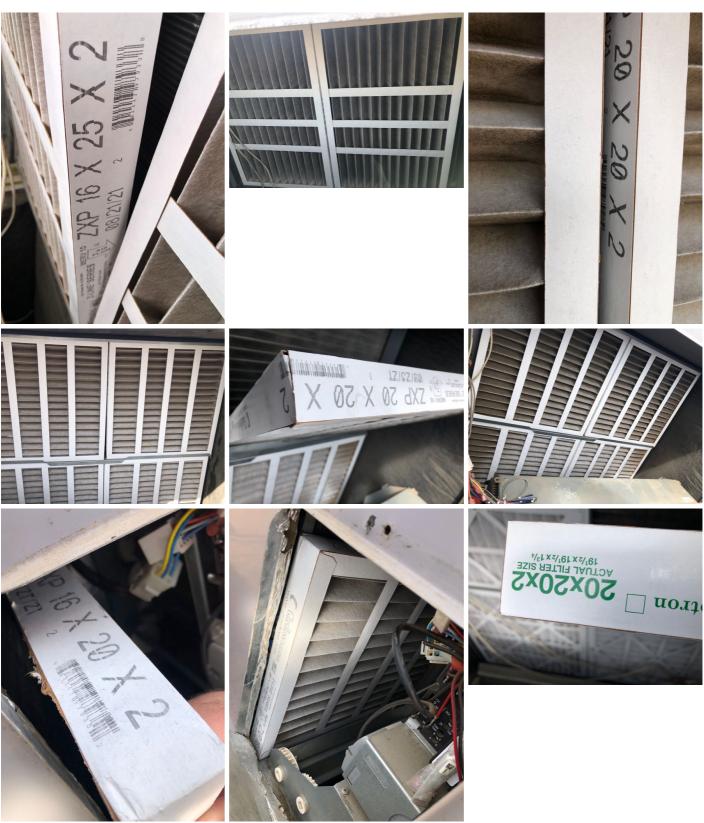
Ductwork: Pictures of the filters

Pictures of the filters for reference.

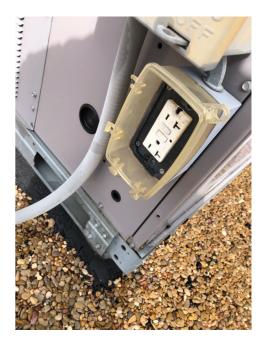
COVER PLATES MISSING

• One or more receptacles are missing a cover plate. This causes short and shock risk. Recommend installation of plates.

Contact a qualified electrical contractor.

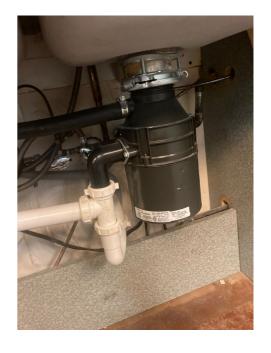
The garbage disposal was seized at the time of inspection. This condition should be corrected as necessary.

Contact a qualified appliance repair professional.

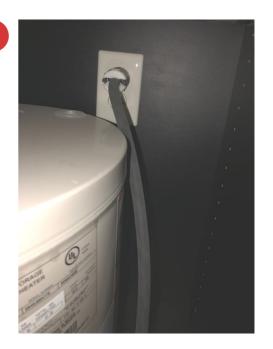
8.4.1 Water heaters

PIG TAIL NOT ALLOWED

Contact a qualified electrical contractor.

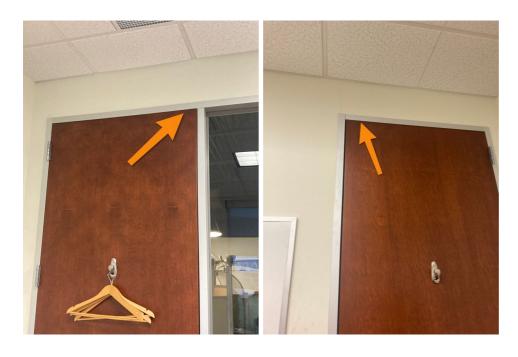
10.1.3 Doors

DOOR DRAGS (ON JAM)

One or more of the doors were observed to drag on the door Jam at the time of inspection. This condition should be corrected as necessary.

Contact a qualified door repair/installation contractor.

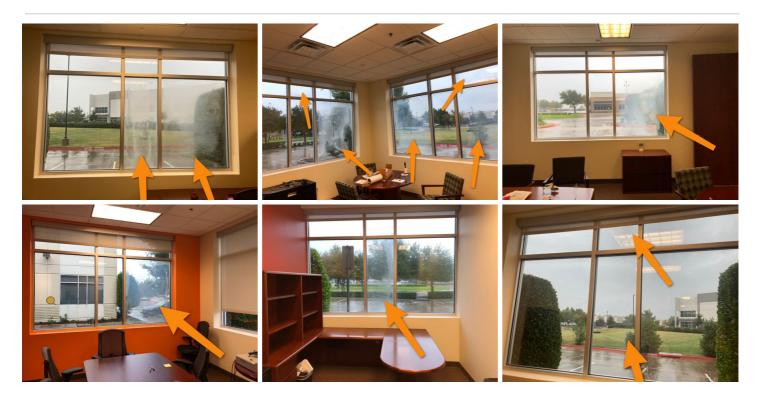
One or more of the windows appeared to have lost their sealed and moisture has entered between the panes of glass

Contact a qualified window repair/installation contractor.

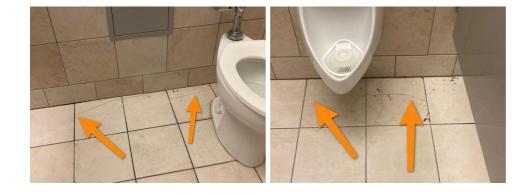
10.3.1 Floors

CRACKED TILE

There was one or more areas observed with cracked tiles at the time of inspection. This condition should be corrected as necessary.

Contact a qualified flooring contractor

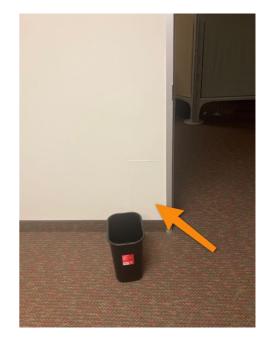
Sub-standard drywall patching observed at time of inspection. Recommend re-patching.

Contact a qualified drywall contractor.

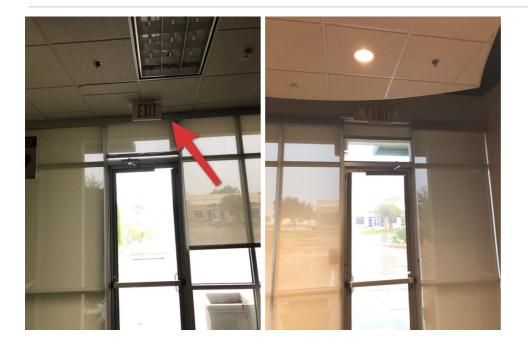
One or more of the emergency exit lights were without power at the time of inspection Recommendation

Contact a qualified electrical contractor.
