## HOME INSPECTION REPORT

1762 NW 57th St Unit 102  
Seattle WA 98107

APRIL 2, 2019

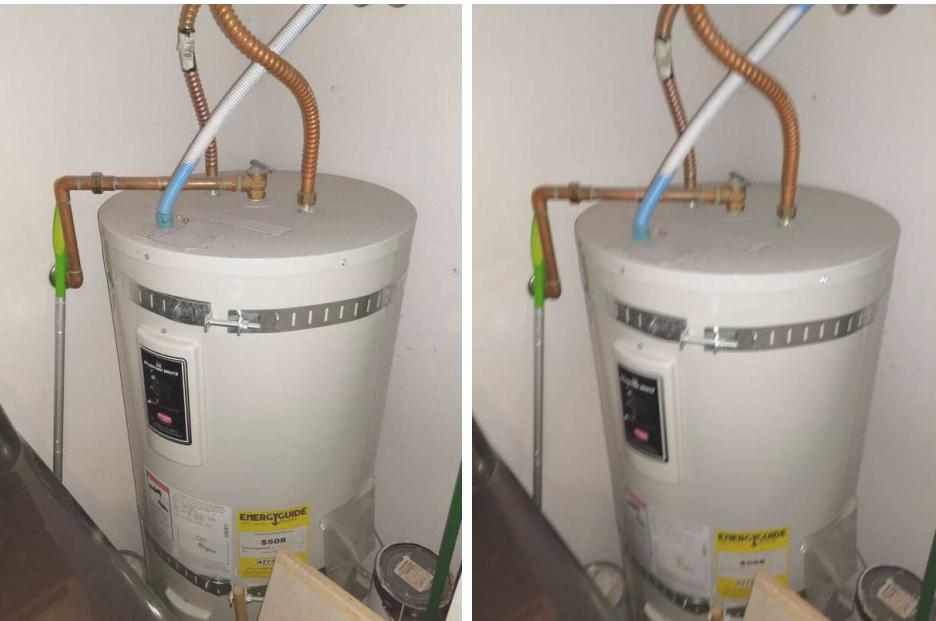
<b>Water Heating System: Energy Source/Type</b> Electric	<b>Water Heating System: Year</b> 2008	<b>Water Heating System: Location</b> Laundry Closet
<b>Water Heating System: Capacity</b> 50	<b>Water Heating System: Middle Age</b>  The water heater is in the middle years of its expected service life.	<b>Main Water Shut-Off, Distribution &amp; Supply: Main Water Shut off Location</b> Not found
<b>Main Water Shut-Off, Distribution &amp; Supply: Water Meter Location</b> Unknown	<b>Main Water Shut-Off, Distribution &amp; Supply: Water Supply Material To House</b> Copper, PVC	<b>Drain, Waste, &amp; Vent Systems: Waste pipe Material</b> ABS
<b>Water Heating System: Manufacturer and picture</b> Bradford & White

I recommend flushing & servicing your water heater tank annually for optimal performance. Water temperature should be set to at least 120 degrees F to kill microbes and no higher than 130 degrees F to prevent scalding.

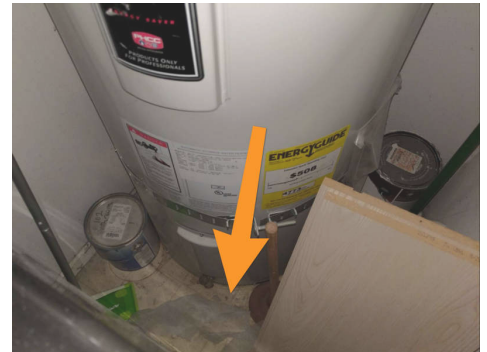
#### 5.1.1 Water Heating System

##### NO DRIP PAN

No drip pan was present to prevent small leaks from causing moisture damage to surrounding area. Recommend installing a drain pan, at least when getting a new water heater.

Recommendation

Contact a qualified plumbing contractor.

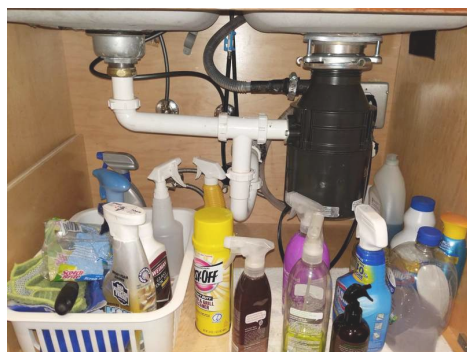
#### Under Sink Photos

The presence of seller's items limited our view of the cabinet and plumbing below the sink.

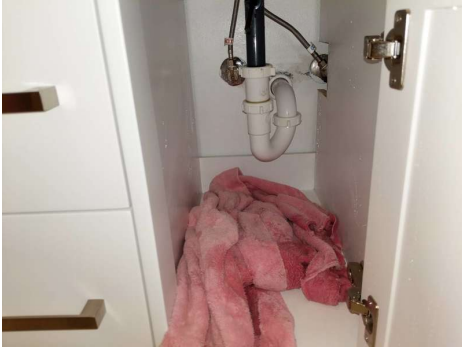
### Below Sink Photos

The presence of seller's items limited our view of the cabinet and plumbing below the sink(s).

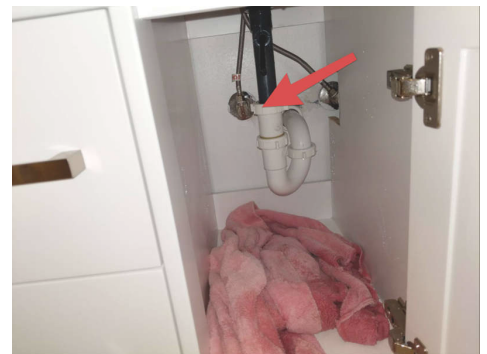
### 8.2.1 Trap and Drain

#### LEAK AT DRAIN LINE BELOW THE SINK

High Priority

There is a leak at the drain line below the sink which should be repaired as necessary.

Recommendation

Contact a qualified professional.
