HOME INSPECTION REPORT

10918 209th Ave East
Bonney Lake WA 98391

APRIL 13, 2018

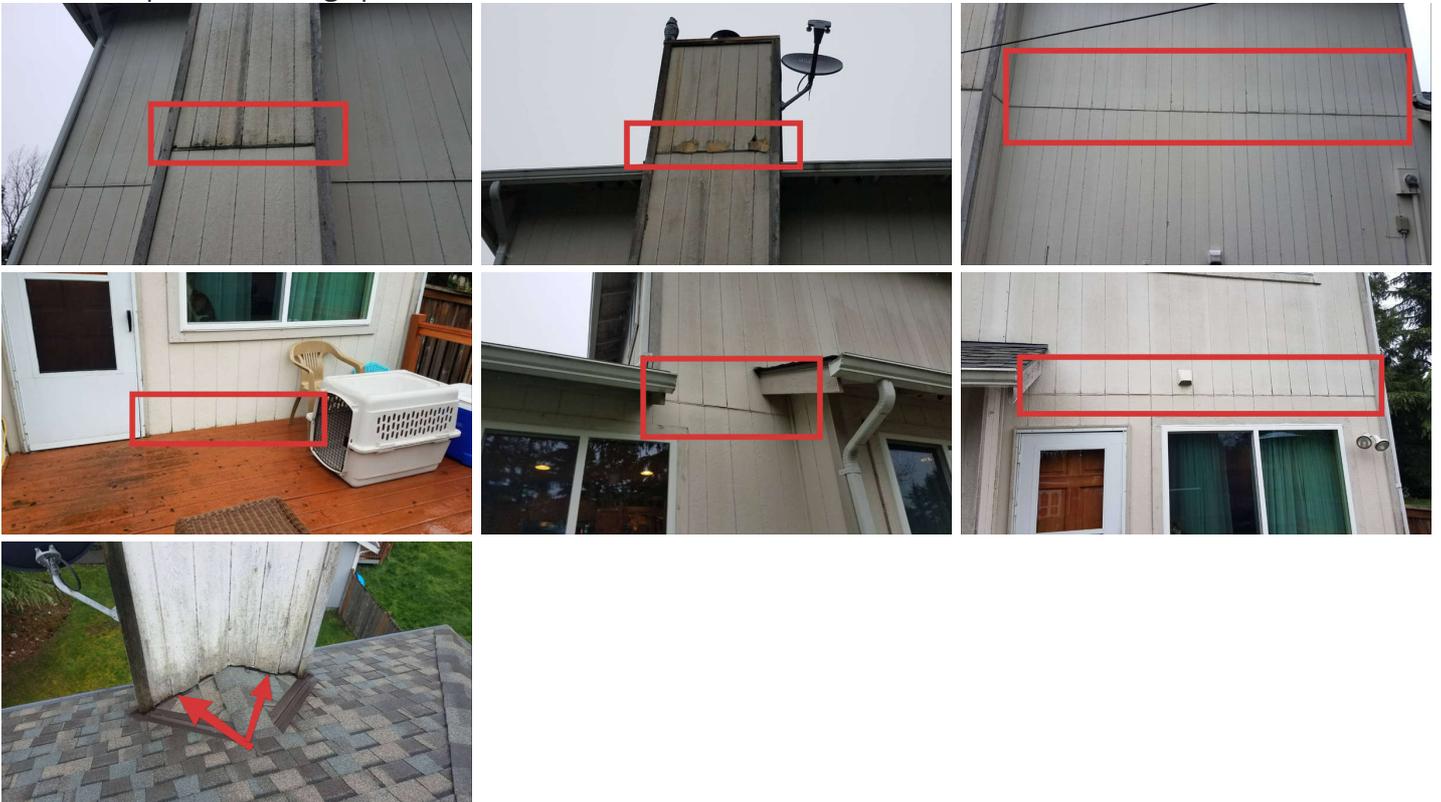
SIDING MOISTURE DAMAGED

Portions of the siding are moisture damaged and should be further evaluated by a contractor.

Contact a qualified siding specialist.

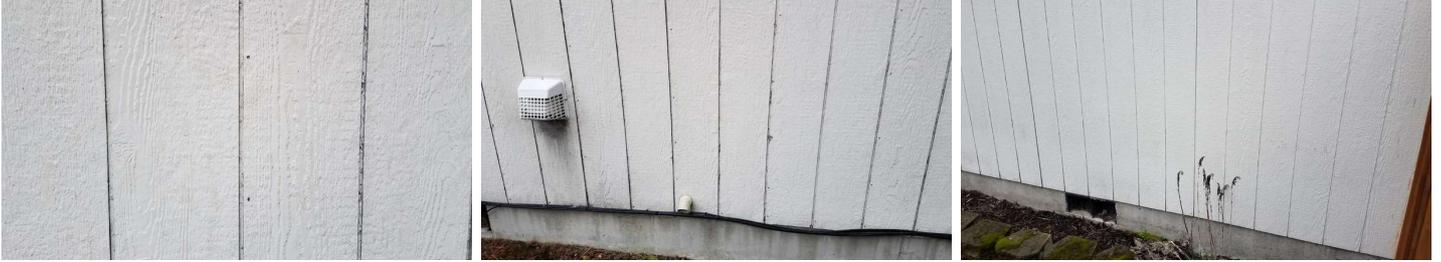
A number of holes or deflections through the surface of the siding material were not properly caulked and sealed. These were caused by driving nails deep into the siding material. This can cause accelerated deterioration of the siding from moisture. Caulking and painting of all nail heads, surface breaks and depressions that have broken through the siding surfaces is recommended.

Contact a qualified professional.

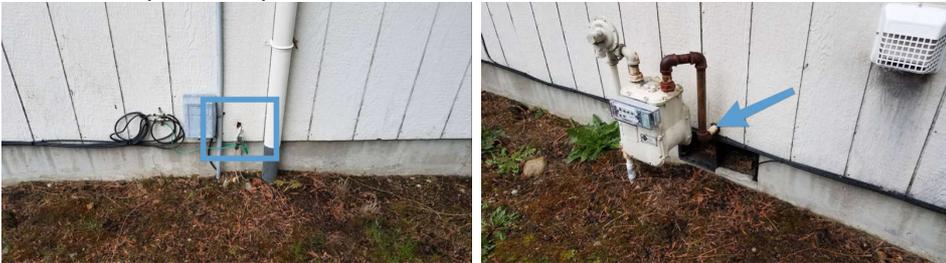
Gaps and/or holes were observed on one or more sides in the siding around plumbing, gas, cable, wiring and/or other penetrations. We advise that all the holes and the gaps be caulked and/or sealed to prevent moisture and/or pest intrusion.

Contact a qualified professional.

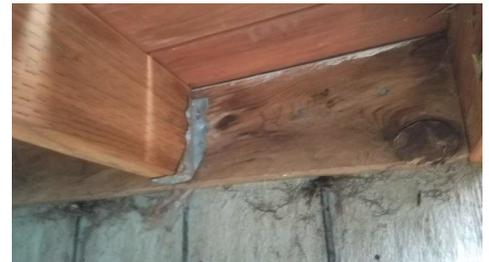
3.16.1 Deck

IMPROPER ATTACHEMENT TO HOUSE

The connection of the deck to the house is lacking lag screws as recommended. Some of the floor joist hangers were also missing nails. We recommend that additional lag bolts be installed to adequately secure the deck to the house and properly securing joists to the house.

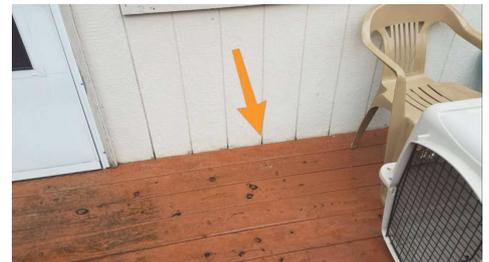
3.16.2 Deck

MISSING FLASHING

There is no flashing where the deck is attached to the Exterior wall connection of the house. This can allow the water to penetrate into the wall. We recommend the deck wall intersection be flashed to prevent water intrusion at this location.

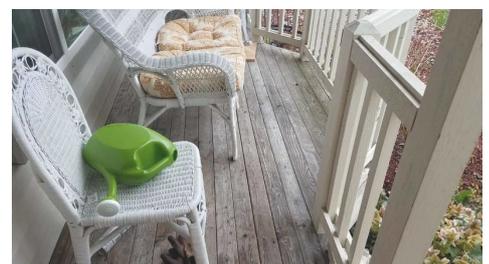
FRONT

Portions of the deck we're weathered and in need of minor repairs and maintenance.

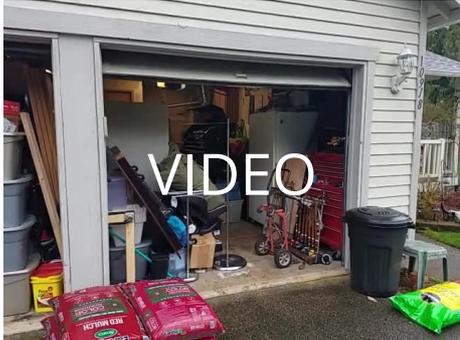
Automatic Opener: Acceptable

The automatic garage door opener is acceptable

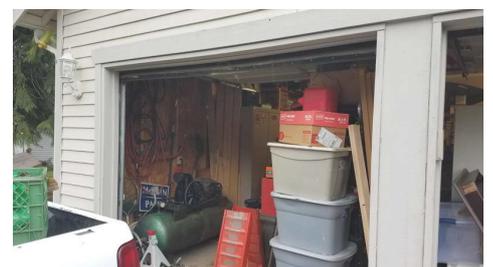
There was not a garage door opener present during the inspection. Recommend installing as desired.

Recommendation

Contact a qualified garage door contractor.

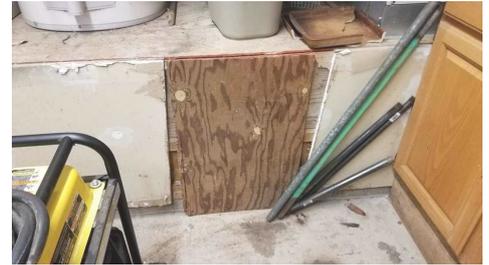
THE VOIDS IN THE GARAGE FIREWALL MUST BE REPAIRED

The voids in the garage firewall must be repaired, in order to maintain the necessary firewall separation between the garage and the residence.

Contact a qualified professional.

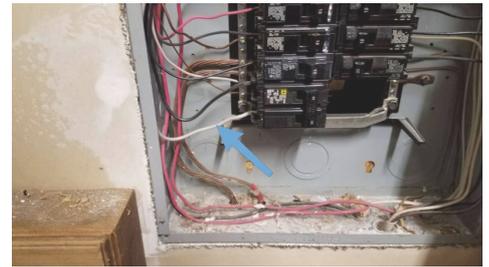
Neutral wires (white) which are being used as hot power, were not taped to show use as HOT. Recommend that black electrical tape be installed on these white wires.

Contact a qualified professional.

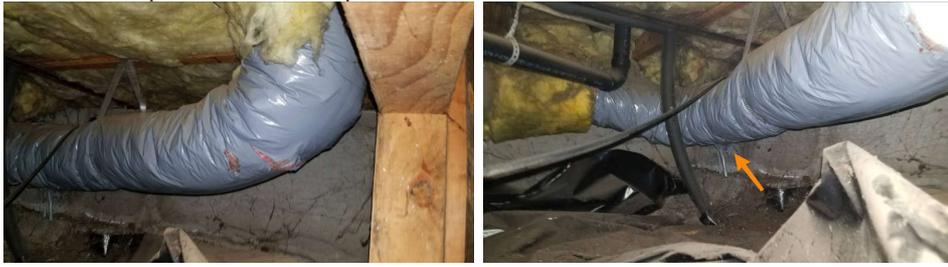
OUTER SLEEVE DAMAGED

The ducts are a modern flexible type that are comprised of an outer plastic sleeve and a clear inner liner that contains fiberglass insulation. However, portions of the outer sleeve are damaged and the ducting should be replaced.

Contact a qualified HVAC professional.

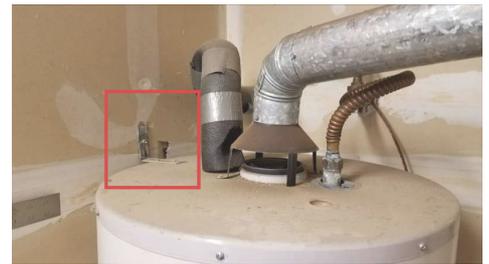
SEISMIC STRAPS - MISSING/INSUFFICIENT

The hot water heater was missing seismic straps or was insufficiently anchored. Recommend two straps to properly secure water heater in the case of an earthquake.

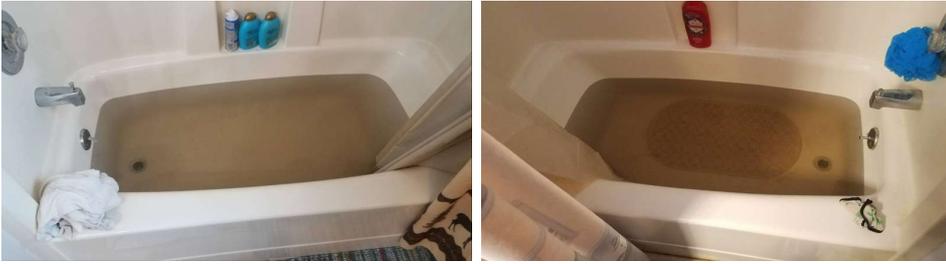
The hot water at the fixtures was discolored. This may be related to the age of the water heater. We recommend flushing the water heater. If discoloration continues, further evaluation may be needed.

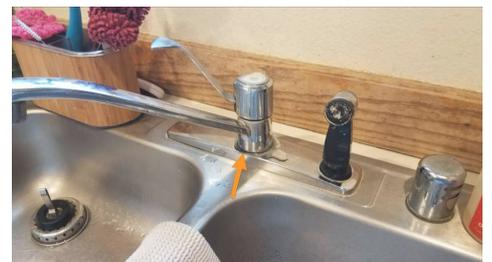
FAUCET LEAKS AROUND THE STEM

The kitchen faucet leaks around the stem while in use, which is indicative of a defective seal, and should be repaired or replaced as necessary.

Contact a qualified handyman.

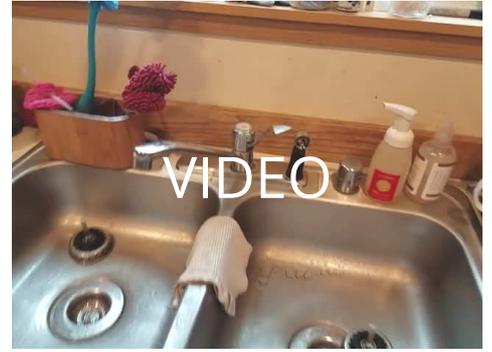
The faucet has no on/off stop. The faucet just turns.
SUGGESTION: We recommend repair.

Contact a qualified professional.

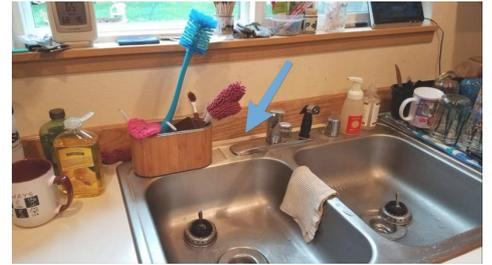
A typical separation between the kitchen countertop and the backsplash should be grouted or caulked to forestall moisture intrusion in the kitchen.

Recommended DIY Project

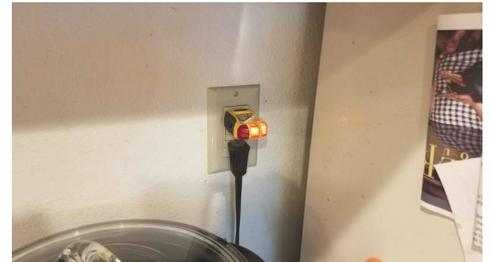
The GFCI outlet worked but didn't trip when tested. Recommend replacement of the outlet.

Contact a qualified electrical contractor.

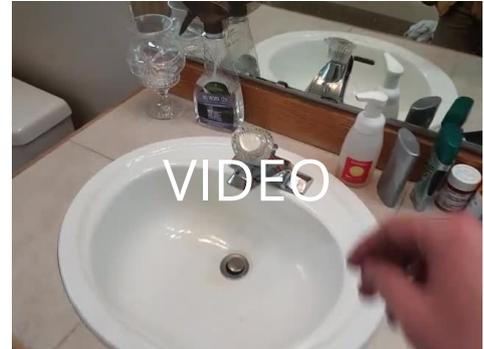
The sinkstopper does not work properly and repair is recommended.

Contact a qualified handyman.

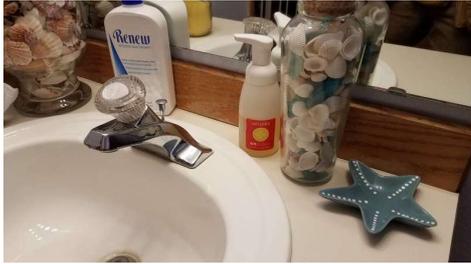
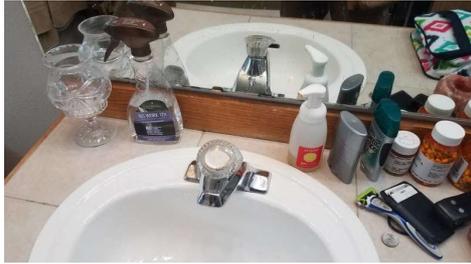
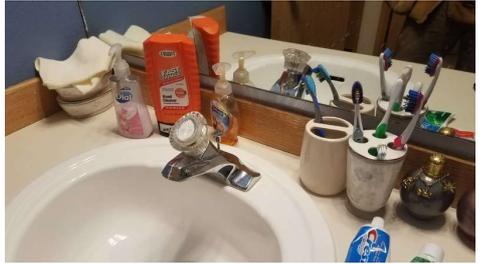
11.14.1 Outlets, Electrical Observations

REVERSED POLARITY ON OUTLET

Recommendation

Contact a qualified electrical contractor.

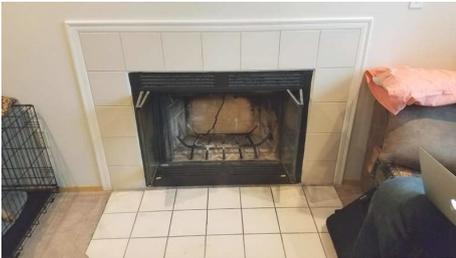
Fireplace Notes: Type of fireplace & Photo

Wood Burning

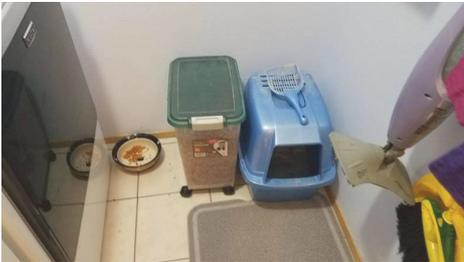
There are pets in the home which you can smell and getting the carpets professionally cleaned is recommended. Further evaluation with urine stain identifying equipment would be appropriate. This type of testing is beyond the scope of a home inspection.

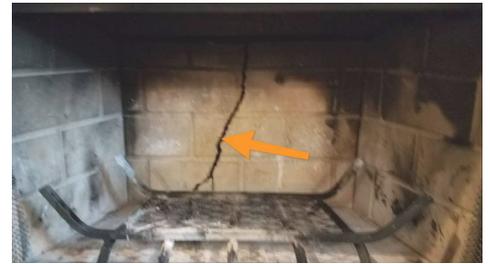
FIREPLACE NEEDS REPAIRS

The fireplace is in need or repairs prior to use.

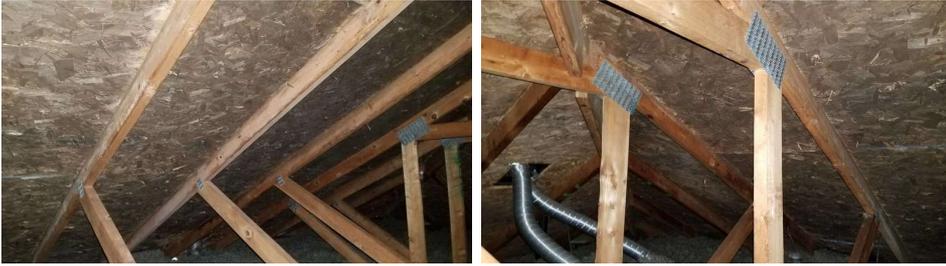
DECK STAINING

Discoloration and dark staining was observed on the roof sheathing. This is often caused by poor ventilation and is commonly considered a microbial growth. Recommend improving ventilation and cleaning.

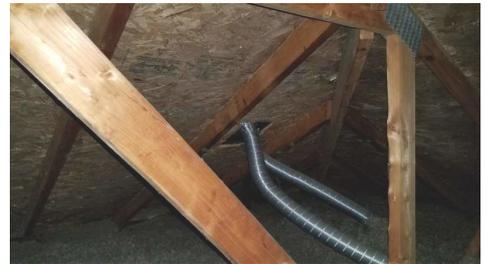
BATHROOM EXHAUST EXTEND TO EXTERIOR

The bathroom exhaust duct should be extended to an exterior vent port.
